ARCHITECTURAL CONSERVATION REPORT

*MASONRY STABILIZATION*  
*AT TYUONYI PUEBLO (LA 00082)*  
*2007*

# **Bandelier National Monument**

### *Masonry Stabilization at Tyuonyi Pueblo, 2007*

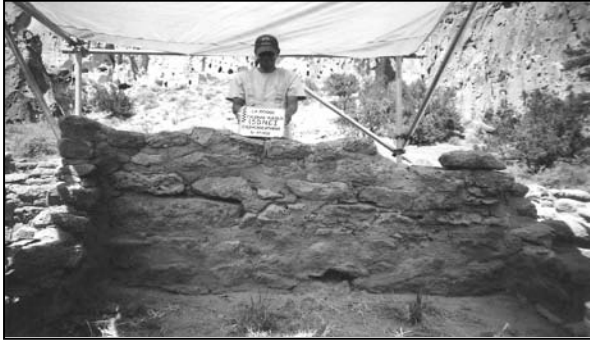
**Before**

Specially trained masons have been stabilizing and repairing the fragile walls of Tyuonyi Pueblo since the 1930s. The “before” picture, below left, shows the cement mortar that was used to stabilize the walls through the 1990s. We now know that the hard cement mortar damages the soft volcanic stone. Beginning in 2001, masons began removing the old mortar and replacing it with a more compatible earthen mixture. The “after” picture, below right, shows the same wall after treatment. The project will continue until all of the walls in Tyuonyi Pueblo have been repaired.

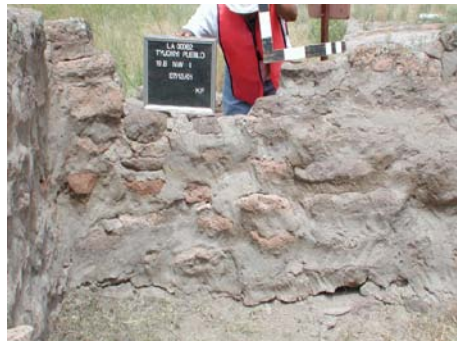
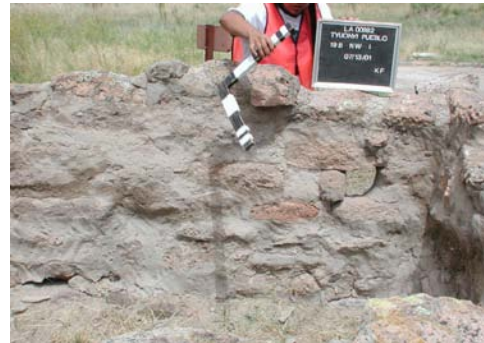
Some walls in Tier 19 were severely smeared with cement to the extent that individual stones were difficult to identify in the 2001 digital image. Consequently, we learned to clean out as much mortar as possible before disassembling the wall. Then take a current digital photo, and use this image to document the treatment and to help replace the stones in an historical pattern. The 2001 image is stored in the other side of the acetate sleeve for that wall.

**19B NW I, smeared with cement (2001 photo)**

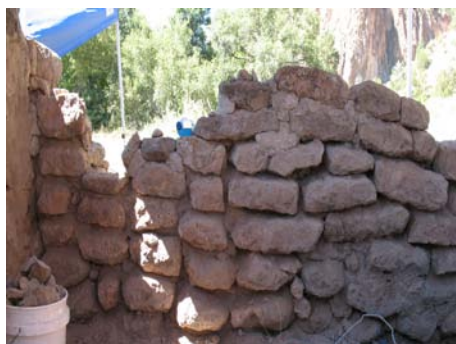
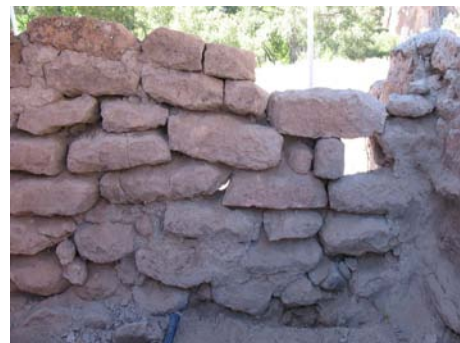
**19 B NW I, after cleaning out joints and exposing the stones**

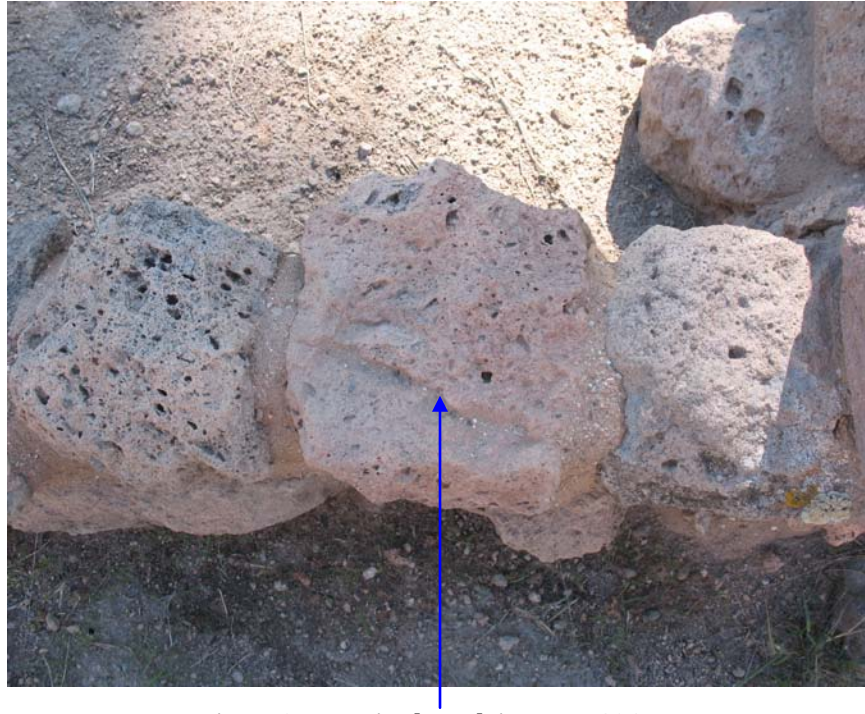
**Figure 8: Repaired crack in stone, 30CNE**

Cracked stones may present stabilization problems, however they are part of the historic fabric and should be kept in place if not compromising the overall stability of the wall. A combination of concentrated El Rey 200, crushed tuff, and the amended mortar mix in a watery mixture was used in attempts to cement, or glue, broken stones. Instead of buttering the faces with mortar as in past attempts, the stones were pressed together along the fracture zone and the slurry was dripped into the void and allowed to dry. Wall 30CNE contains two broken stones repaired in this manner and should be periodically checked (see Graphic Documentation Forms for location of the stones).
