# **Graffiti Mitigation at Bandelier National Monument**

**Prepared for the National Park Service  
by the School of Architecture and Planning  
University of New Mexico, 2010**

# Graffiti Mitigation

## Frijoles Canyon Cavates 2010

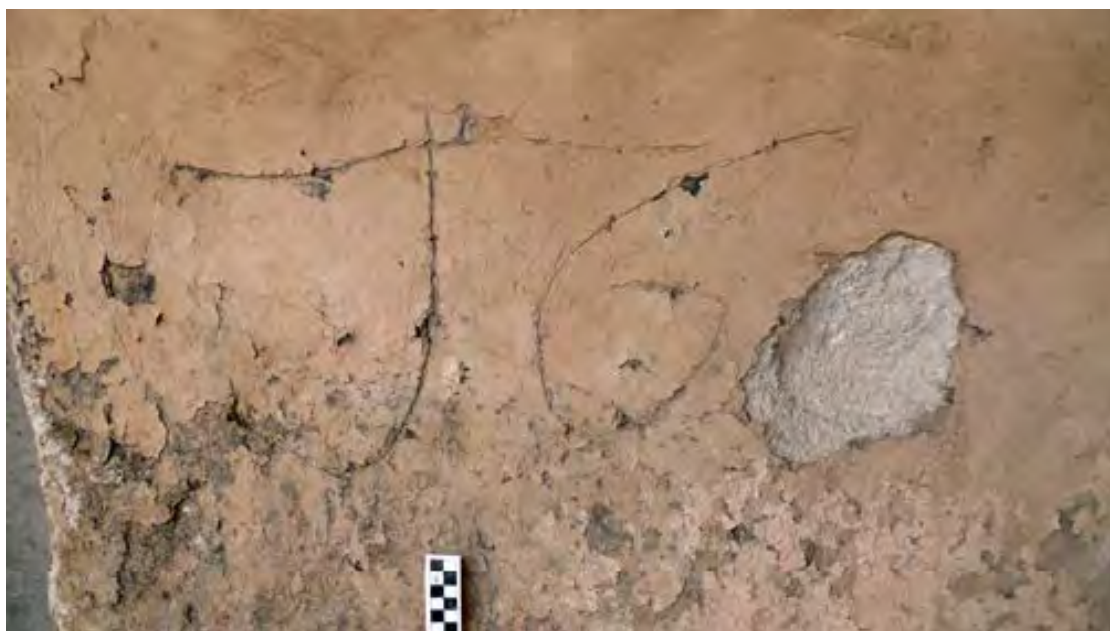
**Before Photo**

**Treatment location:** south wall**Height from floor:** 43 cm**Type of graffiti:** incised**Substrate:** earthen plaster and tuff**Area of damage (l x h):**

**Number of plaster layers penetrated:** 3**Is tuff exposed?** yes**Additional incision damage? (describe):** flaking of plaster around incision**New graffiti since 2004? (photo comparison):** no**Notes:**

1. Removed loose tuff particles and dust from incised graffiti with small brush and air bulb.
2. Wet the treatment area with water.
3. Applied a slip (watery mortar consisting of clay #2 : wash silt (1:1) to the scratched area.
4. Filled the graffiti with multiple thin layers of mortar (clay #2 : wash silt (1:1) and pressed it into the void with a microspatula, compacting the mortar.
5. Finished plaster infill by marking it with a bamboo skewer and stiff dry brushes to match surrounding texture.
6. Applied a slip with a small sponge (clay #2 : clay #1 : wash silt (1:1:2) to match the original plaster texture and color.

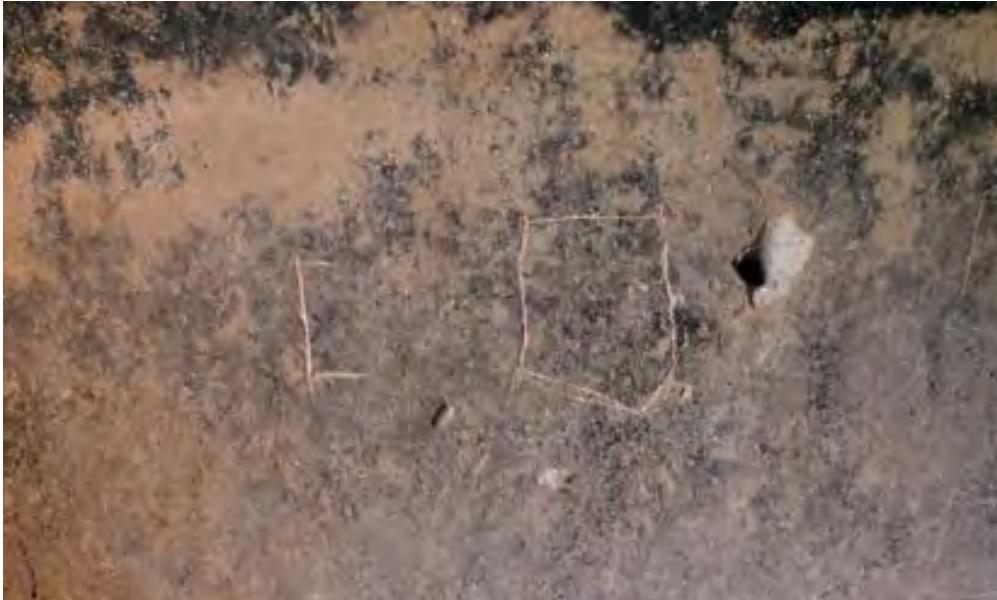
**Before Photo**

**Treatment location:** west wall**Height from floor:** 34 cm**Type of graffiti:** incised**Substrate:** earthen plaster and tuff**Area of damage** (l x h):

**Number of plaster layers penetrated:** 3**Is tuff exposed?** yes**Additional incision damage? (describe):** flaking of plaster around incision**New graffiti since 2004? (photo comparison):** no

1. Removed loose tuff particles and dust from incised graffiti with small brush and air bulb.
2. Wet the treatment area with water.
3. Applied a slip (watery mortar consisting of clay #2 : wash silt (1:1) to the scratched area.
4. Filled the graffiti with multiple thin layers of mortar (clay #2 : wash silt (1:1) and pressed it into the void with a microspatula, compacting the mortar.
5. Finished plaster infill by marking the surface with a bamboo skewer and dabbing a very light coating of slip onto the repair with a small sponge to match the original plaster texture and color.

Paint (pigment in water) was lightly stippled onto the infilled treatment area to match the surrounding sooted plaster. Only the repair was inpainted.

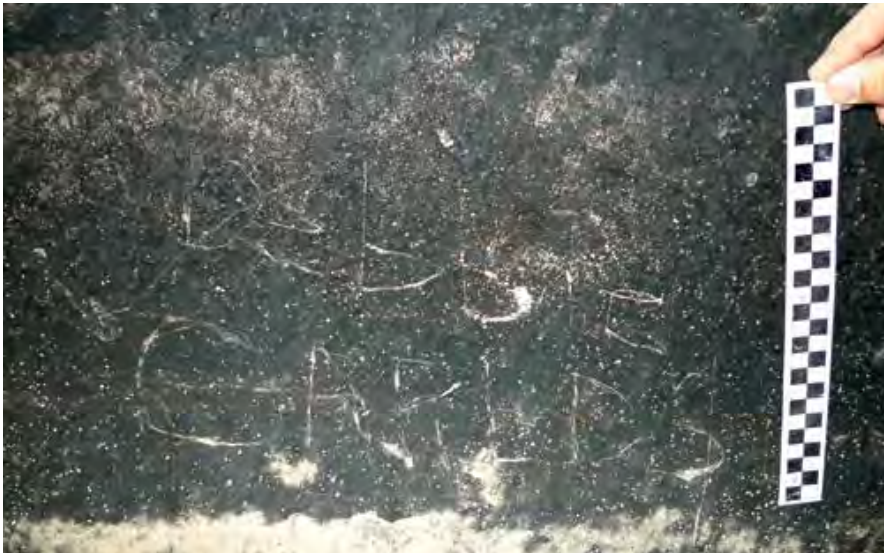
**Before Photo**

**Treatment location:** west wall**Height from floor:** 60 cm**Type of graffiti:** incised**Substrate:** earthen plaster and tuff**Area of damage** (l x h):  
36 cm X 22 cm**Depth of Incision** (deep x across):  
1 mm X 1-2 mm**Number of plaster layers penetrated:** 1**Is tuff exposed?** no**Additional incision damage? (describe):** none**New graffiti since 2004? (photo comparison):** no

1. Removed loose tuff particles and dust from incised graffiti with small brush and air bulb.
2. Wet the treatment area with water.
3. Applied a slip (watery mortar consisting of clay #2 : wash silt (1:1) to the scratched area.
4. Filled the graffiti with multiple thin layers of mortar (clay #2 : wash silt (1:1) and pressed it into the void with a microspatula, compacting the mortar.
5. Finished plaster infill by dabbing a very light coating of slip onto the repair with a small sponge to match the original plaster texture and color.

1. Lightly stippled the paint (pigment in water) onto the infilled treatment area to match the surrounding sooted plaster. Only the repair was inpainted.
2. Applied sieved grey tuff with a dry brush to further camouflage infill.

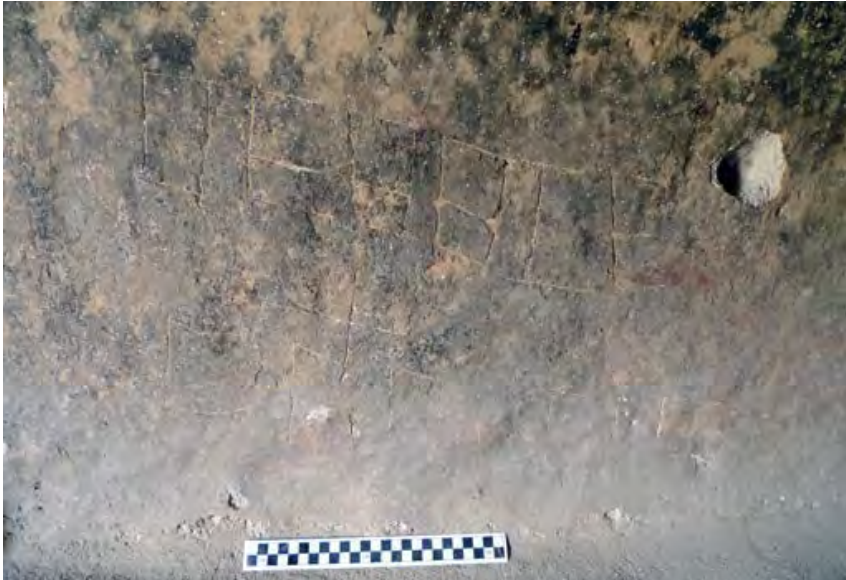
**Before Photo**

**Treatment location:** west wall**Height from floor:** 9 cm**Type of graffiti:** incised**Substrate:** earthen plaster**Area of damage** (l x h):

**Number of plaster layers penetrated:** 1**Is tuff exposed?** no**Additional incision damage? (describe):** none**New graffiti since 2004? (photo comparison):** no

1. Removed loose tuff particles and dust from incised graffiti with small brush and air bulb.
2. Wet the treatment area with water.
3. Applied a slip (watery mortar consisting of clay #2 : wash silt (1:1) to the scratched area.
4. Filled the graffiti with multiple thin layers of mortar (clay #2 : wash silt (1:1) and pressed it into the void with a microspatula, compacting the mortar.
5. Finished plaster infill by marking with a rock and dabbing a very light coating of slip onto the repair with a small sponge to match the original plaster texture and color.
6. A dry black pigment was also applied with a brush for color matching.

Paint (pigment in water) was lightly stippled onto the infilled treatment area to match the surrounding sooted plaster. Only the repair was inpainted.

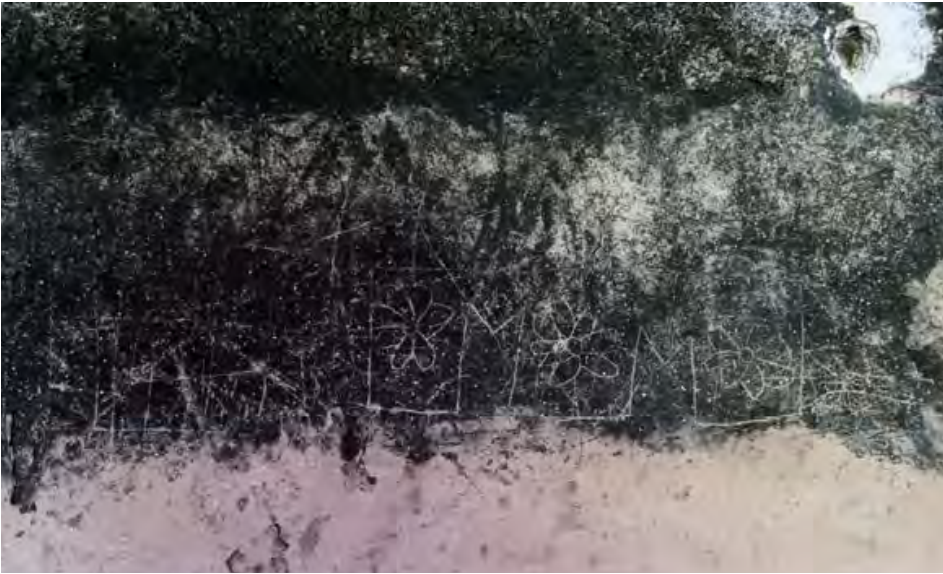
**Before Photo**

**Treatment location:** north wall**Height from floor:** 63 cm**Type of graffiti:** incised**Substrate:** earthen plaster**Area of damage** (l x h):  
29 cm X 9 cm**Depth of Incision** (deep x across):  
<1 mm X 1-2 mm**Number of plaster layers penetrated:** none**Is tuff exposed?** no**Additional incision damage? (describe):** none**New graffiti since 2004? (photo comparison):** no**Notes:**

Paint (pigment in water) was lightly stippled onto the infilled treatment area to match the surrounding sooted plaster.

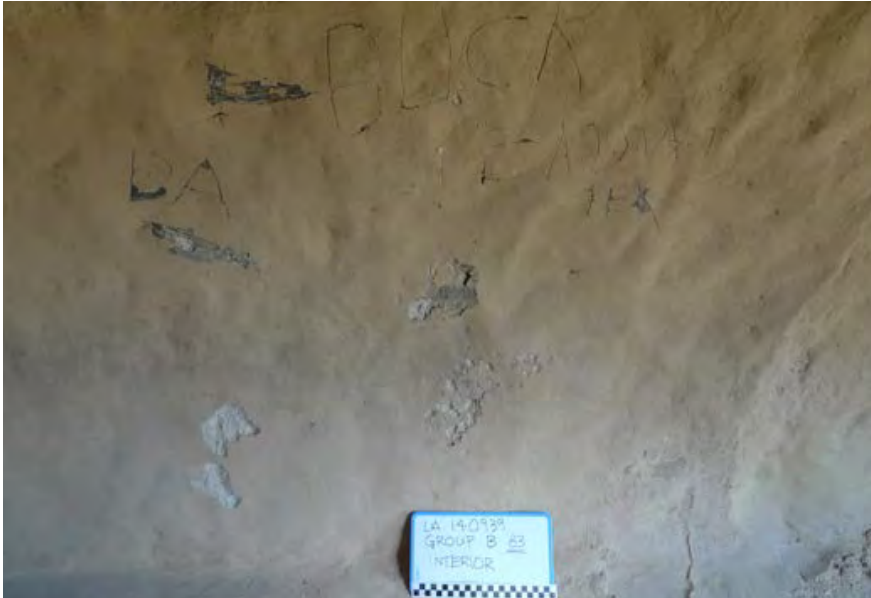
**Before Photo**

**Treatment location:** northeast wall**Height from floor:** 68 cm**Type of graffiti:** incised**Substrate:** earthen plaster and tuff**Area of damage** (l x h):  
90 cm X 33 cm**Depth of Incision** (deep x across):  
1 mm X 1-2 mm**Number of plaster layers penetrated:** 1**Is tuff exposed?** yes**Additional incision damage? (describe):** flaking of plaster around incision**New graffiti since 2004? (photo comparison):** no**Notes:**

1. Removed loose tuff particles and dust from incised graffiti with small brush and air bulb.
2. Wet the treatment area with water.
3. Applied a slip (watery mortar consisting of clay #2 : wash silt (1:1) to the scratched area.
4. Filled the graffiti with multiple thin layers of mortar (clay #2 : wash silt (1:1) and pressed it into the void with a microspatula, compacting the mortar.
5. Finished plaster infill by dabbing a very light coating of slip onto the repair with a small sponge to match the original plaster texture and color.

An earthen slip was applied alternately with a sponge and brushes to the infill to match the texture and the color of the surrounding original plaster.

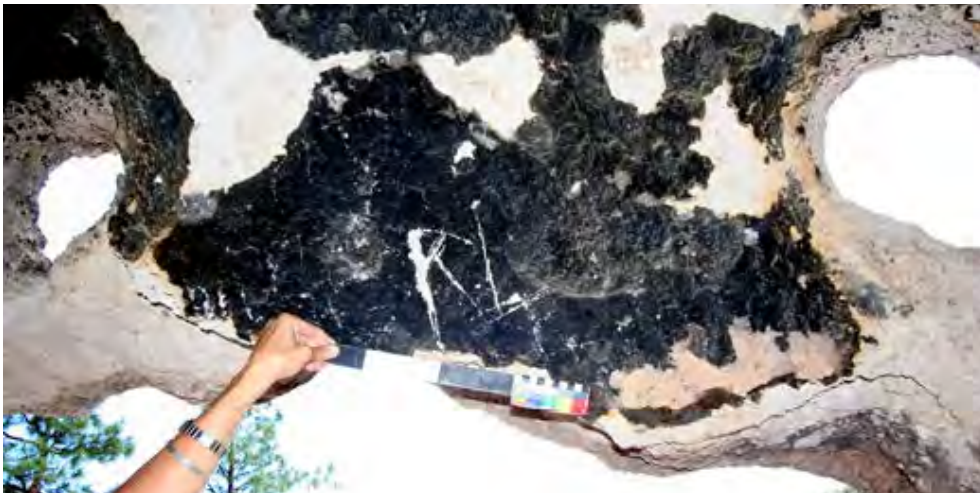
## Before Photo

**Treatment location:** south ceiling**Height from floor:** 184 cm**Type of graffiti:** incised**Substrate:** tuff**Area of damage** (l x h):  
15 cm X 18 cm**Depth of Incision** (deep x across):  
1-10 mm X 1-15 mm**Number of plaster layers penetrated:** none**Is tuff exposed?** yes**Additional incision damage? (describe):** none**New graffiti since 2004? (photo comparison):** no**Notes:**

1. Removed loose tuff particles and dust from incised graffiti with small brush and air bulb.
2. Wet the treatment area with water.
3. Applied a slip (watery mortar consisting of wash silt : hydrated hydraulic lime (HHL) (2:1) to the scratched area.
4. Filled the graffiti with multiple thin layers of mortar and pressed it into the void with a piece of pumice. The rock compacted the mortar and gave it an uneven texture.

1. Stippled black watercolor along edges of repair mortar to blend the sharp lines with the surrounding sooted tuff.
2. Brushed or sprayed one coat of the acrylic emulsion in water to the surface of the repair mortar to ensure paint and pigment adhesion.
3. Sponged or brushed dry black pigments on the repair surface to match the repair to the surrounding granular texture and color of the tuff.
