**VICKSBURG NATIONAL MILITARY PARK  
SHIRLEY HOUSE**

**HISTORIC STRUCTURE  
REPORT**

**Cultural Resources, Southeast Region  
National Park Service**

**2004**

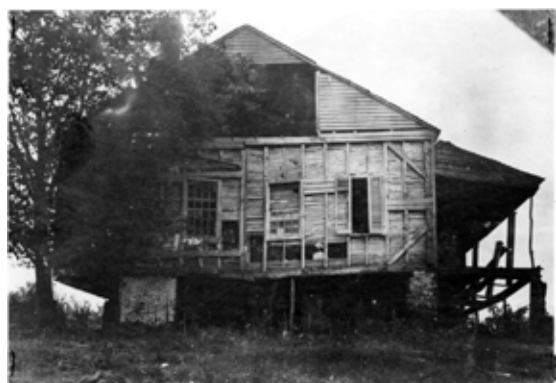
**Figure 10** View of east end of house, 1900. HABS File No. MISS, 75-VICK, V. 3-8.

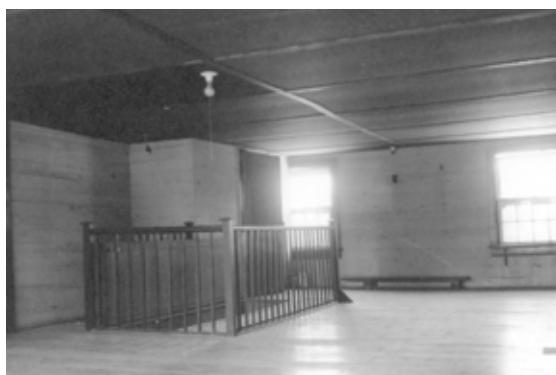
**Figure 18** View north in Room 200, May 1965, showing fiber board ceiling installed by Major Holt in 1931. VICK Coll.

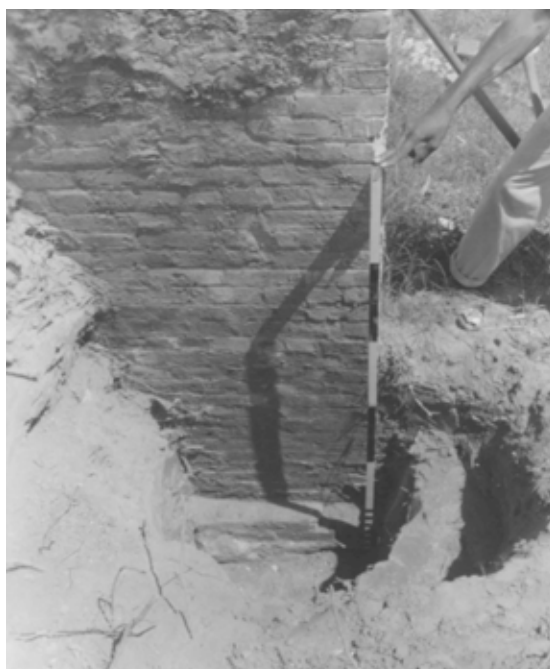
**Figure 27** Excavated foundation at southeast corner of house, 1965. VICK Coll.

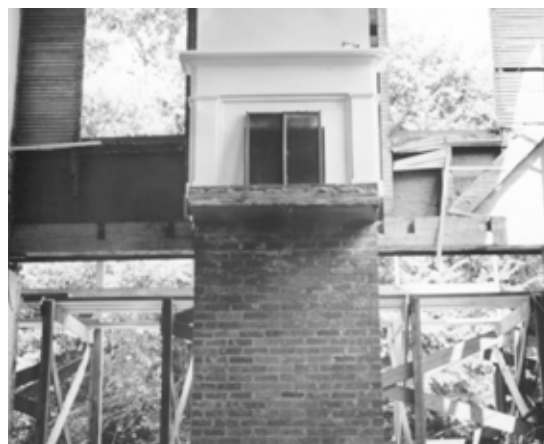
**Figure 31** View east after removal of floor in Room 105, May 1966. VICK Coll.
