Fort Point National Historic Site  
Golden Gate National Recreation Area

## Abbreviated Fort Point Historic Structure Report

September 2006

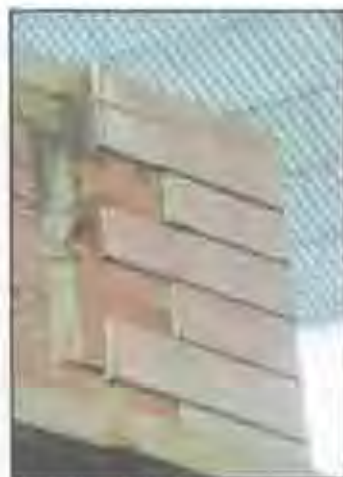
Lateral displacement is evident in the south flank parapet. (Jane Lehman, 2005)

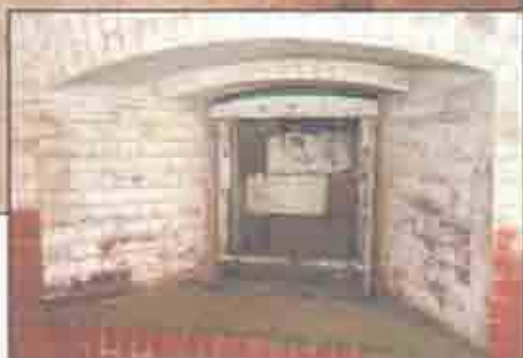
Most of the iron embrasures have deteriorated over the years and the openings have been infilled with brick and block for security purposes. (John Martini, 2005)

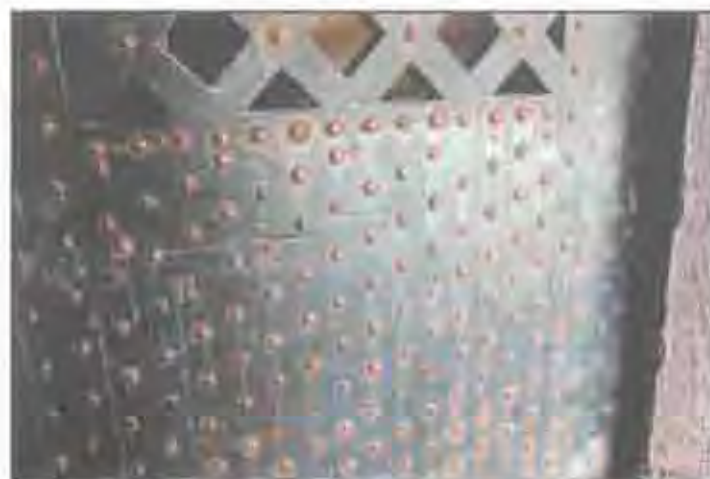
The original granite floors remain in good condition although a large concrete patch exists where a previous water line was installed. (John Martini, 2005)

The rivets on the original wood doors rust quickly in the marine environment. (John Martini, 2005)

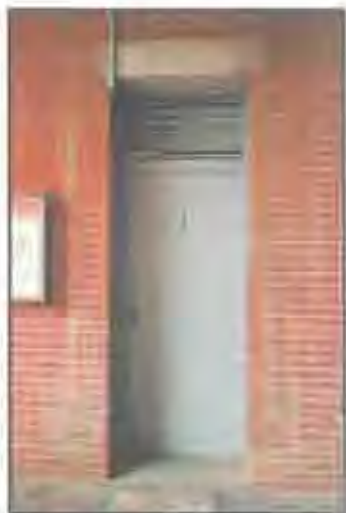
The transom windows above the 3rd tier gallery doors were replaced with wood louvers. These louvers need to be replaced because they are all installed backwards. (John Martini, 2005)

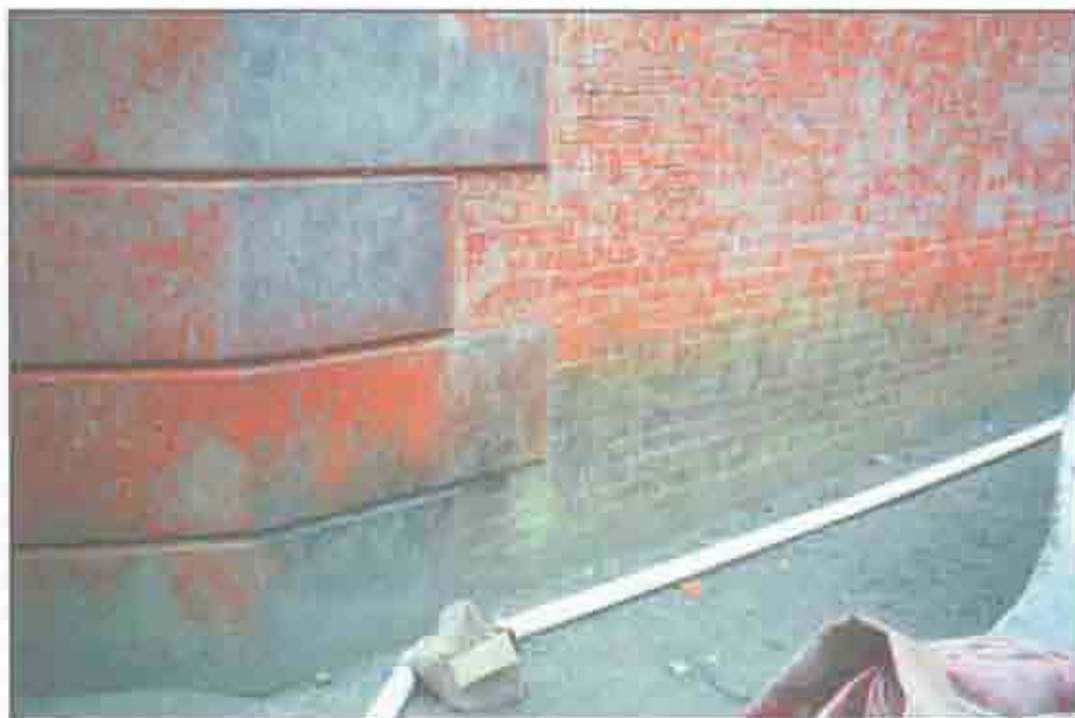
Condition Photo 2:  
Intersecting Arch of Casements  
98 and 99; Biological growth and  
efflorescence settle on masonry  
surfaces. (Courtesy of ARG, 2003)

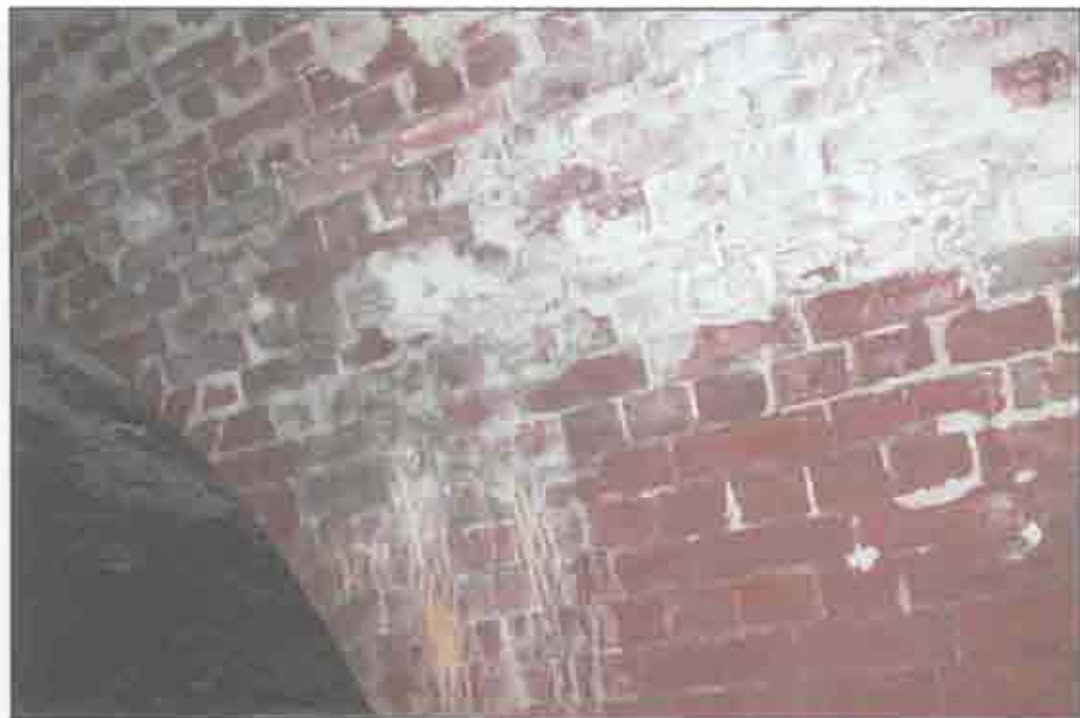
Condition Photo 3:  
Casemate 101; Calcium deposits  
are draining from open joints  
and coating is no longer extant.  
(Courtesy of ARG, 2003)

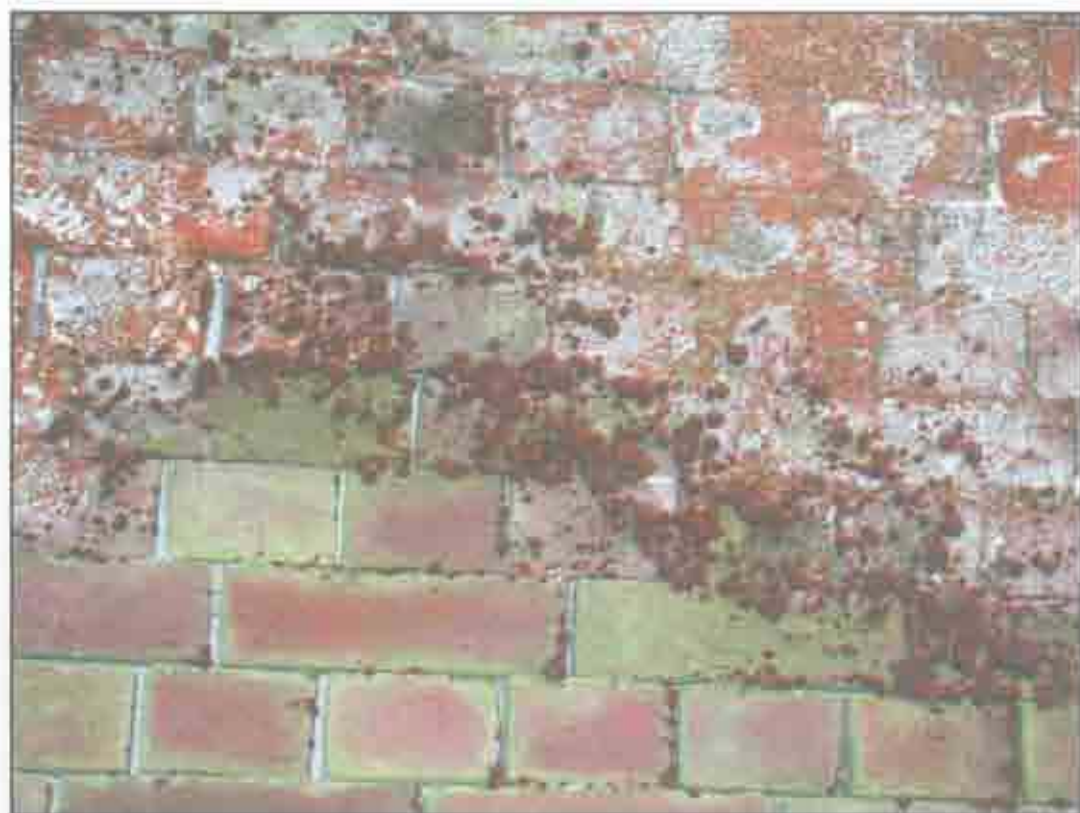
Condition Photo 4:  
Casemate 100; Biological growth and  
salts on masonry surface.  
(Courtesy of ARG, 2003)

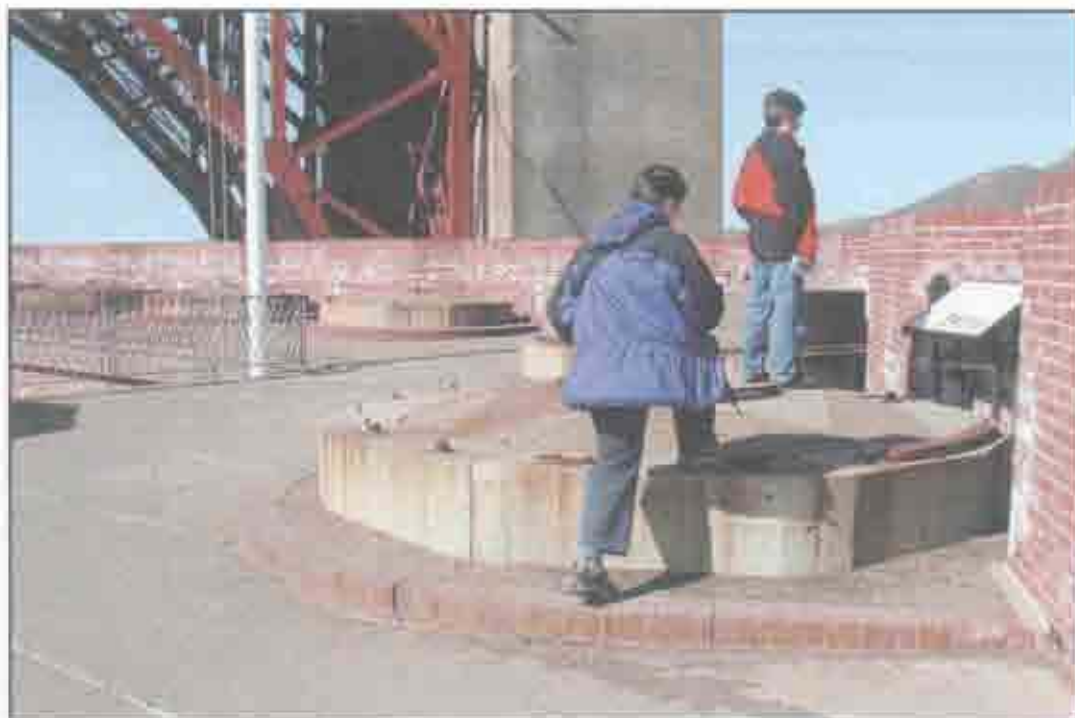
Condition Photo 6:  
Top Landing at Barbetta Tier; Crack  
in granite. (Courtesy of ARG, 2003)

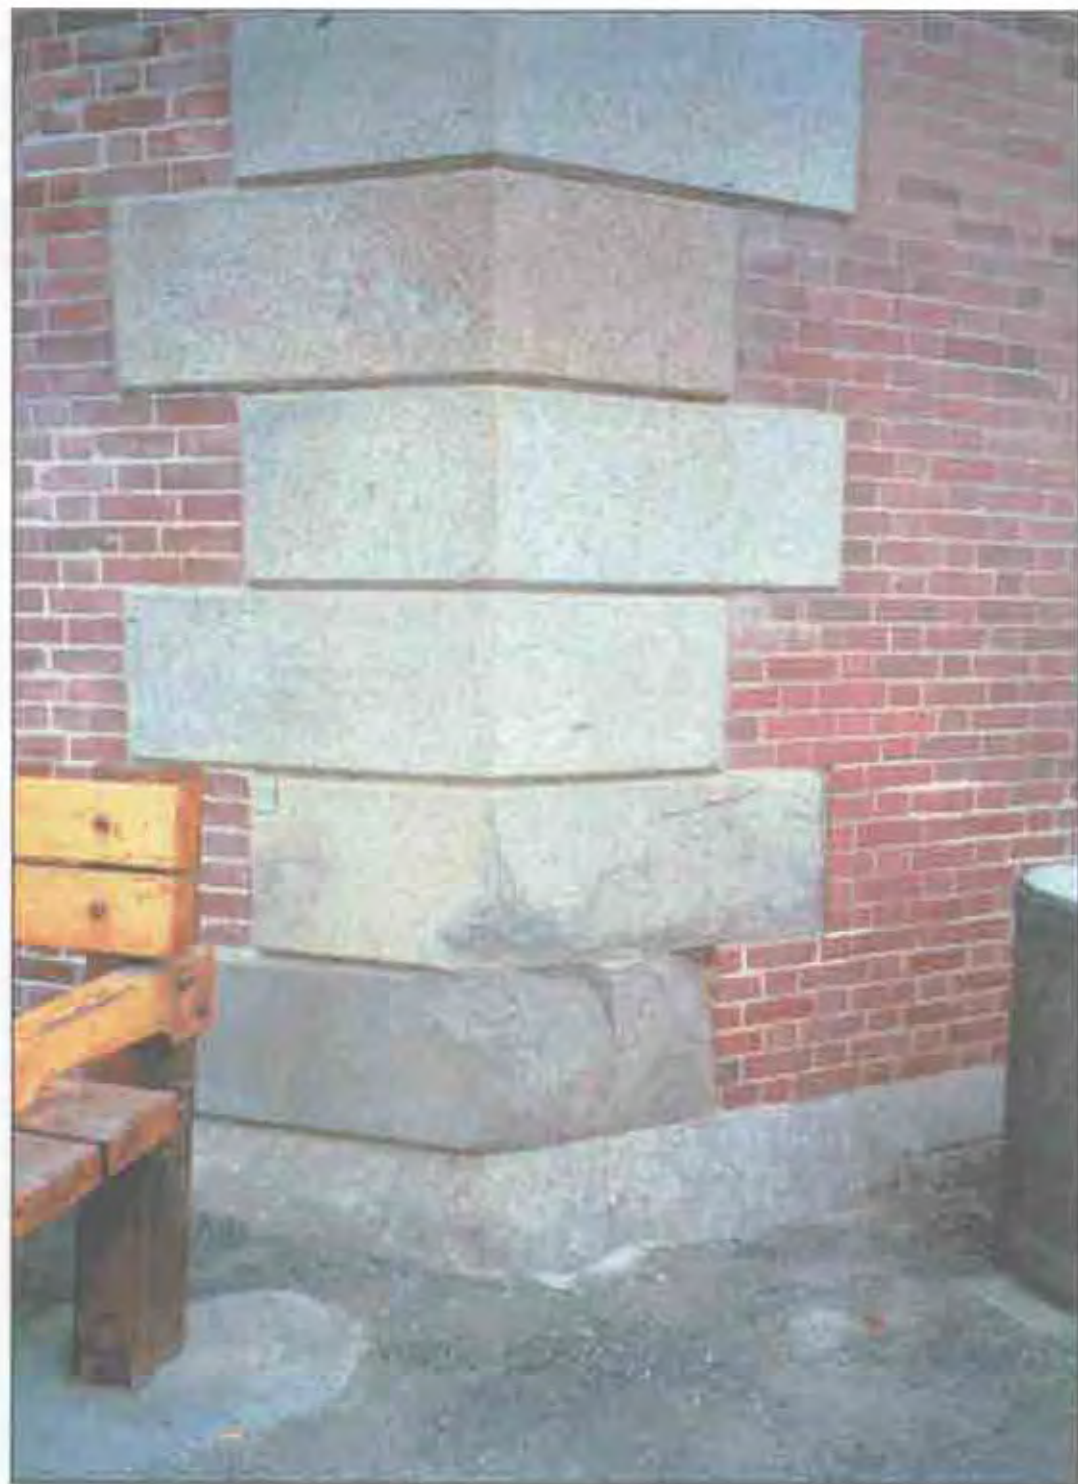
Condition Photo 7:  
East Bastion—East Hank; impact  
damage at granite quoins and base.  
(Courtesy of ARG, 2003)

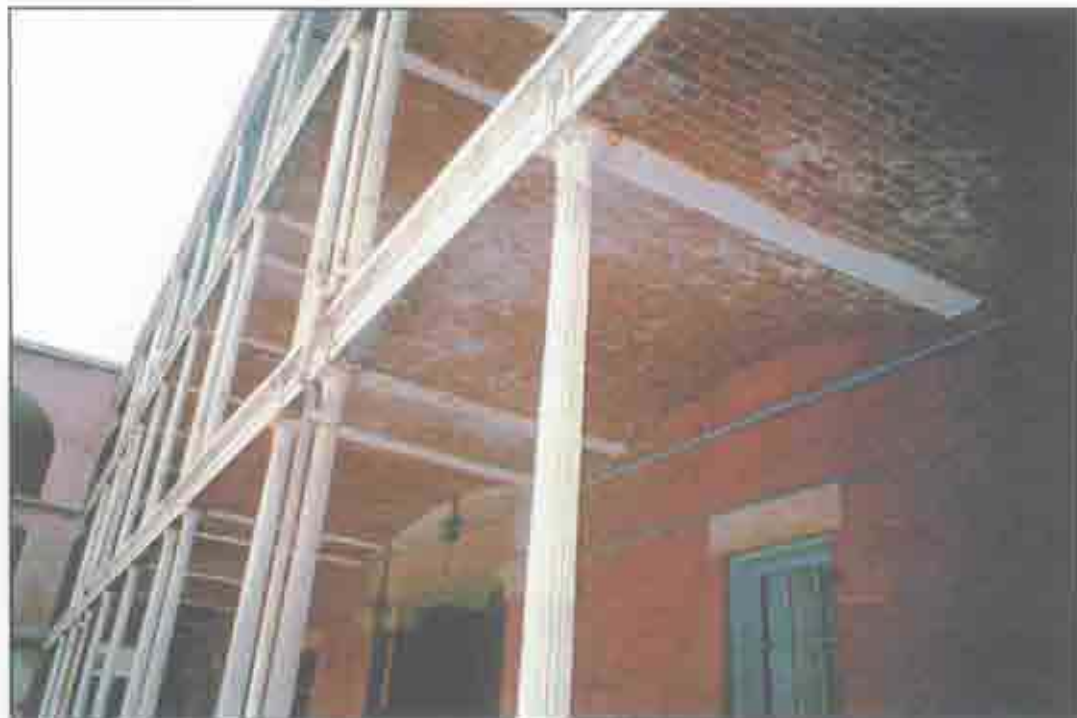
Condition Photo 10:  
Southeast Face Courtyard: Corroding  
metal columns and walkway  
supports. Missing metal railings in  
this photo have been reinstalled.  
(Courtesy of ARG, 2003)

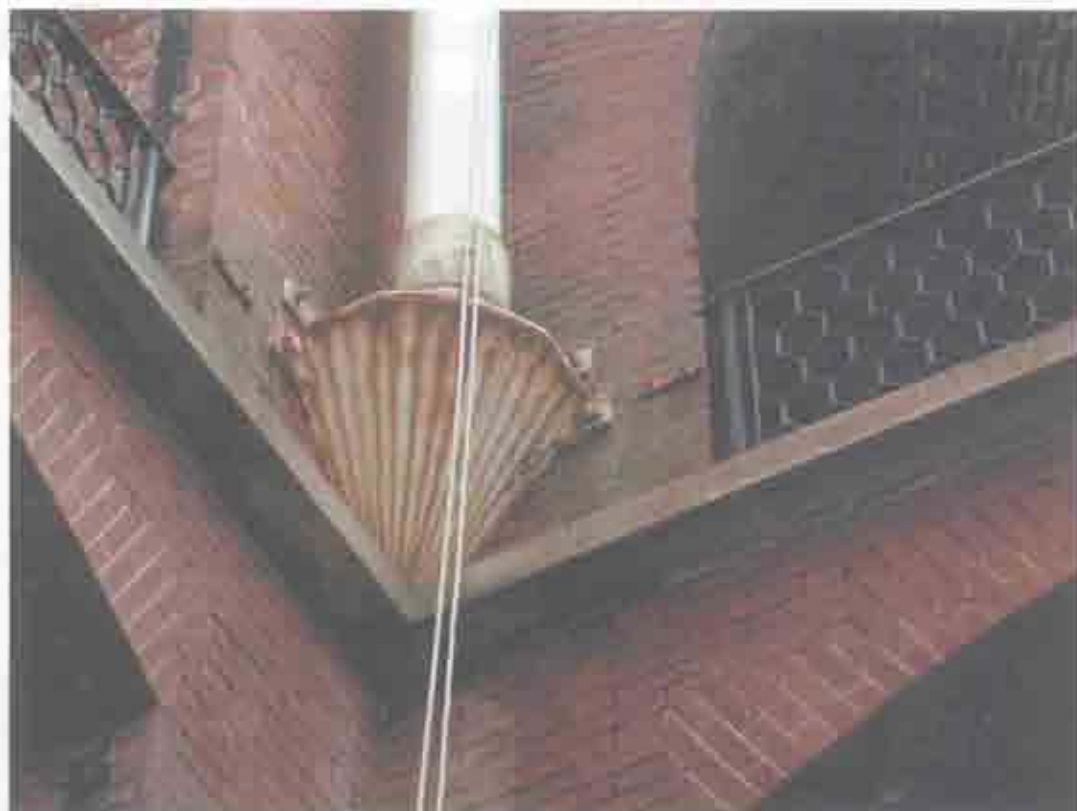
Condition Photo 11:  
Biological growth on flagpole.  
(Courtesy of ARG, 2003)

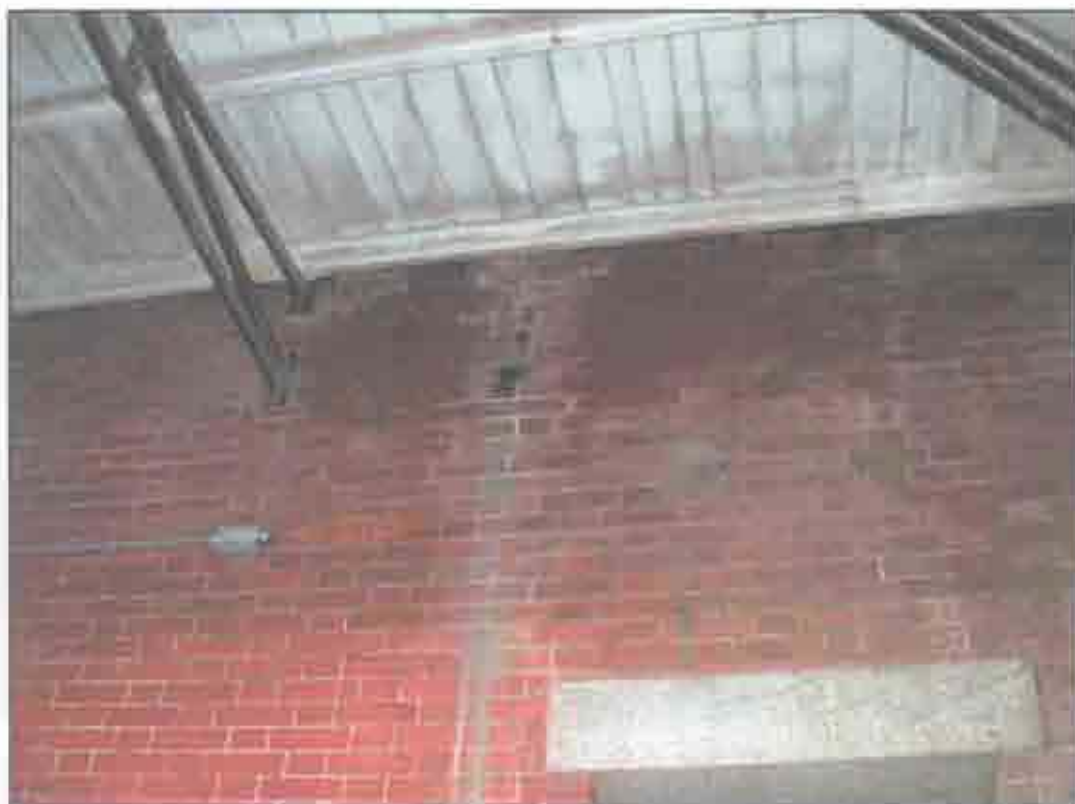
Condition Photo 13:  
Stair 3: Missing siding exposes the  
structural framing. (Courtesy of ARG,  
2003)

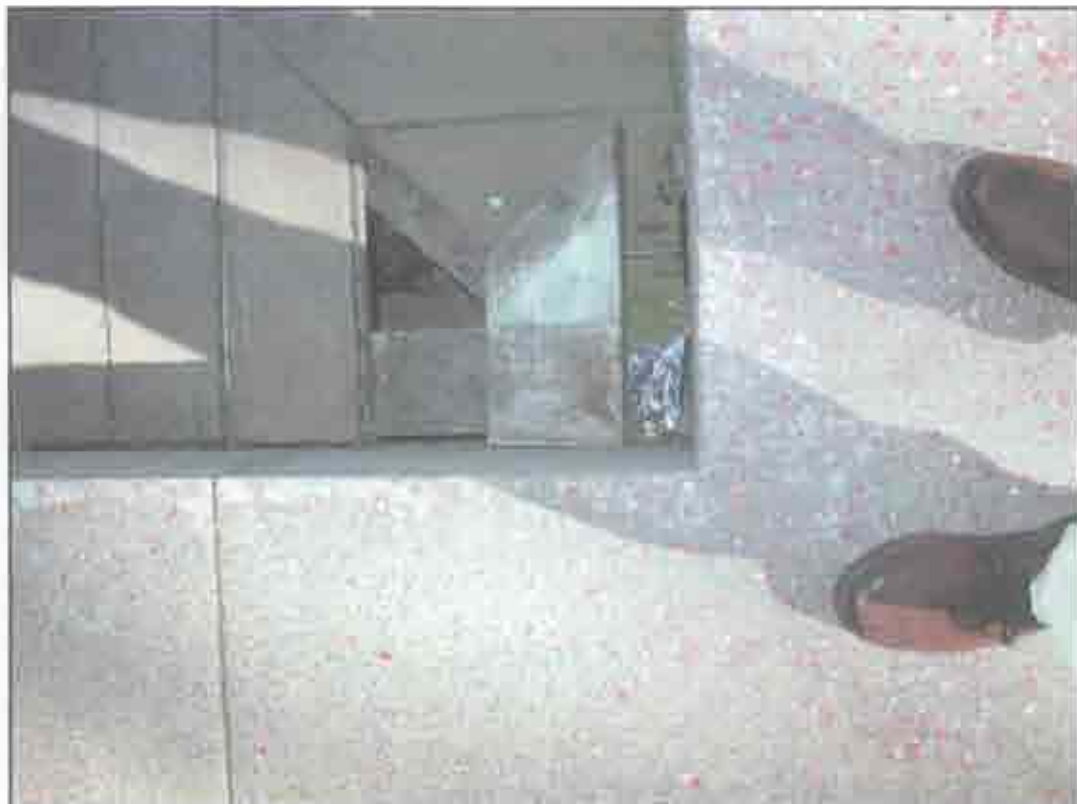
Condition Photo 14:  
Wood Walkway – Barrette Tier  
by Stair 1; Components are not  
properly fastened at wood walkway.  
(Courtesy of ARG, 2003)

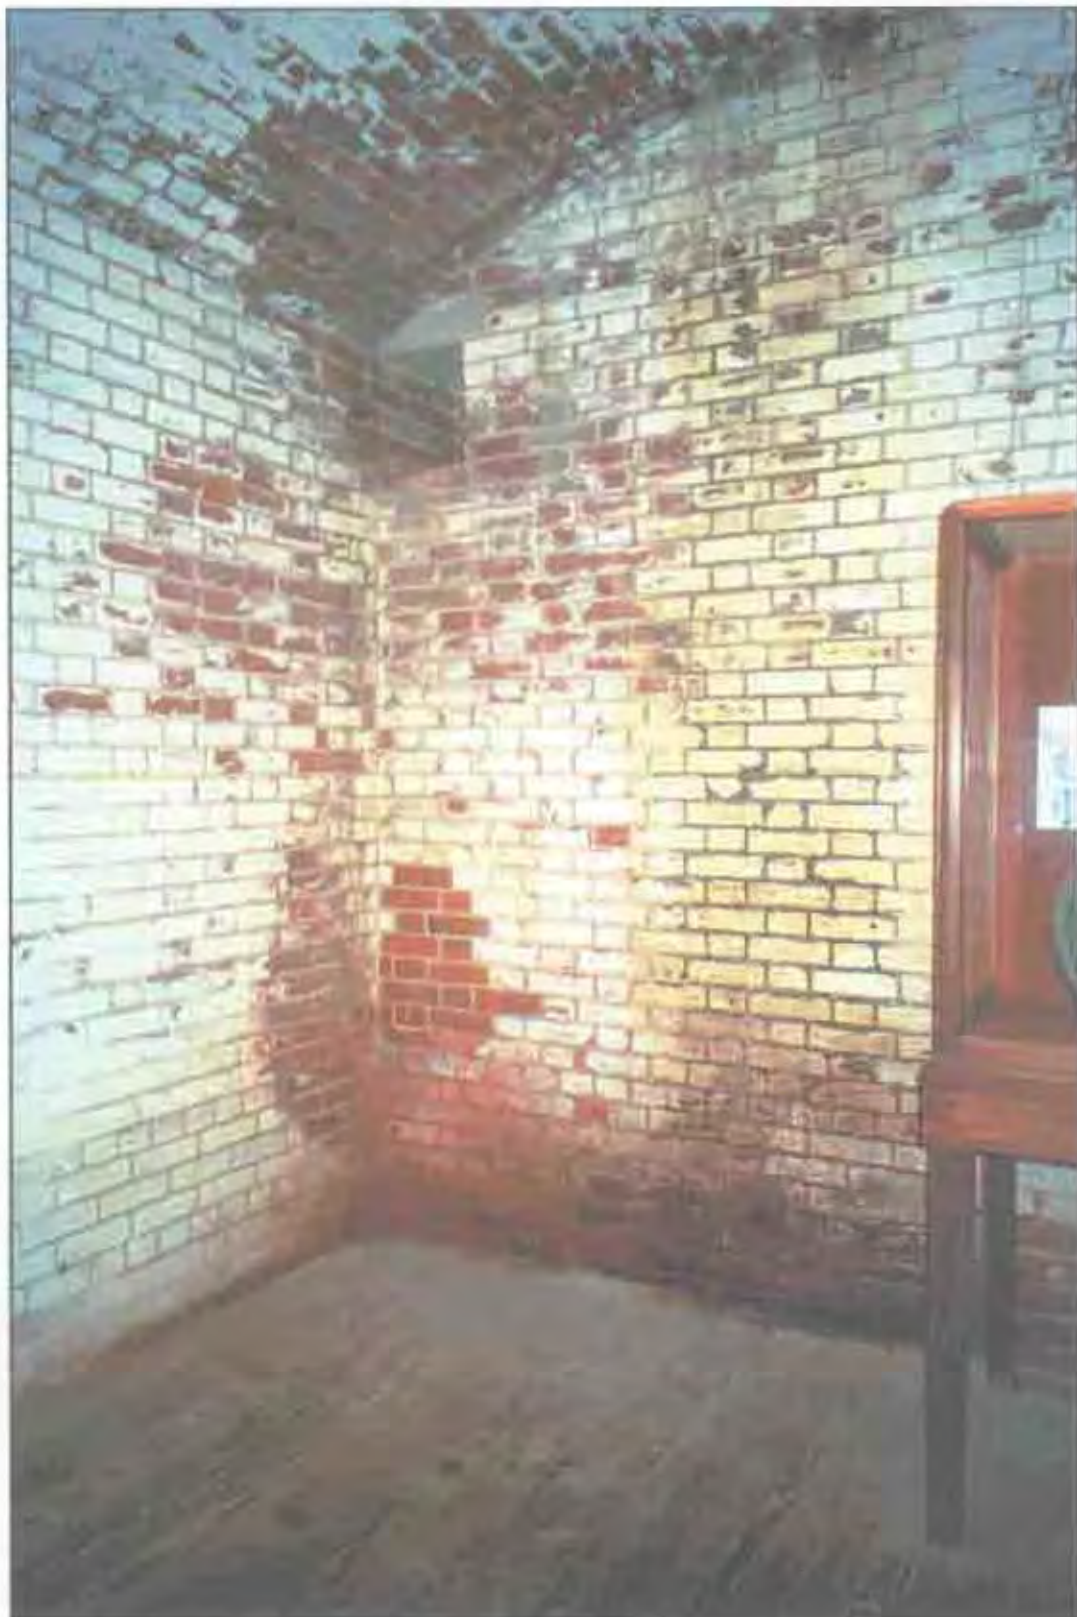
Condition Photo 16:  
Casemate 11. Open joints at the  
brick masonry and heavy water  
infiltration. Biological growth on  
the interior brick. (Courtesy of ARG,  
2003).

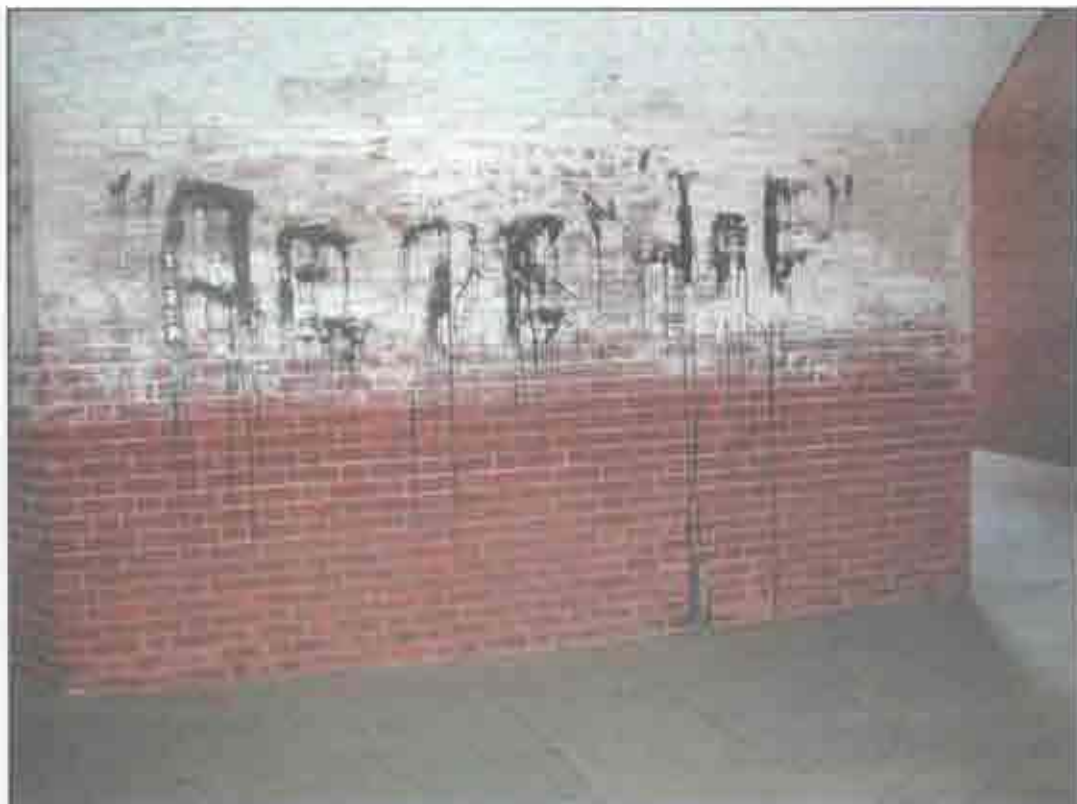
Condition Photo 18:  
Casemate 68A—Second Tier: Graffiti  
noted on masonry wall.  
(Courtesy of ARG, 2003)

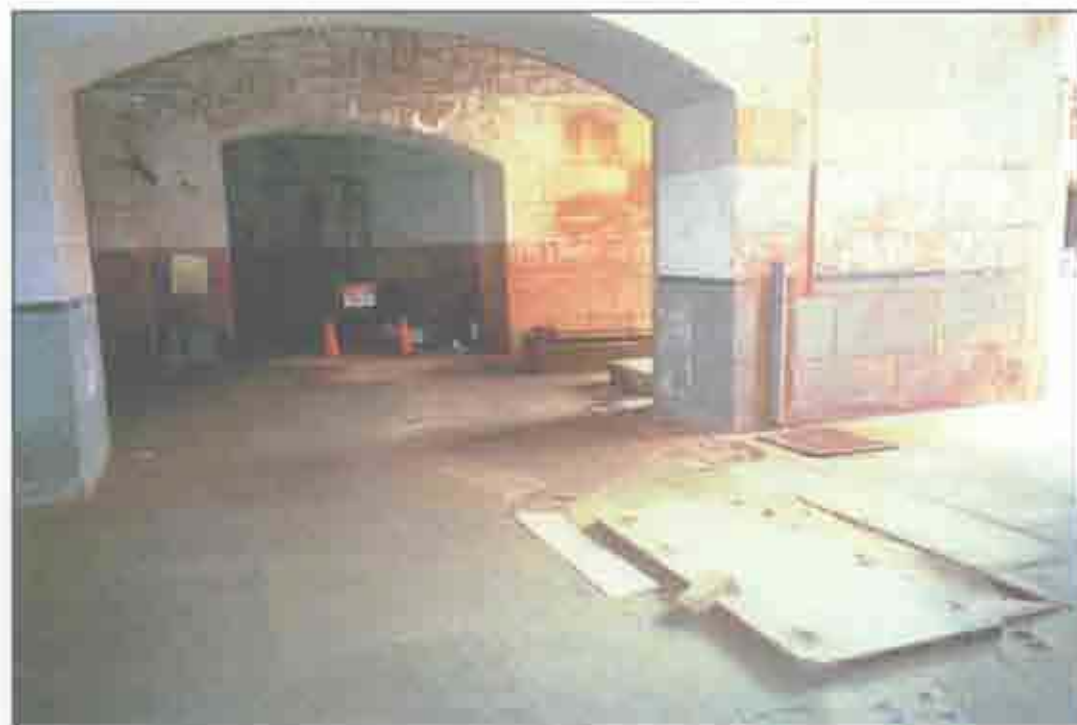
Condition Photo 19:  
Casemate 34: Uneven surfaces, open  
holes and potential tripping hazards.  
(Courtesy of ARG, 2003)

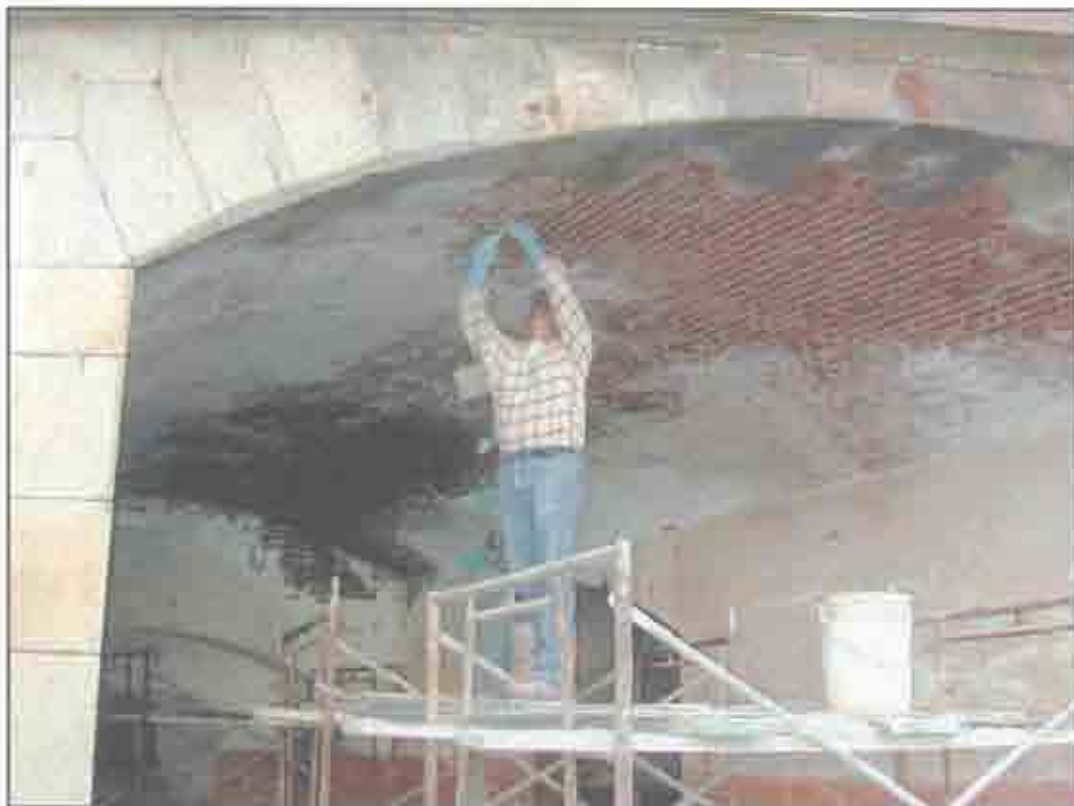
Condition Photo 22:  
Masonry repointing project at 1<sup>st</sup>  
tier. (Courtesy of ARG, 2003)

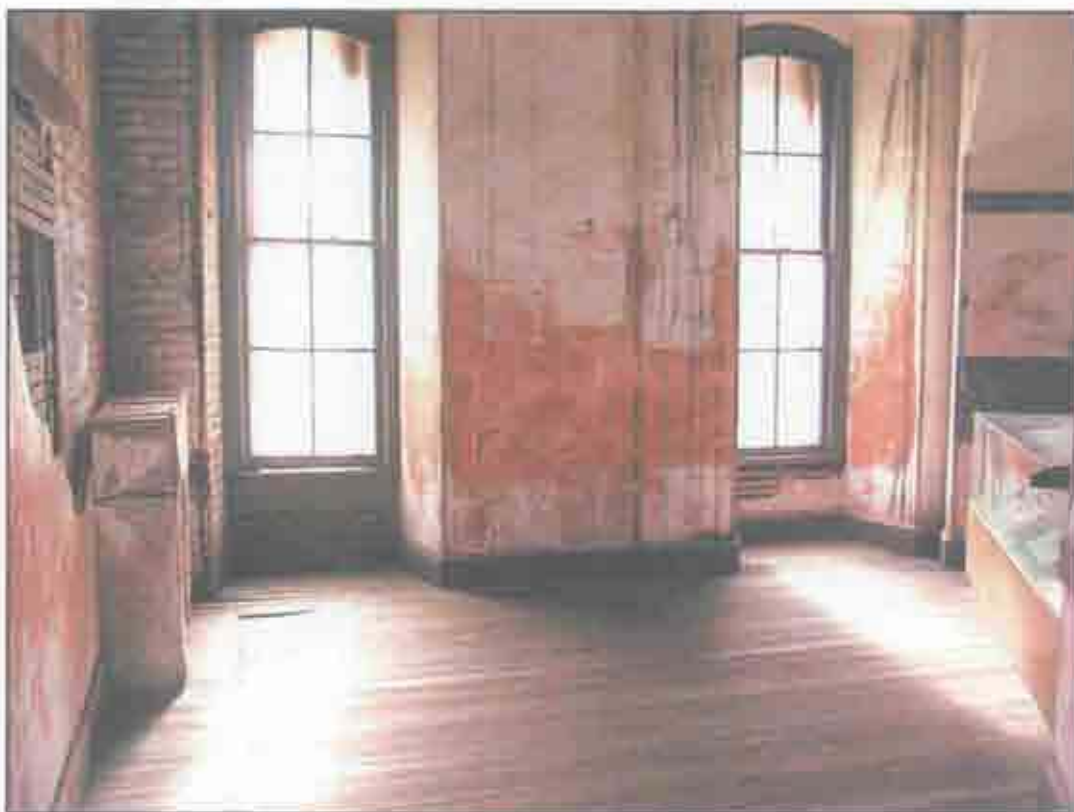
Condition Photo 23:  
Stained plaster at Casemate 21.  
(Courtesy of ARG, 2003)
