# ALLIE B GROUNDING SITE

## Administrative Draft Restoration Plan/Environmental Assessment

*Prepared for:*  
The National Park Service  
Biscayne National Park

April 2005

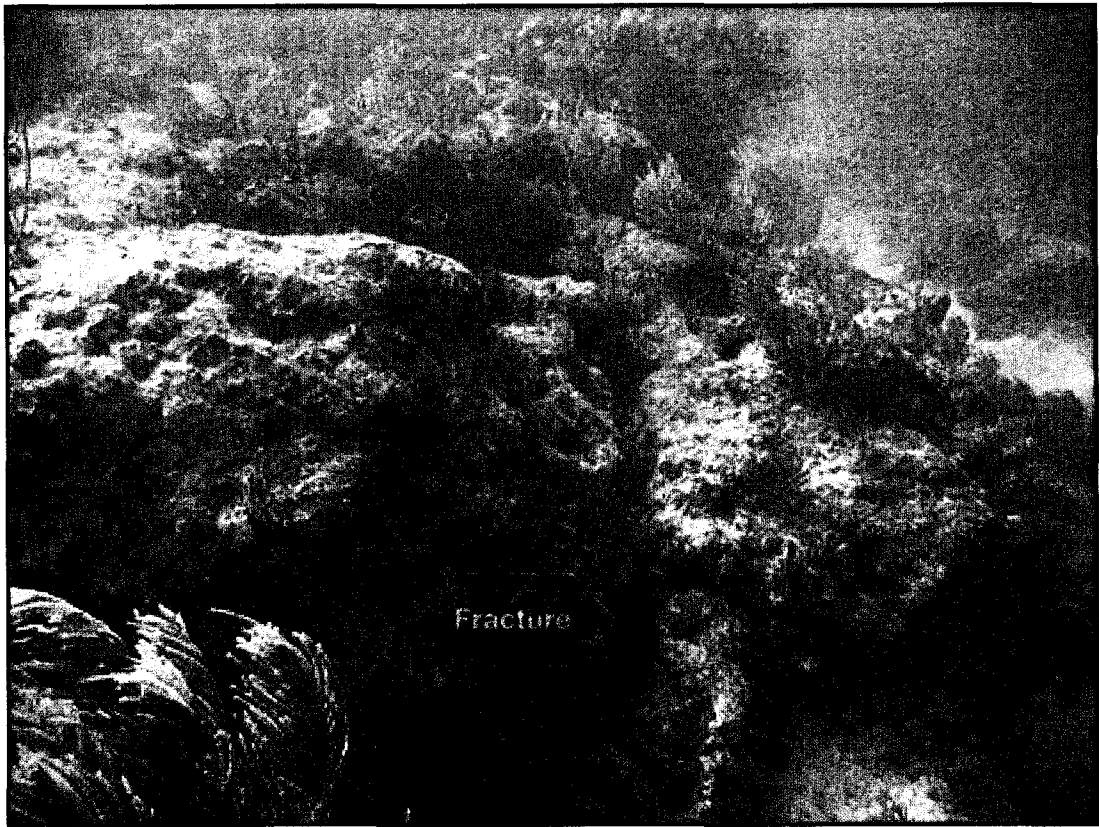
Fracturing of reef substrate at the Allie B sites was difficult to conclusively identify as grounding-related due to post-injury biological and erosional masking. The most prominent fracturing was observed in association with the graded topographic features of the barge site. Some of the smaller impact features identified during the post-grounding injury assessments by LawGibb (1998) could not be located during the recent site surveys. Fractures and subsequent lateral separation of the substrate appeared relatively stable at most of the graded (i.e., leveled or planed off) impact features at the barge site (Figure 3-1). The assessment of fracture stability was based on observations made over a short period; large fractures observed at the barge site have substantially increased the surface area of the exposed substrate. Based on this trend, which is likely to persist, it is expected that substrate degradation will not stabilize and may accelerate as erosional processes continue. Some of the graded impact features, originally tagged during assessment operations and located again during the recent site surveys, were characterized by fissures and localized loose substrate fragments. One impact feature was severely degraded and was distinguished from other locations by the high degree of substrate fragmentation (Tetra Tech, 2005).

**Figure 3-1. Lateral Separation of Substrate along Fracture at One of the Barge Site Graded Impact Features**

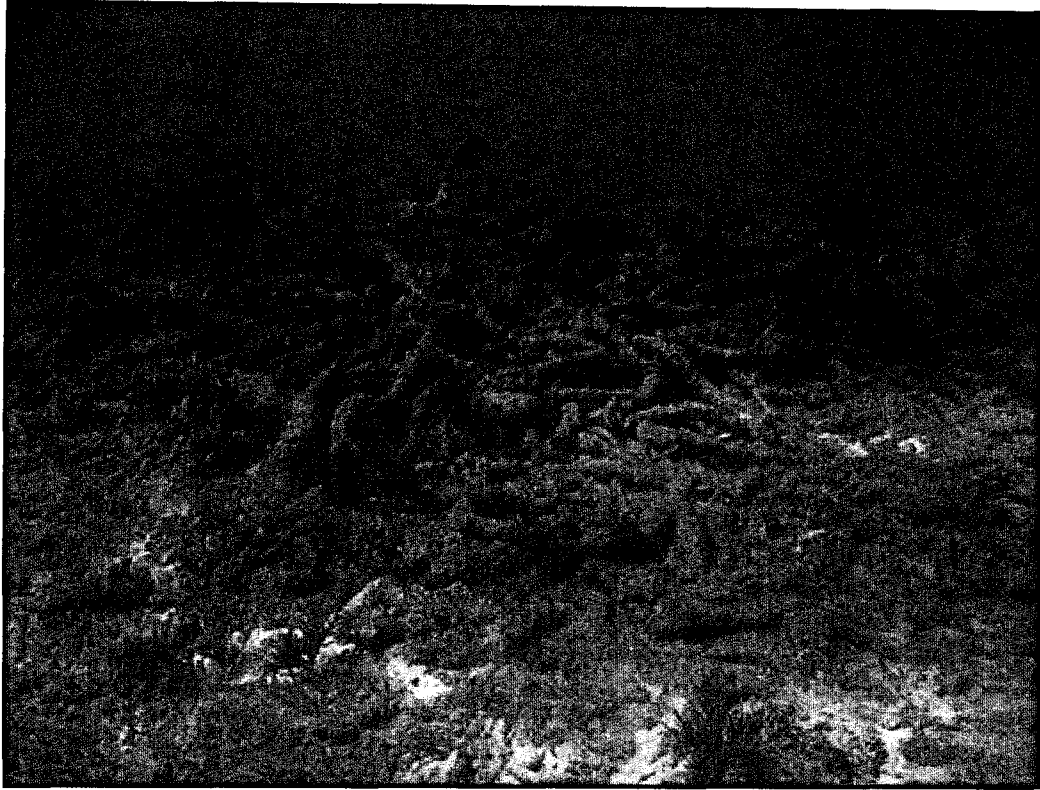
The altered topography at the Allie B grounding sites has not recovered. That fact was apparent during the Tetra Tech/MRI site survey performed in December 2004 (MRI, 2003; Tetra Tech, 2005). The graded topography at the barge site shows only limited biotal recruitment, and was easily identifiable even 5.5 years after the grounding. The degree of topographic alteration at the barge site can be extrapolated by the amount of (1) loose substrate fragments directly adjacent to graded impact features and (2) the inverted biotal orientation on large substrate pieces displaced during the grounding. Identifiable features of altered topography at the tug site include the blowholes outlined by surficial sand substrate and what appear to be small remnant piles of substrate rubble (Figure 3-2).

**Figure 3-2. Small Pile of Substrate Rubble Located at the Allie B Tug Grounding Site**

Rubble, a consequence of the grounding and extrication events that originally altered the topography, was observed to remain at the Allie B grounding sites during the December 2004 site survey (Tetra Tech, 2005). An estimated 20 pieces of large substrate rubble (>0.5 m long) were observed to be loose and adjacent to graded impact features at the barge grounding site. Most of the rubble near the graded impact features site was relatively stable due to the degree of burial in soft sediments, their size, and to a lesser extent, their orientation. Rubble at the tug grounding site included both large reef substrate and piles of smaller semi-consolidated substrate (see Figures 3-2 and 3-3). Larger pieces of substrate with associated attached biota were observed along the shoreward edge of the reef crest and directly adjacent to the primary blowhole formation. These large substrate pieces were relatively isolated and were prone to scouring along the base (Figure 3-4). Two semi-consolidated rubble piles were observed along the shoreward edge of the blowhole formations. The apparently remnant accumulations of rubble associated with blowhole formations appeared to be relatively stable (Tetra Tech, 2005) (see Figure 3-2).

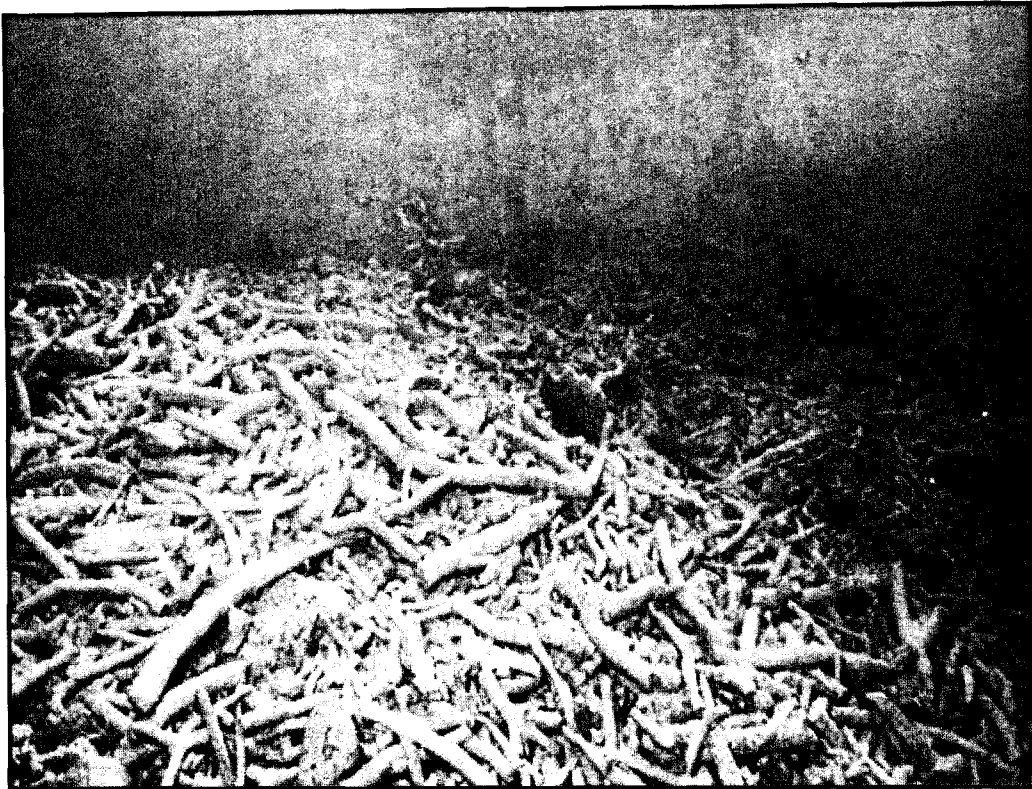
Rubble was produced at both Allie B grounding sites and was extremely severe at the tug site (LawGibb, 2001). Rubble ranging in diameter from 0.25 to 3 m was reported from the barge site (LawGibb, 2001). Large piles (i.e., berms) of displaced substrate composed primarily of hard coral fragments, abraded calcium carbonate rubble, and sand were created by the prop wash during the extrication of the grounded tug (Figure 3-3). The mechanical disruption of the prop in conjunction with its forceful movement of seawater (i.e., prop wash) rapidly eroded the semi-consolidated reef matrix that supported the grounded vessel. The extrication of the Allie B tug demonstrated that uncontrolled efforts to remove grounded vessels can be more detrimental to the habitat than the grounding itself. Prop wash greatly increases the spatial extent of an impact due to displacement/burial and creation of a fine sediment plume.

**Figure 3-3. Berms of Displaced Substrate Created by Prop Wash  
at the Allie B Tug Grounding Site**

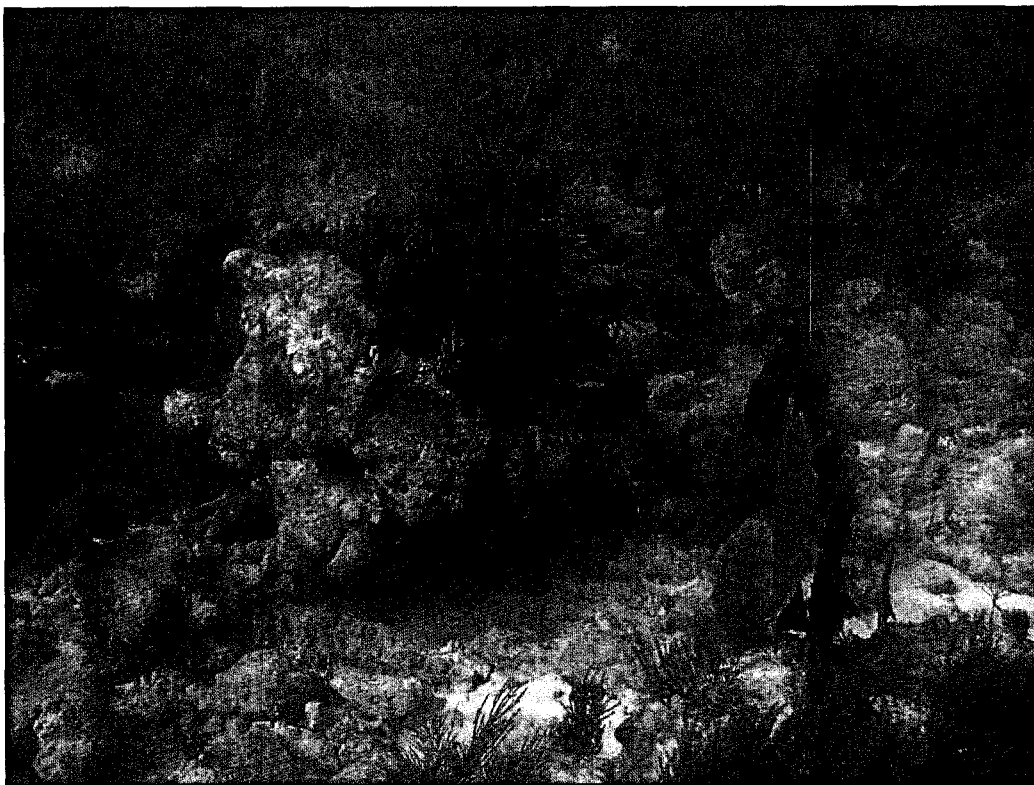
**Figure 3-4. Larger Pieces of Substrate with Attached Biota**
