Memorandum

Subject: Hydrology of the Ramp 49 area, Cape Hatteras National Seashore

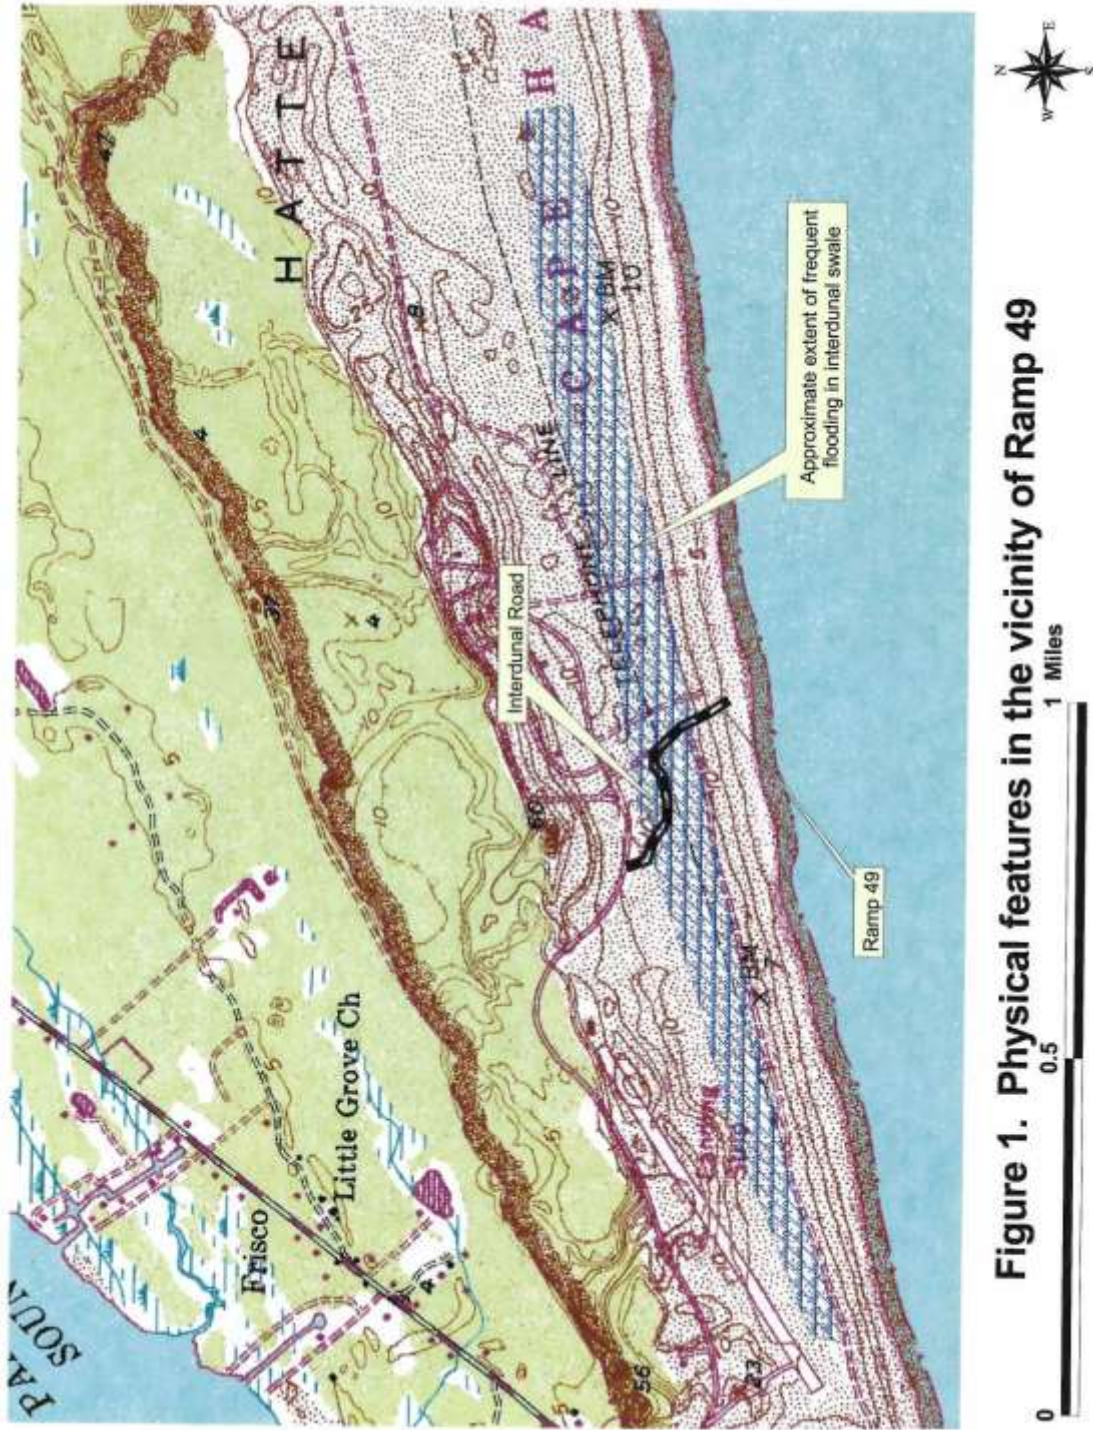
Figure 1. Physical features in the vicinity of Ramp 49

Figure 1 shows the location of the interdunal road, Ramp 49, and other physical features in the area.

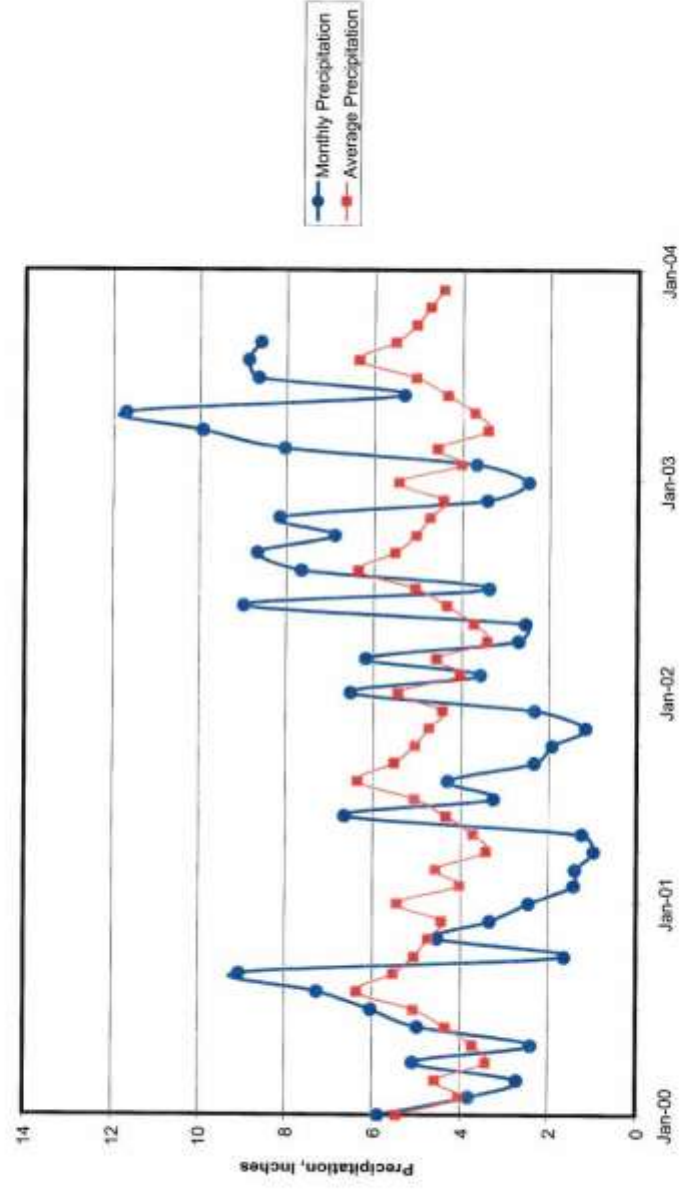
Figure 3. Monthly precipitation at Cape Hatteras

Figure 3 shows monthly precipitation at the Cape Hatteras Weather Service Office. It shows that precipitation was below normal during the latter part of 2000 and most of 2001. This dry period would have allowed the water table to decline to lower than normal levels and caused longer periods during which the road to Ramp 49 would have been dry. This would have contributed to a misperception regarding the amount of time that the road to Ramp 49 is normally flooded. Precipitation was above normal during most of the last half of 2002 and most of 2003. Wetter than normal conditions cause the water table to rise, increasing the duration and frequency of the access road. Thus we have a situation where short-term memory regarding the amount of time that the access road is flooded is distorted by comparing conditions during a drought with conditions during a wetter than normal period.

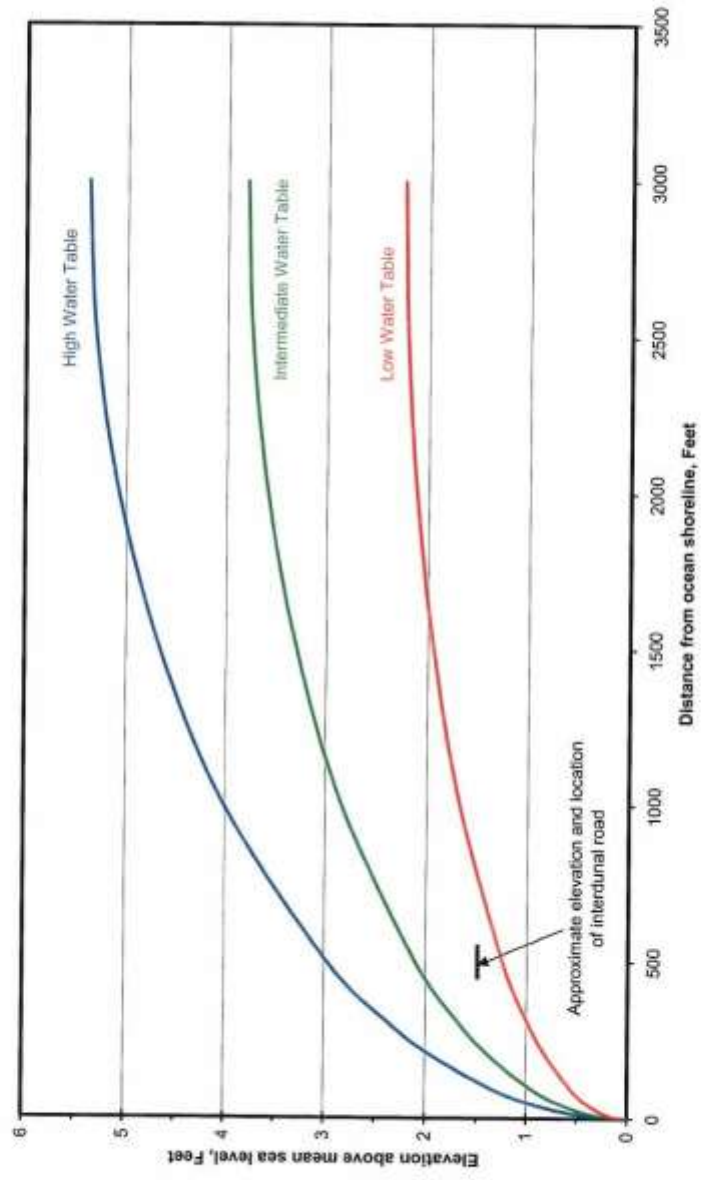
Figure 4. Approximate water table elevations in the vicinity of Ramp 49, Cape Hatteras National Seashore

periods of above average precipitation, high water table elevation near the shoreline will persist for extended periods, for as long as precipitation remains above average. These concepts are shown in Figure 4.

Figure 4 shows approximate water table elevations along a north-south cross-section from the Ramp 49 area to the center of the island. Water table elevations were computed using equation 8.8 in Fetter (2001). Estimates of physical properties, e.g., hydraulic conductivity and recharge rate were taken from a report by Gregory and Morgan (1996) or estimated by scaling measurements from the USGS topographic maps of the area. Data used in the computation of water table elevations were;

Figure 4 shows that the interdunal road is likely to be flooded under normal high-to-intermediate water table conditions. During periods when rainfall occurs regularly enough to maintain the water table at high-to-intermediate conditions, the water table may not lower far enough to allow the water table to drop below the level of the road, resulting in long periods of flooding.

Schematic Cross Section across the southern half of Hatteras Island showing calculated water table elevations for wet, intermediate, and dry conditions
