Re: Review and recommendations for Ft. Bowie NHS water supply well

At the request of Larry Martin, we have completed a review of the situation with the water supply well constructed in 2000 at Ft. Bowie National Historical Site (Well no. 2, well registration no. 55-582902). This well has been experiencing water quality and performance decline. Larry and the maintenance staff provided file information on this well and we had the opportunity to visit the site and talk with the staff August 30, 2007.

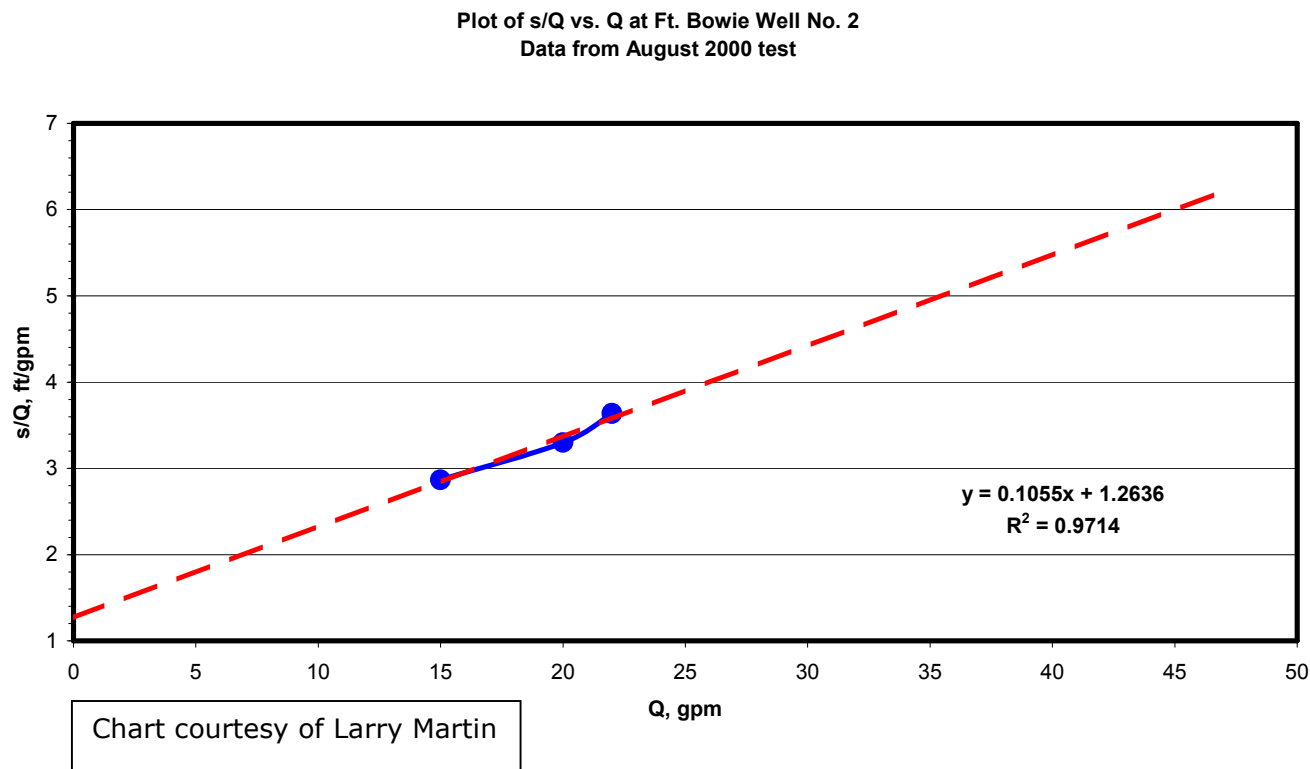
The inverse of  $Q/s$  ( $s/Q$ ) is used in graphical analysis of step-drawdown pumping tests (Krusemann and de Ridder, 1994). These were not from a pro forma step test, but as the plot on the following page illustrates, they plot reasonably well on a straight line, typical of valid step test results. Using this plot, a y-axis intercept (B) can be estimated and used in the formula  $BQ/s$  to yield a well efficiency value ( $E_w$ ) as shown above. This serves in the absence of calibrating values from an aquifer test.

All the values for 10 gpm were extrapolated for illustration and the  $s = 230$  for  $Q = 40$  gpm also estimated. The  $s = 140$  ft for 40 gpm was that measured, but it is clear that it was far from being a stable PWL. Extrapolation from analysis indicates that the original 40-gpm  $s$  would exceed total well depth (about 230 ft).

In water well design, efficiencies below 70-80 % are considered poor. The other thing to note is that the  $Q/s$  values are very poor, such that drawdown is excessive. Consequently the  $s/Q$  values are very high, indicating either poor contact with the formation or very low water zone transmissivity ( $T$ ). This well has been hydraulically inefficient from the beginning and began life with steep drawdown performance.
