# United States Department of the Interior

## Memorandum

Subject: Water-Supply Well Issues at Fort Bowie

Summary: Alternatives for providing a safe, reliable water supply for facilities at Fort Bowie include continuing to use water from the well in the maintenance area, reconstruction of a pipeline and electrical service to the well in Siphon Canyon, and construction of a new well near the visitor center.

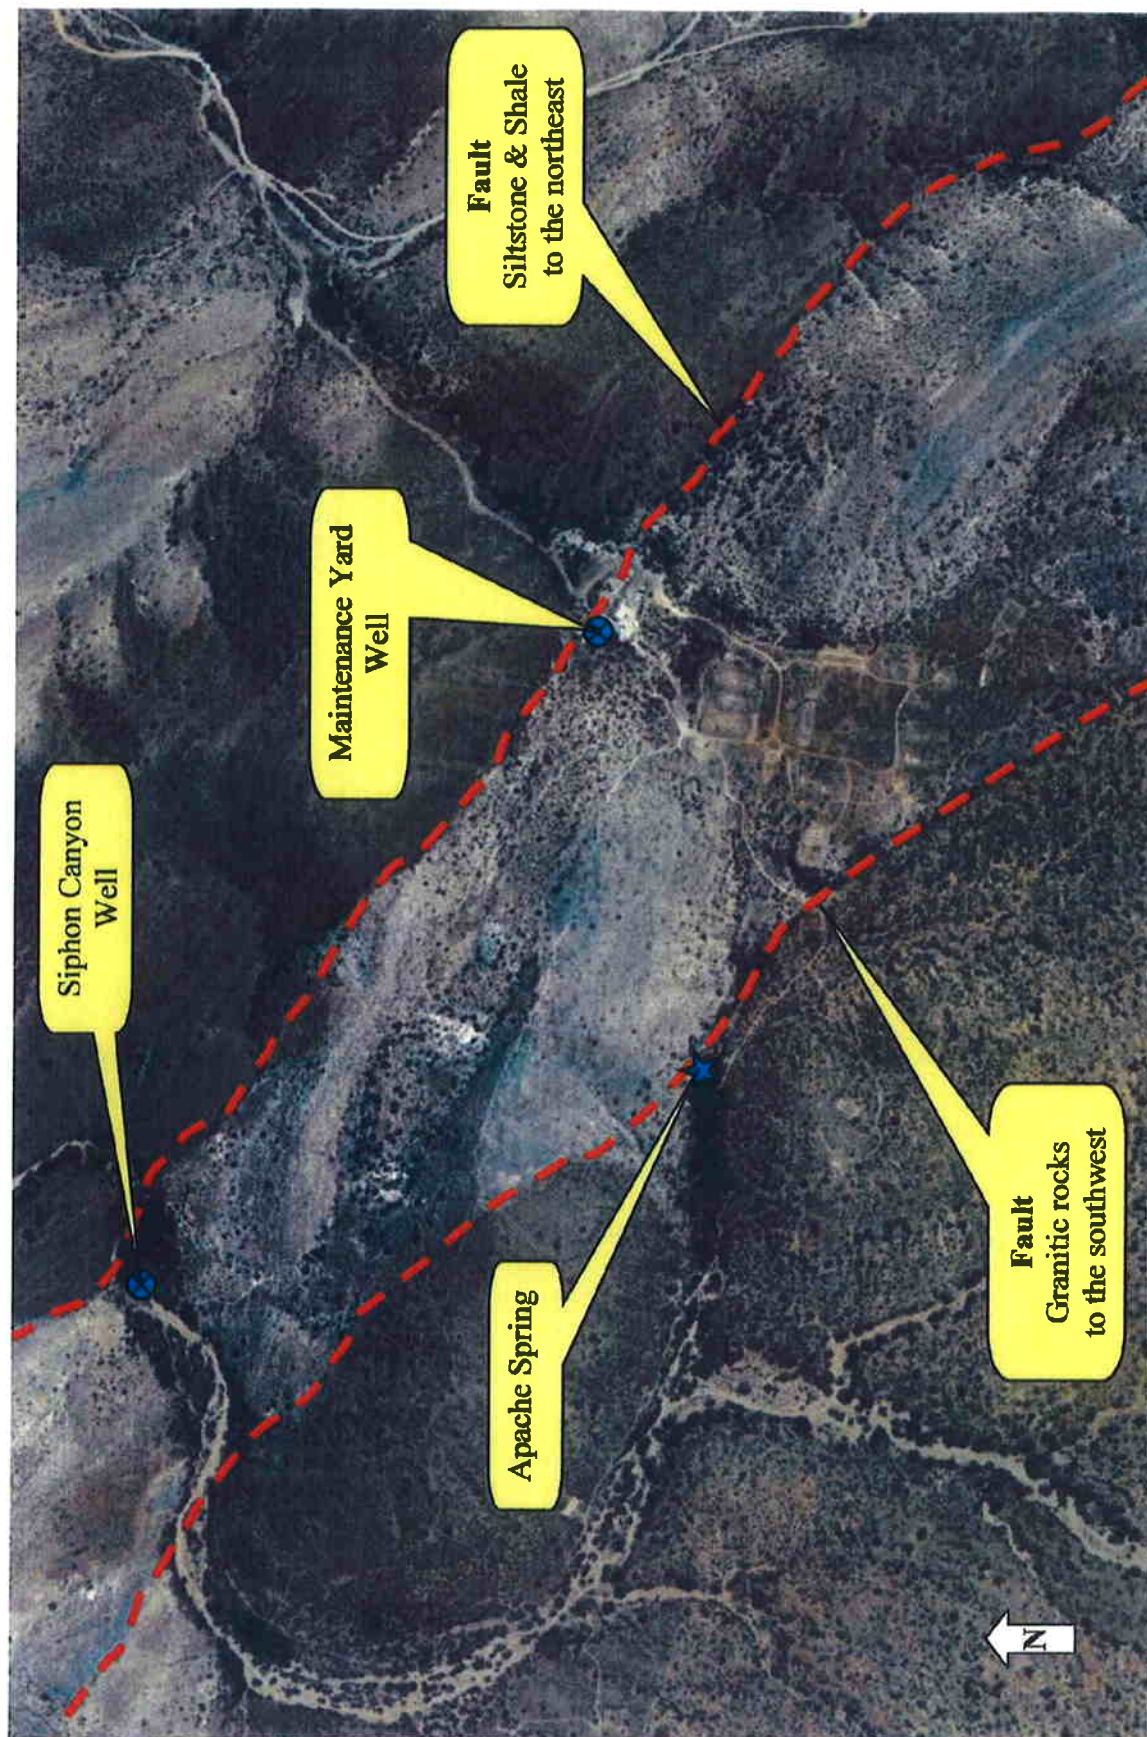
Figure 1 is a map from Google Earth with annotation to show approximate locations of geologic faults, springs, and wells in the vicinity of Fort Bowie National Historic Site.

Figure 1. Location of wells, springs, and geologic features in the vicinity of Ft. Bowie. The permeable limestone bedrock formations occur as a NW-SE band between the fault zones.

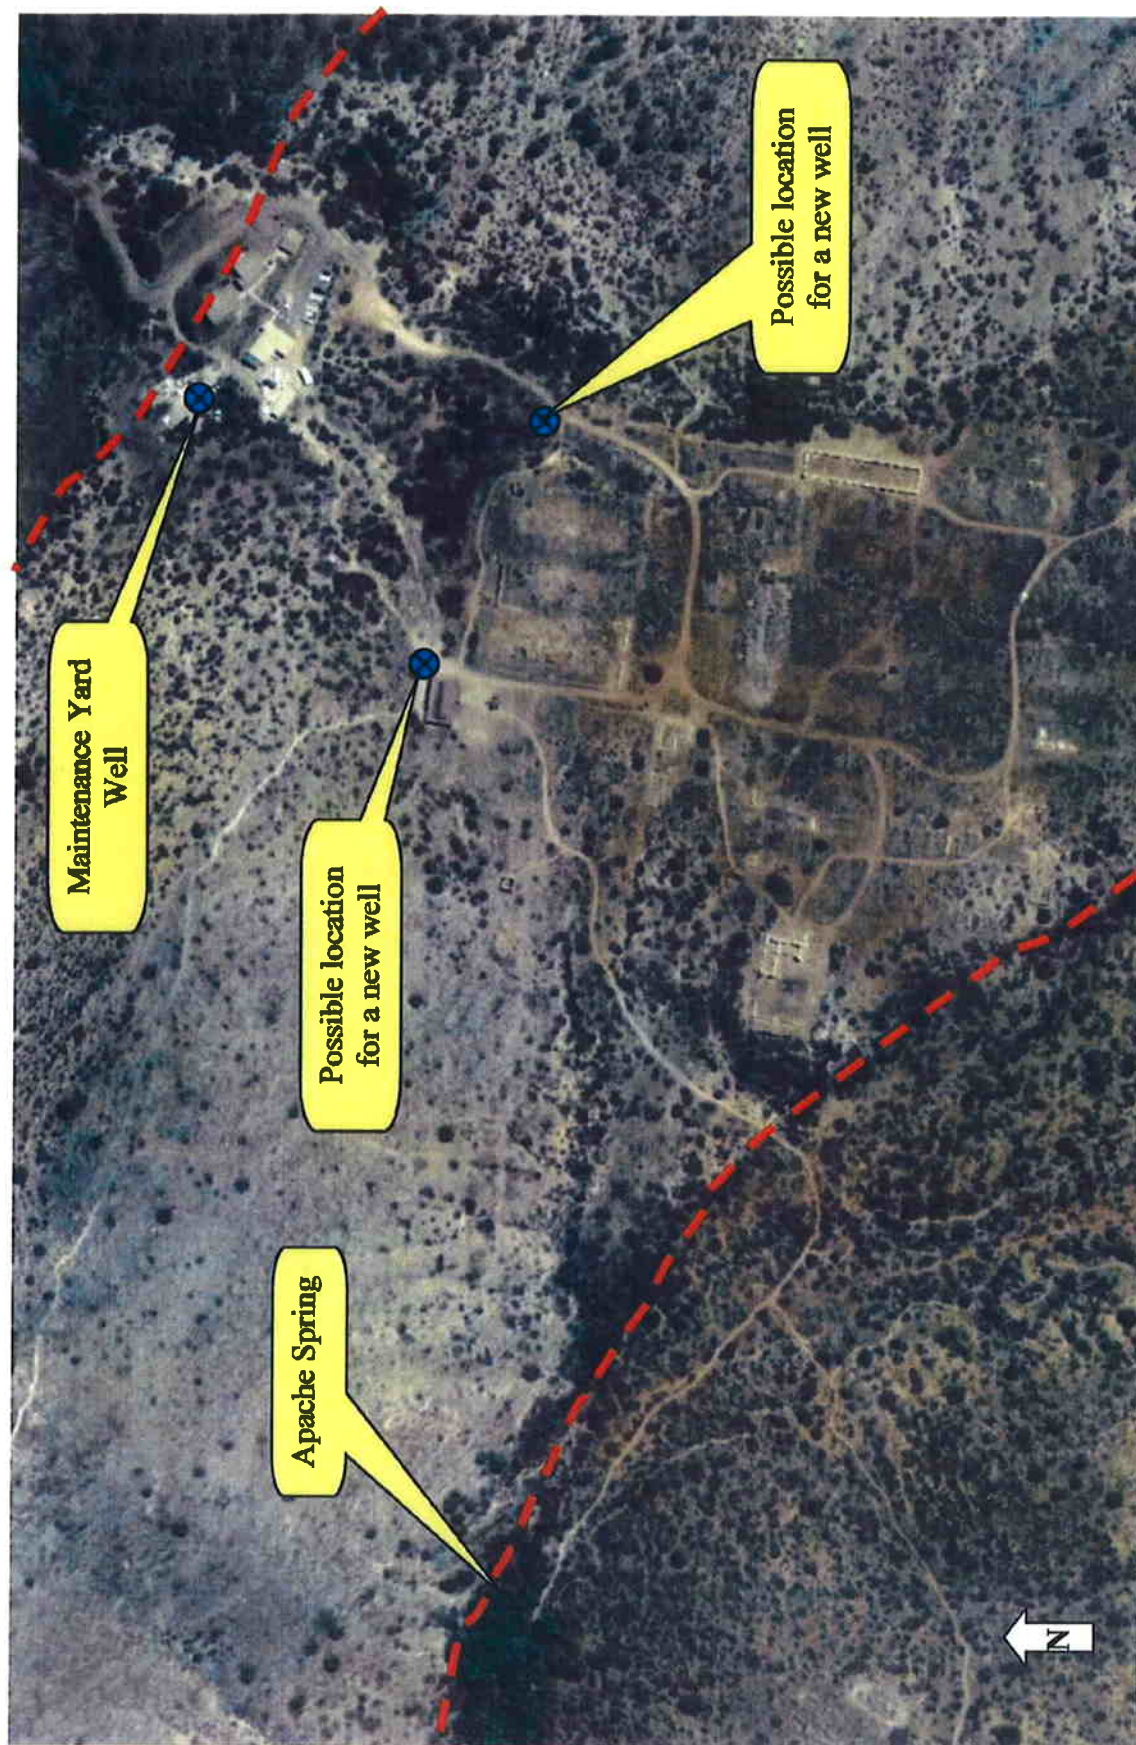
Figure 2 shows two possible locations for a new well at Fort Bowie. These sites were selected using these criteria:

1. Locate the well in an area where it would penetrate the fractured limestone aquifer.
2. Locate the new well as far from the fault zone as possible to minimize the potential contact with metamorphosed limestone containing carbon and iron, i.e., attempt to avoid the geologic conditions encountered by the well at the maintenance yard.
3. Locate the well sites along existing roads, or at least in areas that would not require construction of a new road that would be a visual intrusion on the historic scenery of the effort.
4. Avoid locating the well within the perimeter of the ruins of the fort.
5. Maintain a setback distance from springs to limit impacts of groundwater pumping on spring flow.
6. Consider proximity to existing electrical service, routes for the water line to the storage tank, and the need for a chlorinator building.

The potential sites for a new well shown on figure 2 are examples for discussion purposes at this time. If it is decided to pursue construction of a new well, additional analysis and discussion should occur to identify the optimal location for a new well.

Figure 2. Potential locations for a new water supply well at Ft. Bowie.
