# United States Department of the Interior

NATIONAL PARK SERVICE  
Water Resources Division  
1201 Oak Ridge Drive, Suite 250  
Fort Collins, CO 80525

## Memorandum

Subject: Technical Assistance Request Report to Jewel Cave National Monument  
Site Visit - May 16, 2012

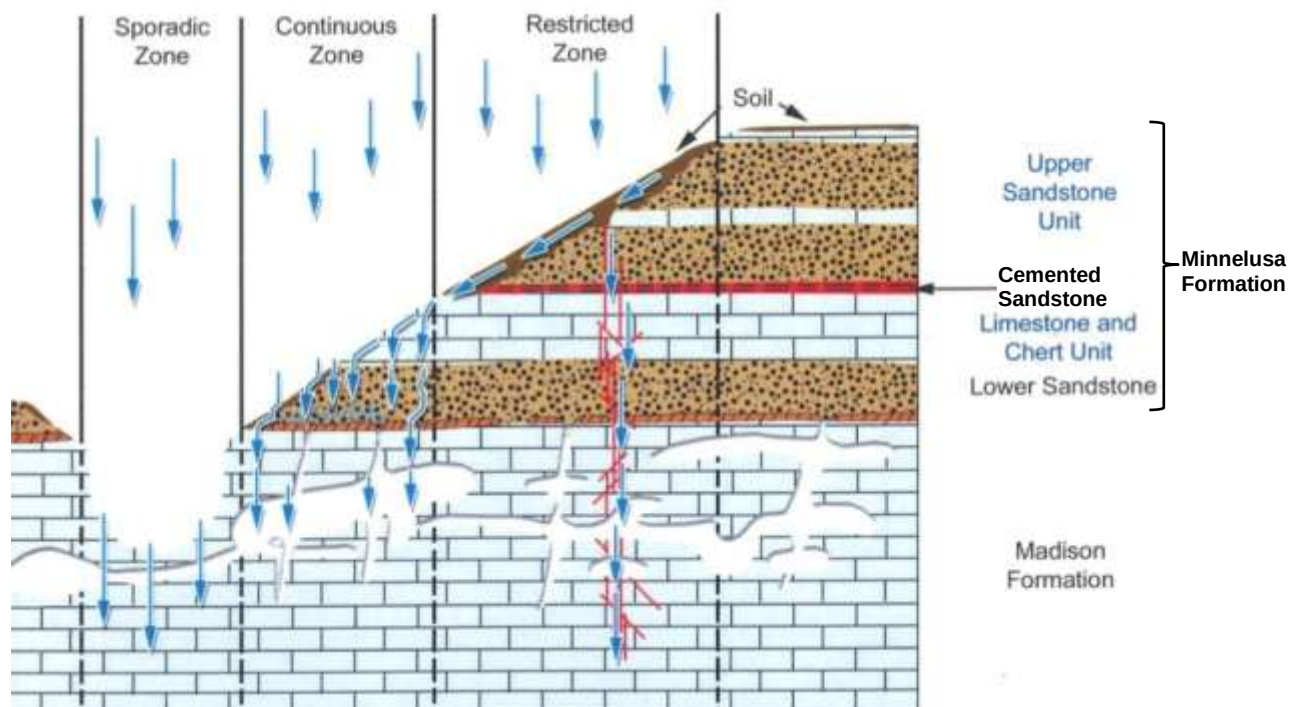
Figure 1. Conceptual geologic cross-section in the vicinity of the Jewel Cave elevator shaft.

Hydrogeology – Figure 1 shows a conceptual geologic cross-section in the vicinity of the elevator shaft. The elevator can be thought of as occurring in the general location to the right of the center, and shown by the blue arrows indicating downward percolation of water and the red lines indicating fractures in the bedrock. We don't know that the bedrock in the vicinity of the elevator is fractured, but the figure provides an otherwise reasonable depiction of the geology.

Cemented sandstone in the upper part of the Minnelusa Formation is thought to act as an impermeable layer over much of the cave area. The cemented sandstone is above a limestone and chert unit and a sandstone unit at the base of the Minnelusa Formation. The cave below is dry wherever the cemented sandstone layer is present above. The impermeable layer was penetrated during construction of the elevator shaft. The impermeable seal was not recreated during construction of the shaft. It's likely that the occurrence and significance of the impermeable layer were not recognized at that time.

Water infiltrating into the ground in the vicinity of the elevator will percolate downward until it reaches the impermeable layer (the cemented sandstone shown as a thin red layer on the cross-section). Water will then flow laterally until it finds an opening where it can percolate down through the cemented sandstone. That might be the elevator shaft, or it could be naturally occurring fractures in the bedrock. However, it is generally thought that the cemented sandstone provides an effective impermeable barrier to downward percolation because the cave is generally dry below wherever the cemented sandstone is present above.

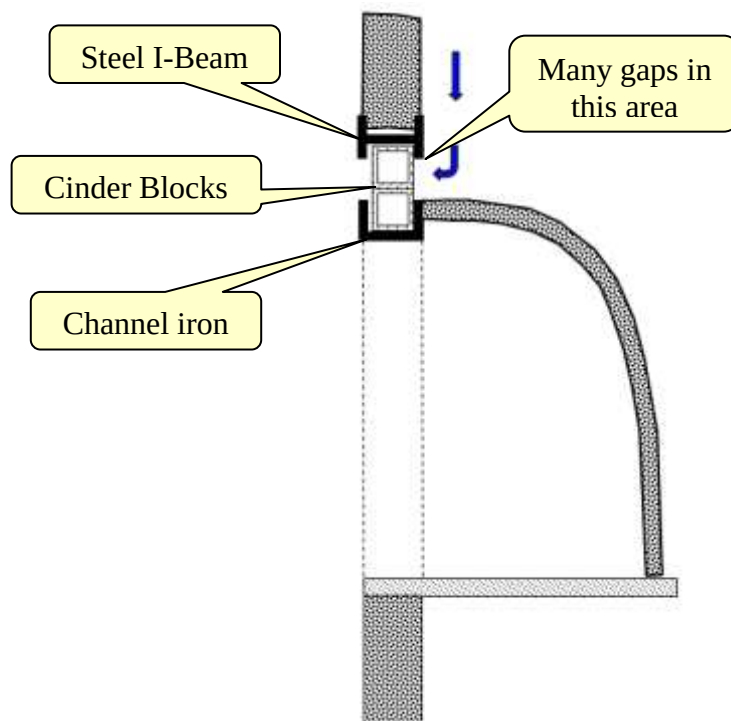
Figure 3. Schematic cross-section of the elevator doorway at the cave lobby.  
Blue arrows indicate pathways for water seeping into the doorway openings.

Headers above the elevator doorways at the cave levels are another area where water seeps in from behind the concrete walls. Figure 3 shows a schematic cross-section of a typical construction of the elevator doorway opening at the cave lobby. A steel I-beam is laid on its side as a header. Under the I-beam is a course or two of concrete blocks and then a piece of channel iron to frame the opening. There are a lot of gaps between steel, concrete, and bedrock in this area. Water seeps and drips into the elevator doorway, wreaking havoc with the steel components of the door and frame and eventually finding its way into the electrical components. The openings could be filled with some type of waterproof, expanding foam or epoxy materials. An example is found at this website <http://www.epoxy.com/420.htm>. Other materials are undoubtedly available and further research should be conducted to select an appropriate product. A series of weepholes should be drilled above and alongside the doorways to drain the water that will build up after sealing the openings at the top of the doorways. Otherwise the water will eventually develop enough hydrostatic pressure to leak in around the new seal. Water from the weepholes should be drained to the gutters and downspouts via flexible tubing, as with the other weepholes throughout the shaft.

2. Seal the openings at the headers above the elevator doorways at the cave lobby entrances. This will require some type of waterproof, expanding foam or epoxy. Drill a series of weepholes above and alongside the doors to drain water and reduce the hydrostatic pressure at the newly sealed areas above the doorways.
