L54(2380)  
MEVE/General

Memorandum

Subject: Trip Report for travel to Mesa Verde National Park on June 4, 2003

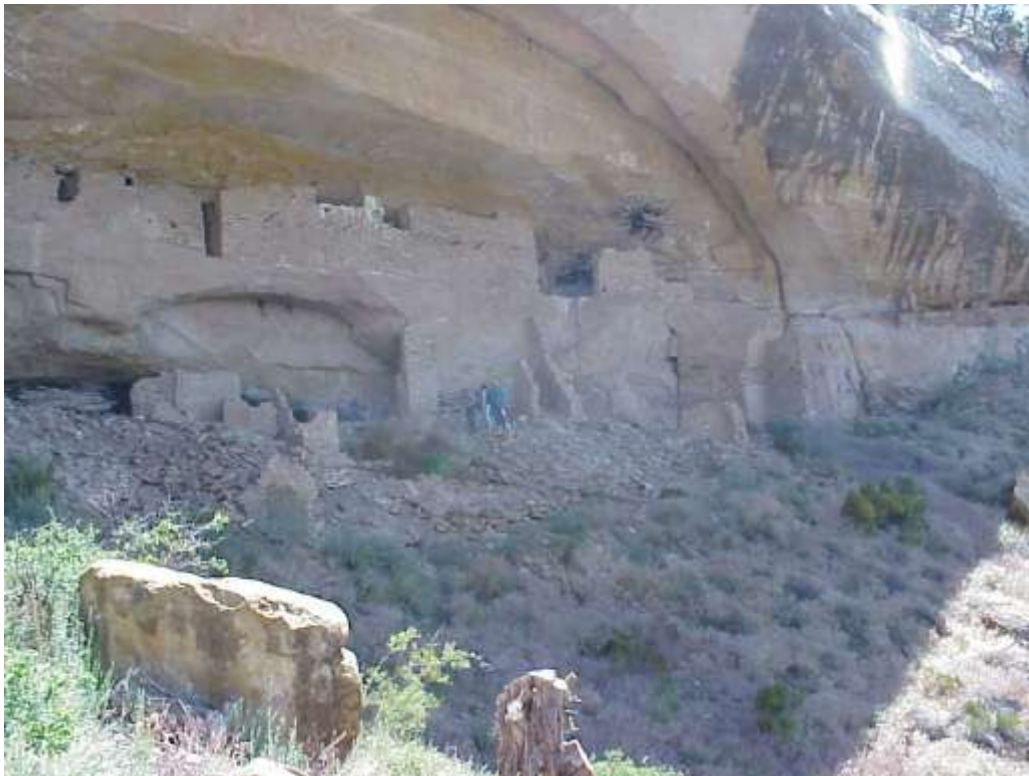
Southern part of Spring House. The spring area is to the right of this photo.

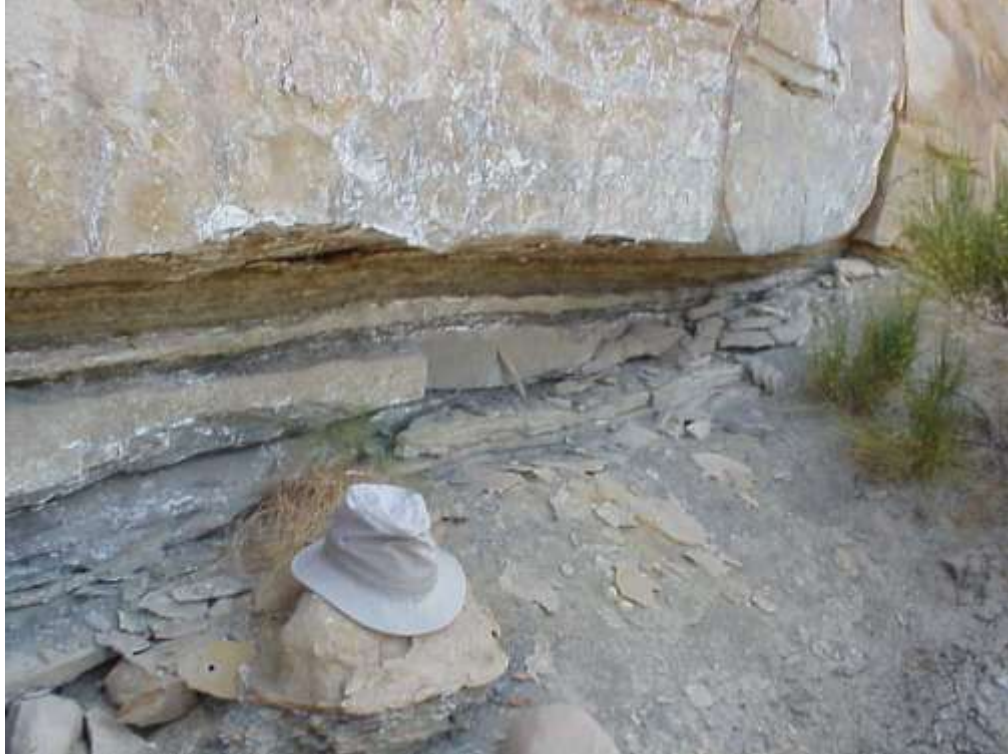
Shale layers at the bottom of the Upper Cliff House Sandstone.  
Photo location is a few tens of feet north of the cliff dwellings.

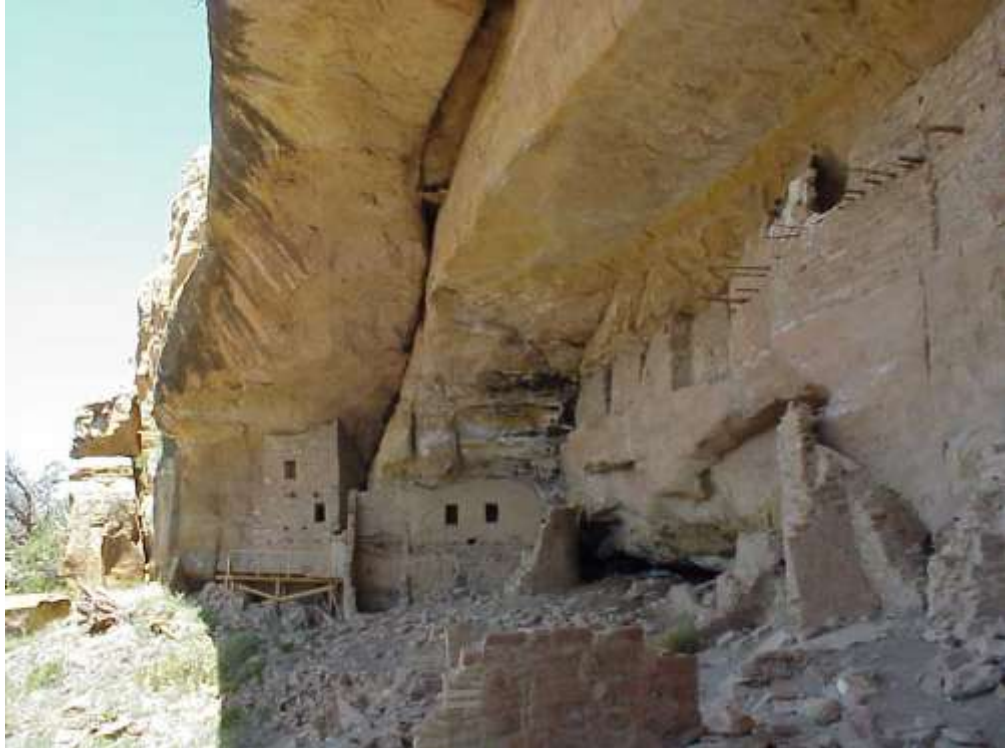
The large vertical fracture in the upper sandstone behind Spring House provides a pathway for groundwater and surface water to migrate through the sandstone. When the water encounters the impermeable shale layers, it is forced to flow horizontally resulting in a small spring or seep area near the intersection of the vertical fracture and the horizontal shale layers. I did not measure the flow rate, but estimate it was in the range of a few gallons per hour. Flow from the seep creates a small pool of water (approximately two feet across and 6 inches deep at the time of our site visit) in a small depression at the base of the cliff. This pool is behind some of the few remaining intact walls at the site. Water infiltrates into the underlying sandy sediments, creating a constant source of moisture in the soil and fill material in the cliff dwellings. This water may, or may not, be an important source of water for the population of Trailing Four O'Clock wildflowers that are present on the slope below the cliff dwellings.

Photo of the northern part of Spring House. The spring is at the intersection of the vertical crack and the base of the cliff, behind the wall in the center of the photo.
