## **Water Supply Wells At Park Headquarters, Organ Pipe Cactus National Park**

Subject: Repair/Rehab of wells in Headquarters Area

## ORPI – SOUTH WELL

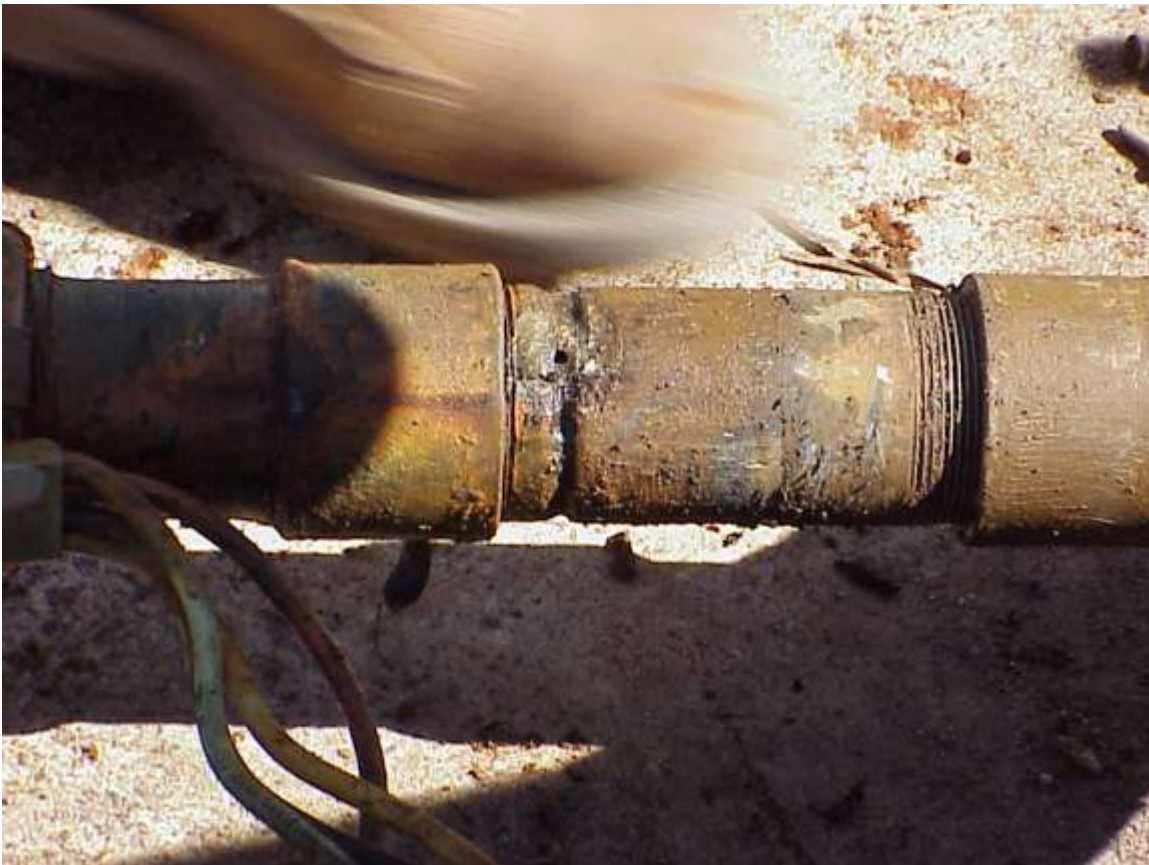
The drop pipe from above the water table was in good shape, both inside and out. The pipe from below the water table had a lot of encrustation on the outside. The pump intake was nearly plugged with rust particles and fragments of green electrical tape. The worn ring and hole in the nipple above the pump was thought to be caused by vibration and rubbing of the attachment of the pump shroud at that location.

MVC-007L shows Holes in two inch by six inch nipple above pump.

They installed new drop pipe, new wire, check valves, and added a sand separator to the bottom of the pump. Not sure if the pump was replaced.

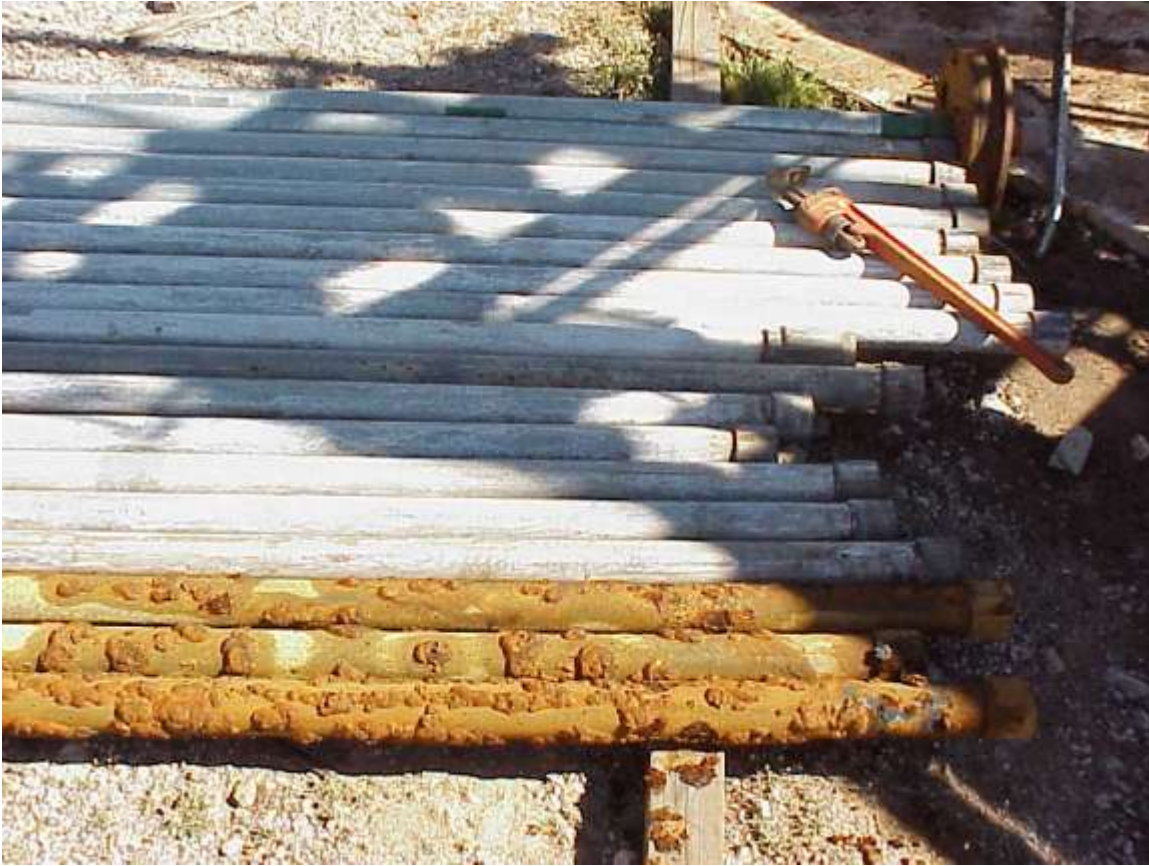
At both wells, the check valves in the drop pipe were not working properly. Water in the drop pipes would drain into the well when the pumps were turned off. This creates conditions where the inside of the drop pipe is alternately wet and then exposed to air; perfect conditions for corrosion of the pipe. Much of the sediment material that has been collected from the wells appears to be rust, most likely from the inside of the drop pipes.

MVC-008L shows corrosion on pipe and amount of pipe pulled. if you look closely at the pipe near the middle you will see a check valve.

Both wells should have new drop pipe and check valves installed. The South Well needs a new pump, but the motor might still be useable. The condition of the pump and motor in the North Well should be assessed after it is pulled from the well. The electrical cable should be replaced if necessary. Installation of Lakos sand separators should eliminate or greatly reduce sediment pumped from the wells, prolonging the life of pumps and valves.

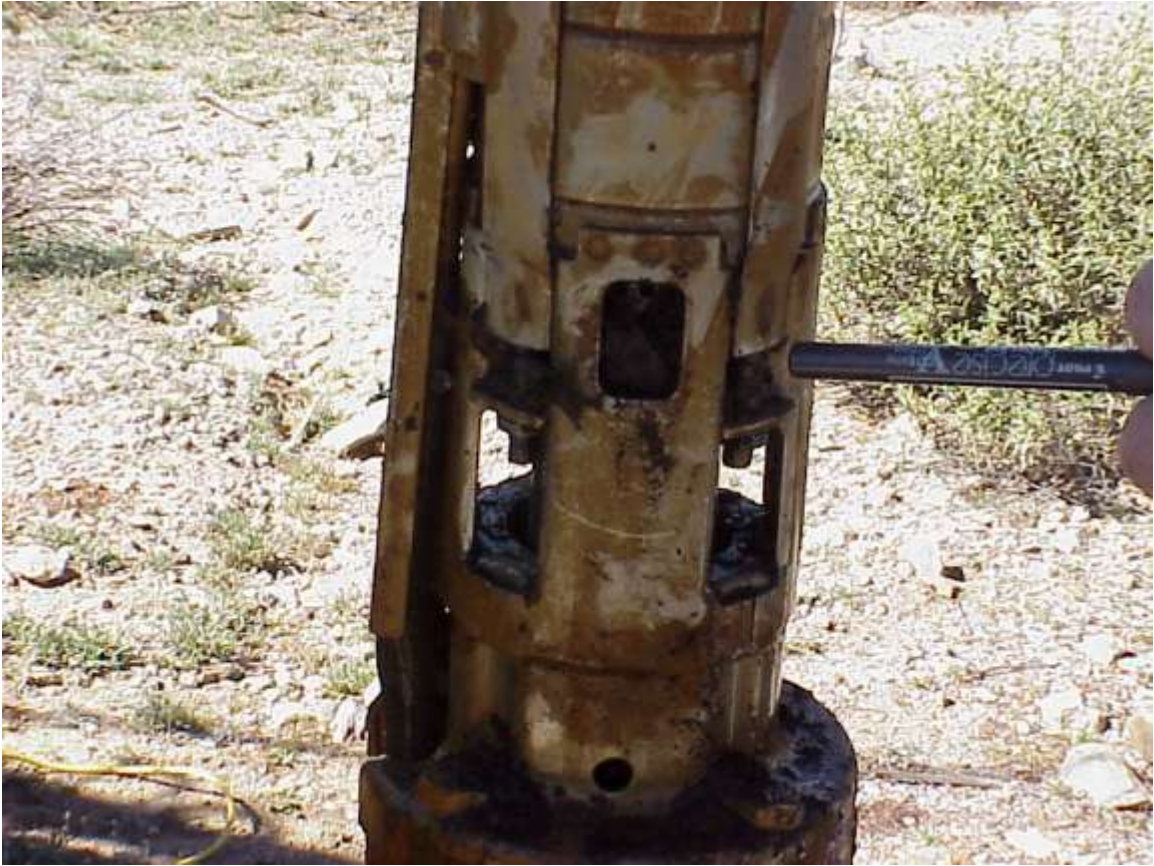
MVC-009L shows plugged intake.

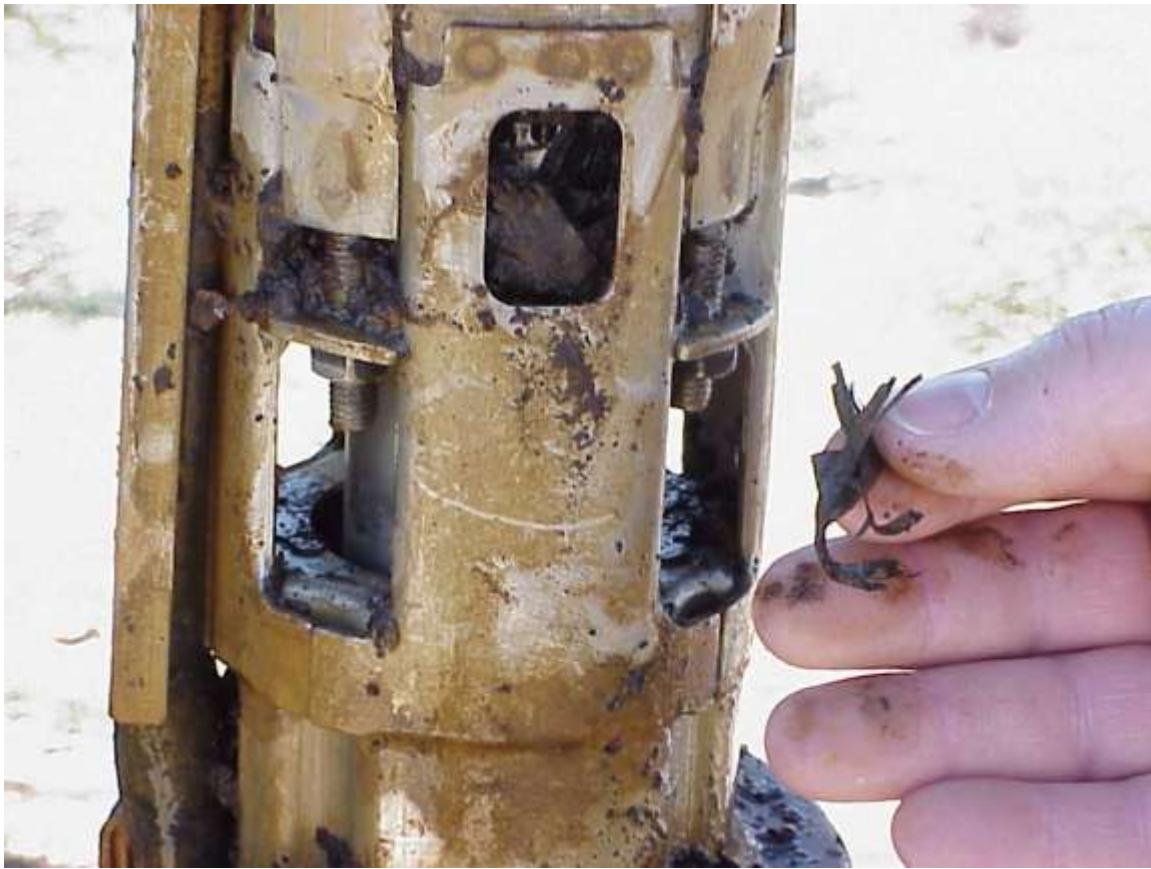
The green particle found in samples that I had in my shop are green plastic tape that held the electrical wire to the two inch drop tube.

MVC-010L shows different view of the plugged intake and a piece of plastic tape that was removed from the intake
