# United States Department of the Interior

Subject: Trip Report to Drewry's Bluff Unit of Richmond National Battlefield Park  
September 13, 2011

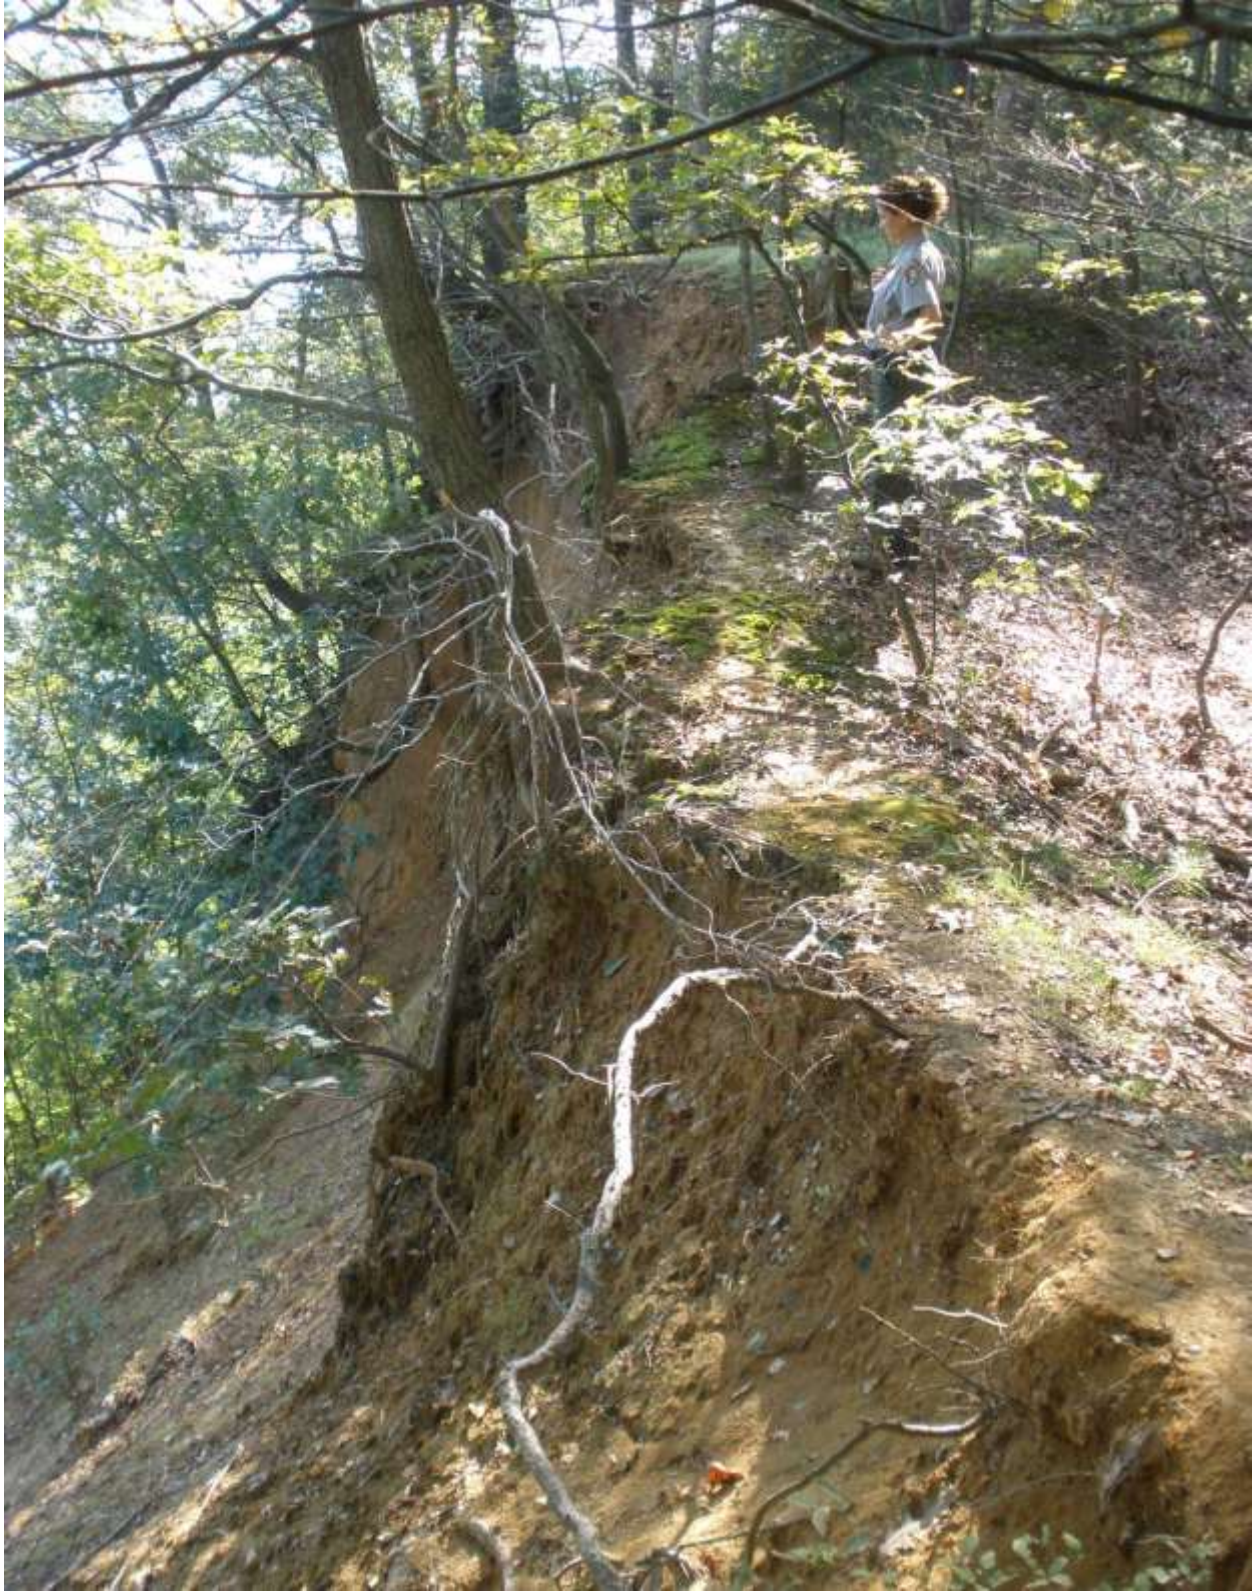
Summary: Natural geologic processes have resulted in formation of near-vertical faces along some parts of the escarpment near the top of Drewry's Bluff. In other areas, the upper slope of the bluff is a more stable, gentle slope. The near-vertical faces are unstable and will eventually fail, slumping down the hillside as a series of small debris flows. There is nothing that can be done to prevent these slumps from occurring. Areas adjacent to the vertical bluff faces should be fenced and signed to warn persons about the inherent instability of these areas. If there are important artifacts or infrastructure in these areas, they should be removed to save them from otherwise inevitable destruction.

Photo of a near-vertical face at the top of the bluff. Failure and slumping of this area is inevitable. When that happens, the edge of the bluff will have migrated some distance to the right of the area shown in the photo.

This issue may be comparable to lighthouses near the coast. NPS has moved several lighthouses that were in danger of being lost as natural processes caused erosion of the coastline toward the lighthouse. In a similar manner, NPS may need to move the overlook back from the crest of the bluff, and cut some trees, etc. to recreate the desired viewpoint at a safe distance from the edge of the bluff.

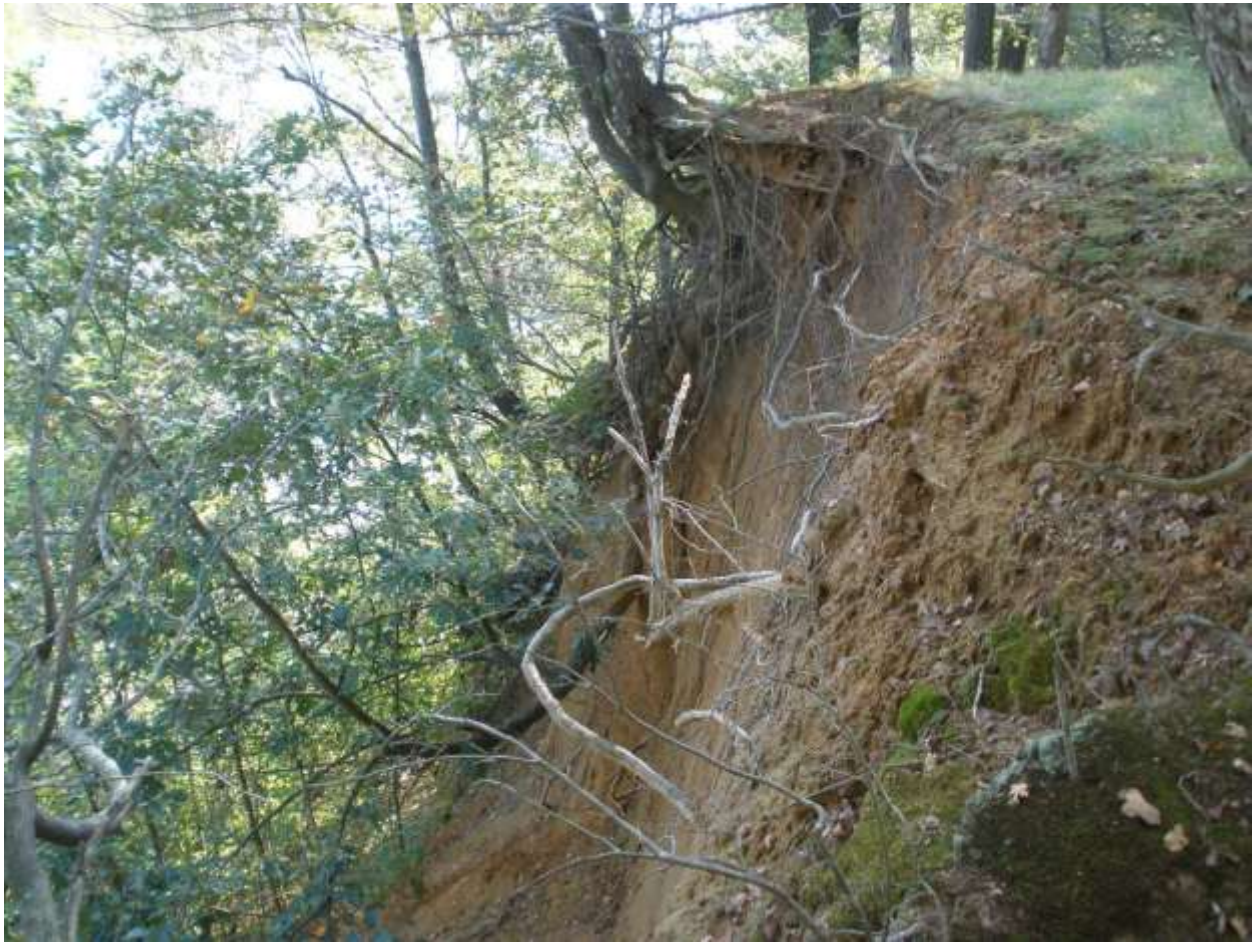
Photo of a near-vertical slope at the top of the bluff. This area is inherently unstable. Slope failure and slumping is inevitable. The material exposed on the bluff face is sand and gravel.

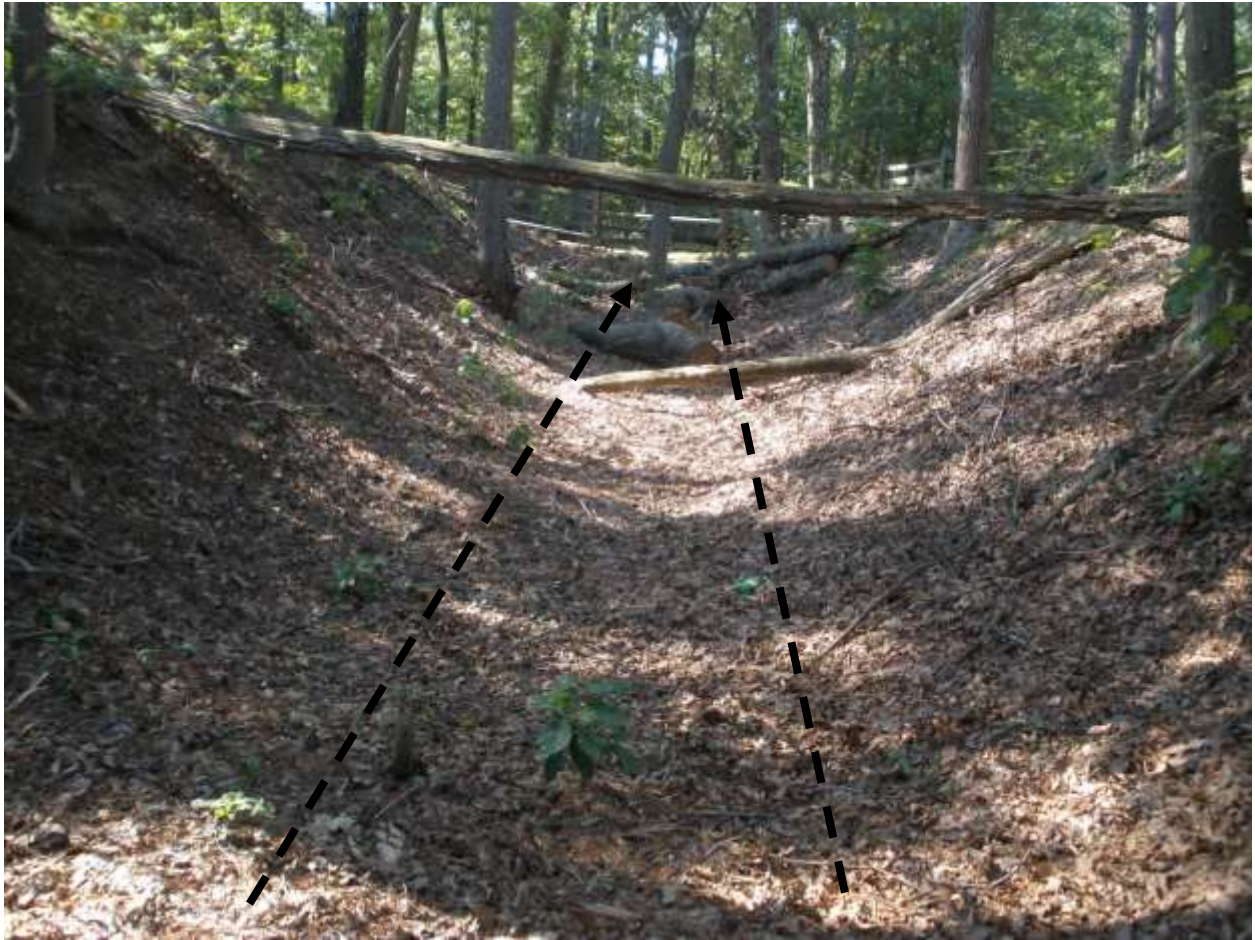
During my site visit, I noted what seems to be a correlation between the active slump areas and excavated areas near the bluff. The fort was an earthen structure, constructed by excavating a trench and piling the excavated earth adjacent to the trench to form an earthen embankment. These trenches might now act as infiltration beds. Rainfall and runoff from adjacent areas flows toward the bottom of the trenches where it infiltrates in a more concentrated area and then flows toward the face of the bluff, discharging at discrete zones where coarse sand and gravel overlie less permeable sand and silt layers. These areas of concentrated groundwater discharge are inherently weaker and may be the trigger points for formations of slumps. We might be able to intercept and redirect the flow of groundwater under the trench areas by constructing French drains along the bottom of the trenches. There might be two, or more, parallel drains along the bottom of a trench area. The excavation might be 2 feet deep. A perforated pipe in a gravel bed would be laid in the trench, with the pipe sloped away from the slope to drain the water toward the east until the drainage pipe can daylight and discharge its water into the natural drainage of the creek system. A sketch of a potential design for a drain system is shown on an attachment to this report. The final design should be done by someone with expertise in designing drainage systems.

Photo of one of the trenches excavated during the construction of the fort. In this area, two parallel trenches might be constructed with perforated pipe to intercept infiltration and drain the water away from the bluff. Dashed lines show approximate layout of drainage pipe.

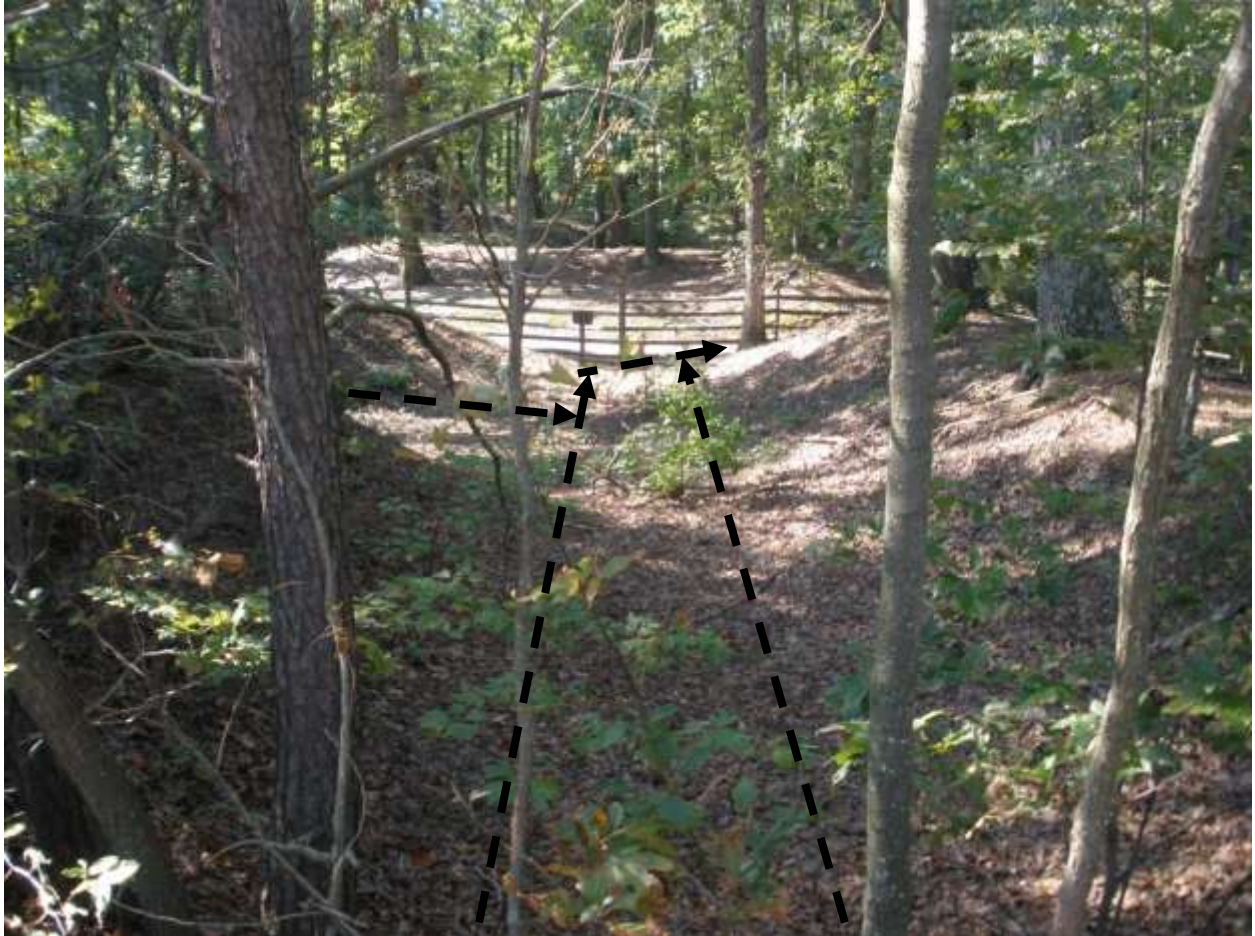
Another photo of a trench area where we could install a French drain to intercept infiltration and drain it away from the bluff. This photo is taken from near the edge of the bluff, looking back toward the footpath near the entrance to the fort. Dashed lines show approximate layout of drainage pipe.
