Memorandum

Subject: Trip Report for Travel to Rocky Mountain National Park on August 29-30, 2000.

PURPOSE: This trip was made to conduct drawdown and yield testing at the Aspenglen Campground supply well.

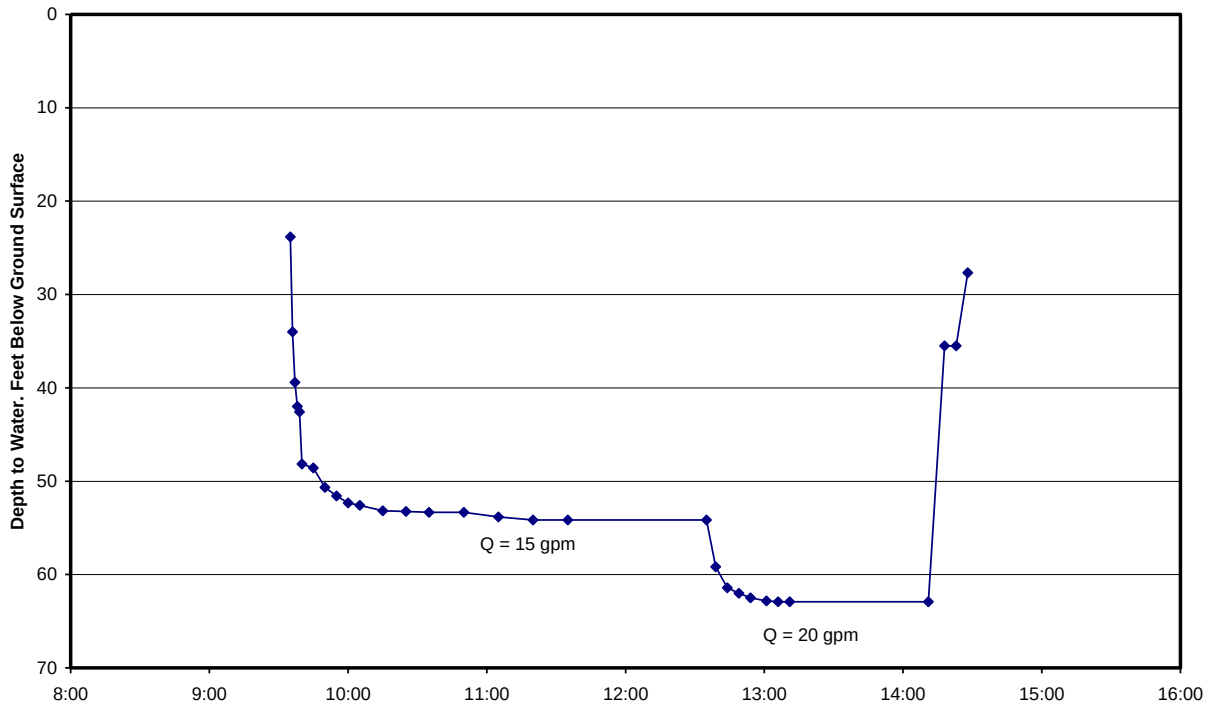
**Figure 1**

Well No. 2 was constructed with Stainless steel well screen (0.020" slot size) from 44-54 and 63-73 feet below ground surface. Colorado Silica Sand 8-12 was installed as a filter pack from 20-73 feet below ground surface. A drawdown and yield test was conducted at Well No. 2 at the time of construction. Static water level was 24 feet below ground surface. At a pumping rate of 15 gpm, the water level was drawn down to 54 feet below ground surface. At a pumping rate of 20 gpm, the water level was drawn down to 63 feet below ground surface. Data from this test are plotted on the attached Figure 1.

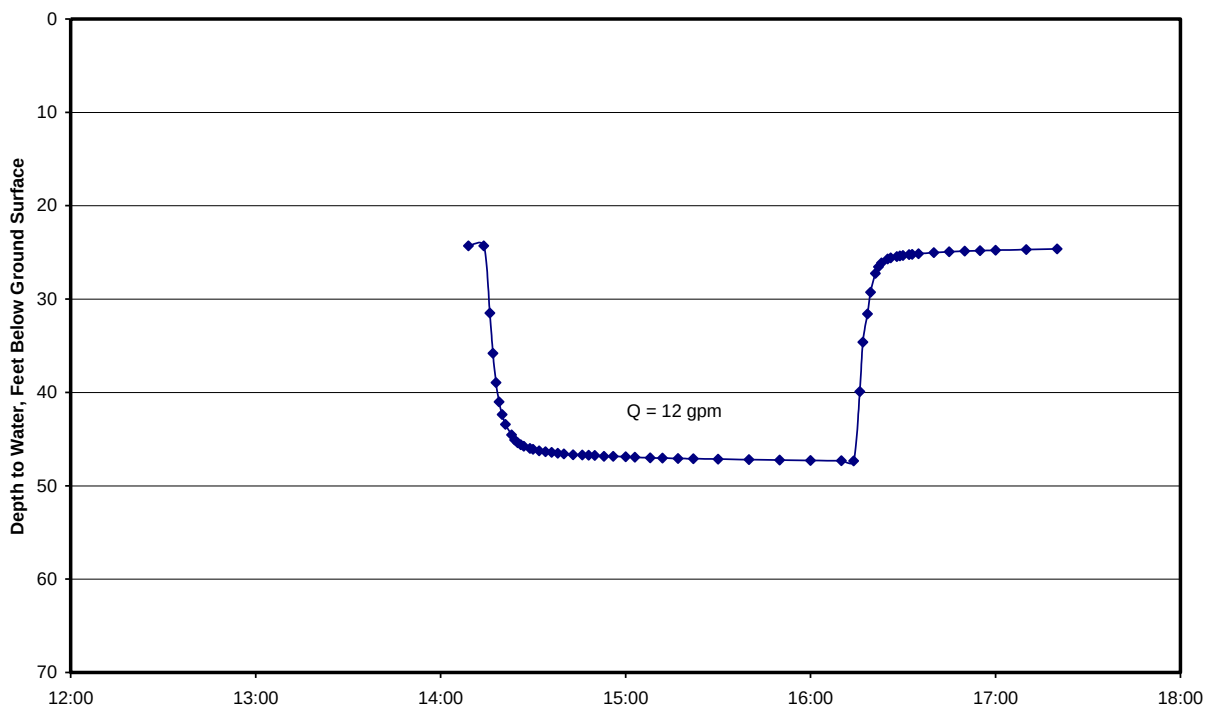
**Figure 2**

The well was retested on August 29, 2000 using the 1-hp pump that is normally installed in the well. Response of water level in the well to pumping is shown on Figure 2. The well was pumped at an average rate of 11.8 gpm for 2 hours. Drawdown stabilized at 46 feet below ground surface. Most of the drawdown and recovery of the water level in the well occurred in the first 10 minutes after starting or stopping pumping. This is probably indicative of an inefficient well; the water level in the well is drawn down more than the water level in the aquifer to induce flow into the well. Water level in Well No. 1 (located 10 feet from Well No. 2) was also monitored during this test. Water level in Well No. 1 was lowered 0.9 feet during the test. This indicates that the water level in the aquifer was not lowered very much.

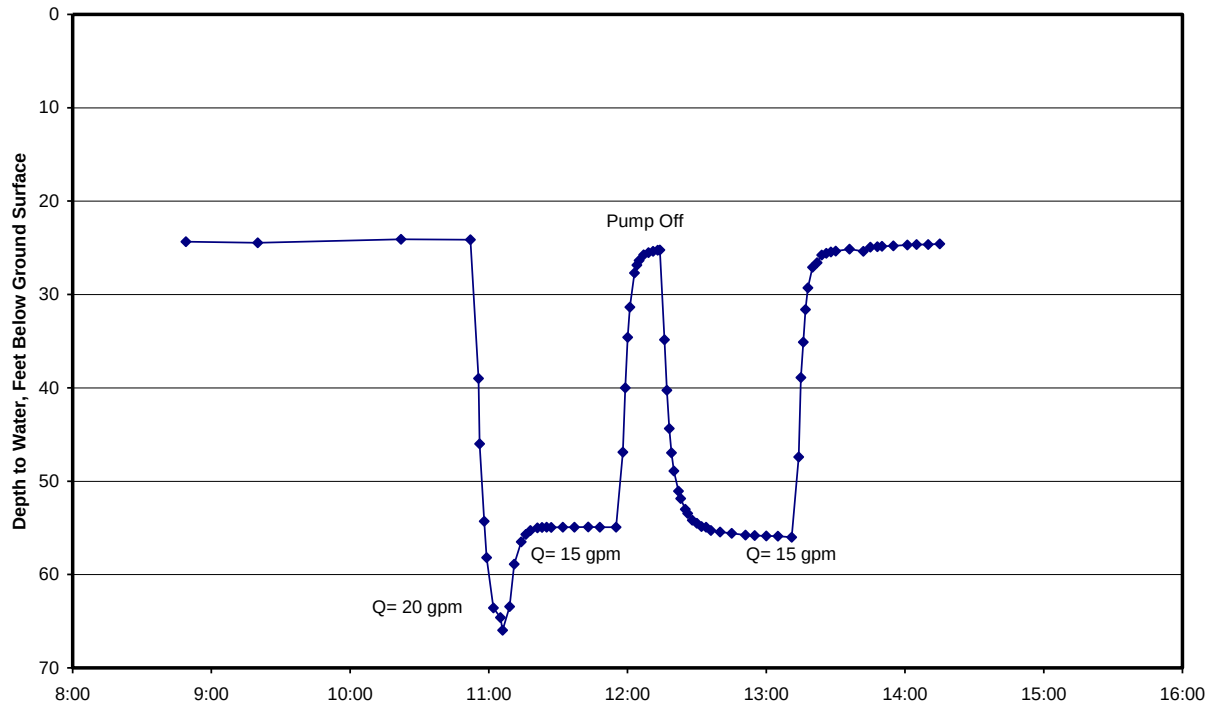
**Figure 3**

A 1½-hp pump was installed in Well No. 2 for testing on August 30, 2000. Response of water level in the well to pumping is shown on Figure 3. The well was initially pumped at the maximum rate of the pump, 20 gpm. The water level was quickly drawn down to the pump intake at 67 feet below ground surface. A valve on the discharge line was partially closed to reduce the pumping rate to about 15 gpm. This resulted in the water level in the well recovering to about 55 feet below ground surface. After 50 minutes, the pump was turned off to monitor recovery. Water level quickly rose to within about 1 foot of the static water level. The pump was restarted and the water level was drawn down to about 56 feet below ground surface. Pumping continued for an hour. When the pump was turned off, the water level in the well quickly recovered to within about 1 foot of the static water level and then recovered at a much slower rate. These data indicate that the water level in the aquifer is lowered only about 1 foot during pumping, but that the water level in the well must be drawn down much further to create enough head differential between the aquifer and the well for water flow into the well.

The combination of evidence from the testing of Well No. 1 and Well No. 2 leads me to believe that Well No. 2 should be capable of producing much larger quantities of water than is currently being obtained. It appears that Well No. 2 was either not properly constructed or not properly developed to obtain maximum yield from the aquifer. The screen may not have been placed in the proper intervals, opposite the most prolific water-bearing zones. The well may not have been properly developed, leaving fine-grained sediments clogging the well screen and sand filter pack. We can't do anything about the location of the well screen. We can redevelop the well by "jetting" it. Jetting is the process of spraying water at high pressure through the well screen and into the sand filter pack outside of the well screen. The spray of water causes fine-grain particles in the sand filter pack to be washed into the well. The sediment is then removed by bailing the well. The process should result in more efficient movement of water from the aquifer, through the sand filter pack, and into

the well. The well should then be capable of being pumped at higher rates with less drawdown of the water level.

Park staff will arrange to have the well jetted, probably in Spring 2001. WRD staff will then retest the well to determine an optimal pumping rate. Park staff can then select a pump for the well, based on the results of the testing.

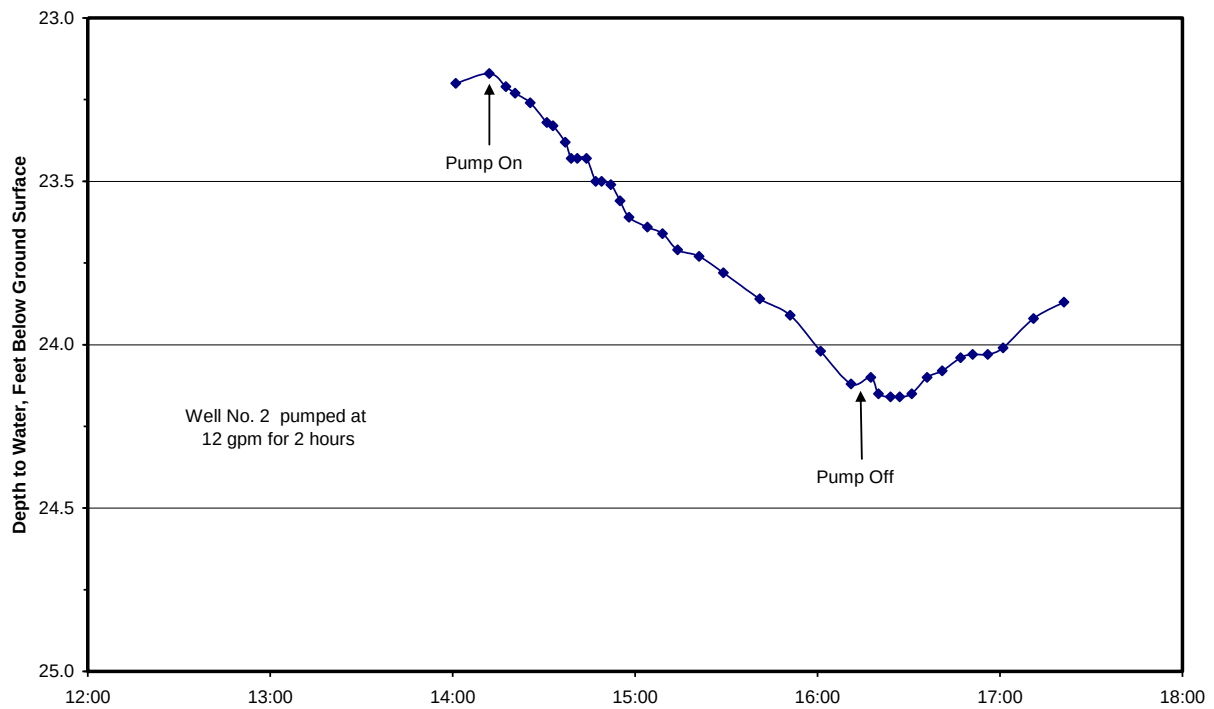
**Figure 4**

Response of the water level in Well No. 1 to pumping Well No. 2 on August 29 and 30 are shown in figures 4 and 5.
