Memorandum

To: Superintendent, Shenandoah National Park

From: Larry Martin, Hydrogeologist, Water Operations Branch, WRD

Subject: Evaluation of several water systems in Shenandoah National Park

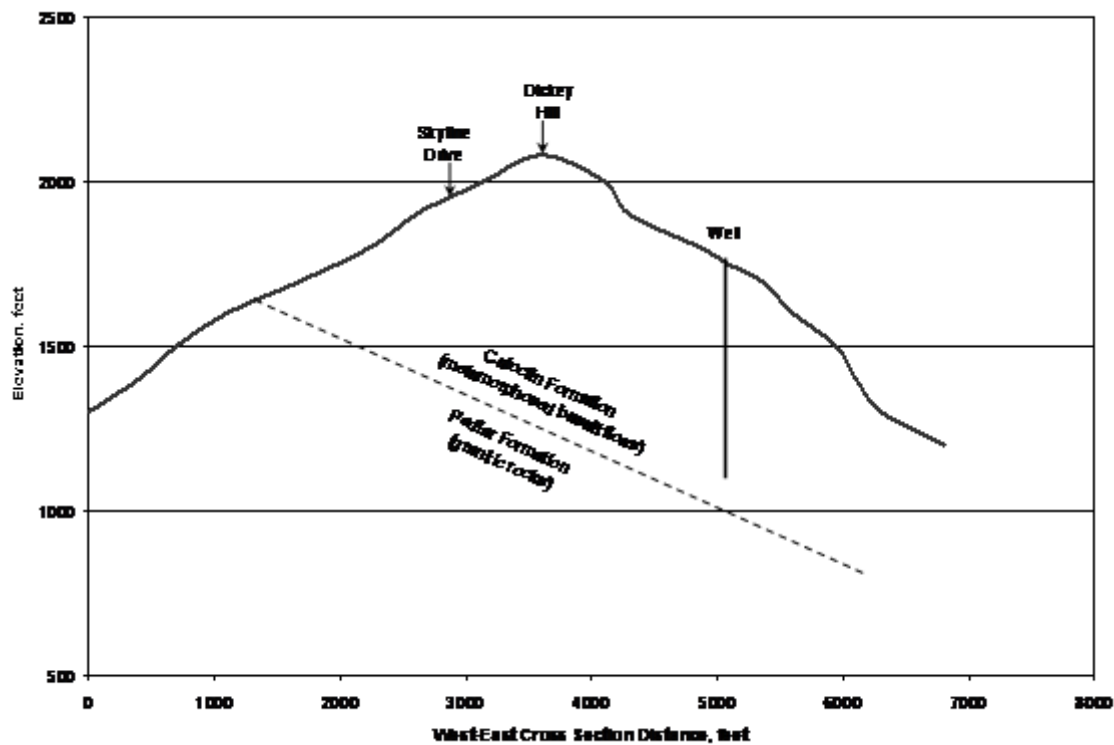
A general schematic cross section of the geology in the vicinity of Dickey Ridge is shown on the following figure. The Catoctin Formation is a series of lava flows that have been metamorphosed and then thrust from the southeast up and over the underlying granite. Throughout the park, wells constructed into the Catoctin Formation are the most reliable source of groundwater, but only where the wells have intersected fractures within the Catoctin. In the Dickey Ridge area, four shallow test wells (200-250 feet deep) either did not intersect fractures or the fracture zones were above the water table. We have learned from experience that wells in this area need to be deep (650 feet or more). Also, future well locations should be as far to the east as possible to place them as far downgradient from recharge areas along the ridgeline. It is probable that more fractures will be found near the base of the Catoctin Formation associated with movement along the thrust fault between the Catoctin and Pedlar Formations.

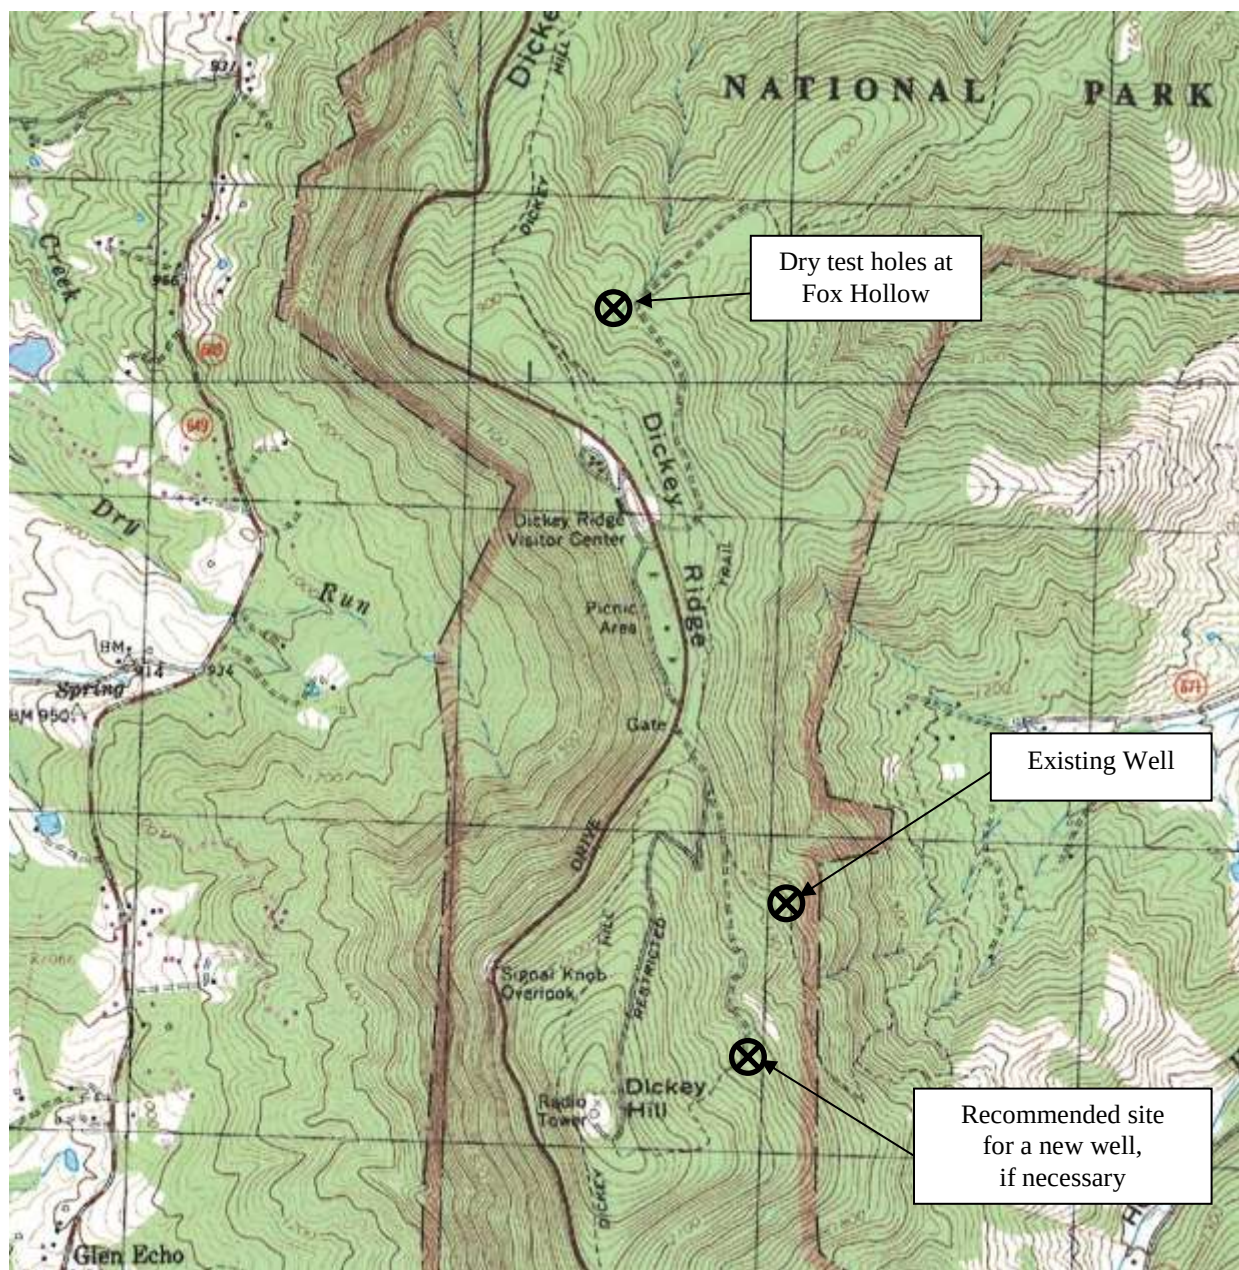
Figure 1. Well locations near Dickey Ridge

In 1963 the Park Service began looking for a new water source for facilities at Dickey Ridge to replace water that was obtained from a spring at Lands Run Gap 3¾ miles to the southeast of Dickey Ridge. Even though a usable well was eventually completed near Dickey Ridge in 1967, the park continued to use the spring at Lands Run Gap until 1999. At that time, the State of Virginia determined that water from the spring was "under the direct influence of surface water" and should be treated as if it were a surface water source. Rather than construct a surface-water treatment system, the park abandoned its use of the spring and began using the well for the water supply at Dickey Ridge. The situation today remains that facilities at Dickey Ridge are dependent on a single source for the water supply, the deep well located about 4000 feet south-southeast of the Visitor Center.

During this site visit, the well was pumped at 7-8 gpm for 1½ hours. The water level in the well could not be measured because the measuring tape continually got hung up on obstacles in the well, most likely torque arrestors on the drop pipe. Park staff reports they have never had a problem with the well running dry, even during the spring when the well is pumped continuously for several days to refill the 100,000 gallon tank. So although we could not conduct a drawdown and recovery test of the well, it has proven to be a reliable source based on several years of use. When it was first constructed in 1967 the well was test pumped at 35-60 gpm for 26 hours, resulting in 330 feet of drawdown. As the recovery rate following pumping was rather low, it was recommended that the pumping rate be restricted to 10 gpm. The well is equipped with a 7 gpm pump and pumping is controlled by a timer. The well easily supplies the water needs of NPS facilities at Dickey Ridge. The large storage capacity for the area further provides a buffer for peak demand days.

There is probably enough storage capacity at Dickey Ridge to provide water during periods when maintenance or repair is needed at the well. However, if a new well is desired at Dickey Ridge, it should probably be located in the Snead Farm area. That would place it about as far downgradient of recharge areas as is practical without constructing new roads. The planned depth for a well at the Snead Farm should be 700-800 feet deep. If the granitic rocks are encountered at a shallower depth, drilling should stop when the granite is encountered. Constructing the well at Snead Farm would also place it in the same general area as the existing well and make it a little easier to connect into the existing water line and supply electricity to the new well. The location of the current well and the proposed location of a second well are shown on figure 1.

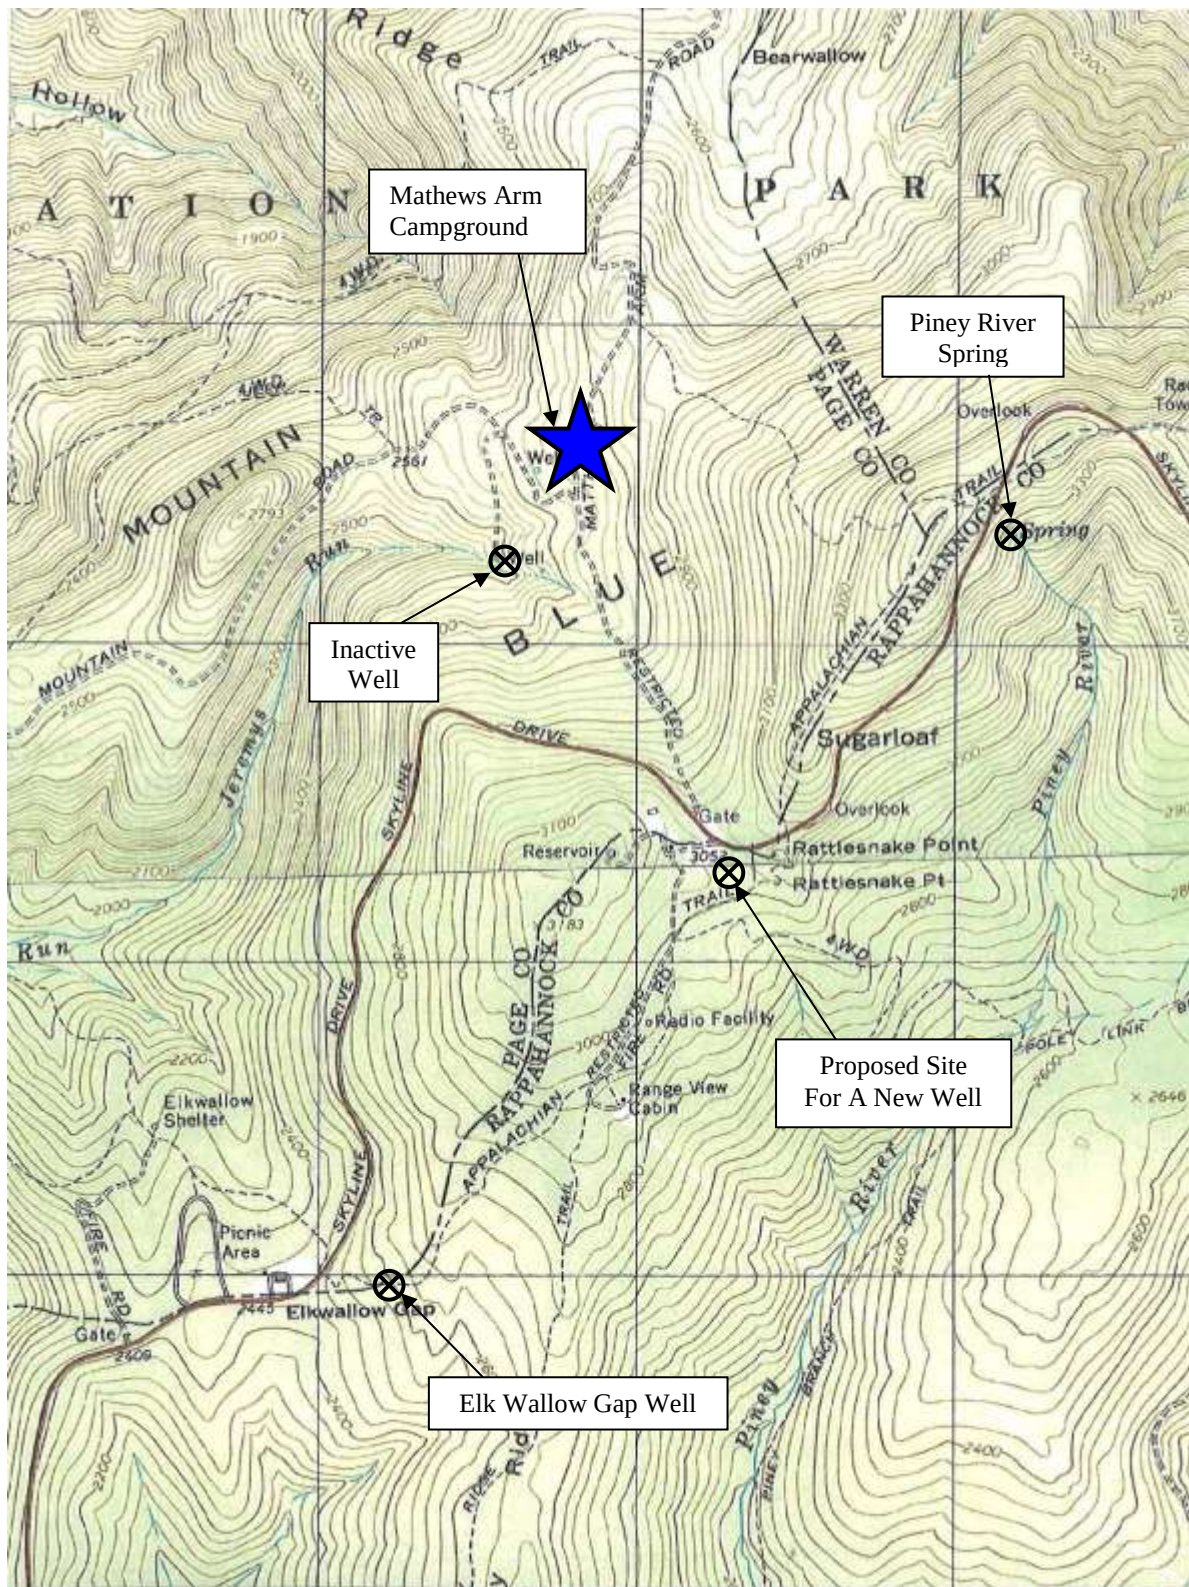
Figure 2. Location of wells and springs in the vicinity of Mathews Arm, Piney River, and Elk Wallow

Water for the Mathews Arm campground and facilities at Piney River is supplied from a spring at the head of Piney River, about 1000 feet south of the Hogback Overlook. Water flows by gravity from the spring to a 100,000 gallon storage tank. Water is chlorinated prior to entering the storage tank. Water demand at the campground (based on inflow records at the sewage treatment plant) is about 1000 gpd in midweek, rising to about 3000 gpd on weekends. Water usage rises to about 10-12,000 gpd on weekends during peak visitation periods. The campground at Mathews Arm is open from spring through October. Facilities at Piney River include; the North District Ranger Office with 1 bathroom, the North District Trail Office with 1 bathroom, and a maintenance building with 1 bathroom. Water use for facilities other than the campground does not exceed a few hundred gallons per day.

The area at Mathews Arm Campground and Piney River is underlain by Catoctin Formation, metamorphosed lava flows. The Catoctin Formation is the most reliable source of groundwater for wells in the park. The well at the Mathews Arm Campground produces more than 20 gpm from fractures in the Catoctin Formation. The well at Elk Wallow, approximately 6000 feet southwest of Piney River was drilled to a depth of 363 feet in the Catoctin Formation. The well produces 10 gpm from fractures at 70-75 and 140-145 feet below ground surface. Based on successful well construction nearby, we would expect that a well constructed in the vicinity of NPS facilities at Piney River should be capable of providing at least enough water for a low-capacity system.

The spring is about 7000 feet from the storage tank at Piney River. Continued use of the spring will require total rebuilding of the collection system at the spring, regrading of the area to protect the collection system from inflow of surface water and replacement of the water line from the spring to the storage tank. Alternatives to continued use of the spring include; 1) converting the system to rely solely on the well west of the campground, 2) constructing a new well at Piney River to supply facilities at Piney River and use the well at the campground to supply the campground on a separate system, and 3) if a new well at Piney River produces sufficient water, it could be used to supply facilities at Piney River and the campground using the existing storage tank and distribution system.

Success in constructing wells into the Catoctin Formation at other locations in the park indicates there is a reasonable chance of obtaining water from a well at Piney River. There appears to be a NNW trending linear feature, depicted as an intermittent stream on the topographic map, to the south of the Piney River maintenance area. This linear trend may be an expression of a zone of weakness or fractures in the underlying bedrock. If a new well was constructed at Piney River, it should be located to intercept the extension of this linear feature. Thus, the ideal well location would be along the east side of the maintenance yard, perhaps just south of the road to the ranger station. The location could be anywhere in this general area that is conveniently located with respect to electricity, existing water lines, and that will not interfere with other uses in the area. A well in this area might need to be drilled to 800 feet to insure the bottom of the well is at an

elevation lower than the Piney River Valley about a mile to the east. If a test well at Piney River doesn't initially produce enough water, the yield might be improved by hydrofracking.

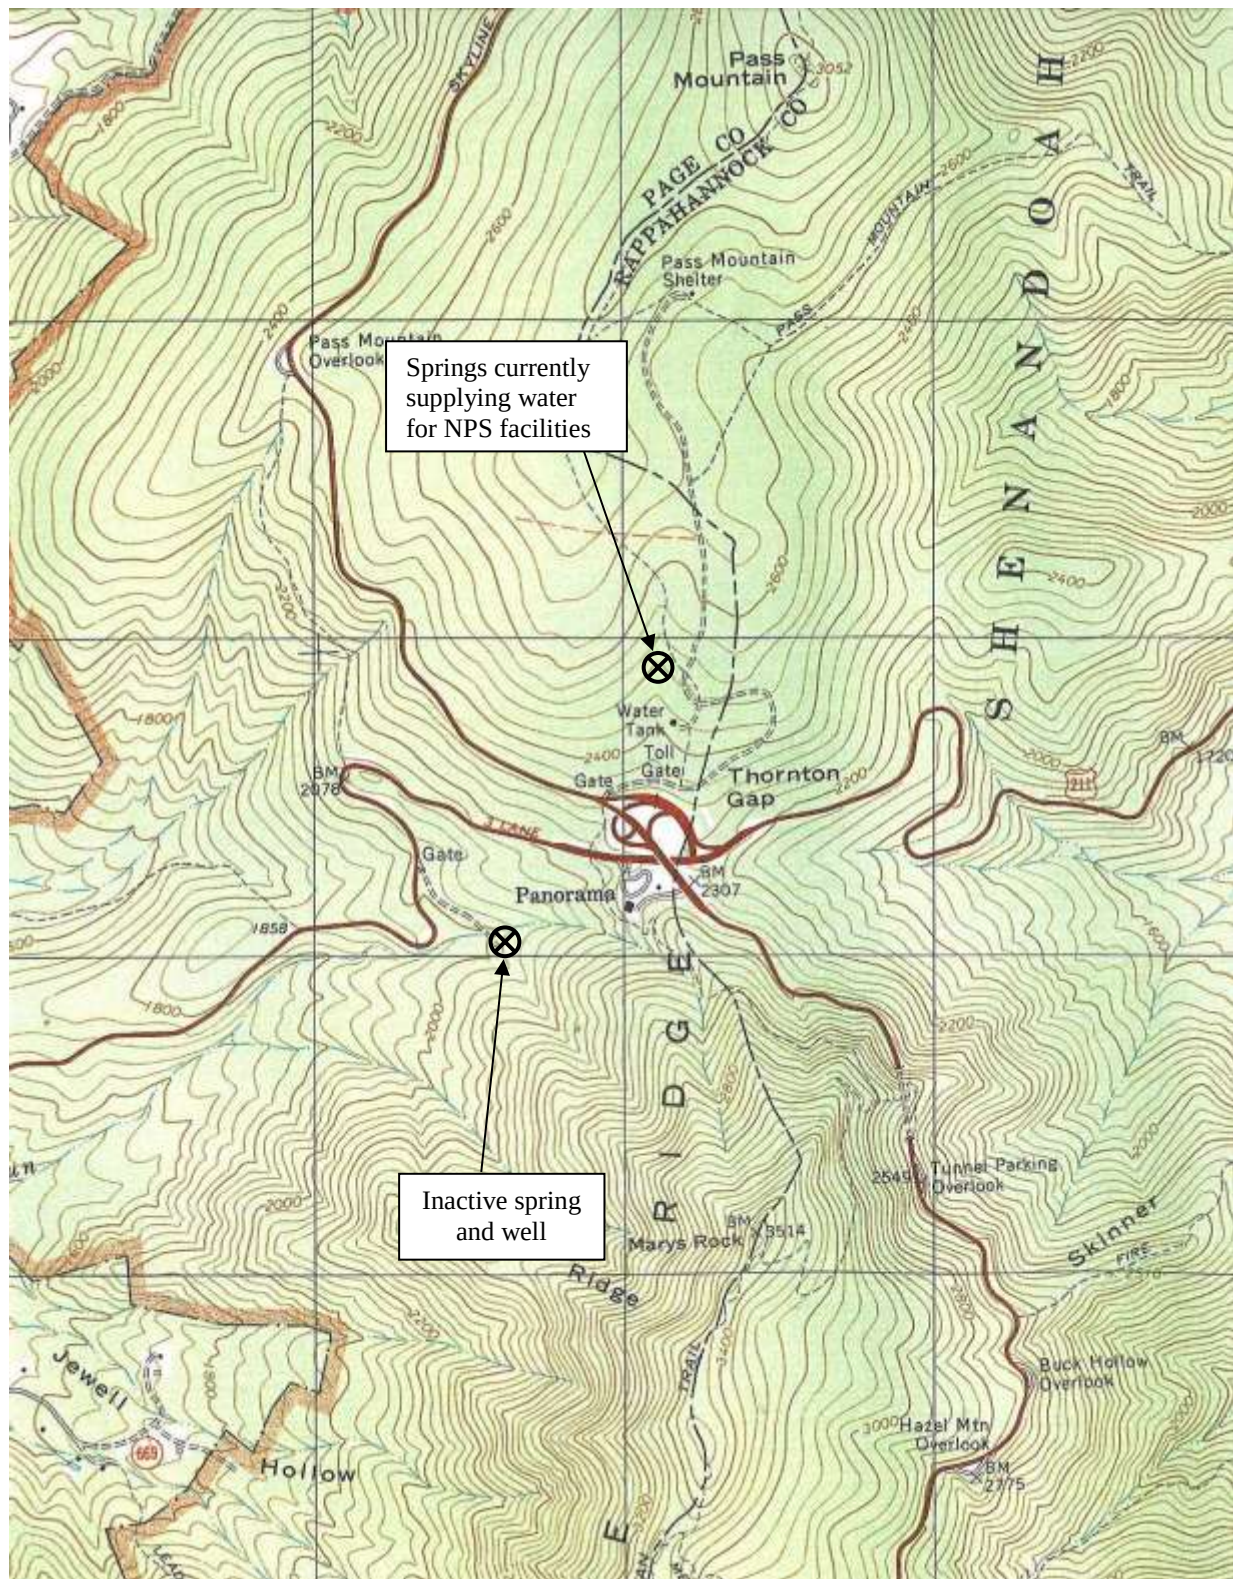
Figure 3. Location of springs and wells in the Thornton Gap – Panorama area.

Water for facilities at Panorama and Thornton Gap is supplied from two springs on the mountain about 1200 feet north of the entrance station. Water from the collection systems at the springs is piped to a clear well and then to a chlorinator and storage tanks. The primary storage tank is a 200,000 gallon steel tank above ground. There are also two underground storage reservoirs, 20,000 and 50,000 gallons capacity, which are not currently used. Inflow to the spring collection boxes becomes turbid following rainfall, showing an interconnection with surface water in the area and the potential for contamination.

There is another spring and a well that were developed about 1100 feet WSW of the restaurant and 500 feet south of Hwy. 211 at an elevation of 2050 feet. The sustained yield of the well was estimated to be slightly less than 5 gpm (Dekay, 1972). Information regarding past use of the well and spring are not well documented. There was power to the well site and a water line is in place, so it is clear that the water was pumped to the restaurant at an elevation of about 2300 feet at some time in the past. Based on the state of disrepair observed during the 2005 site visit, it is obvious that the spring and well below the restaurant have not been used for many years.

Alternative water sources for the area include; 1) repair and reconstruction of the well and spring WSW of Panorama and reconstruction of the water line, 2) reconstruction of the spring collection systems on the mountain north of the entrance station, and 3) drill a new well near the storage tanks, north of the entrance station. Options 1 and 2 are the reliable alternatives. Option 3 has a large risk of failure. The springs can not continue to be used as a potable water supply in their current condition as they are highly susceptible to contamination from surface sources.

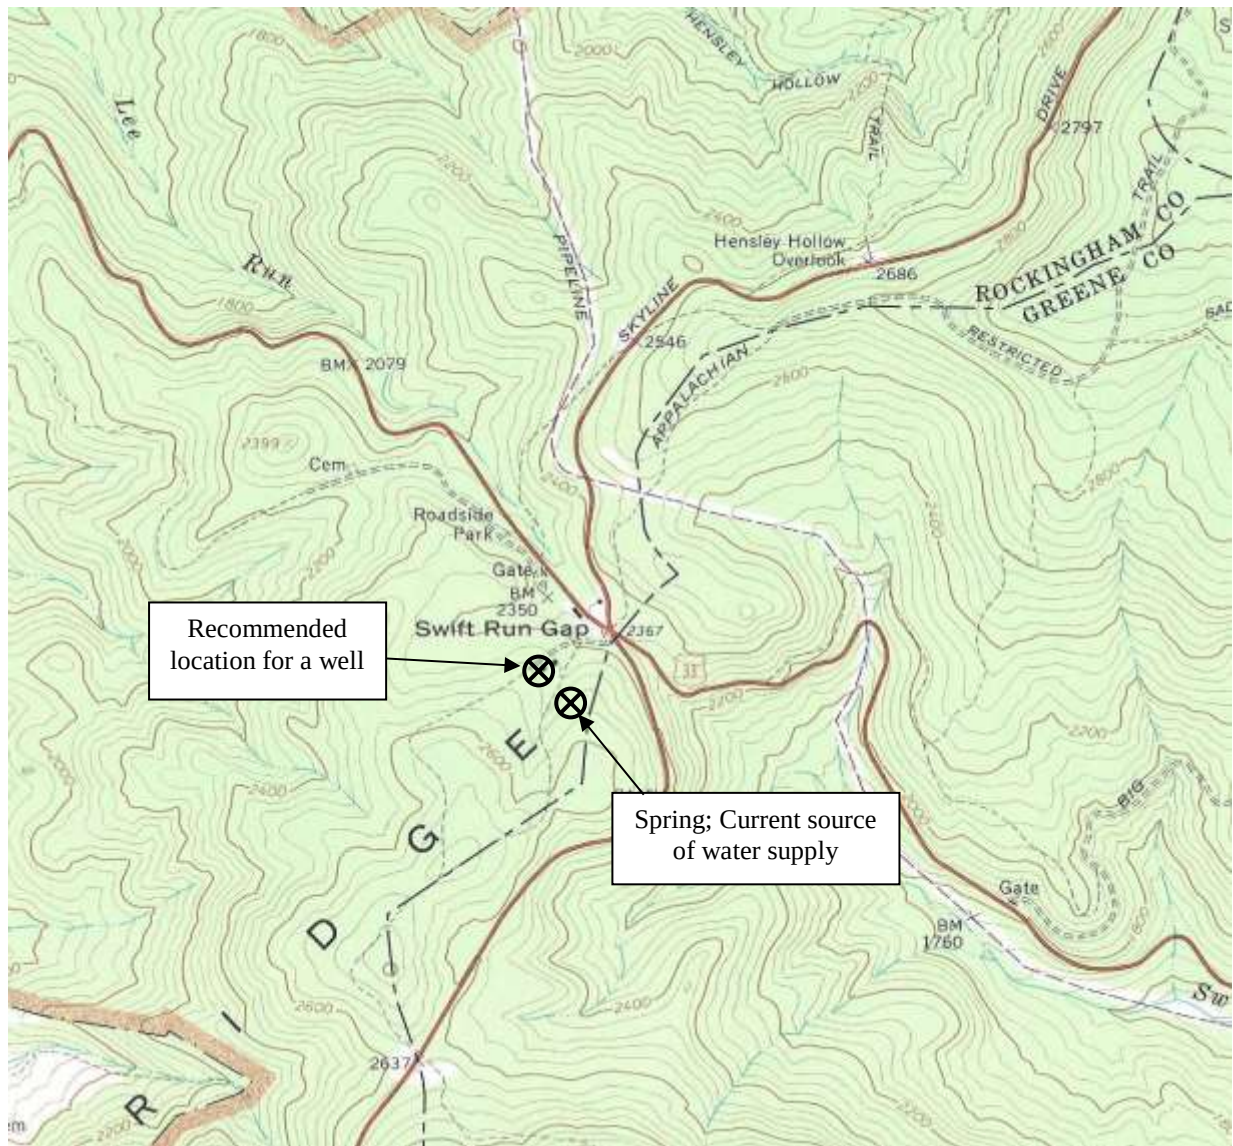
Figure 4. Location of the currently used spring and potential location for a well at Swift Run Gap

Water for facilities at Swift Run Gap is supplied from a spring about 1000 feet WSW of the entrance station. Water flows from the spring through a chlorinator to an underground storage tank. Water is used at the maintenance shop and the entrance station. There are no public facilities in the area. The entire system operates by gravity flow. The spring collection system, in its current condition, is susceptible to contamination from surface sources. No test wells have been constructed at Swift Run Gap.

1. Reconstructing the spring box and collection system to provide a safe water system that is not as susceptible to contamination from surface sources.
2. Drill a well at the maintenance area. The recommended site for a well is anywhere along the eastern side of the parking area at the maintenance yard. This location is closely aligned with the trend of an intermittent stream trending SSW. Target depth of a well should be at least 400 feet. If an adequate water supply has not been obtained it may be necessary to hydrofrack the well.
3. Continue to use the existing spring and collection system and provide bottled water or a small under-the-counter reverse osmosis unit to treat water for drinking.

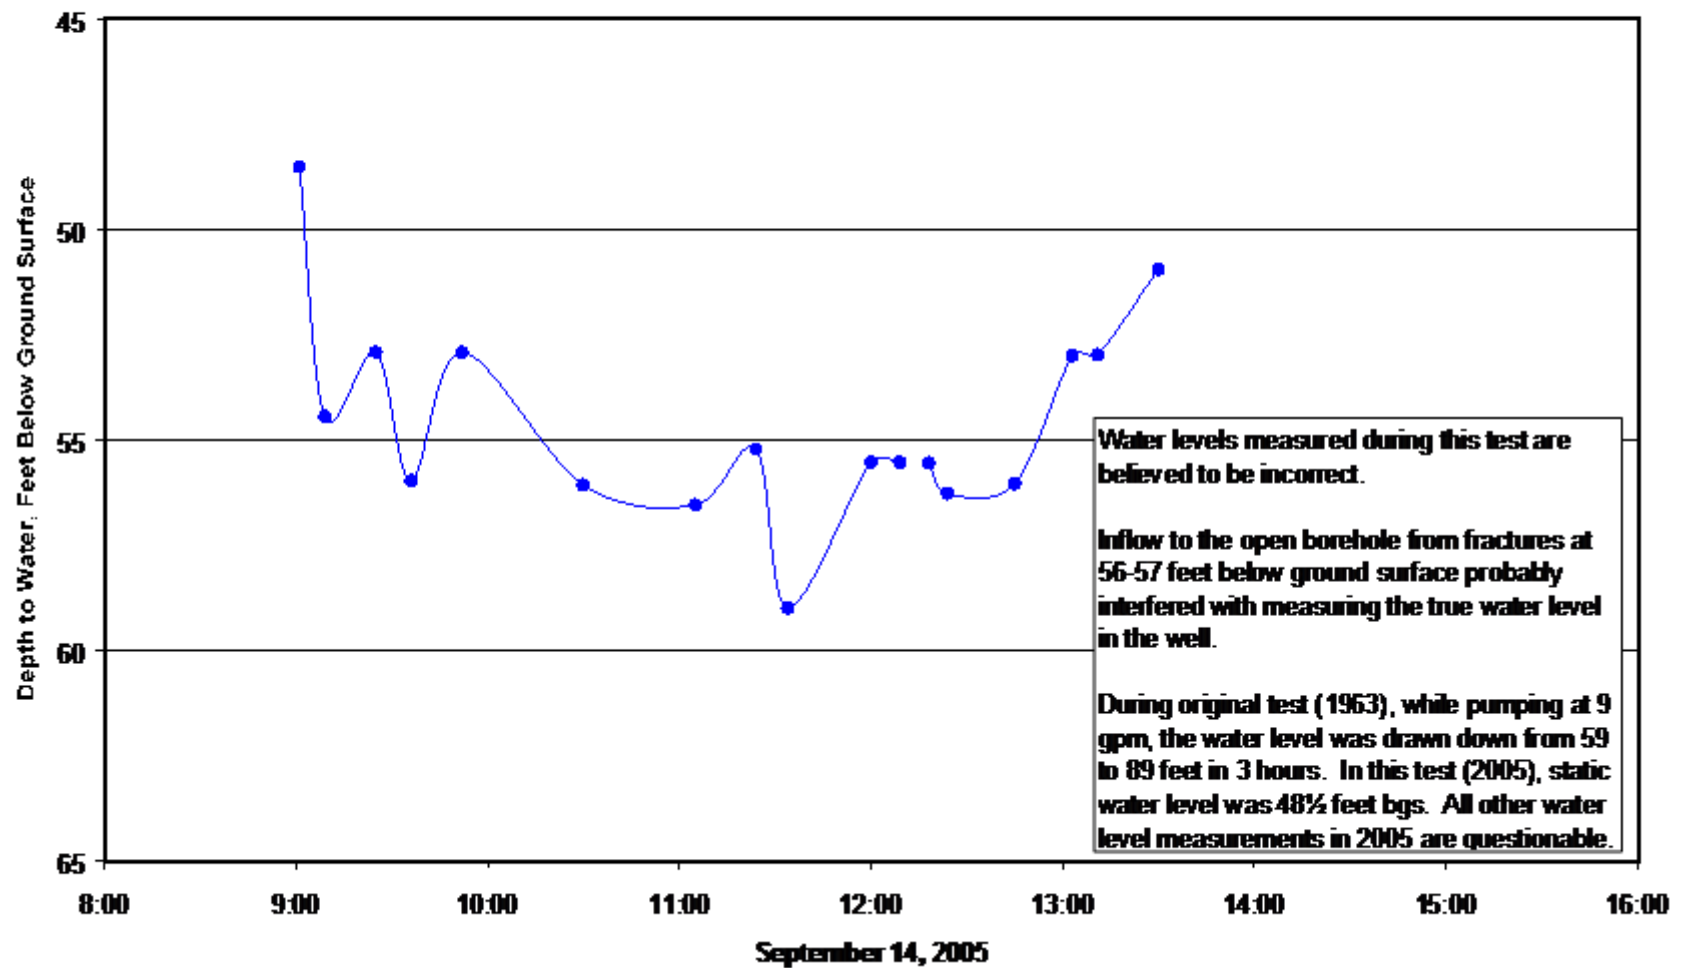
Figure 5. Hydrograph of drawdown and recovery in Well No. 1 in the headquarters area.

Well No. 1 (the west well) was drilled in the northwest corner of the Headquarters area and encountered water-bearing fractures at depths of 56, 89, 107, 117, and 150 feet. The well is 280 feet deep and is cased with 6¼-inch steel casing to a depth of 50 feet. The annular space between the casing and borehole was grouted to seal the well from surface contamination. The remainder of the hole is a 6¼-inch open borehole. The static water level was 59 feet below ground surface. The well was test pumped at 9 gpm for 20½ hours causing the water level to be drawn down to 108 feet below ground surface. The pumping rate was then increased to 25 gpm causing the water level to drop another 100 feet in the next 1½ hours. The safe yield for this well is about 10 gpm.

Water level measurements in Well No. 1 were affected by water cascading into the well from fractures in the rock about 56-57 feet below ground surface. Accurate measurements of drawdown and recovery in response to pumping the well were unobtainable. The 2005 test was conducted at an average pumping rate of 11-12 gpm. Dekay (1972) estimated the safe yield of Well No. 1 at 10 gpm. The well could probably be pumped for several hours a day using the current pump (11-12 gpm). The 2005 test of this well was conducted with the water being discharged at the surface a few hundred feet from the well. If the well were connected to the water system, the increased head associated with pumping the water to the storage tank would likely decrease output from the well to about 10 gpm.

The potable water supply for the Headquarters area should incorporate both wells, perhaps alternating between wells on a weekly basis. That would insure that park staff knew that both wells were operating properly and provide alternative sources. The wells should not be pumped for more than 12 hours per day, allowing time for recovery of water levels in the aquifer between pumping periods. If the water demand for the area increases beyond the capacity of either well individually, both wells could be used with one well scheduled to pump at night and one during the day.

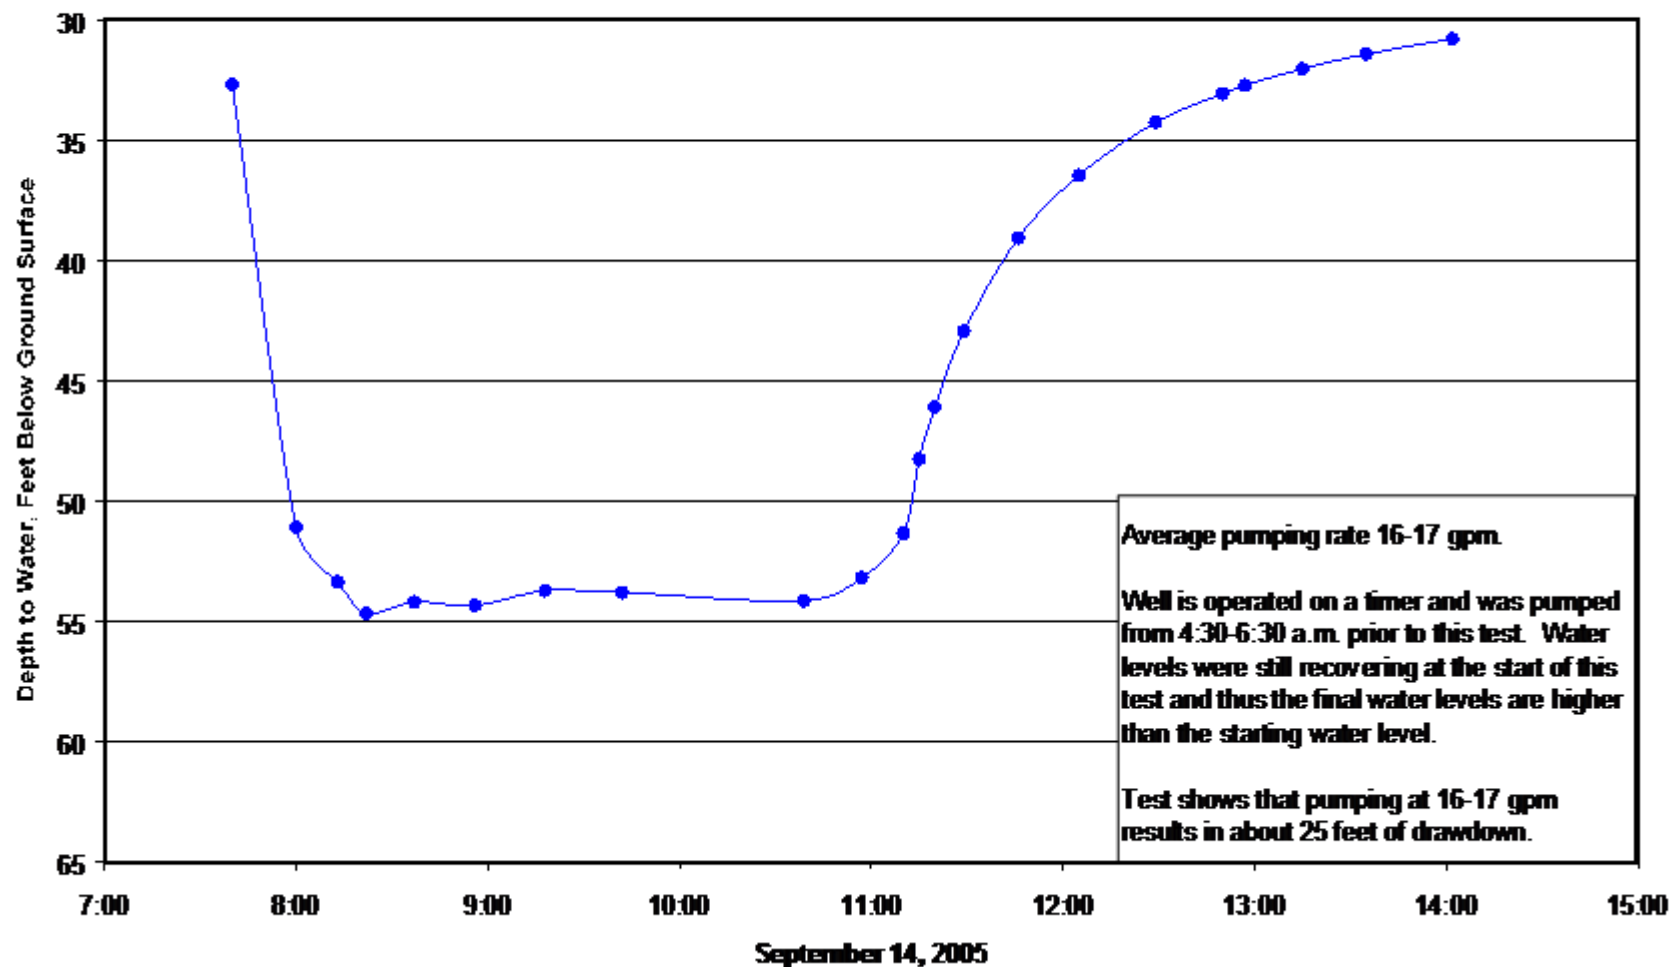
Figure 6. Hydrograph of drawdown and recovery in Well No. 2 in the headquarters area.

Well No. 2 (the east well) was drilled about 400 feet east of Well No. 1. The well penetrated metamorphosed basalt from 20-220 feet, encountering water-bearing fracture zones at 60 and 189 feet below ground surface. The well is 220 feet deep and is cased with 6¼-inch steel casing to a depth of 50 feet. The annular space between the casing and borehole was grouted to seal the well from surface contamination. The remainder of the hole is a 6¼-inch open borehole. The static water level was 40 feet below ground surface. The well was test pumped at 15-23 gpm for 24 hours causing the water level to be drawn down to 174 feet below ground surface (134 feet of drawdown). The safe yield for this well is about 20 gpm.

The hydrograph for Well No. 2 (the current production well) shows a typical drawdown and recovery pattern. Well No. 2, as equipped, could supply the Headquarters area with up to 10,000 gpd using a schedule of 12 hours on and 12 hours off each day. If additional water is needed for the Headquarters area, Well No. 1 could be used as a supplemental supply, or additional testing could be conducted at Well No. 2 to determine if a larger pump could be installed. Dekay (1972) estimated the safe yield of well No. 2 at 20 gpm.

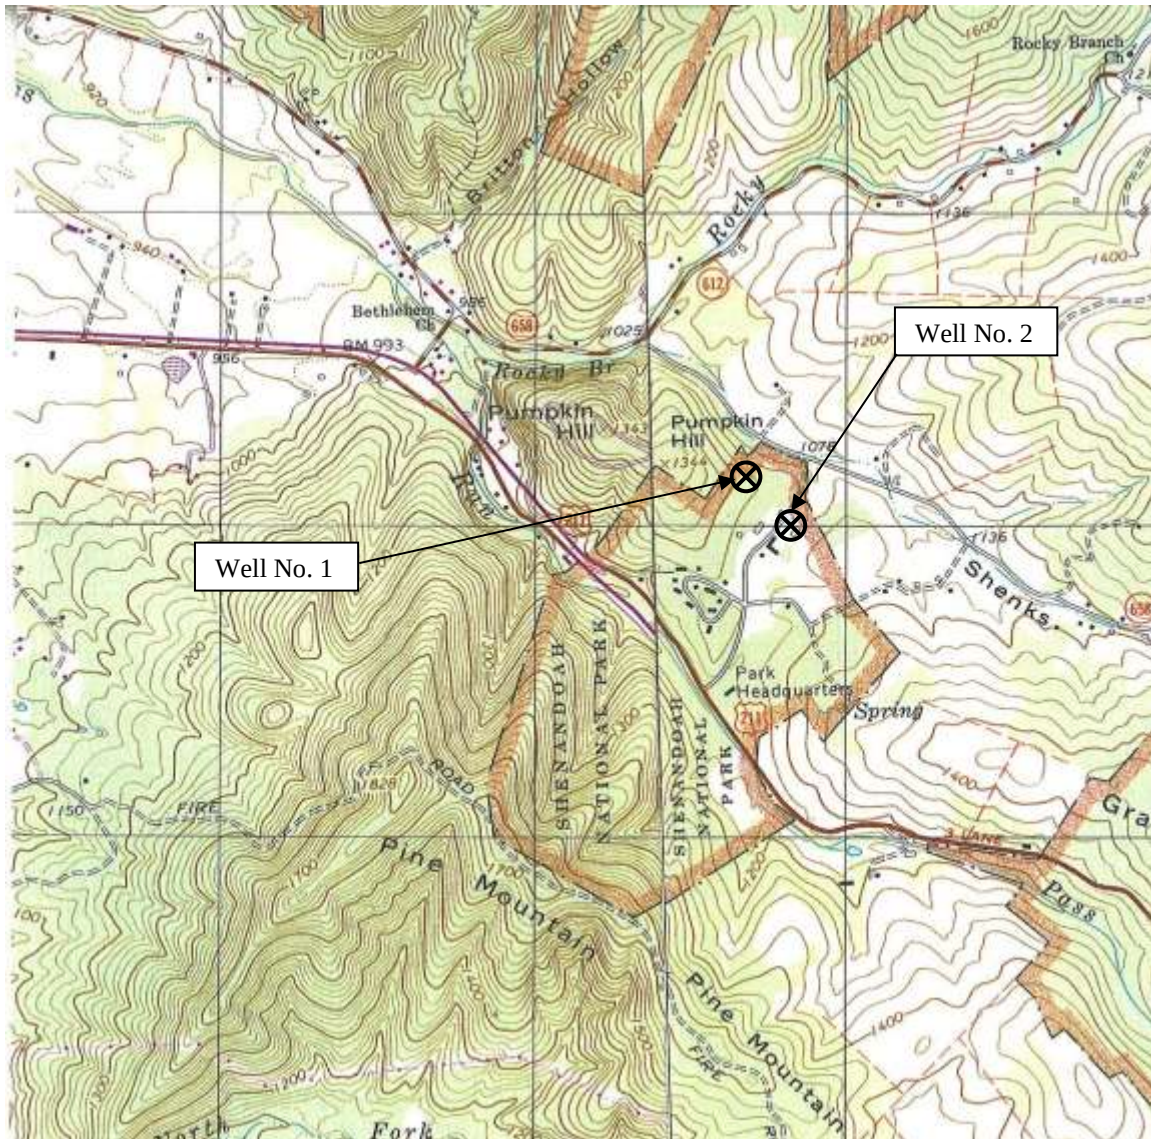
Figure 7. Location of Wells at Headquarters area

Two wells were drilled in 1963 in the headquarters area. Prior to this, water was supplied from a spring a mile to the east. The wells are about  $\frac{3}{4}$  mile southeast of the visitor center. The test holes were drilled to 280 and 220 feet. Both wells produce groundwater from fractures in the metamorphosed basalt bedrock (Catoclin Formation). The spring continued to be used for many years after the wells were constructed.

Well No. 2 has been the only water source for the Headquarters area for about the last 10 years, since use of the spring was discontinued. Park staff do not recall ever having used Well No. 1 (the west well) to supply water for the area.

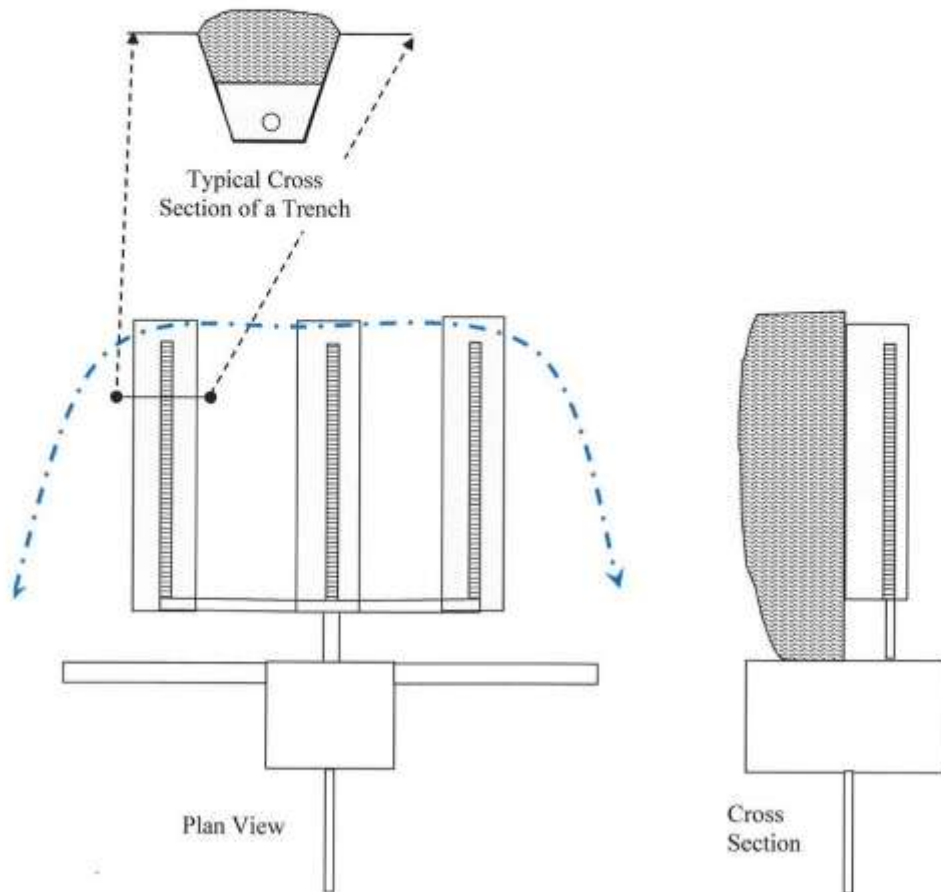
### **Typical Design for Reconstruction of a Spring Water Collection System**

Most, if not all, of the spring collection systems in the park were constructed by the CCC in the 1930's. These systems are now 70 years old and very little, if any, maintenance has ever been conducted at the springs. Basic maintenance and upgrading of the collection systems at the springs is overdue. At a minimum the collection systems should be improved by installing new perforated pipe and gravel in the collection areas, raising the spring boxes several feet above ground surface and installing tightly fitting covers, and grading the vicinity of the collection areas and spring boxes to route surface flow away from the springs. The area above the collection systems should be kept cleared of woody vegetation to reduce the intrusion of roots into the collection systems, which creates a pathway for surface contamination to enter the water system.

Excavate trenches about 2 feet wide by 20-40 feet long and 2-3 feet below the water level. Backfill the trench with pea gravel and perforated pipe. Place geotextile over the pea gravel and backfill with compacted soil from the excavation. Mound the backfill over the trenches to cause surface water to flow away from the collection trenches. Construct a drainage ditch around the perimeter to divert surface water away from the collection systems. Construct wingwalls extending out from the collection box to help back up water into the collection pipes. Raise the elevation of the top of the collection boxes about 2 feet above ground surface and fit the collection boxes with a tight cover to keep the bugs and rodents out. Initiate a regular program of mowing and brush clearing over the collection system to prevent plant roots from entering the collection pipes.
