November 2009

Larry Martin  
Hydrogeologist  
970-225-3515

## **Garton Lake and Well White Sands National Monument**

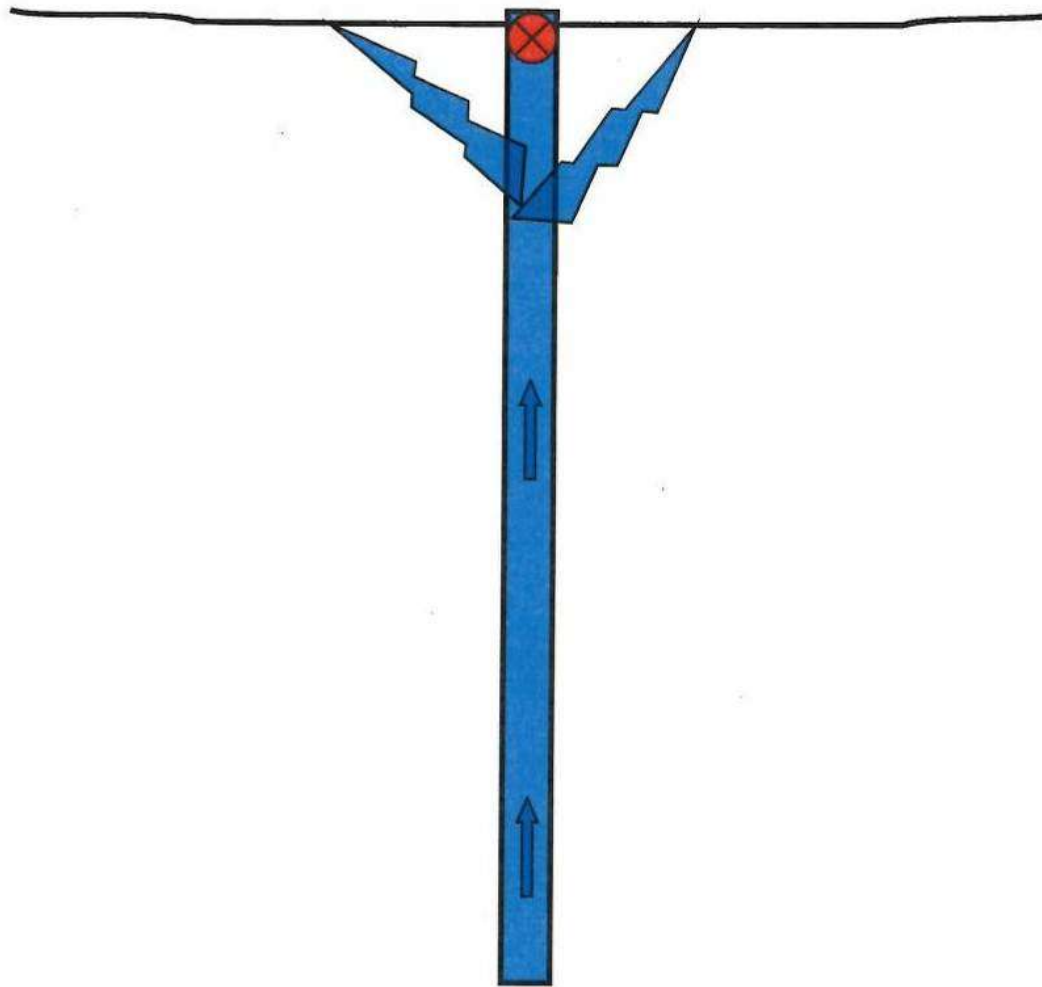
Sometime in June or July 1936, the valve was closed and shortly thereafter, numerous spring-like discharge areas formed at the ground surface within about 40-50 feet of the wellhead. Obviously, the casing had broken at some fairly shallow depth, allowing water to find new pathways to the surface. (If the casing break had occurred deep underground, the weight of the overlying sediments would have been too great for the artesian pressure to overcome.) When the valve was reopened, quantities of sand and gravel were ejected and the flow from the casing was almost stopped. Flow from the "springs" adjacent to the casing continued and additional sand and gravel was ejected from the well and deposited to a depth of 0-3 feet in an area 70 feet or more from the well. The sand and gravel ejected from the well created an undetected cavity underground.

Figure 1. Sketch of probable conditions at the Garton Well when it was fitted with a valve and the valve was closed in 1936. The artesian pressure in the well caused a rupture of the steel casing at a depth of about 35 feet. Uncontrolled flow of water eroded underground cavities that eventually collapsed when they attempted to remove the cement pad and 8-inch well casing.

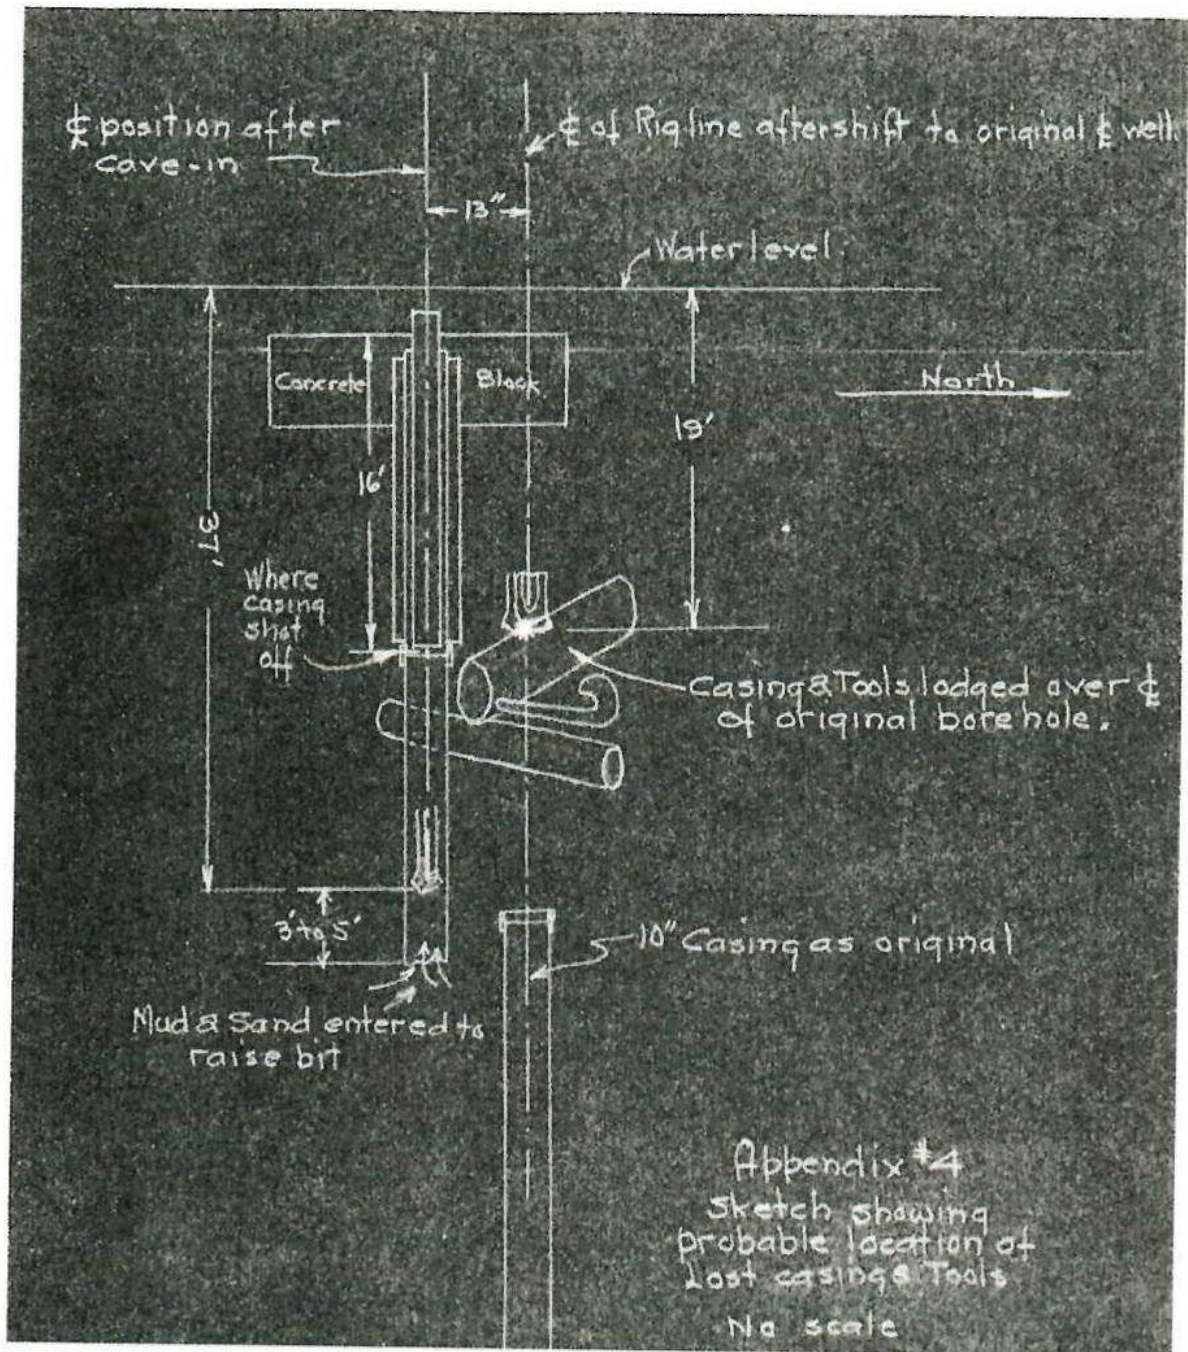
A company was contracted to remove the 16-foot section of 8-inch casing and install new 8-inch casing to some depth. They started work on the project with 840 feet of 8-inch casing at the site, which would have been enough to set new casing all the way through the lake-bed sediments and cement it into the underlying limestone bedrock formations. On the fourth day of work (Nov. 7, 1936), as they were pulling casing out of the hole, the ground around the well collapsed, creating a crater about 40 feet in diameter and 30 feet deep at the casing. The casing and wellhead settled into place about 13 inches southeast of its original location.

Several truckloads of broken concrete were dumped in the crater to fill and stabilize the hole. Later a steel and timber framework was built over the crater to make a stable working platform for further work on the well. Work resumed on the well in June 1937. Initially, they attempted to drill down through the 8-inch casing to clear the borehole. Sand and mud kept rising into the bottom of the casing. They concluded that the casing was broken at about 35-40 feet below ground, possibly at the second joint in the casing. They used dynamite to sever the upper, displaced section of the casing and concrete well pad. The well casing was severed about 16 feet below ground. The drill rig was repositioned over the exact center of the original well location and they attempted to drill down to enter the top of the remaining well casing, below the original break, about 35-40 feet below ground surface. The drill bit and other tools were continually thrown off course by debris in the crater at a depth of about 19 feet. After 4 days, they gave up on trying to reenter the old casing, which was out of sight and buried by several tens of feet of debris.

Figure 2. Sketch of the probable condition of the Garton Well immediately after collapse of land surface around the well (June 1936). Apparently the casing separated about 35 feet below ground surface when they attempted to remove the 8-inch casing. After the ground collapsed, the top section of casing settled to a new position about 13" south of the original location. The drillers were unable to reenter the 10-inch casing (the top of which was about 35 feet below original ground surface). The drill string, casing, and anything else they attempted to lower into the original casing would be deflected by tools, pipe, or other debris that fell into the crater when the collapse occurred.

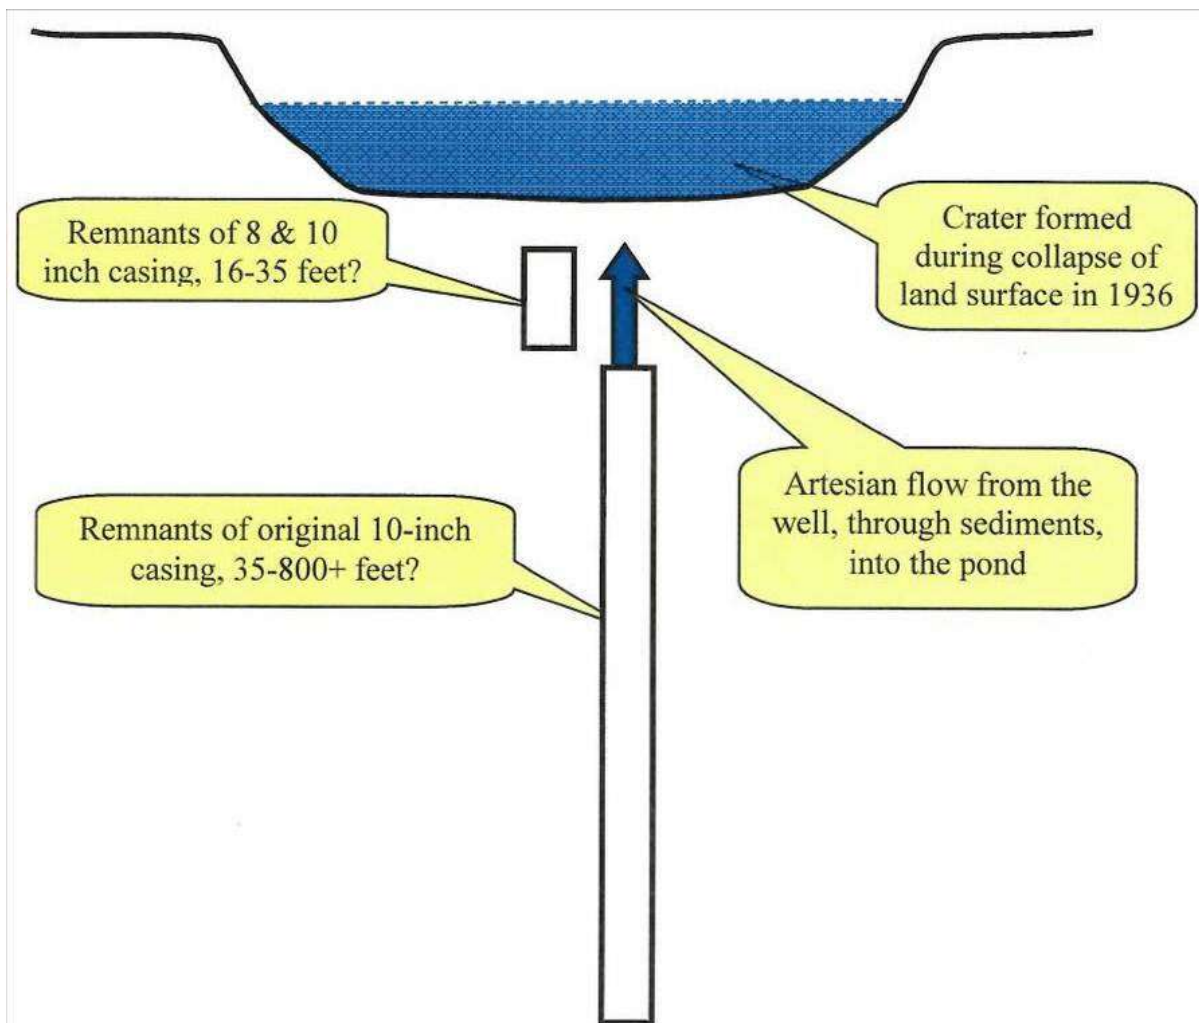
I could find no information regarding work on the well after 1936-37. It's likely that the condition of the well has not changed. The original casing is still in place, starting at some unknown depth below ground surface. It's likely that the top of the original casing is about 35-40 feet below ground surface, coinciding with the depth that they were able to drill through the displaced casing in June 1937. If the casing was not still in place through the majority of the well, it's likely that the borehole would have slumped shut at a depth great enough that the artesian flow would not have been able to continue at the land surface.

The temperature and flow rate has decreased since 1937. By the spring of 1980, the temperature was 75°F and the flow rate was less than 10 gpm (Sprester, 1980). The reduced flow rate is likely a combination of two causes. The aquifer is being depleted after many years of uncontrolled flow and the borehole is gradually sloughing closed following the removal of 500 feet of casing.

Figure 3. Sketch of probable current condition of the Garton Well. Top of the casing is probably 35 feet below ground surface. Artesian flow from the well flows through a few tens of feet of sediment to discharge into the bottom of the pond. The source of the water is a cavity in the shale and limestone bedrock unit at 889-892 feet below ground surface. About 20 feet of casing remains underground, but displaced to the side of the well. Tools, pipe, and other debris that fell into the crater during the 1936 collapse prevent access into the remnants of the original well casing.
