# **PARK SCIENCE**

## **A RESOURCE MANAGEMENT BULLETIN**

WINTER 1984

# Failed Logging Road Interrupts Water Supply

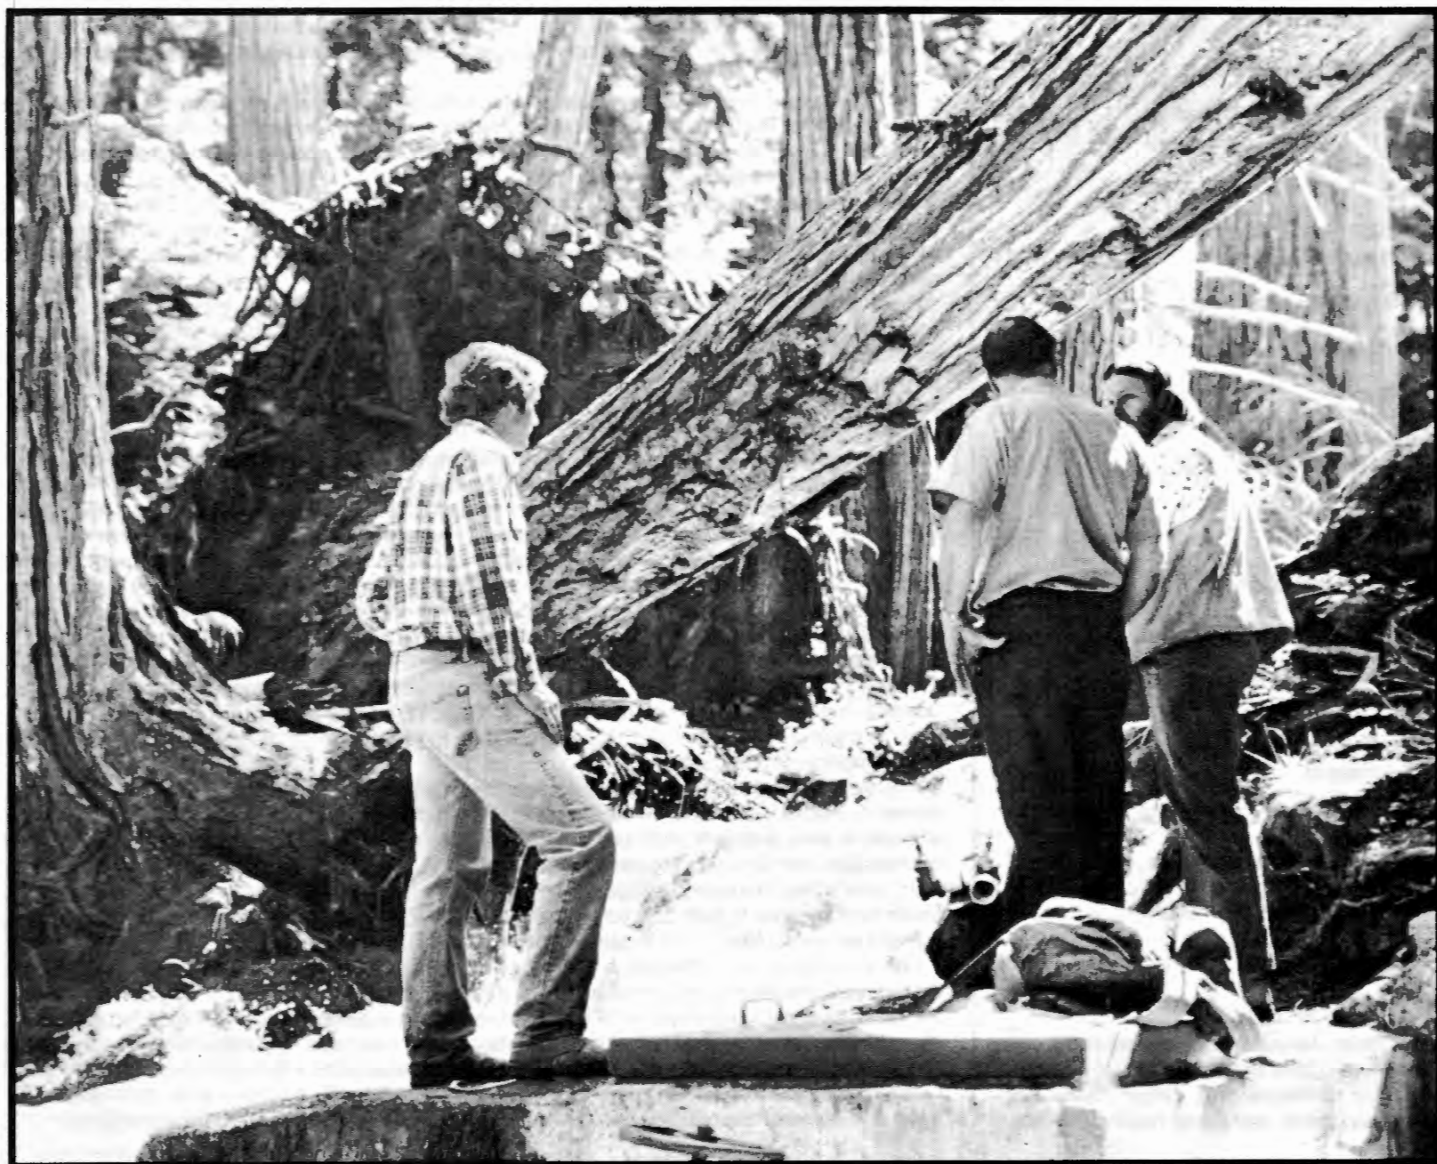
***Cover Photo: The water intake on Lake Creek, supplying Oregon Caves National Monument, is here inspected by Bill Weaver (left), Oregon Caves Supt. John Miele (center), and Danny Hagans. See story page 00.***

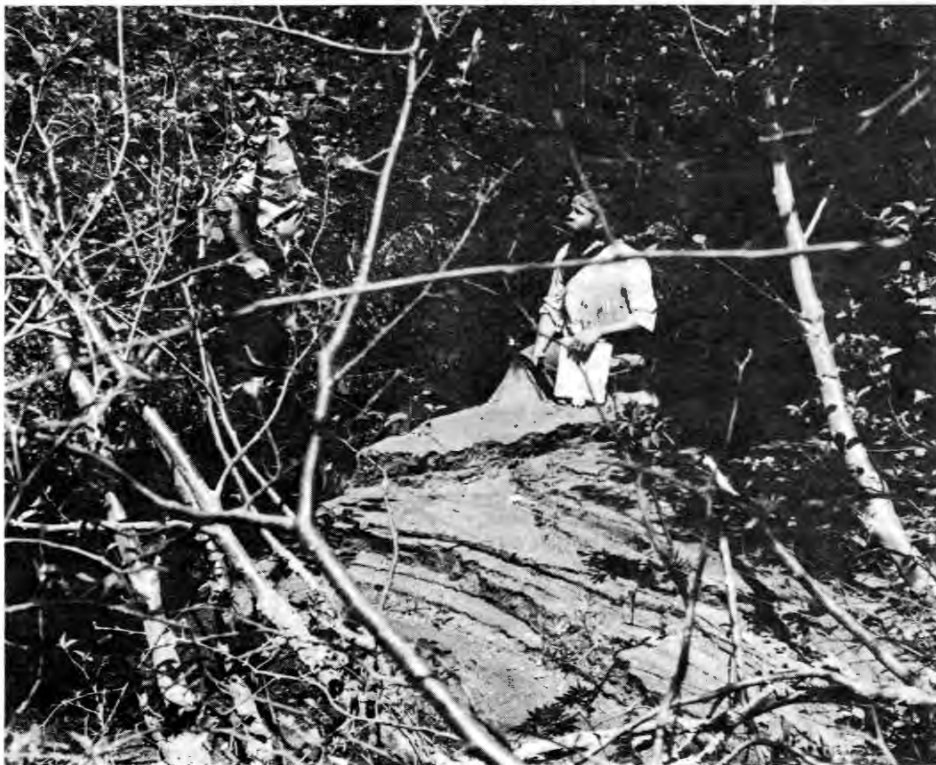
*The lowest sediment storage structure installed by Forest Service personnel was this check dam made of chain-link fence and a filter fabric. The dam, (#1) built next to a large windfall log, collected and stored sediment through much of the 1982-83 winter after which the channel changed course (braided), leading to a lowering of the baseland. Approximately one half to one third of the stored sediment was eroded and transported downslope.*

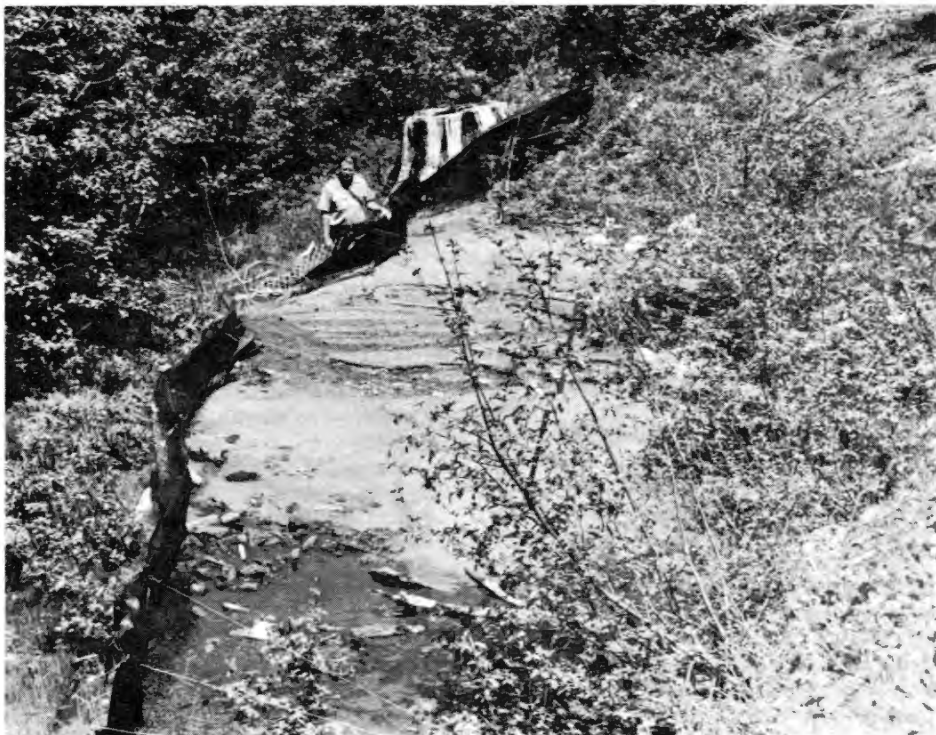
*The next higher dam, (#2), built by the Forest Service, functioned well until May 1983 when a rotational slide occurred, resulting in a mudflow down the channel and causing failure of check dams Nos. 2 and 3 (see next photo). The No. 2 dam currently has no available future storage, so it will only route sediment through or over the dam. Dam No. 2 has the potential of failing in the same manner as Dam No. 1 and transporting stored sediment toward Lake Creek.*

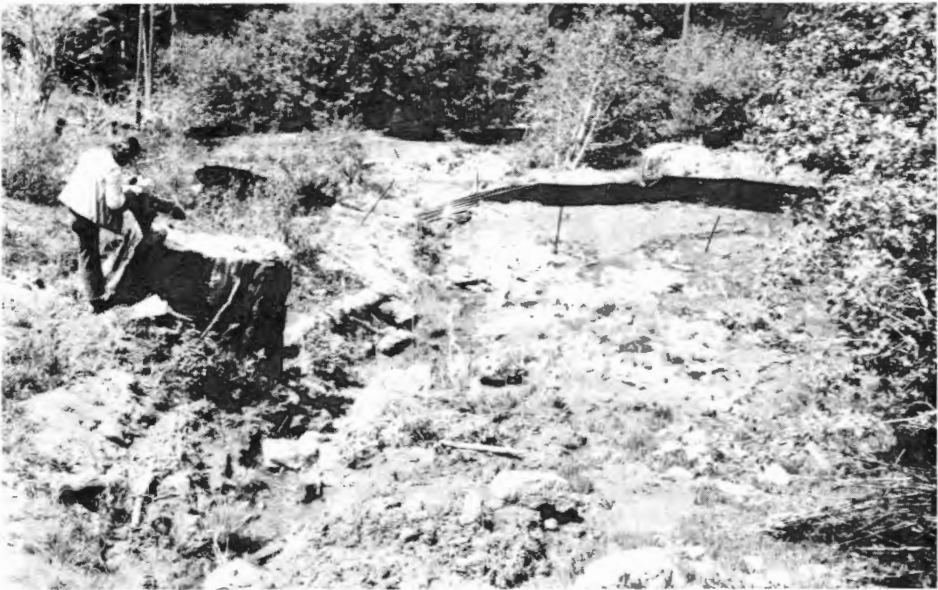
**The view downstream** with Check Dam No. 3 in the foreground and No. 2 in the distance. Dam No. 3 also has failed as a result of the landslide and mudflow above. The same potentials for failure exist here as exist at Check Dam #2.

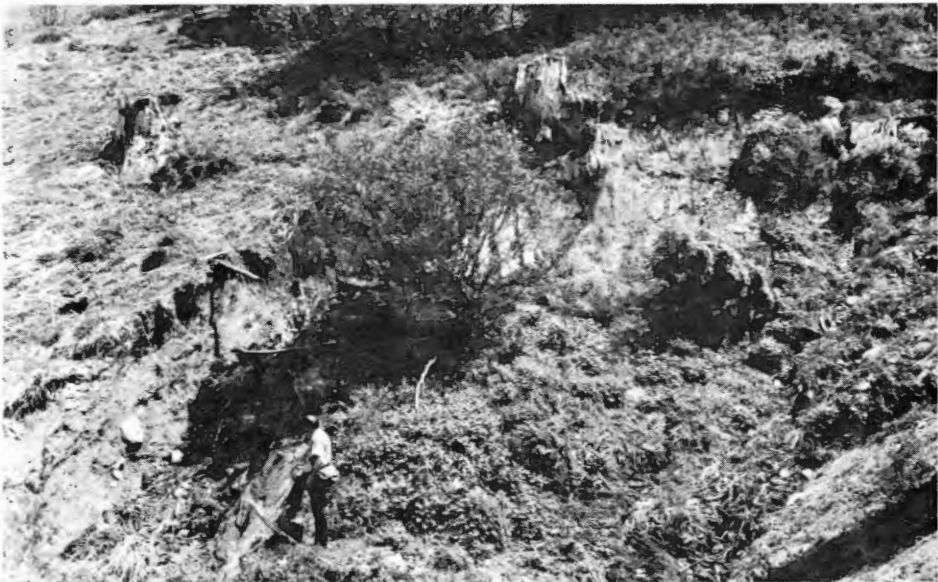
On May 23, 1983, a second high turbidity episode occurred, and on June 8, Weaver and Hagans again were loaned to the Monument to try to determine the cause. The photos and captions shown here describe the state of the slope and the water supply as of June 1983. The 1983 landslide and mudflow was caused, or strongly influenced, according to Hagans and Weaver, by diverted streamflow along the 4045D logging road.

"The accumulation of 1981 landslide debris on the 4045D road currently diverts streamflow to the north along the road for about 50 feet, where it enters 6-inch to 1-foot high scarps along the fill portion of the road prism. The new landslide is approximately 100 feet downslope from the scarps. Slopes within this area are extremely wet and naturally characterized by abundant Willow vegetation. Soils exposed in the crown and lateral landslide scarps are 10 to 15 feet deep and consist of primarily coarse sand derived from decomposed granitic bedrock. The addition of water to an already wet slope underlain by relatively cohesiveless materials apparently elevated pore pressures in the slope and led to the landslide and mudflow. This condition coupled with the existing lack of lateral hillslope support along the 1981 debris torrent track will continue to pose a high risk of future landsliding and, presumably, high turbidity in Lake Creek."

**Landslide slump block** and crown scarps on a very wet slope, which resulted in the mudflow of May 1983 that caused high turbidity values in Lake Creek and probably breached Check Dams 2 and 3. Cause of the slide was diverted streamflow along the 4045D road. USFS personnel have subsequently inspected the site and recognized the need to correct the drainage problem.

Supt. Miele reported to the Pacific Northwest Region on Oct. 13, 1983, that he and Resource Asst. Don McClennan of the USFS had conducted an Oct. 12 inspection of the site . . . that McClennan recognized the need to correct the stream diversion at the 4045D road crossing, and that this would be accomplished "prior to the onset of winter." McClennan agreed that catch basin structures Nos. 2 and 3 would be strengthened, but indicated that the stored sediments would not be cleaned out.

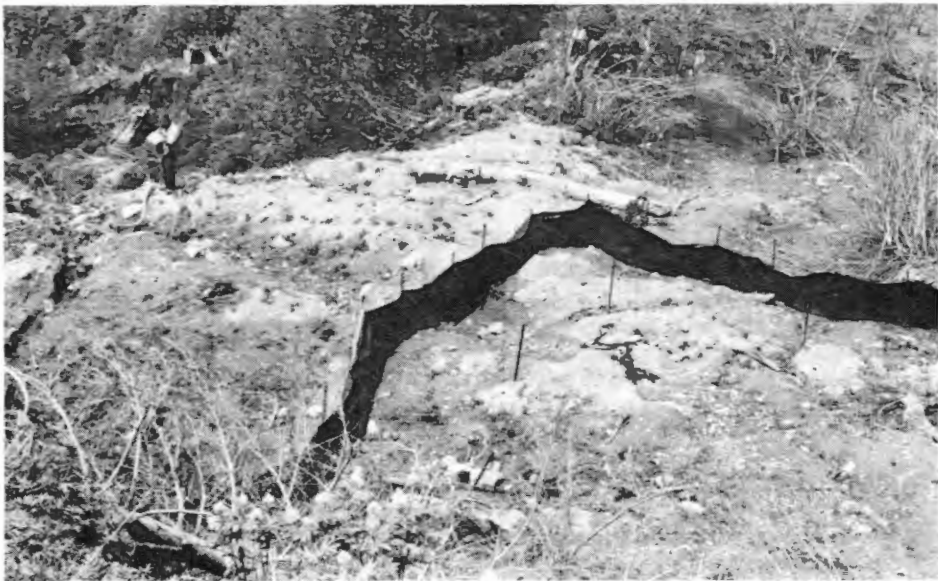
**Looking downslope** at Check Dam #4 on USFS 4045D road with wet slope and May 1983 slide in the distance. Dam #4 stored no sediment and basically no material was transported out of the upslope scar from the December 1981 slide. Streamflow out of the old slide scar is diverted by road to the right in the photo, only to cross the road and travel downslope, causing increased soil saturation in the vicinity of the new slide.
