# Groundwater Contamination Charted At Big Cypress Well Drilling Site

By Cordell Roy, Mark Flora, and Bruce Freet

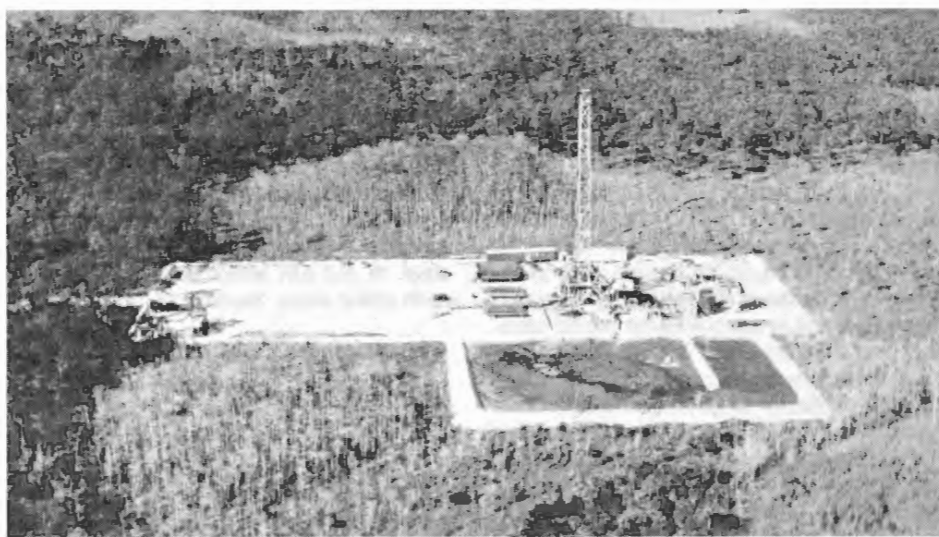
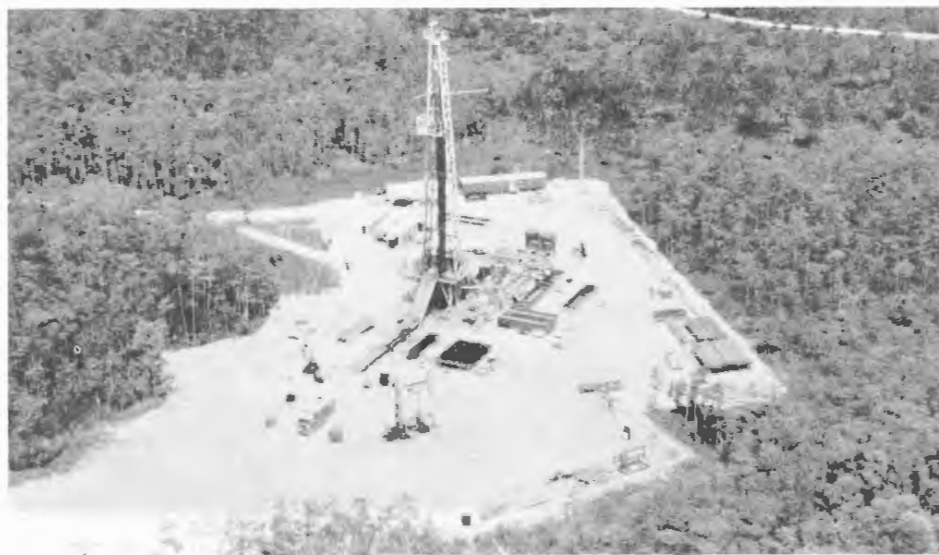
*The upper photo shows the Site 28 oil pad at Raccoon Point. Note the large area utilized by the mud retention pit at the lower right hand corner of the pad. The lower photo illustrates the first well using a containerized system drilled in Big Cypress National Preserve. Note the smaller amount of land required for facilities using this techniques. This well was redrilled on an existing two-well pad.*

Based upon these results, Big Cypress National Preserve and Exxon, U.S.A. agreed that changes in well drilling procedures were warranted. Numerous technical alternatives were considered to implement this change, including modifying existing technique, liner systems, and containerization. Agreement was reached and oil and gas plans of operations were amended to stipulate that drill cuttings be separated from the drilling fluids and produced water, and that the liquids be stored in closed, containerized systems prior to underground disposal. Additionally, the Florida Department of Natural Resources, drawing on the results obtained from this study, now requires that all oil and gas drilling in the Big Cypress Area of Critical State Concern (an area that includes the preserve) use containerized systems. Though more expensive to the operator, these new procedures better protect water quality and disturb a smaller area of land.

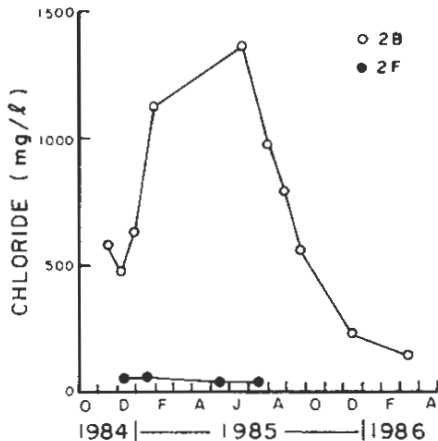
**Figure 1:** Chloride concentration in shallow down-gradient well 2B (90m) and shallow upgradient well 2F following the suspected brine leaching incident at site 2.

Six monitoring wells were installed at the Site 2 location in October, 1984. Four of these wells were located between 15m and 225m downgradient of the mud retention pit; the other two wells served as controls. "Shallow" wells of 0.4m depth were used to monitor specific conductance, chloride, sodium, pH, and oil and grease in the root zone of the cypress, while "deep" wells of 2.7m documented these water quality parameters in the upper zone of the groundwater aquifer. Chloride concentrations at shallow well 2B, located in the root zone approximately 90m downgradient of the pit, peaked at 1380 mg/l approximately 18 months after the leaching incident (Fig.1). This peak value is significantly higher than chloride concentrations found in the shallow control well (13 mg/l-

42 mg/l) and is within the range of chloride values reported as damaging to cypress trees (500 mg/l - 2000 mg/l). Chloride concentrations decreased dramatically during the following wet season, and by March, 1986, the end of the first phase of this work, they were down to 148 mg/l. Since chloride concentrations in the root zone tend to increase during the dry season and decrease during the wet season, projections made by Environmental Science and Engineering suggest that peak chloride concentrations at this well during the dry season will continue to exceed 500 mg/l for at least 3 years following the spill.
