MELROSE ESTATE  
NATCHEZ NATIONAL HISTORICAL PARK

NATCHEZ, MISSISSIPPI

HISTORIC STRUCTURES REPORT  
VOLUME II  
PAINT AND CONCRETE ANALYSIS

ANN BEHA ASSOCIATES

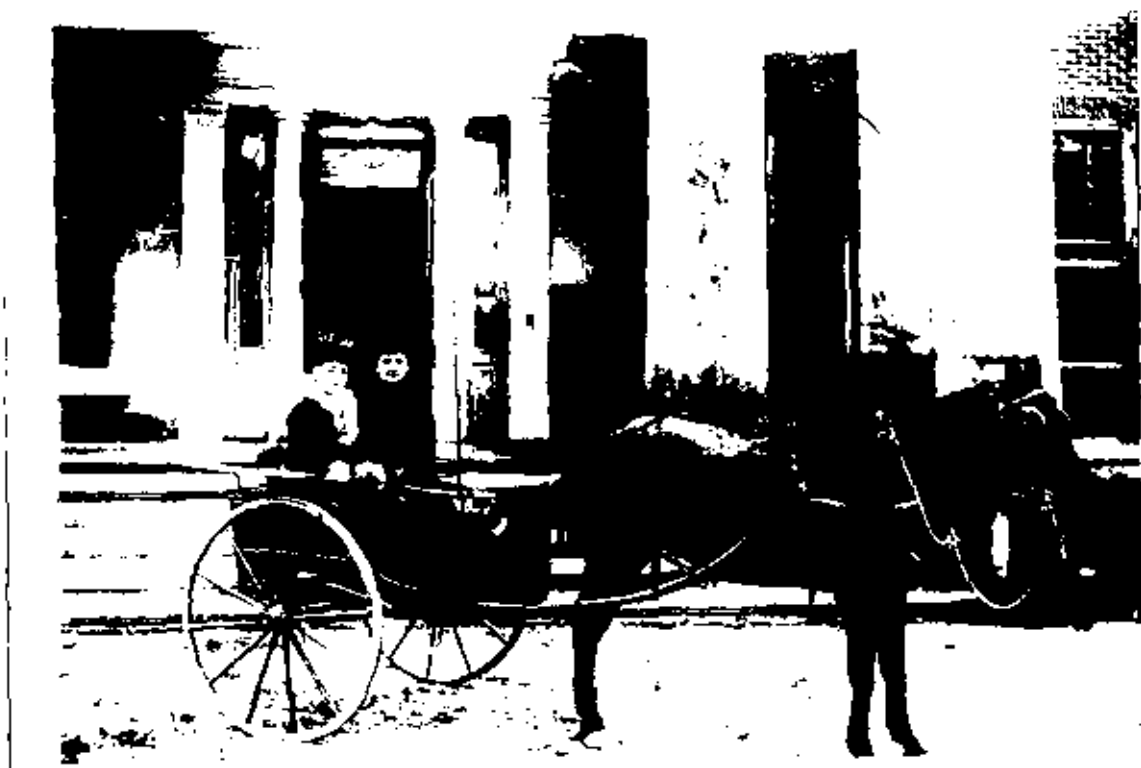
The window sills of the house were painted in a series of dark red colors to imitate the appearance of red sandstone, as can be seen in the late nineteenth-century photographs of Photographs P3 and P5. The first dark red color corresponded to the 5YR 3/4 glossy notation. The second red color matched the 7.5YR 2/4 notation. The third painting of the window sills matched the 2.5YR 3/4 notation. The small, cast-iron foundation vents on the north, south and west elevations were also painted in the same series of red colors as found on the window sills. The first two times the basement windows were painted was with a light-tan color to blend with the surrounding marbleized treatment. All elements of the windows were painted with a 10YR 9/1 tan color from the Munsell glossy collection. The third painting of the basement windows was with the same white, N9.5 color as was used in the third painting of the principal windows.

Photograph P3. This detail of a late nineteenth-century photograph of the west elevation shows the pattern of marbleizing on the wall, column, and pilaster stucco. Also recorded is the dark color of the wall plinth. (NATC Gandy II.A.3)

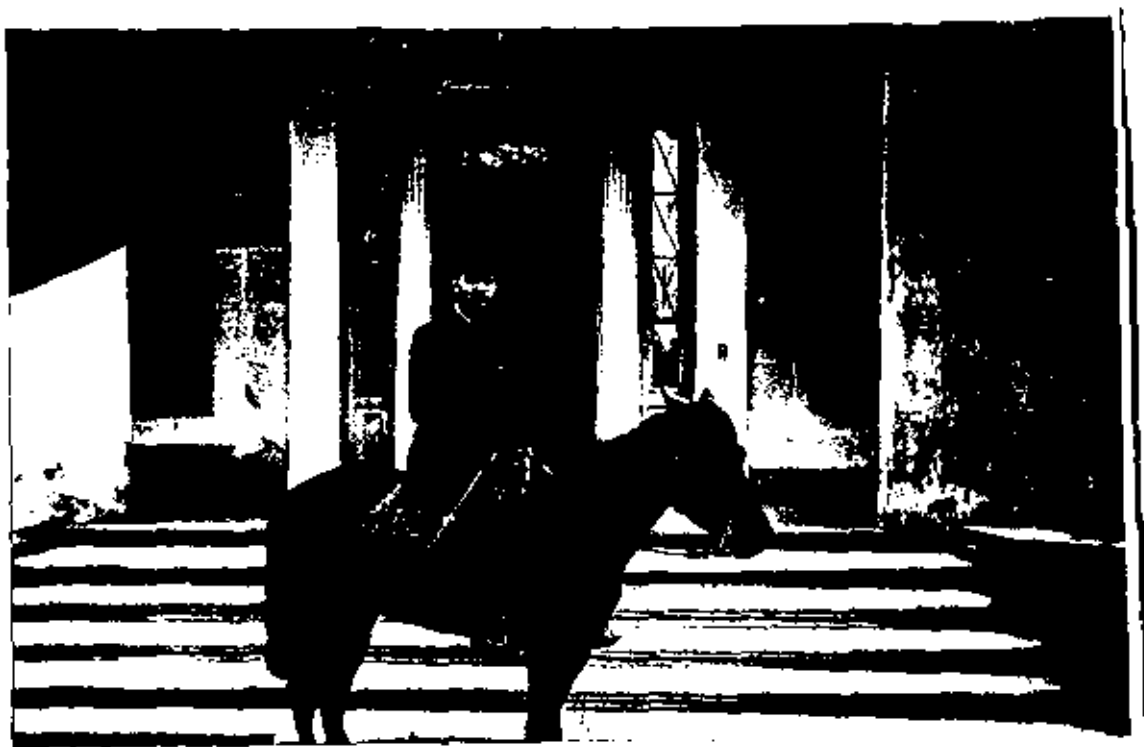
Photograph P4. This detail of a late nineteenth-century photograph of the west elevation shows variations in the colors of the scored stucco blocks. (NATC Gandy II.A.1)

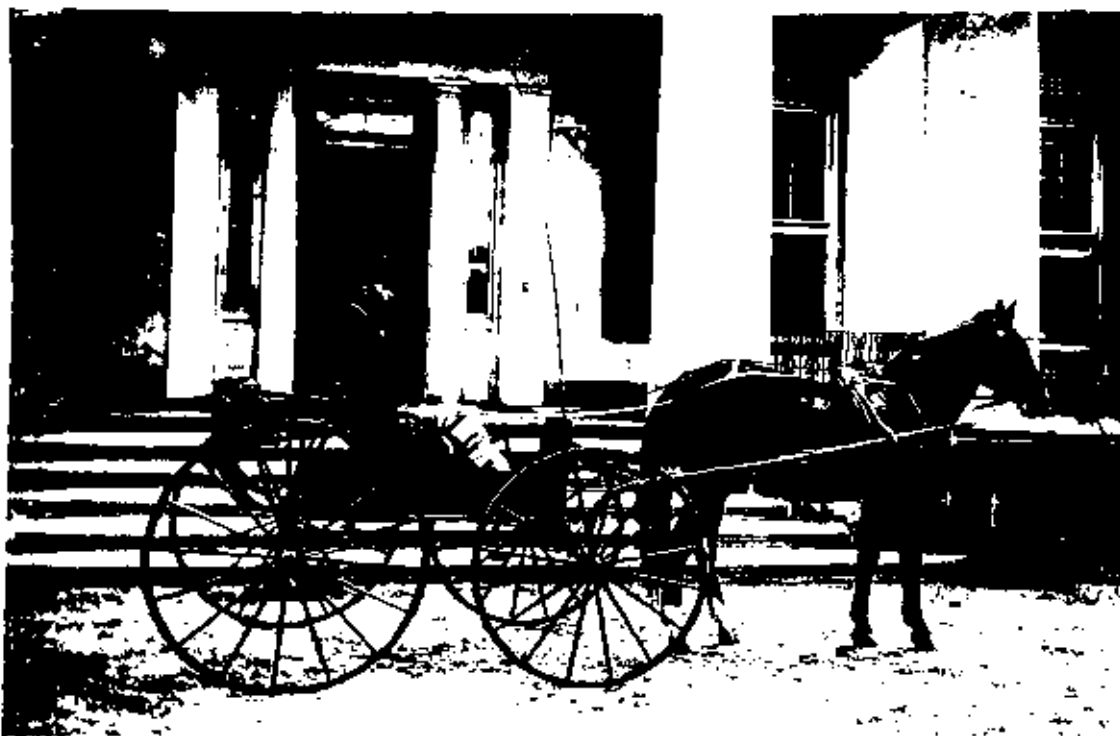
Photograph P5. This detail of a late nineteenth-century photograph of the west elevation shows marbleizing veins above the window to Room 110 and on the water table at the basement level. (NATC Gandy II.A.2)

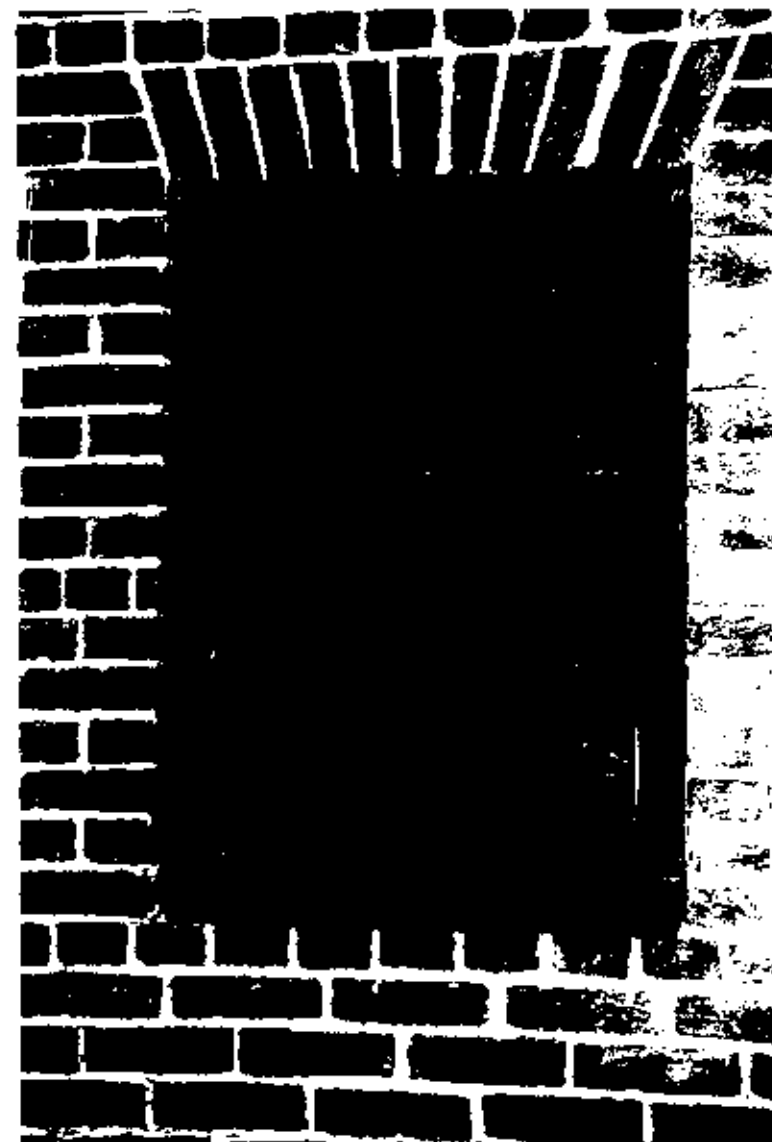
Photograph P29. The louvered window on the smoke house was originally painted in a three-color scheme. The narrow, outer band was painted off-white. The bead, the jamb, and the louvers were painted a medium green. The window sill was painted a dark red. These colors were the same as those used on the exterior of the house.

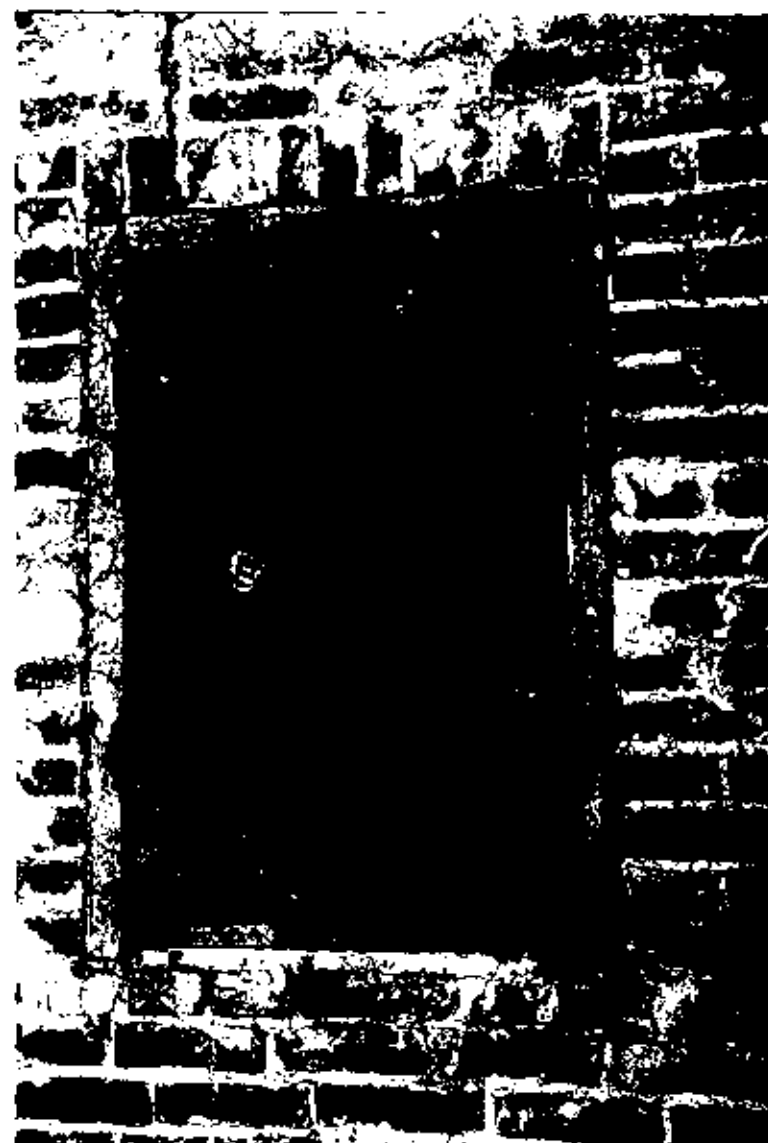
Photograph P31. The paint on the interior face of the smoke house window shutter appears as it did when it was applied in the mid-nineteenth century.

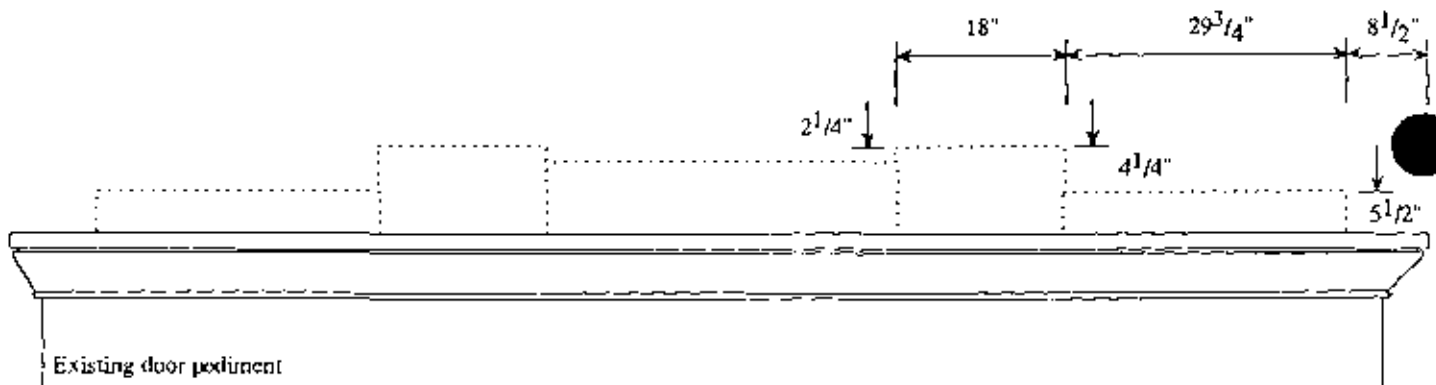
1. ghosts - outlines in paint of removed pediment over entry

Elevation of pediment outline on wall stucco.
