## Oregon Caves Chateau

**Oregon Caves Chateau**  
Oregon Caves National Monument  
**Historic Structure Report**

June 1999

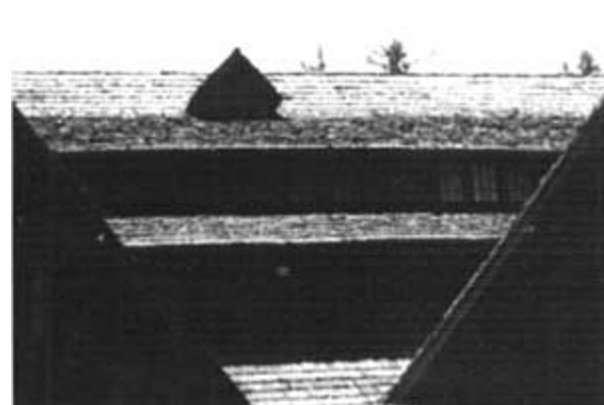
Roof, general field on the east side.

The top layer of shakes is beginning to deteriorate. While the attic has remained dry, the shake roof has steadily deteriorated. There are many missing and broken shakes, and most are curling. The exposure is larger than the recommended length of 7-1/2" as described in Architectural Graphic Standards, but the shakes have weathered fairly well. The formula for exposure is given as  $(\text{Length}-2") / 3$ , which results in the equation of  $(24-2) / 3$  or  $22 / 3 = 7.33$ . This is rounded up to the 7-1/2" dimension given on page 76. A ten inch exposure is typically reserved for vertical surfaces, according to Graphic Standards. The ridge shakes, also experiencing areas of missing and broken pieces, are cut to fit tightly around the projecting rooftop sprinkler system.

- Within five years, the roof will need to be replaced. The number of broken and missing shakes increases every year, and while the attic is dry at this point the chance of water infiltration into the building envelope increases every year. The historic exposure, texture, and thickness should be maintained, and the ridge detail should be kept the same. A copper or galvanized ridge flashing may be installed to curtail moss and lichen growth on the roof, but will not help in areas that are under the eaves. The fungicide should be used to control the growth on the roof. Replacing the roof would be an ideal time for other work outlined above, including valley flashing inspection, repair, and painting, flashing the fascia board above the lobby entrance, and repair of the sheet metal above the chimney. This work should be completed before the roof begins to leak, compromising the building envelope. The roof should be replaced in-kind, with resawn shakes.

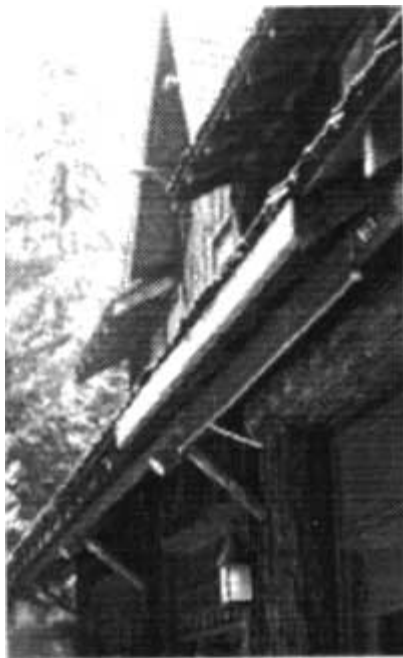
Fascia board for gutter.

runoff above the board flows over it. The board is saturated in periods of heavy rain and snow melt, and the moisture is wicking into the ends of the rafter tails above the door. The sheathing in this area is also wet as the water travels through the rafters and fascia board.

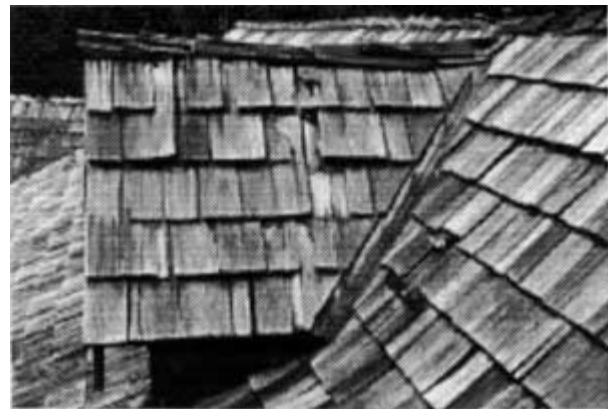
Another problem of the overhangs is that the rain is not allowed to reach all areas of the roof and wash them free of debris. Moss and lichens have begun to grow on the roof in areas that are protected from the weather, especially under the shed roof sections on the north and west sides. The growth is uphill of the drip line of the eave above. The shed roofs that project over the lower entrances to the building are suffering the same growth problems. The entrance to the coffee shop and dining room from the pond area are experiencing heavy growth, as are the roof structures over the stairs to the boiler room and outside entrance to the kitchen.

Growth uphill of drip line.

- The growth on the roof should be kept to a minimum. A moss killer should be applied to the roof to reduce the growth, protecting the shakes from accelerated decay. Care should be taken when applying the chemical so that excess does not fall to the ground and damage vegetation around the eave line of the building.

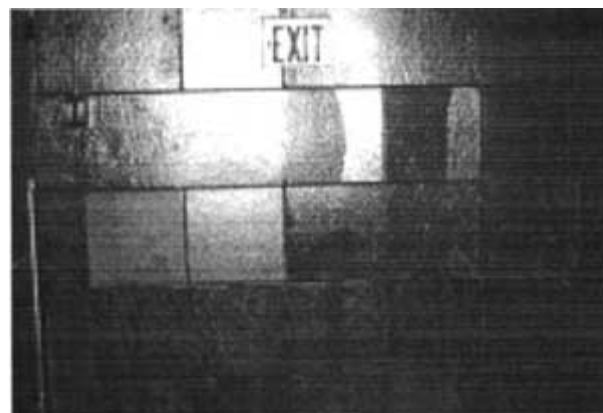
Typical interior hallway. Note the mismatched replacements.

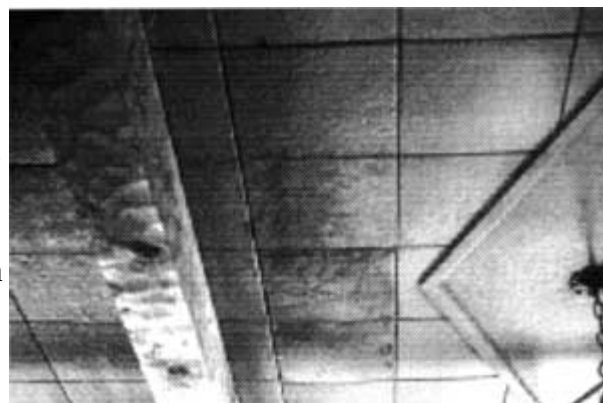
Water damage at the lobby ceiling.

The panels also show signs of water damage, especially in areas under bathrooms on the floors above. When a leak develops, often the only way the concessionaire becomes aware is from water damage to the Nu-Wood panels. This damage is permanent and irreversible, unless the panel is painted over once it has dried. The areas under the window sills, particularly on the 6th floor on the west side of the building also show signs of water damage. A recent article in the APT Bulletin (Vol. 28 #2-3) notes that "the best conservation technique is careful maintenance...finishes must be maintained, and problems must be addressed immediately. Once the boards are warped or deeply stained, the likelihood of successful repair seems remote." (Page 67)

- The use of paint to hide water damage has been employed in some areas of the building. Unattractive portions of the building may be painted to hide this staining. Natural divisions should be maintained between painted and unpainted wall surfaces. For example, where the walls have already been painted, one entire wall plane is painted up to a corner or projecting element. This strategy has been employed in the dining room and many of the guest rooms. This strategy would conserve the historic fabric, but not the historic appearance (which has been significantly altered by the application of the glaze). A matte finish paint should be used if the fiberboard surfaces are painted, in keeping with the historic character of the fiberboard.

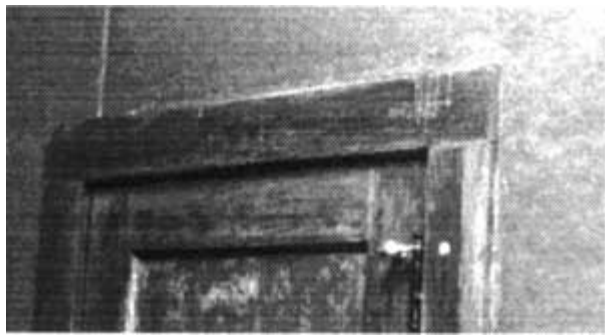
Glaze slopped onto door trim.

appearance of the panels, darkening their color and producing a shiny surface. The glaze is showing defects unassociated with the other damage to the panels. When applied, the glaze provides a thick coating, resulting in an increase in the fire rating of one hour. It should be applied in a number of coats, building up to the appropriate thickness. How the current glaze was applied exactly is uncertain, but it was applied with either a brush or roller. Careless application has resulted in the glaze slopping over onto interior trim, especially at the heads of doors and windows.

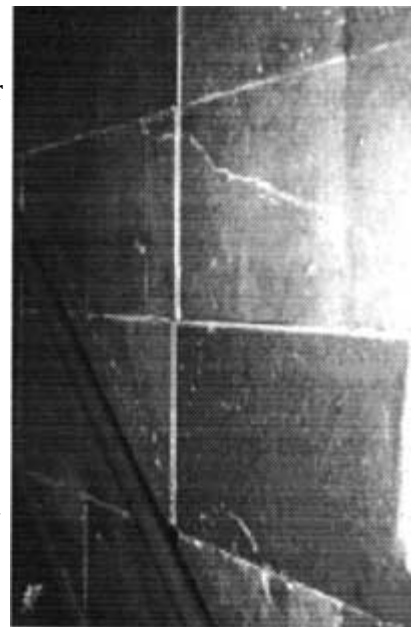
In addition to the problems with the fire retardant glaze, the fiberboard panels have suffered impact and abrasion damage. In the guest rooms, the impact damage can often be attributed to door knobs, as many of the stops are missing. In hallways and utility or linen closets, the damage is typically caused by housekeeping carts, rollaway beds, and other typical hotel equipment. Some of these areas have been patched with a replacement piece of Nu-Wood, either surrounded by small pieces of wood trim or left with the joints exposed. Many others, especially impact damage from door knobs, have been patched with wood putty. To make repairs in the public areas of the building, the concessionaire has removed panels from areas only open to employees, such as the office behind the front desk. The walk in freezer in the kitchen was placed in an opening historically used as an access to the coffee shop, and panels from the ceiling above the freezer have all been taken and placed in locations throughout the building to repair damage.

Abrasion damage at the stair.

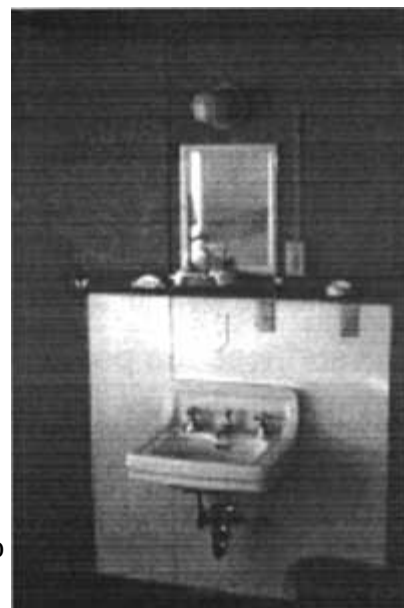
A few areas of the fiberboard have been painted to cover earlier damage with a color closely resembling the color of the glaze coating. Many of the sink surrounds, especially on the sixth floor, that still employ Nu-Wood have been painted white to

Painted sink surround, 6th floor.
