## Geologic Hazards Evaluation of the Lower Falls Section of the Rio de los Frijoles Canyon Trail, Bandelier National Monument

Hal Pranger, Geomorphologist and Chief,  
Geologic Features and Systems Branch  
June 25, 2012

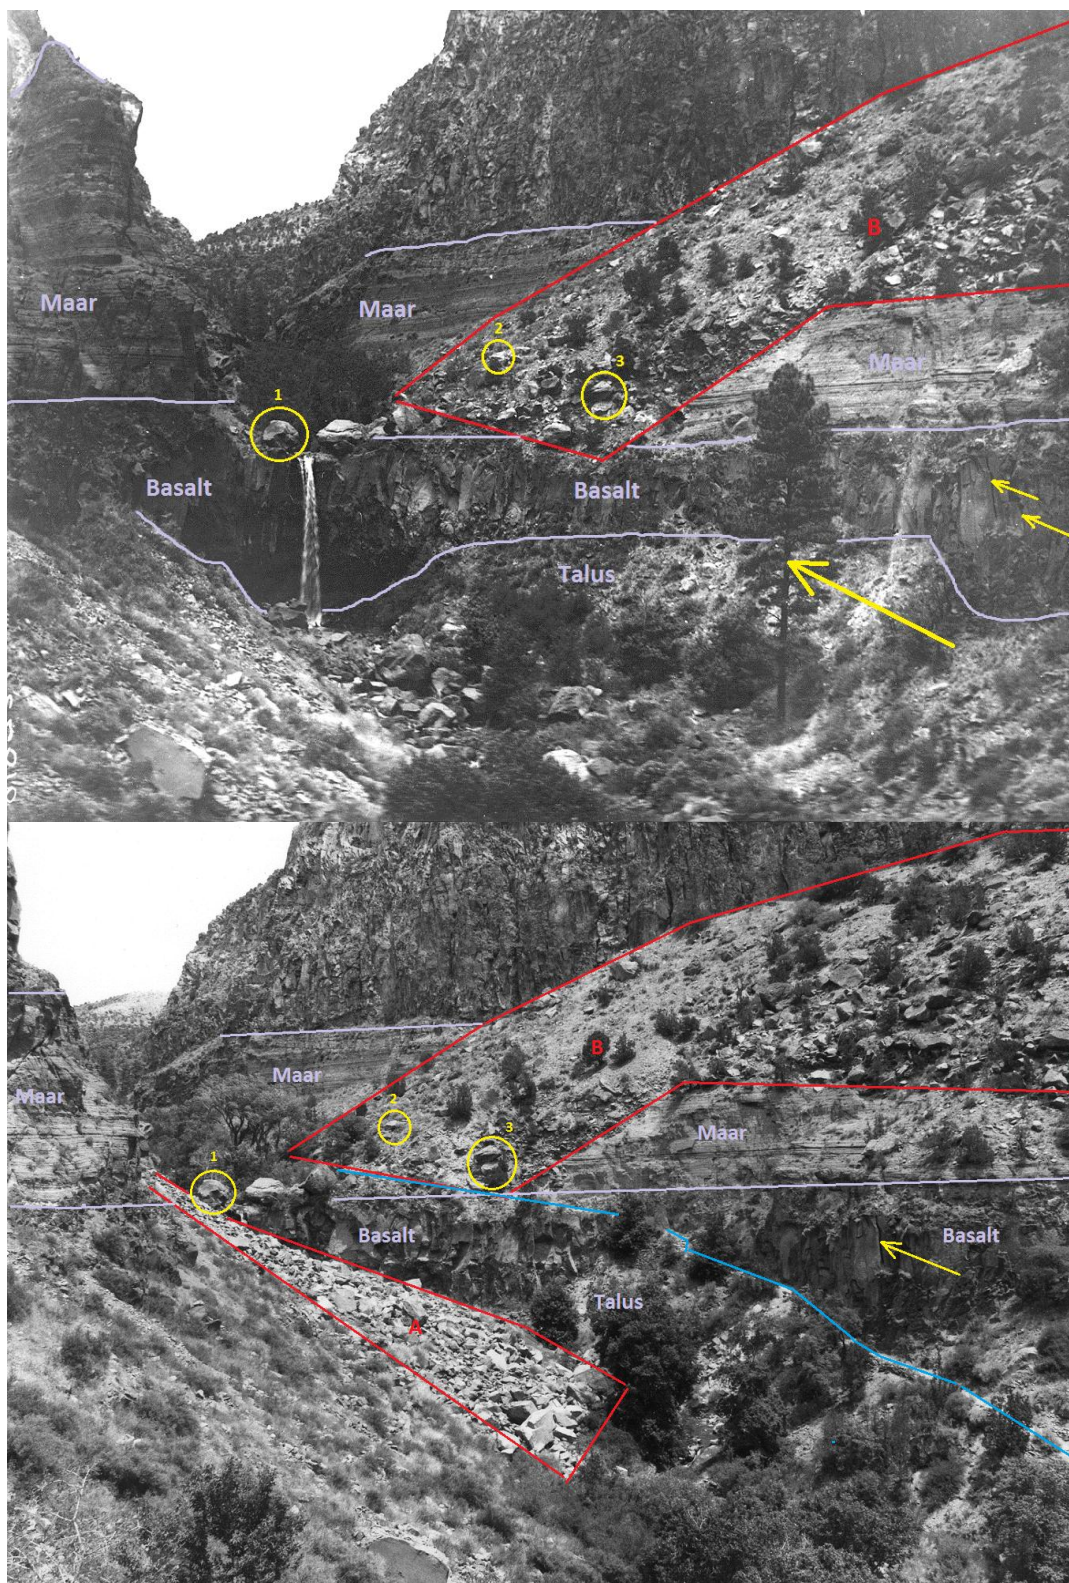
Photos of Lower Falls from 1920 and 1995 show landscape changes that occurred in the 20<sup>th</sup> century (Figure 1 - the circles labeled '1,' '2,' and '3' show common reference points (rocks) that are found on both photographs. Blue line on 1995 photograph shows trail). First, according to park staff a large landslide occurred in the 1930's that created a multi-hundred thousand-ton debris fan (area "A" on the 1995 photograph). Second, an older vegetated and currently inactive coarse debris fan is on the opposite side of the canyon (labeled 'B' on both photographs). Third, large fractures (small arrows) exist just below a portion of debris fan 'B.' Fourth, one can see that many very large (several ton) rocks near and surrounding reference rocks '2' and '3' in the 1920 photograph but not the 1995 photograph; they might have been removed by the trail construction staff of the 1930's, subsequent maintenance staffs, or they could have fallen into the Rio de los Frijoles stream channel. Fifth and finally, the large arrow in the 1920 photograph shows a large Ponderosa Pine tree that is not there in 1995; while it could have died and fell over and was washed away, it very well could have been removed when the trail was being constructed or was destroyed by a slope failure, landslide or by a flood event. A quick evaluation indicates that the bedrock immediately uphill of the tree may have failed during the time between the two photographs, and a small new debris fan appears to occupy the spot where the former tree used to stand. Construction of the trail also could have involved scaling the base of this slope and allowing already fractured bedrock to collapse into the stream channel as well. Cracks in the bedrock still remain in this area (see below).

Figure 1 - View, looking upstream, of the Lower Falls Section of Frijoles Canyon – 1920 (top), and 1995 (bottom). See text for explanation. (NOTE: views were taken from somewhat different positions).

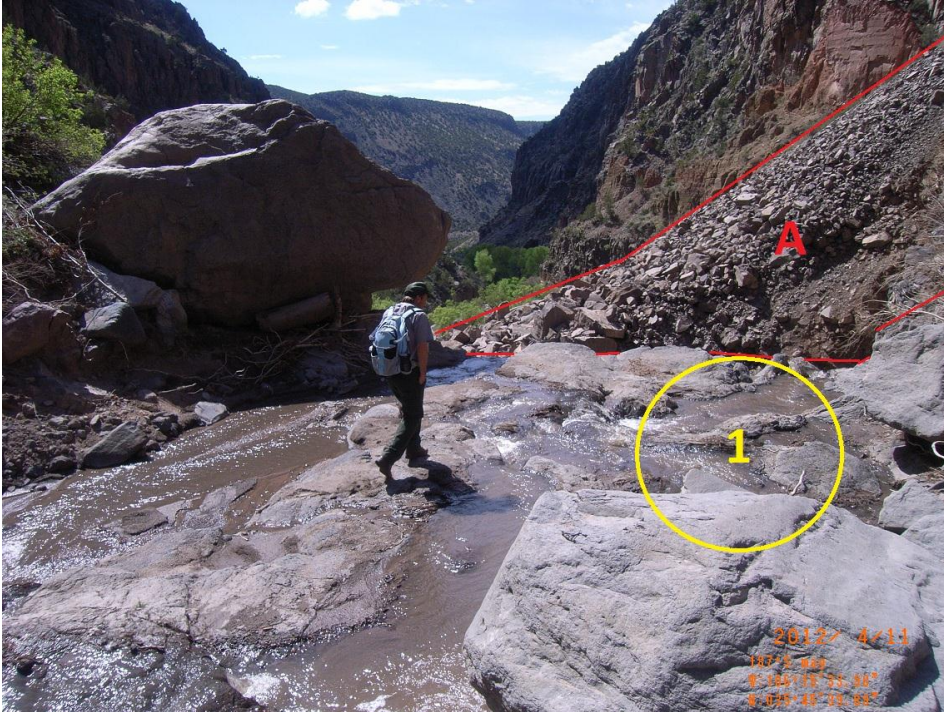
- The rock labeled '1' on both photographs of Figure 1 was mobilized during and likely disintegrated after the August, 2011 flood (compare Figure 1 to Figures 2, 3 and 4);

Figure 2 – View, looking downstream, at Lower Falls. Circle labeled ‘1’ shows location where reference rock shown in Figure 1 used to rest. ‘A’ shows landslide debris fan that occurred in the 1930’s (see Figure 1).

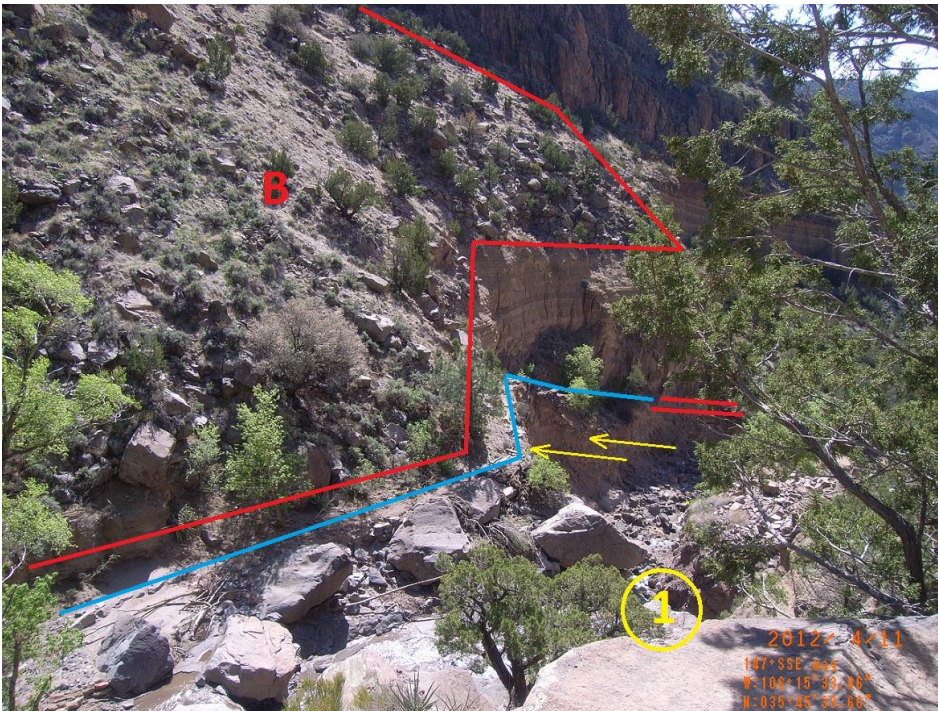
- Regarding the slope immediately below the trail (Figures 3 and 4), the channel scoured and caused slabs of rock to fail and disintegrate immediately below the trail. The trail itself had failure cracks along several sections, and park staff report that more have developed and other small sections of trail have failed;

Figure 3 – View, looking downstream, of primarily the left side of Canyon de los Frijoles and Lower Falls Trail at the Lower Falls. Blue line is existing trail. B is coarse debris fan. Two parallel red lines show destroyed section of trail. Yellow circle labeled ‘1’ shows location of missing reference rock shown in figure 1 at the falls. Two parallel yellow arrows show vertical eroded and failed slope immediately below trail.

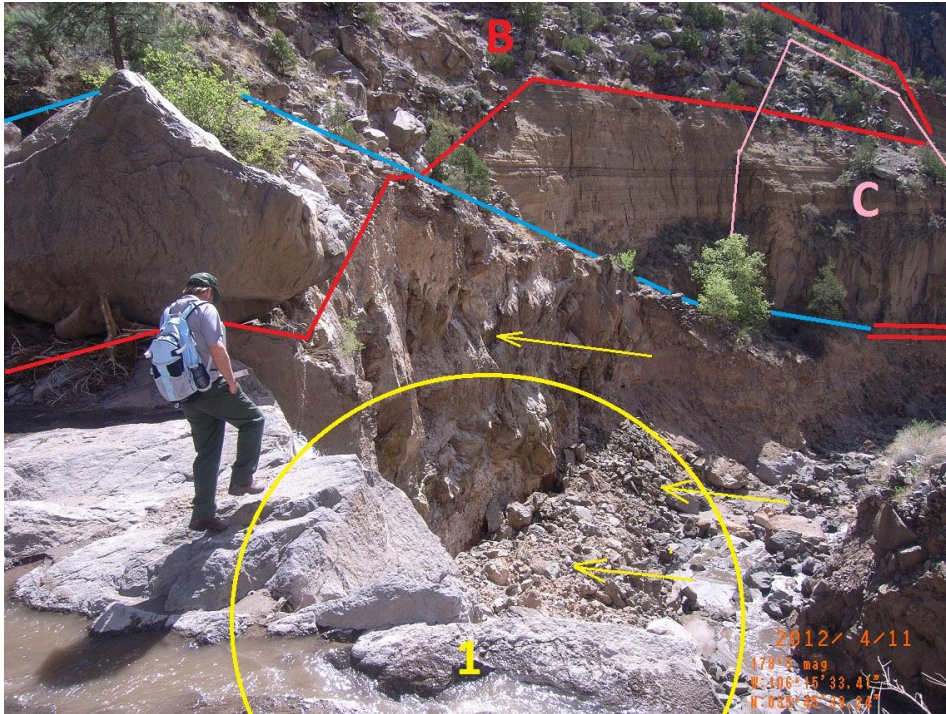
- Regarding the large wedge of bedrock (labeled 'C' on Figures 4 and 5), several large open fractures and the failure at its base during the August, 2011 flood event suggest that a much larger mass will collapse onto the trail, perhaps very soon.

Figure 4 – View, looking downstream, at Lower. Blue line is existing trail. B is coarse debris fan. C is rock wedge that could fail at any time. Two parallel red lines show destroyed section of trail. Yellow circle labeled '1' shows location of missing reference rock (see Figure 1). Yellow arrows show failed bedrock and debris.

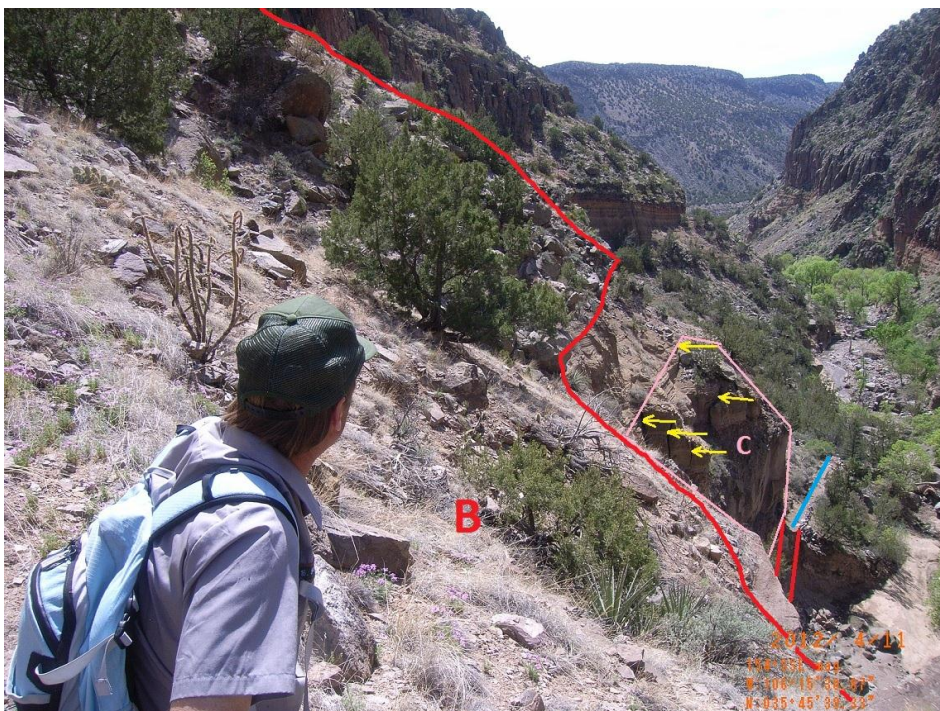
Figure 5 – View, looking downstream, from center of coarse debris fan 'B.' Blue line is existing trail. Two parallel red lines show destroyed section of trail. Parallel yellow arrows show vertical cracks on slope immediately above trail. Pink zone labeled 'C' shows wedge of Maar bedrock that could fail at any time.

- Regarding locating an alternative route for the trail, the site visit did not allow time to explore any more than one potential alternative route, which, when, looking at Figure 5, would pass through the middle of what may be a very unstable debris fan 'B' and go above and then around failing bedrock wedge 'C.' Other potential routes would need to be explored in much more detail by trail design experts. NPS contacts for such trail advice are Ken Hornback, Acting Facility Lead, IMR-Santa Fe, and Hugh Duffy, PLA, ASLA, PMP, LEED® Green Associate, DSC Project Manager - Design & Construction East (see Hugh's information at [http://workflow.den.nps.gov/8 Transportation/docs and studies transplan.htm](http://workflow.den.nps.gov/8%20Transportation/docs%20and%20studies%20transplan.htm)).
