# COPING WITH A STRING OF NASTY BREAKUPS

# Santa Cruz River - Continental Reach

# Continental Ranch Segment

# Low Flow Bank Protection

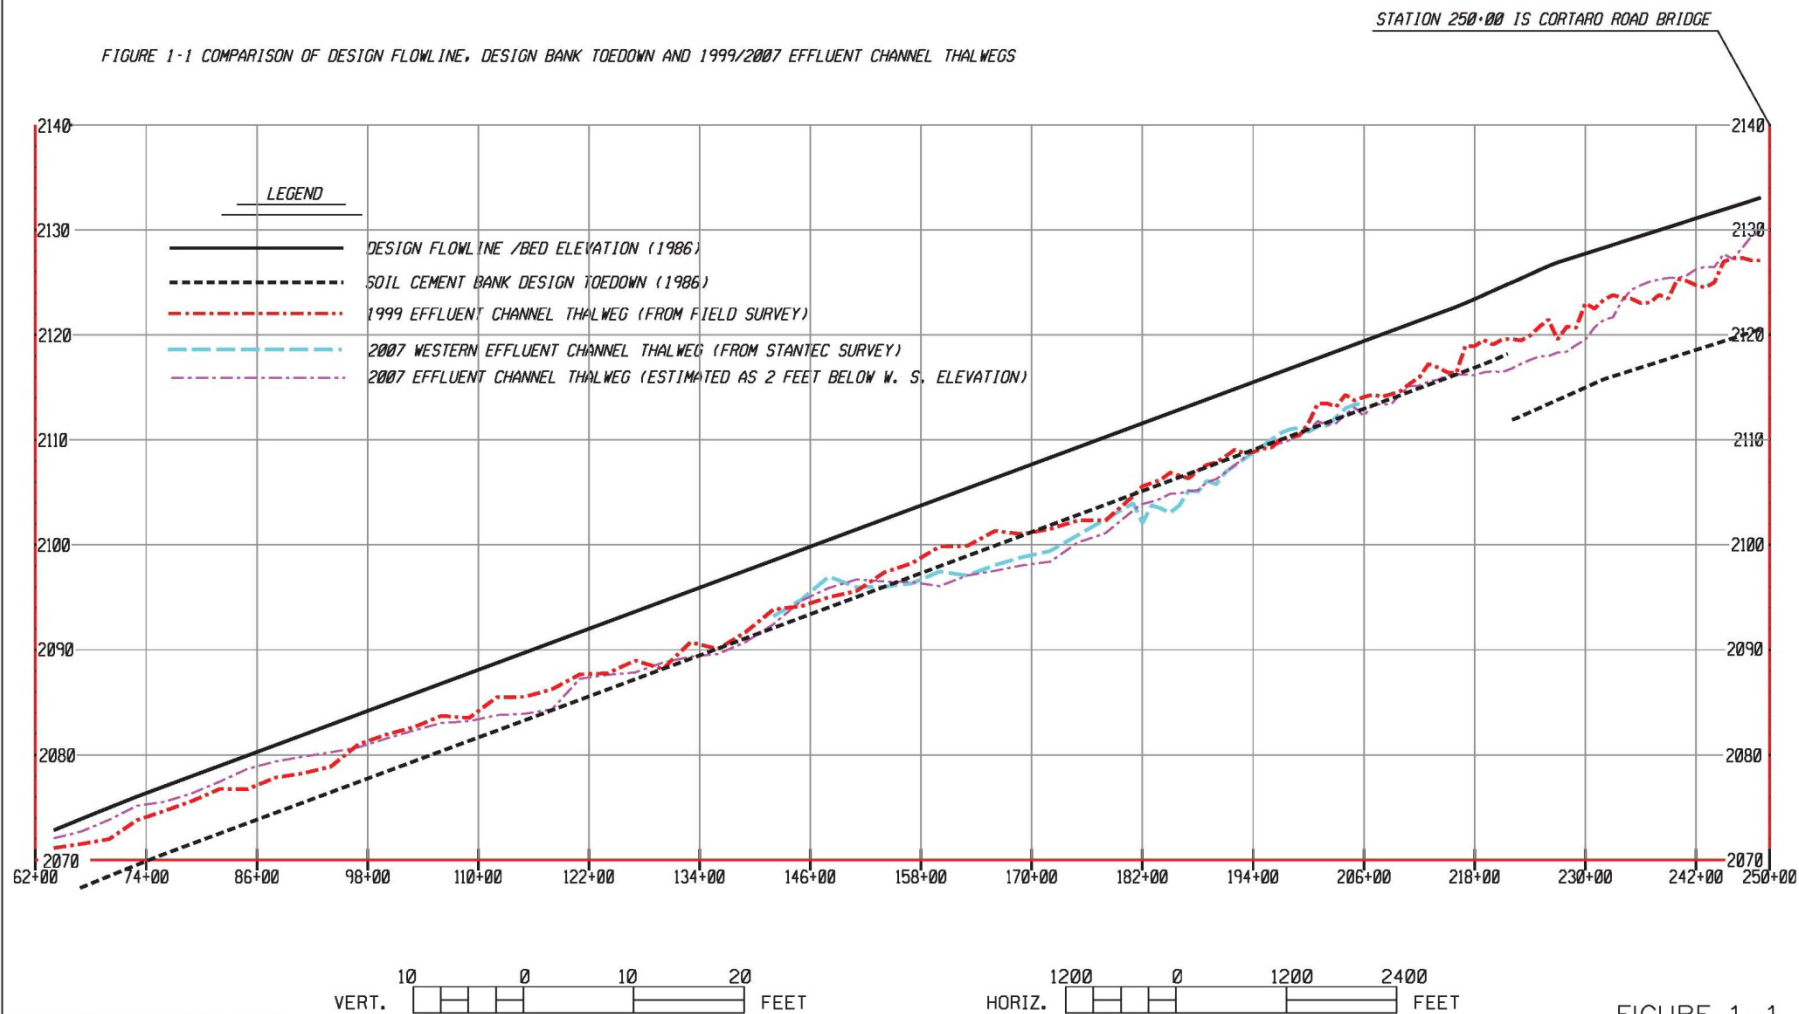
FIGURE 1-1 COMPARISON OF DESIGN FLOWLINE, DESIGN BANK TOEDOWN AND 1999/2007 EFFLUENT CHANNEL THALWEGS

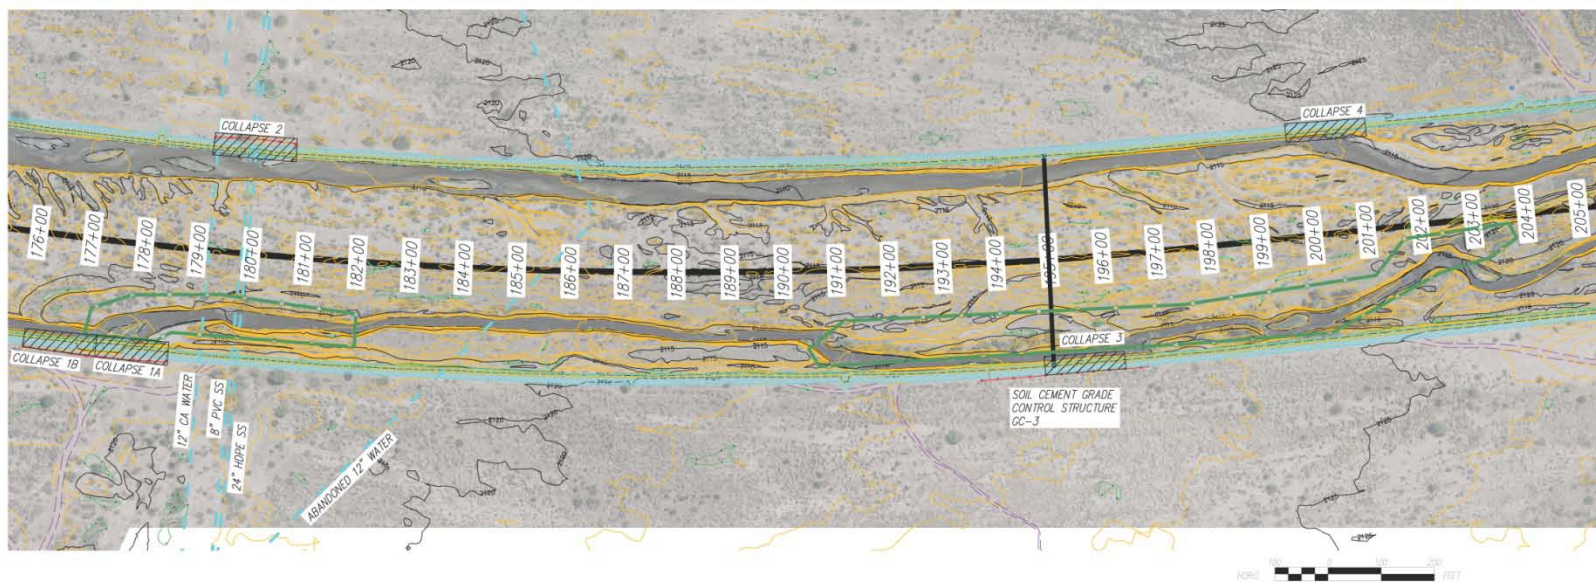
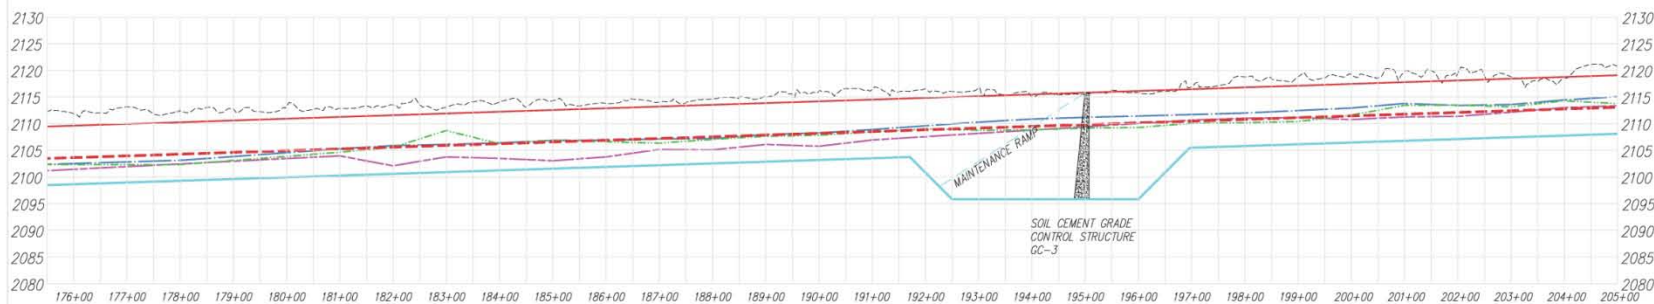
2006 AND 2007 BANK PROTECTION FAILURE AREAS, REPAIRED IN 2007

NEW SOIL CEMENT GRADE CONTROL STRUCTURE  
SEE DTI

**LOW FLOW CHANNEL ALTERNATIVES ANALYSIS**  
**SANTA CRUZ RIVER - CONTINENTAL RANCH**  
**ALTERNATIVE 5 - FULL STRUCTURAL BANK**  
**STABILIZATION WITH GRADE CONTROL STRUCTURES**
