# Weather Station Maintenance in Southwest Alaska Network Parks

## *Summary for the 2014 Hydrologic Year*

Natural Resource Data Series NPS/SWAN/NRDS—2014/725

October 2014

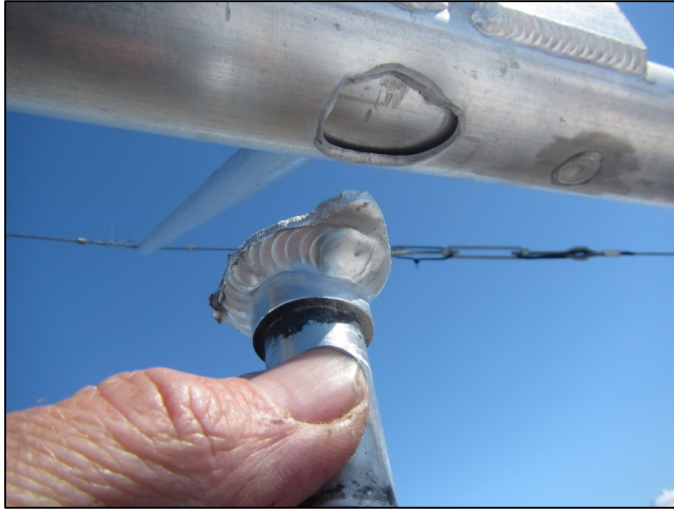
**Figure 2.** Chigmit Mountain RAWS – Broken weld on spreader bar that supports guy-wires for the wind sensor mast.

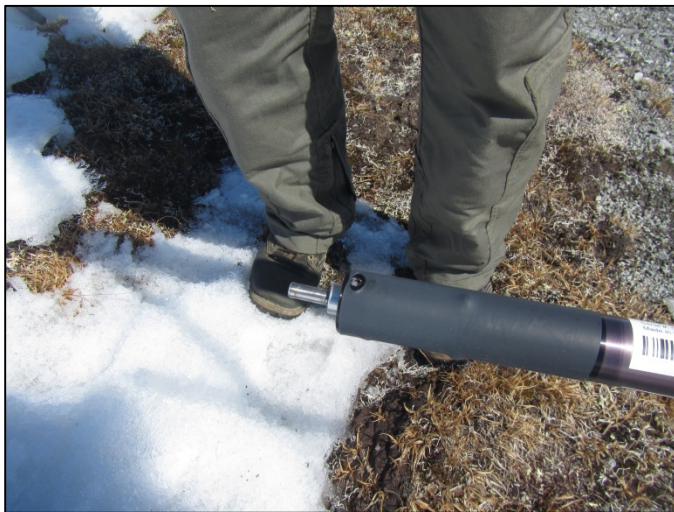
**Figure 3.** Chigmit Mountain RAWS – Wind vane missing from wind direction sensor.

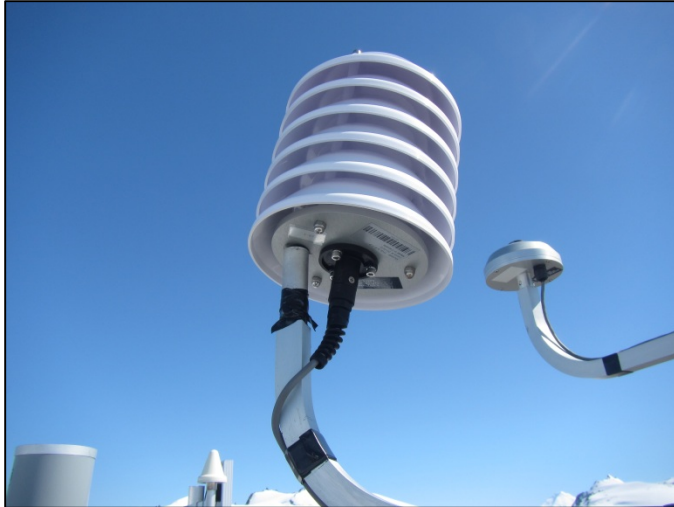
**Figure 4.** Chigmit Mountain RAWS – Loose mount on AT-RH sensor.

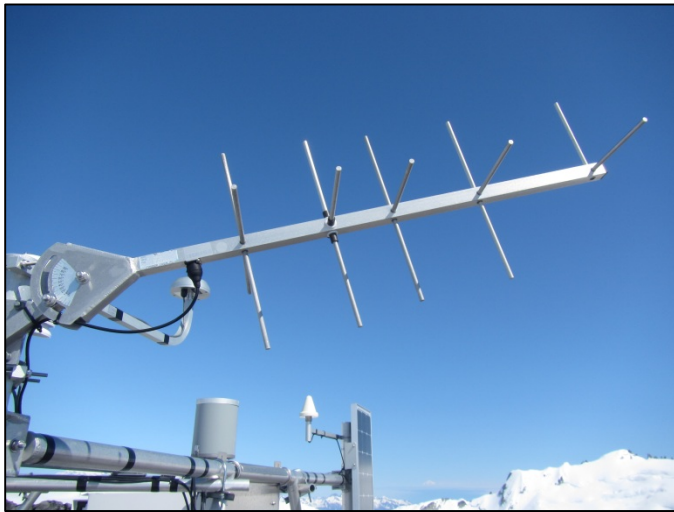
**Figure 5.** Chigmit Mountain RAWS – Missing tines on GOES antenna.

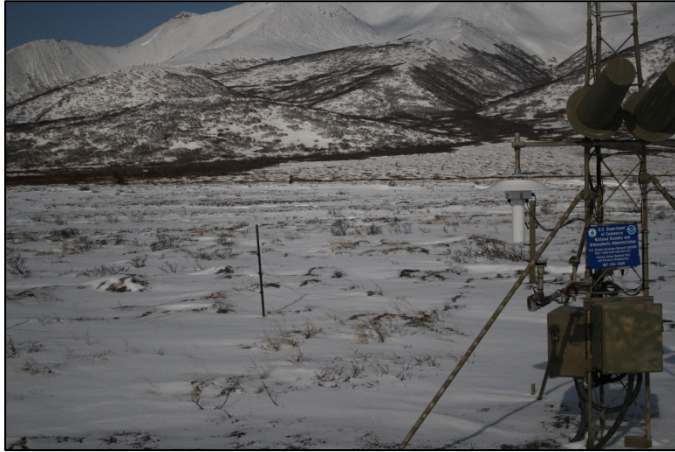
The photographs taken with the current setup are not ideal (Figure 8). The view is obscured by the weather station and the solar panel array on which the camera is mounted moves. A better place to mount a time lapse camera would be on the NOAA CRN instrument tower (visible in Figure 12). One of the newer Campbell Scientific cameras could be mounted to this station but some modifications would be necessary in order to mount a solar panel, battery and charge regulator at this location in a way that doesn't interfere with the weather station operation.

**Figure 8.** Contact Creek phenocam – Photo taken on 3/17/2014. The Climate Reference Network station instrument tower is visible in the foreground and the electric fence is visible in the center of the photograph.

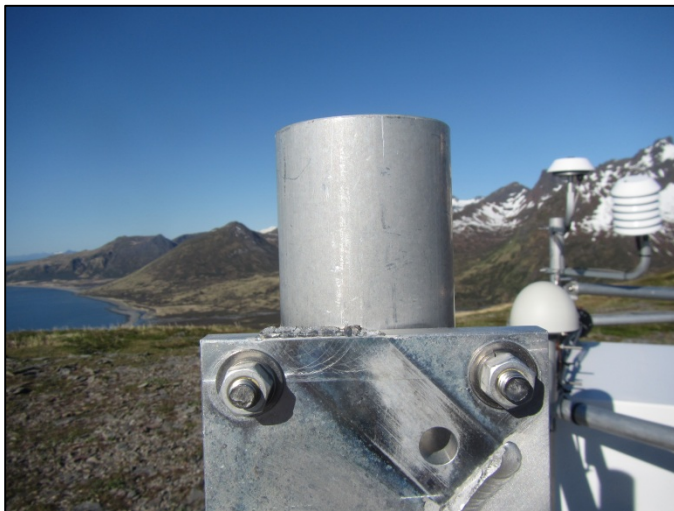
**Figure 16.** Fourpeaked RAWS – The GOES antenna mount broke.

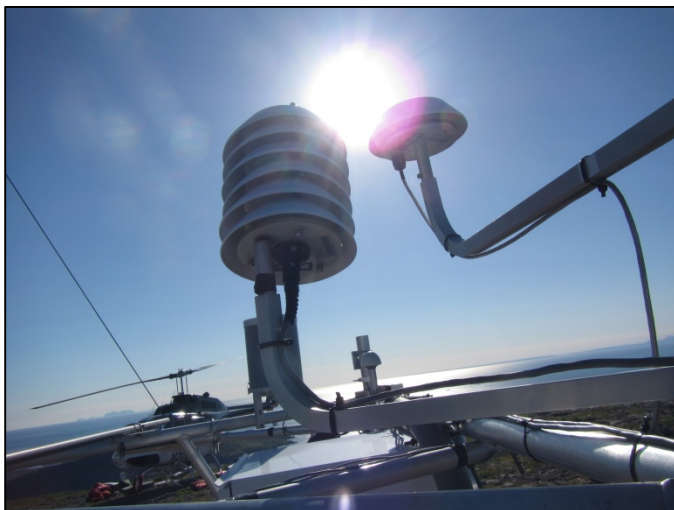
**Figure 17.** Fourpeaked RAWS – Loose mount on AT-RH sensor.

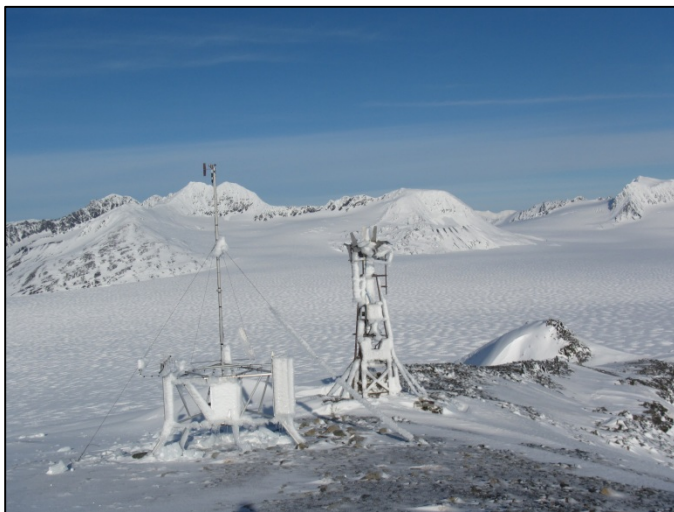
**Figure 20.** Harding Icefield RAWS – Rime ice covers the weather station.

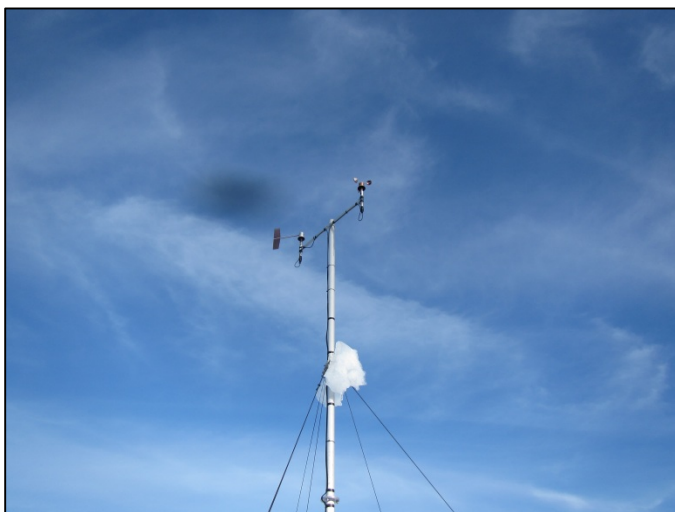
The solar radiation sensor was replaced. It failed on September 1, 2013. This was unscheduled maintenance supported by helicopter availability for glacier monitoring field work. The station was heavily iced (Figures 20 and 21) and the tip had fallen off of the wind direction sensor (Figure 22). Wind direction seemed to be accurate.

**Figure 22.** Harding Icefield RAWS – Wind direction sensor without tip.

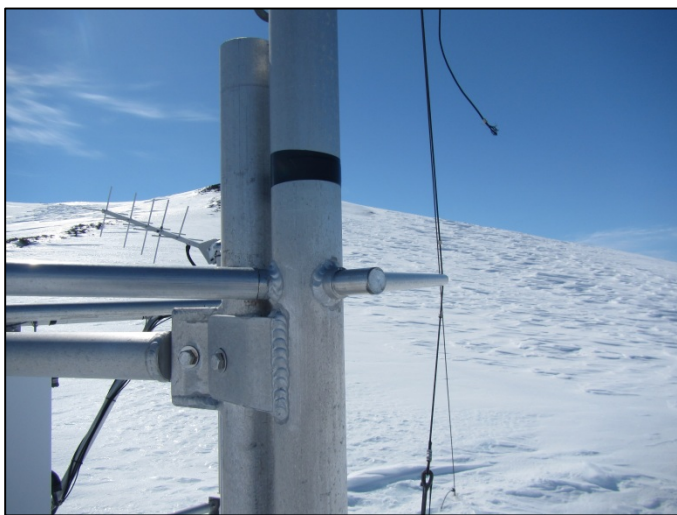
**Figure 23.** Harding Icefield RAWS – Broken spreader bar and guy-wire on the wind sensor mast.

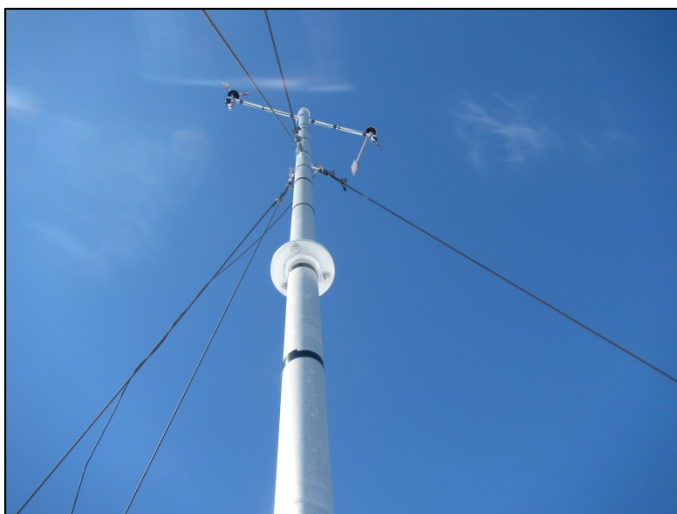
**Figure 24.** Harding Icefield RAWS – Wind direction sensor without tip and broken guy-wire.

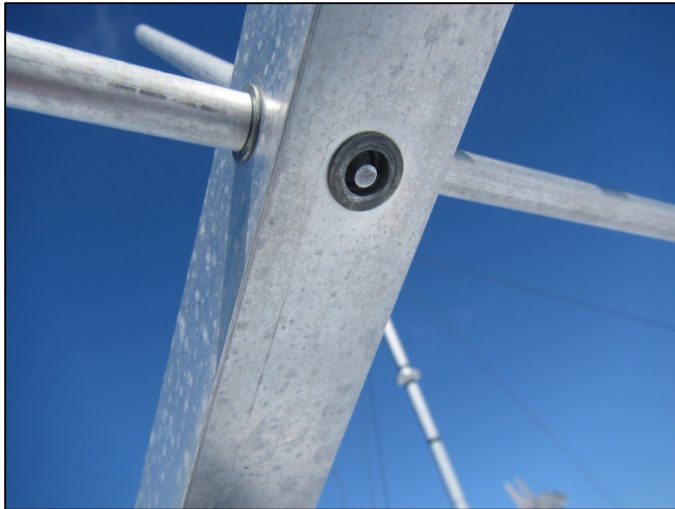
**Figure 25.** Harding Icefield RAWS – GOES antenna tine broken off inside antenna.

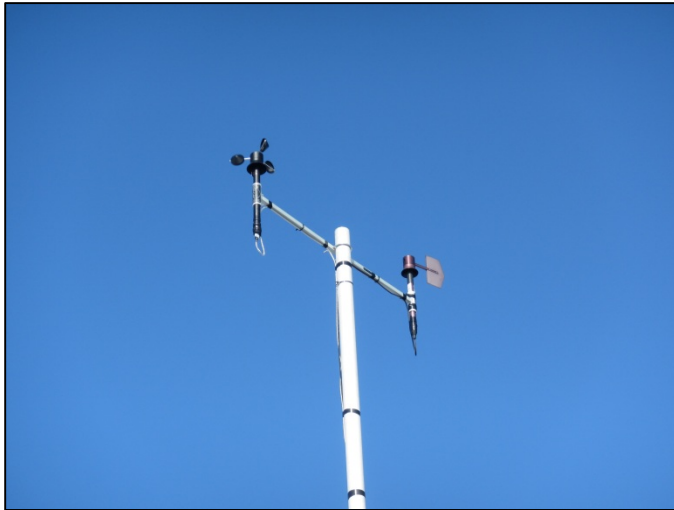
The tail fell off the wind direction sensor on June 7, 2013, shortly after it was replaced during annual maintenance. During the intervening time frame, reported wind directions were off by 180 degrees. This unscheduled maintenance was supported by helicopter availability for glacier monitoring field work. The wind direction sensor was replaced (Figures 29 and 30). The precipitation gauge was also inspected. It was full of antifreeze solution to the outlet and there was no ice inside the gauge orifice – normal conditions.

**Figure 29.** Harding Icefield RAWs – Wind direction sensor (right) without tail piece.

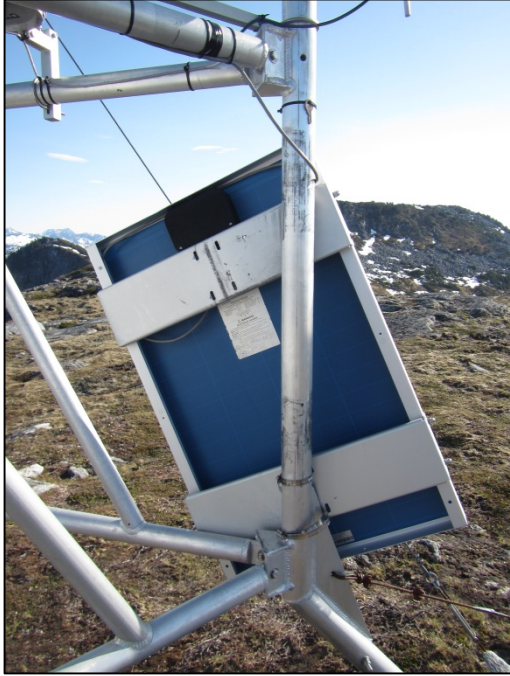
A round-trip helicopter flight was made from Homer. The station showed little signs of damage from rime ice and wind during the winter of 2013-14. However, the solar panel had shifted in orientation and was facing south east (the prevailing wind direction) and three of the four hose clamps that support the solar panel were broken (Figure 33). The AT-RH sensor had malfunctioned on September 25, 2013, but there was no visible damage to sensor or cable. Two tines were missing from the GOES antenna. The AT-RH sensor, WS sensor, and WD sensor were replaced. The missing GOES antenna tines were also replaced. A WD sensor direction test was done. The rain count was zeroed, and a tipping bucket test was done. All data in the data logger were downloaded to send to the WRCC in order to update the archive. All bolts on the station were checked and tightened if loose and all cables were zip-tied. Station observations and GOES transmission quality were checked before departure. Observations and transmissions were verified from the WFMI website and relayed by satellite phone. Before departure the station was photographed from eight directions (every 45°, Figure 34) and the inside of the instrument enclosure (Figure 35) was also photographed. It is recommended that a new solar panel be mounted on to the weather station in the future because the existing hose clamp mounting system does not work well at this location. The solar panel could be set up with U-bolts that would mount onto the frame. For reference, the outside diameter of the aluminum pipe to which the solar panel is mounted is 2-3/8 in.

**Figure 33.** McArthur Pass RAWs – Three out of four hose clamps used to mount the solar panel had broken.

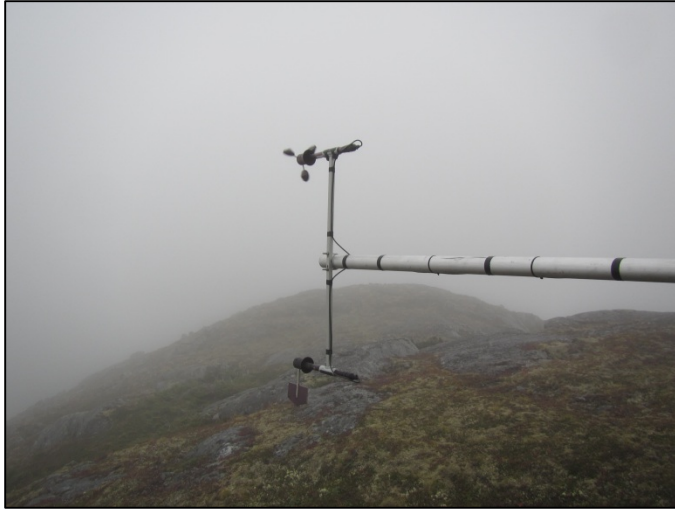
A round-trip helicopter flight was made from Homer to replace the wind direction sensor, which had failed on June 17 during a storm that had peak wind speeds of 93 mph. The fletching (tail) had fallen off the wind speed sensor, so wind directions for this period are off by 180 degrees.

**Figure 37.** McArthur Pass RAWS – The fletching (tail) had fallen off the wind direction sensor.

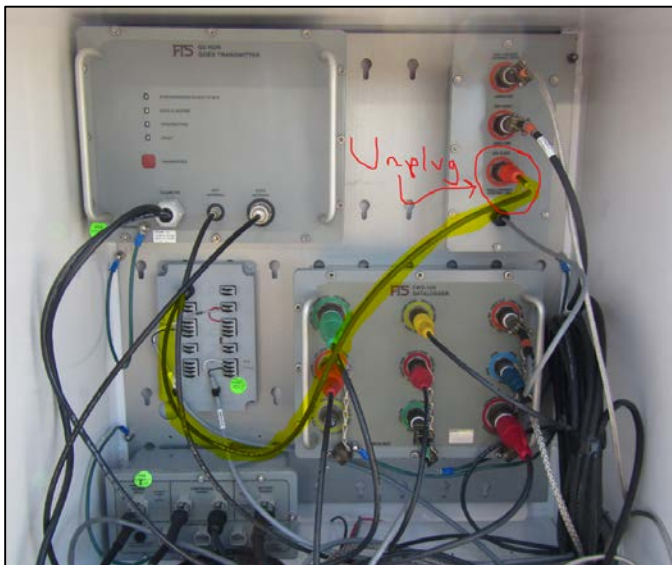
All the sensors that share SDI (snow depth, solar radiation, and soil temperature) stopped working on June 19, 2014. It was assumed that the soil temperature sensors were the cause of this problem because they have been problematic before. Unscheduled maintenance included unplugging the soil temperature SDI-AM from the SDI port (Figure 48). This did not work (snow depth and solar radiation still didn't work). The solar radiation sensor was then directly plugged into the SDI port on the data logger. This also didn't work. The BLM RAWS Depot thinks that the SDI bus in the data logger failed and suggests replacing the data logger.

**Figure 48.** Pfaff Mine RAWS – Inside of instrument enclosure before maintenance. First, the soil temperature sensors were unplugged from the SDI splitter box and then the solar radiation sensor was plugged directly into the data logger SDI port. Neither solution worked.

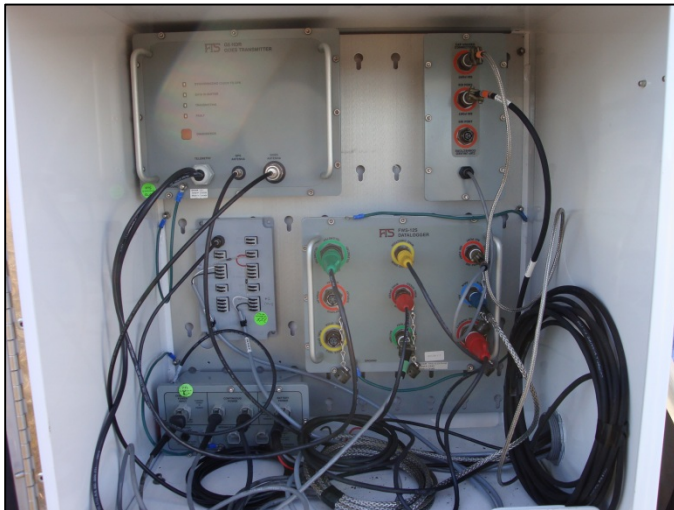
All the sensors that share SDI (snow depth, solar radiation, and soil temperature) stopped working on June 19, 2014. It was assumed that the soil temperature sensors were the cause of this problem because they have been problematic before. Unscheduled maintenance included replacing the data logger. Data logger program PFMI\_DLP\_SR50A.prg was edited to zero the SD sensor. Snow depth was zeroed to an average reading of -0.5 inches to account for fluctuation without reporting misleading snow depth readings. The soil temperature-enabled data logger program was not used and the problem with the soil temperature sensors will not be resolved until summer of 2015. The existing solar radiation sensor wasn't working after replacing the data logger, so it was also replaced. The data logger and solar radiation sensor will be returned to the RAWS Depot for inspection and hopefully the problem's cause can be identified. The inside of the instrument enclosure (Figure 49) was photographed before departure.

**Figure 49.** Pfaff Mine RAWS – Inside of instrument enclosure after maintenance. The soil temperature sensor and SDI-AM are not plugged into the data logger.

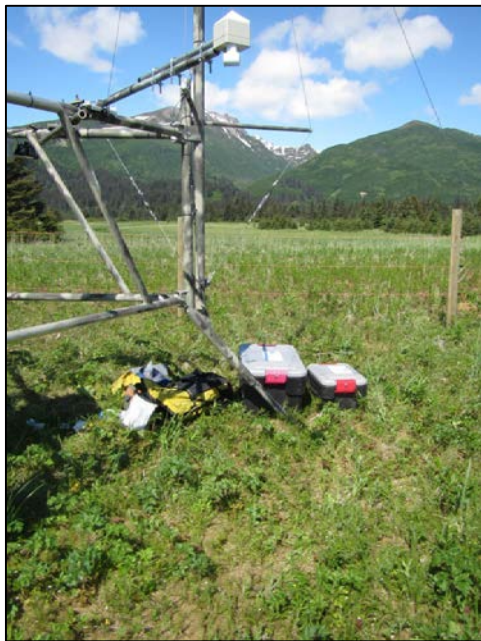
The station was in great condition. Vegetation beneath and around the station had grown significantly (Figure 50). This vegetation was trimmed using a hand-held weed whip and by hand pulling. The electric fence was operational and in good condition. The AT-RH sensor was replaced. The rain count was zeroed, and a tipping bucket test was done. The SD sensor was replaced with a Judd Communications SD sensor (Figure 51), which was rehabbed with new transducer plates and desiccant. Snow depth was zeroed to an average reading of -0.5 inches to account for fluctuation without reporting misleading snow depth readings. All data in the data logger were downloaded to send to the WRCC in order to update the archive. All bolts on the station were checked and tightened if loose and all cables were zip-tied. Station observations and GOES transmission quality were checked before departure. Observations and transmissions were verified from the WFMI website and relayed by satellite phone. Before departure the station was photographed from eight directions (every 45°, Figure 52) and the inside of the instrument enclosure (Figure 53) was also photographed.

**Figure 50.** Silver Salmon Lakes RAWS – Vegetation growth around the weather station.

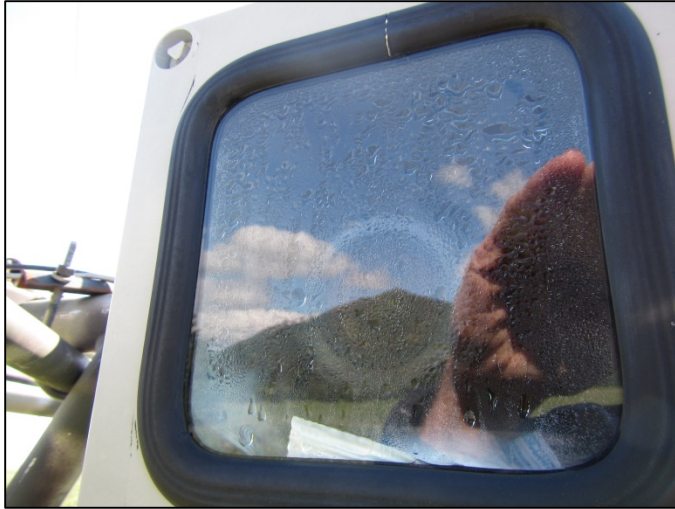
**Figure 55.** Silver Salmon Lakes phenocam – Moisture inside the phenocam housing.
