## Hydrogeologic Assessment of the water-supply well at Kamloops Island Campground Lake Roosevelt National Recreation Area

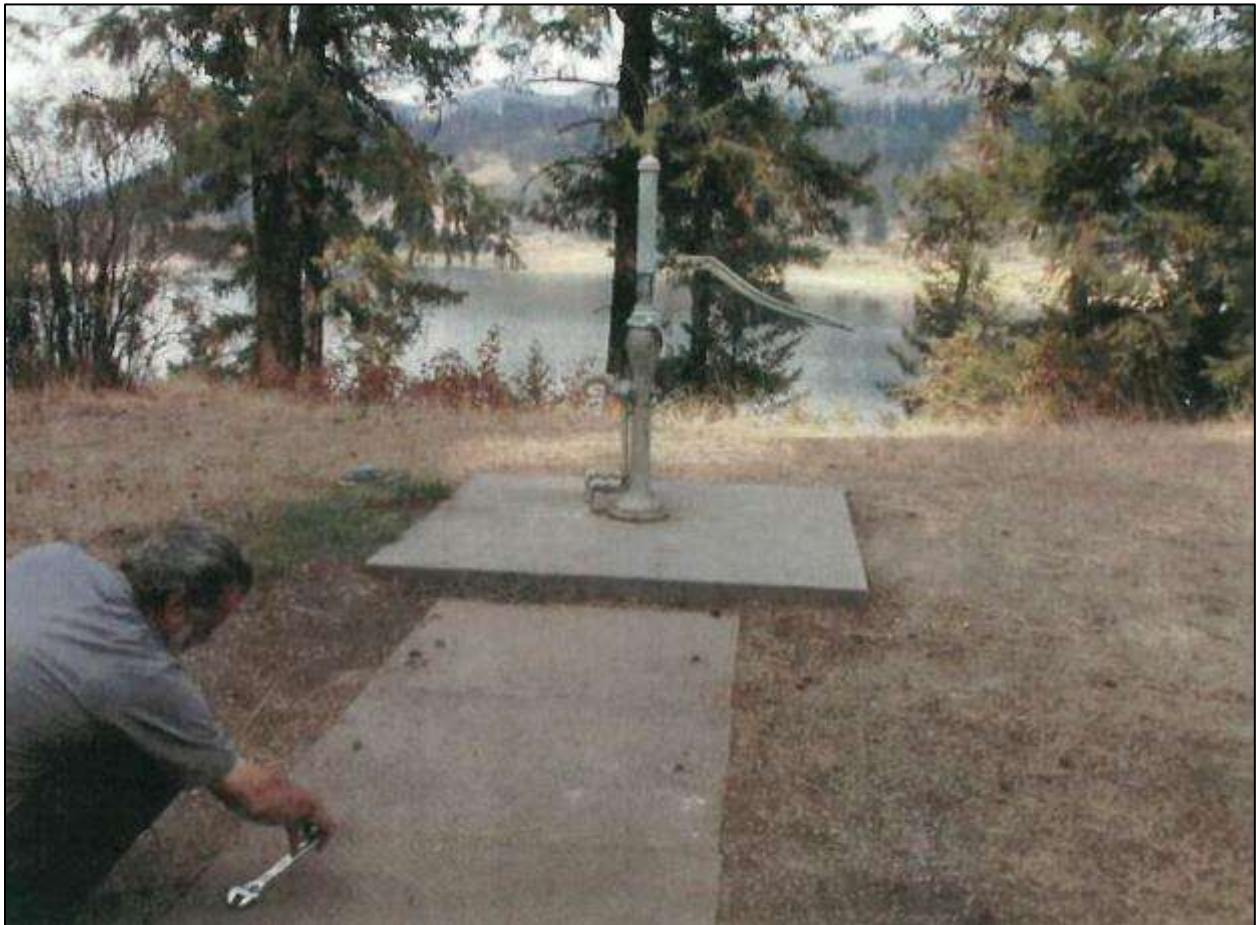
Figure 2. Hand pump on well at Kamloops campground. The iodine treatment and contact chamber are in the vault in the foreground of the photo.

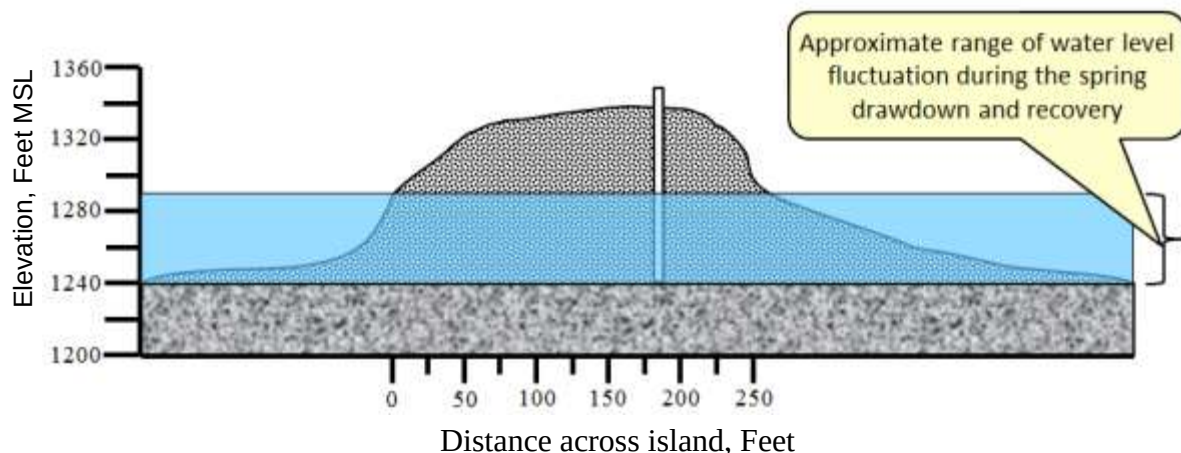
A conceptual model of a geologic cross-section through the island shows the deposit of sediments overlying a bedrock knob (Figure 5). During most of the year, the water level of the reservoir (and the water table of the island) is around 1290 feet MSL. When the water level is drawn down in the spring, it sometimes goes below 1240 feet, resulting in drainage of the sediments comprising the island. When that happens, the well goes “dry”. When the reservoir level is raised, water infiltrates back into the sediments causing the water table to rise.

Figure 5. Conceptual hydrogeologic cross-section through Kamloops Island.
