# Las Conchas Post-Fire Response Plan

Bandelier National Monument

AUGUST 2, 2011

**PREPARED BY:** National Park Service Las Conchas BAER Team

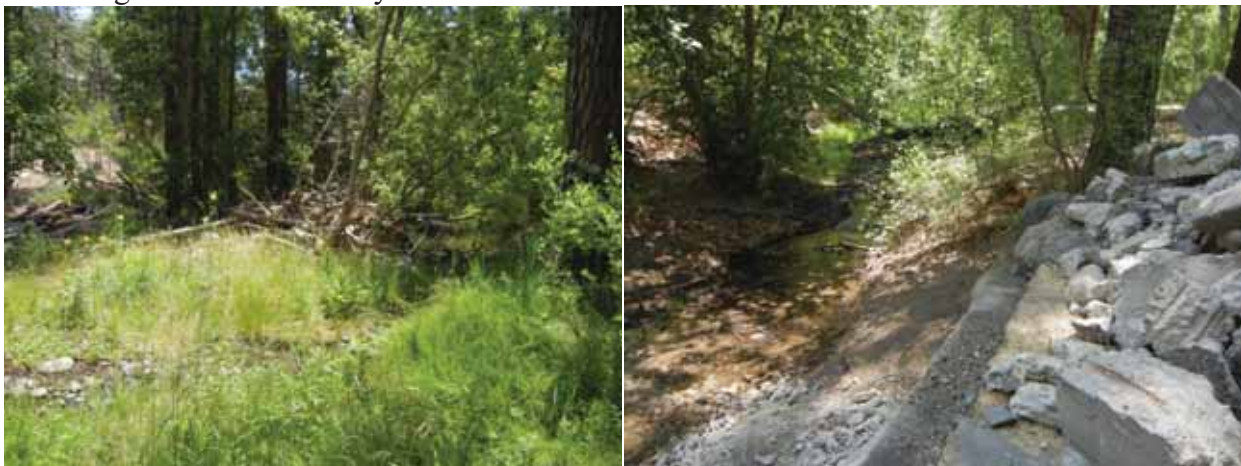
**Woody debris dam in channel.**

**Down tree in channel and concrete debris.**

An emergency consultation was initiated with the New Mexico State Historic Preservation Officer on July 3, 2011 requesting concurrence with a proposal to demolish the crossing structures. Concurrence with that proposal was received on July 4, 2011. Within the following week, seven (7) pedestrian bridges and one motor car bridge were demolished (two by park staff and five by a contractor.) Additionally, floatable debris within the Rito de Frijoles vicinity, consisting primarily of dead and down woody material, were removed. Down mature trees in the channel adjacent to the parking lot and a woody debris dam near the streamflow gaging station are still in place and should be removed. Concrete and other deconstruction debris should also be removed from near the channel. With these preparations, agency managers acted to assure that free flows within the creek were restored and flash flood events were unlikely to exceed the highest levels identified in the Delineation of Floodplains memo, and that the exposure of the archeological sites in the canyon to flood damage was at a low level.

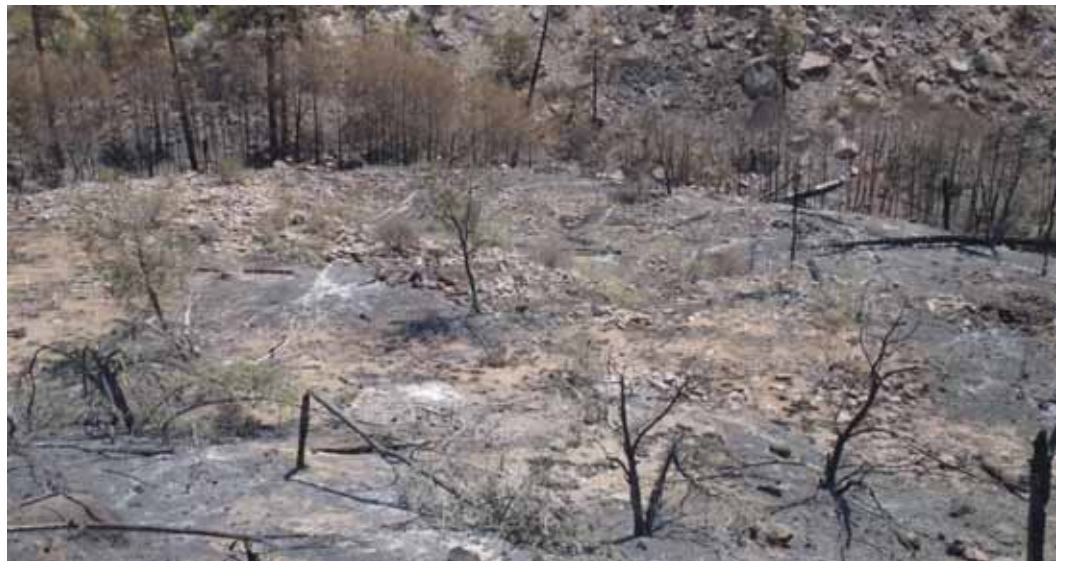
Shohakka Pueblo showing standing dead and proximity to Capulin Creek

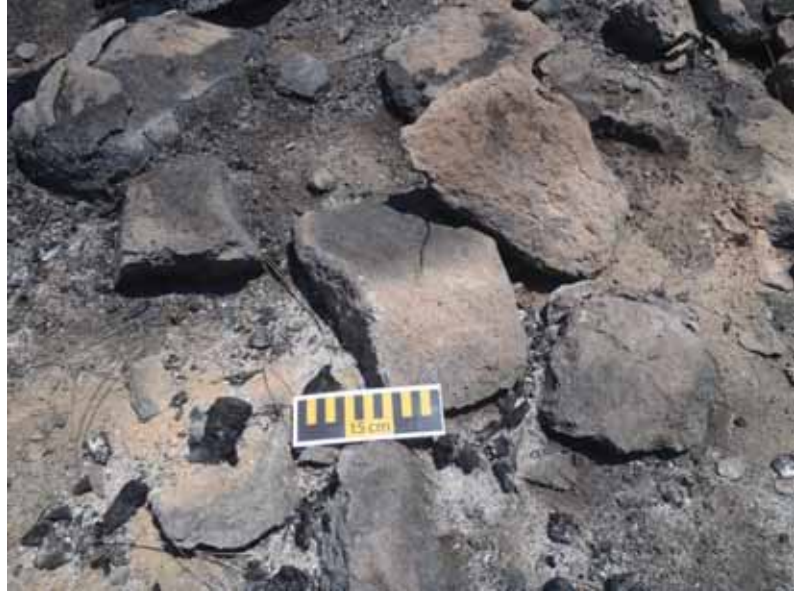
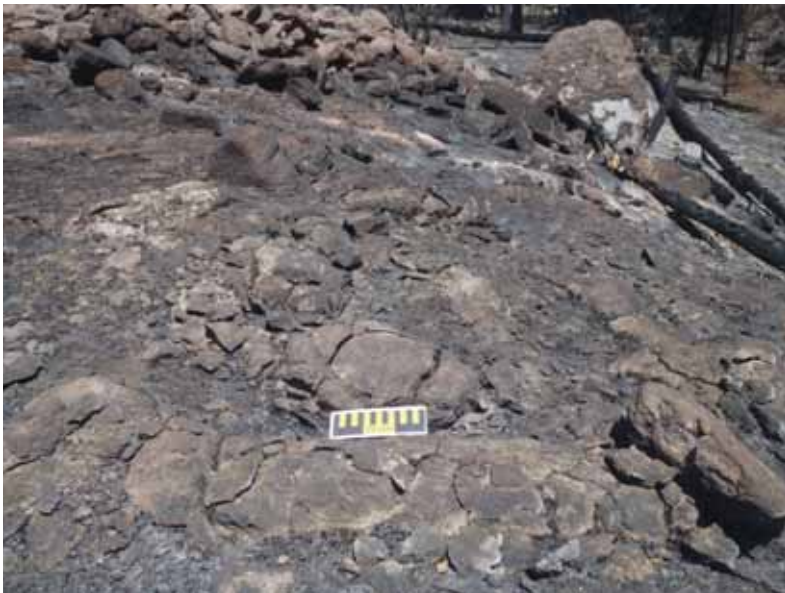
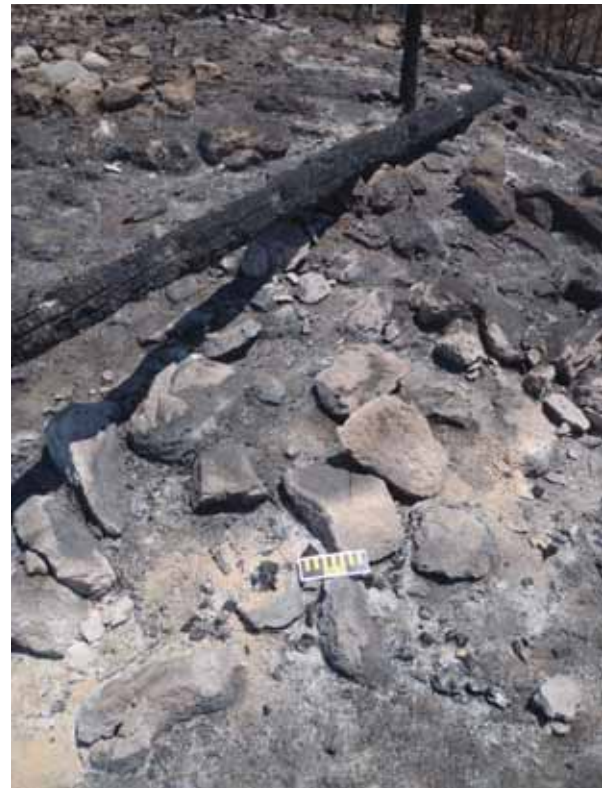
Shohakka Pueblo views showing high severity to masonry fabric, spalling, cracking, color change

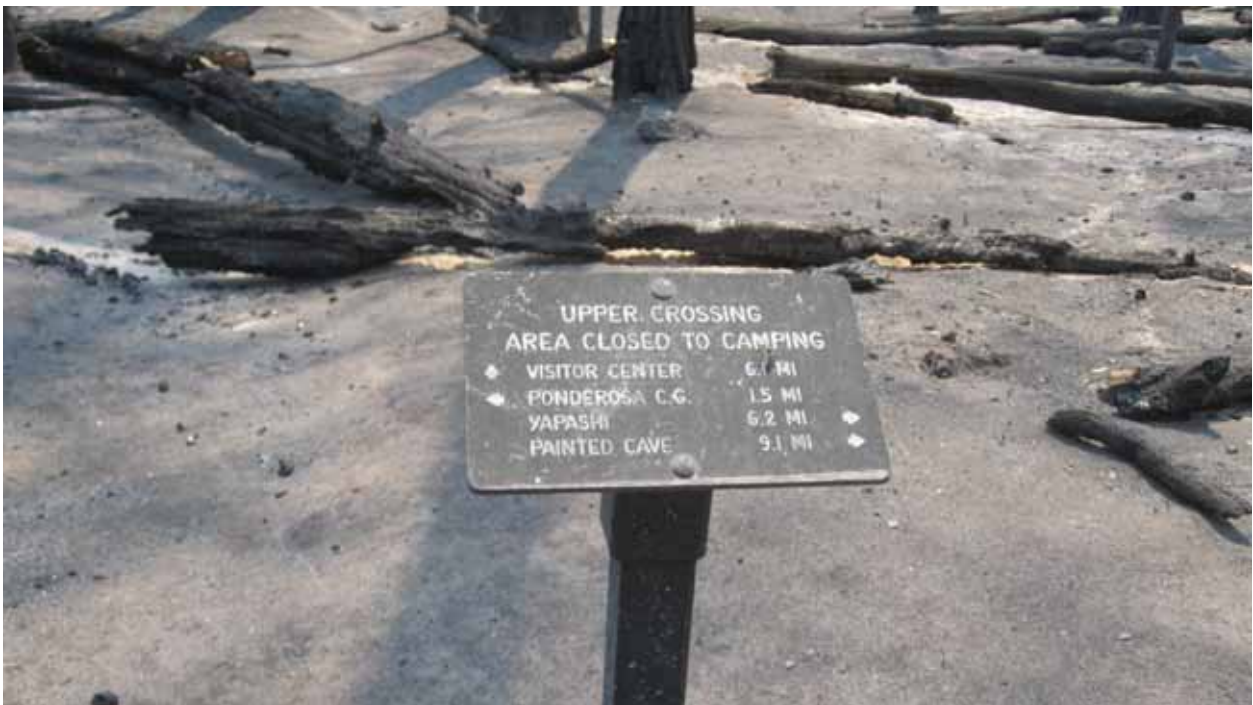
Damaged trail sign at Upper Crossing

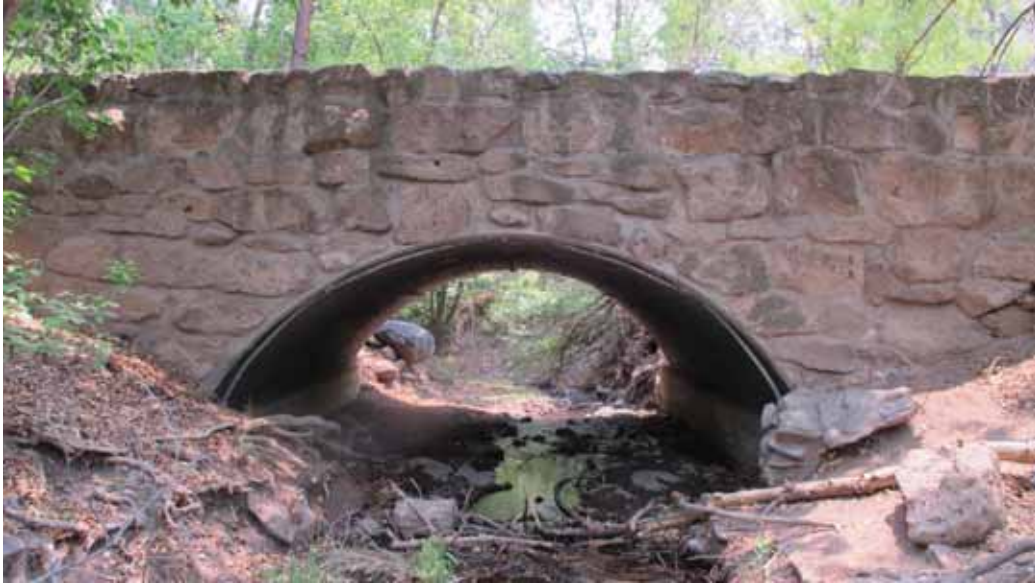
View 1 – Motor Car bridge as viewed from Rito de Frijoles; note that the bridge is essentially a large culvert.

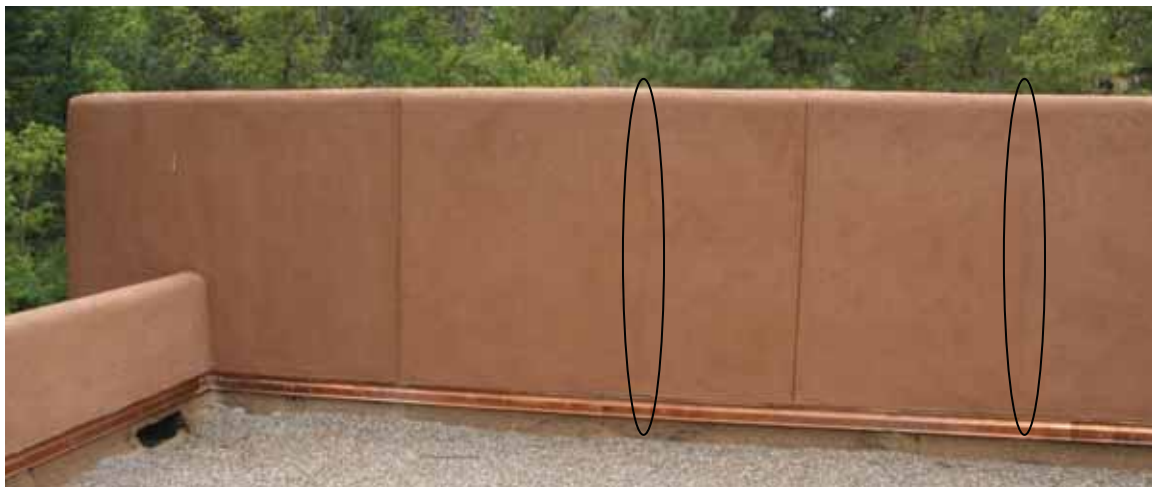
On the date of this inspection several areas of minor cracking in the theater addition were observed. These could be attributed to differential settlement and thermal expansion/contraction that is fairly common when newer construction materials and techniques are utilized to connect modern structures to historic structures. The more obvious areas were photographed and can be utilized as observation points to determine to settlement is affected by future flood events.

---

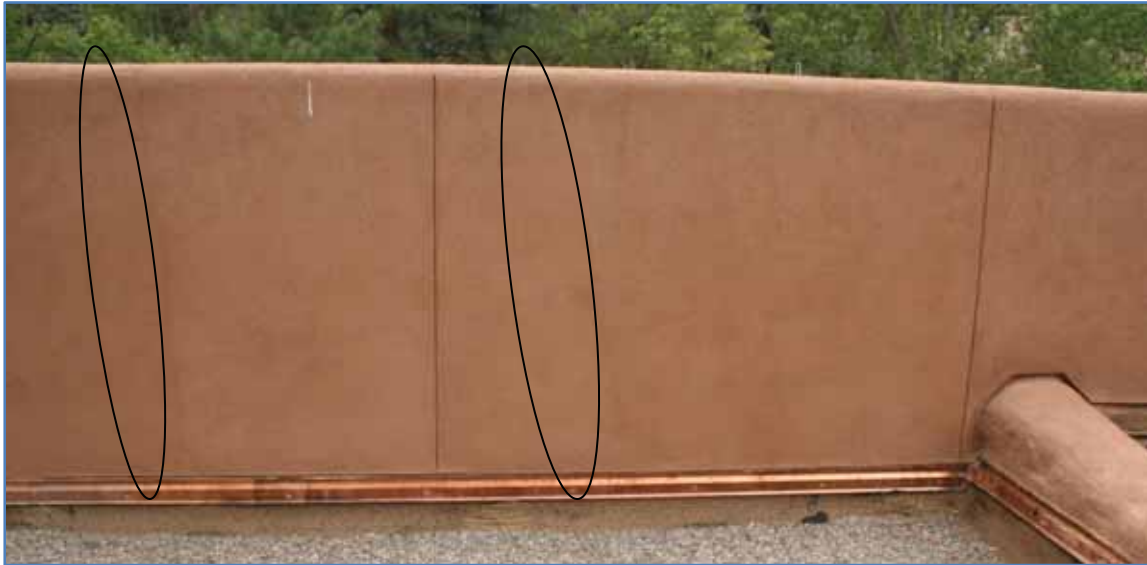
Figure 3. Southeast wall of Theater showing minor cracking.

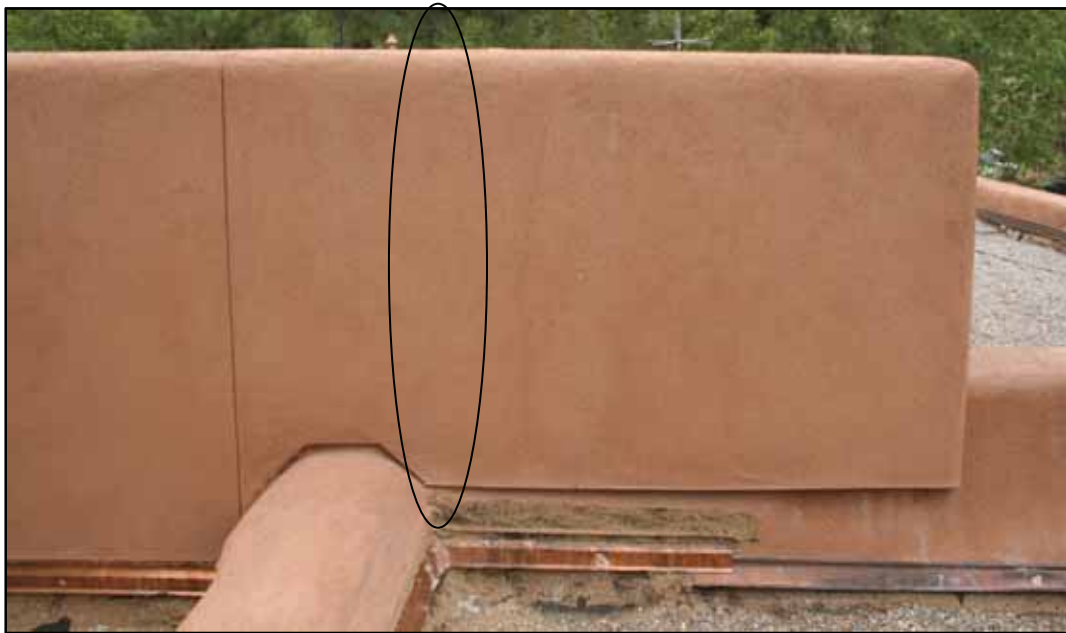
Figure 4. Southeast wall of Theater showing minor cracking.

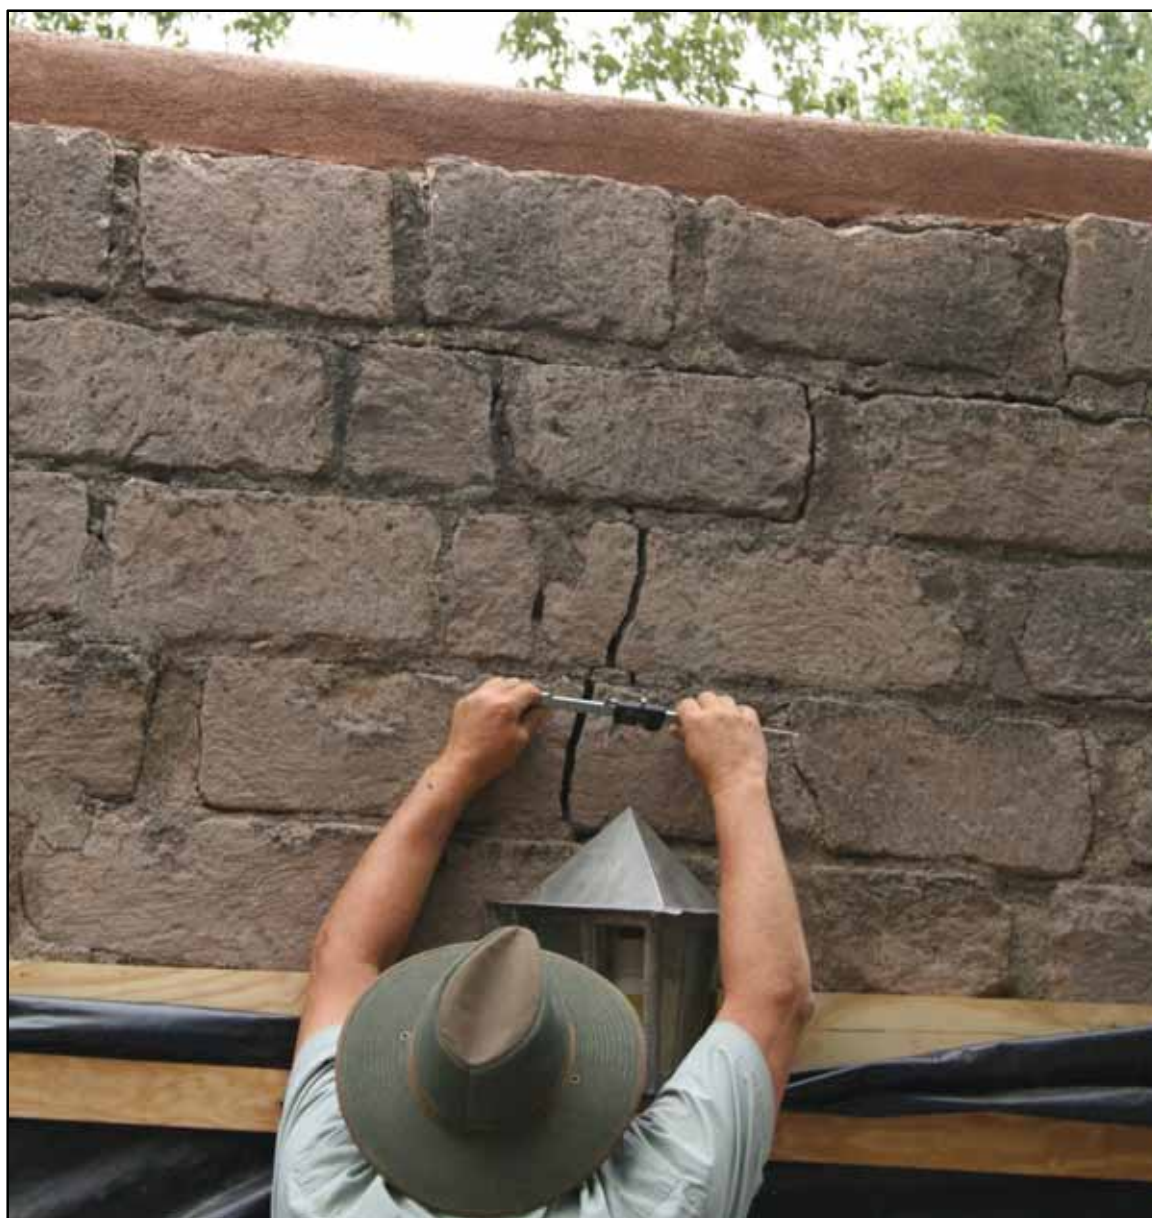
A caliper measurement point was etched into the stone on each side of an existing crack at the northwest end of the Portale, directly above the existing light fixture (Figure 5). The initial measurement was 75 mm. This measurement point should be checked after each catastrophic flood event to determine if any movement has occurred. The marks are located on the third course down from the top and look like this  
├┤.

Figure 5. Caliper measurement point on Northwest end of Portale.

establish the current vertical profile of the wall at this point. This should be remeasured annually to determine if the wall profile is changing which would indicate settlement of the theater addition.

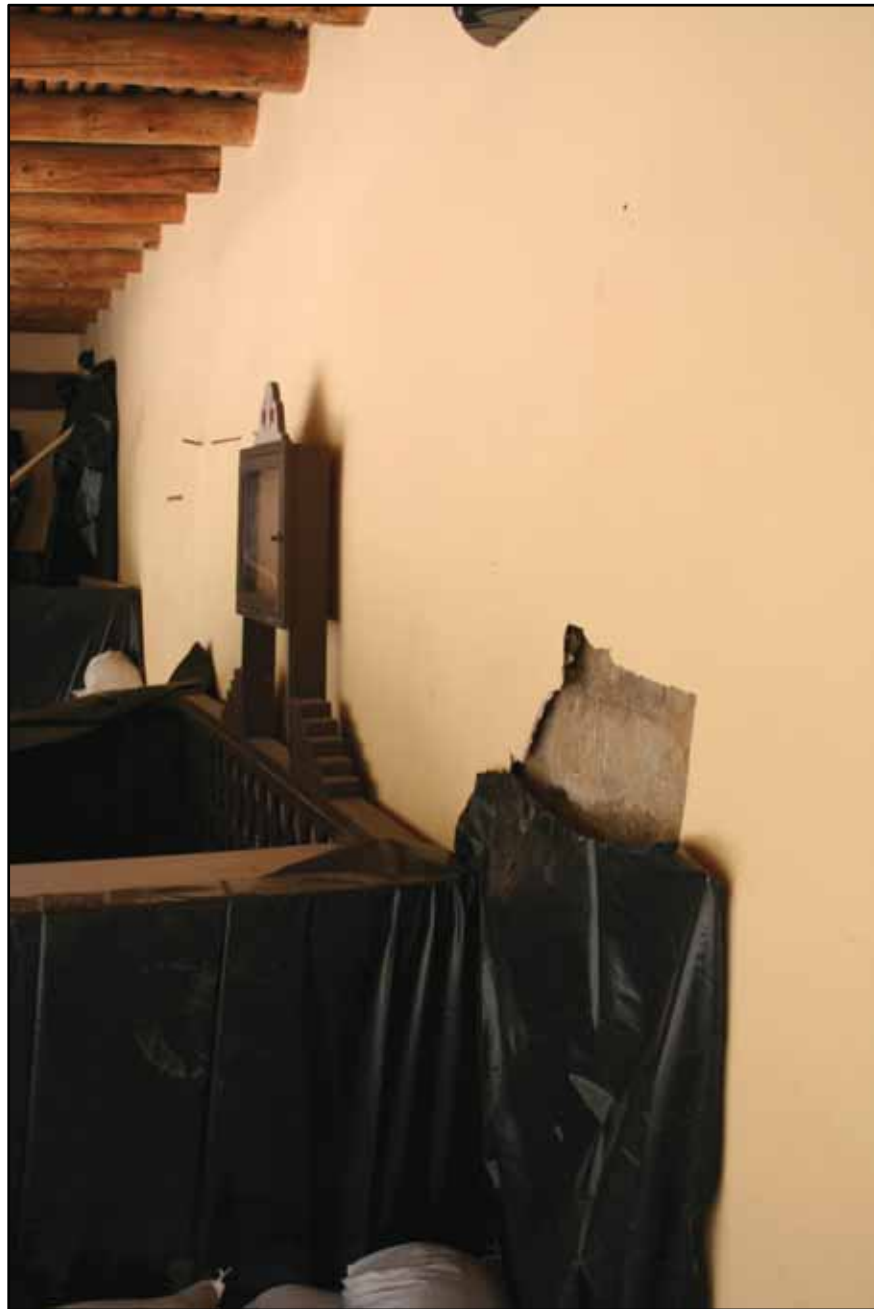
Figure 6. Plaster loss on northwest wall of Portale.

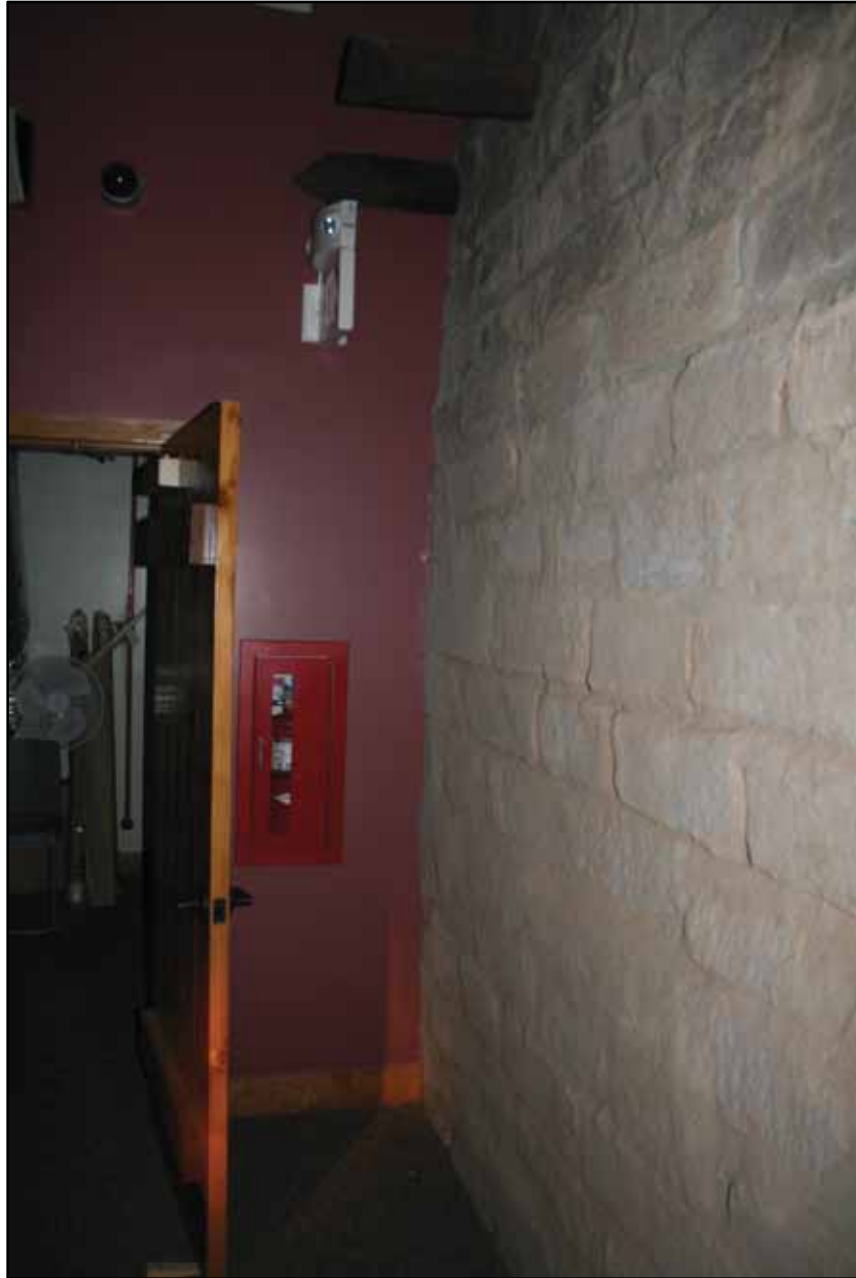
Figure 7. Northeast interior wall of theater addition showing profile of original exterior portale wall. Note apparent bulging.

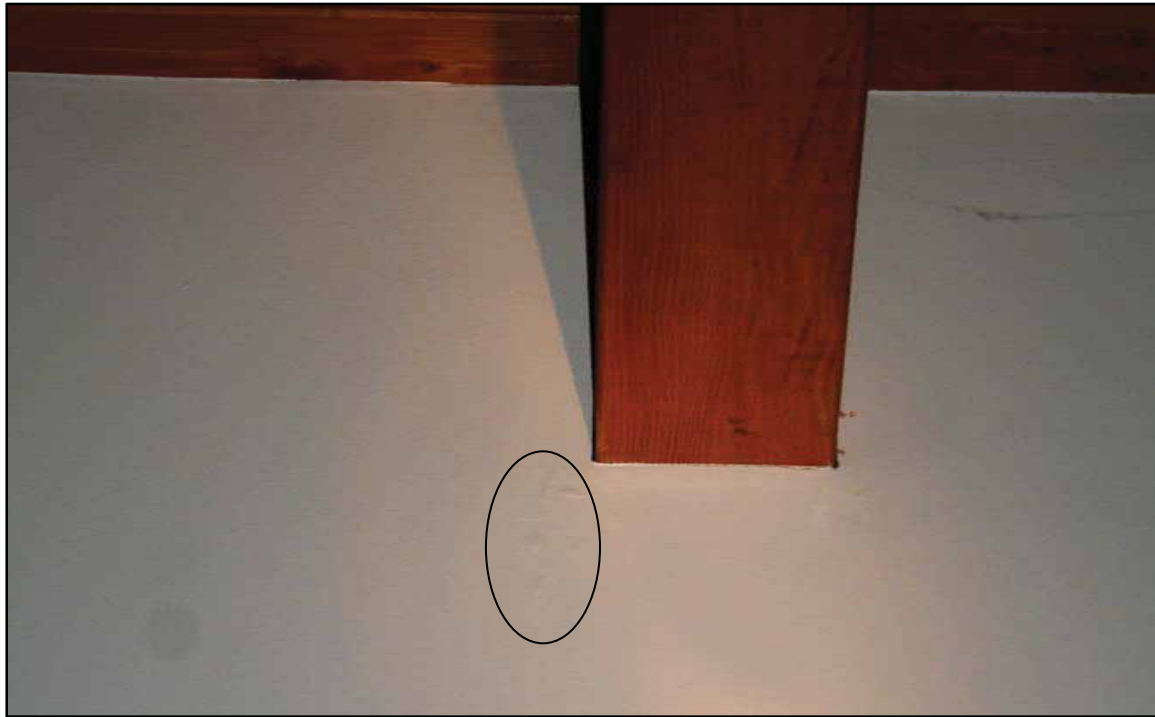
Figure 14. Closeup of wall and the 6<sup>th</sup> beam from the southeast end of the southwest wall of the theater addition. Note “bubbling” below beam.

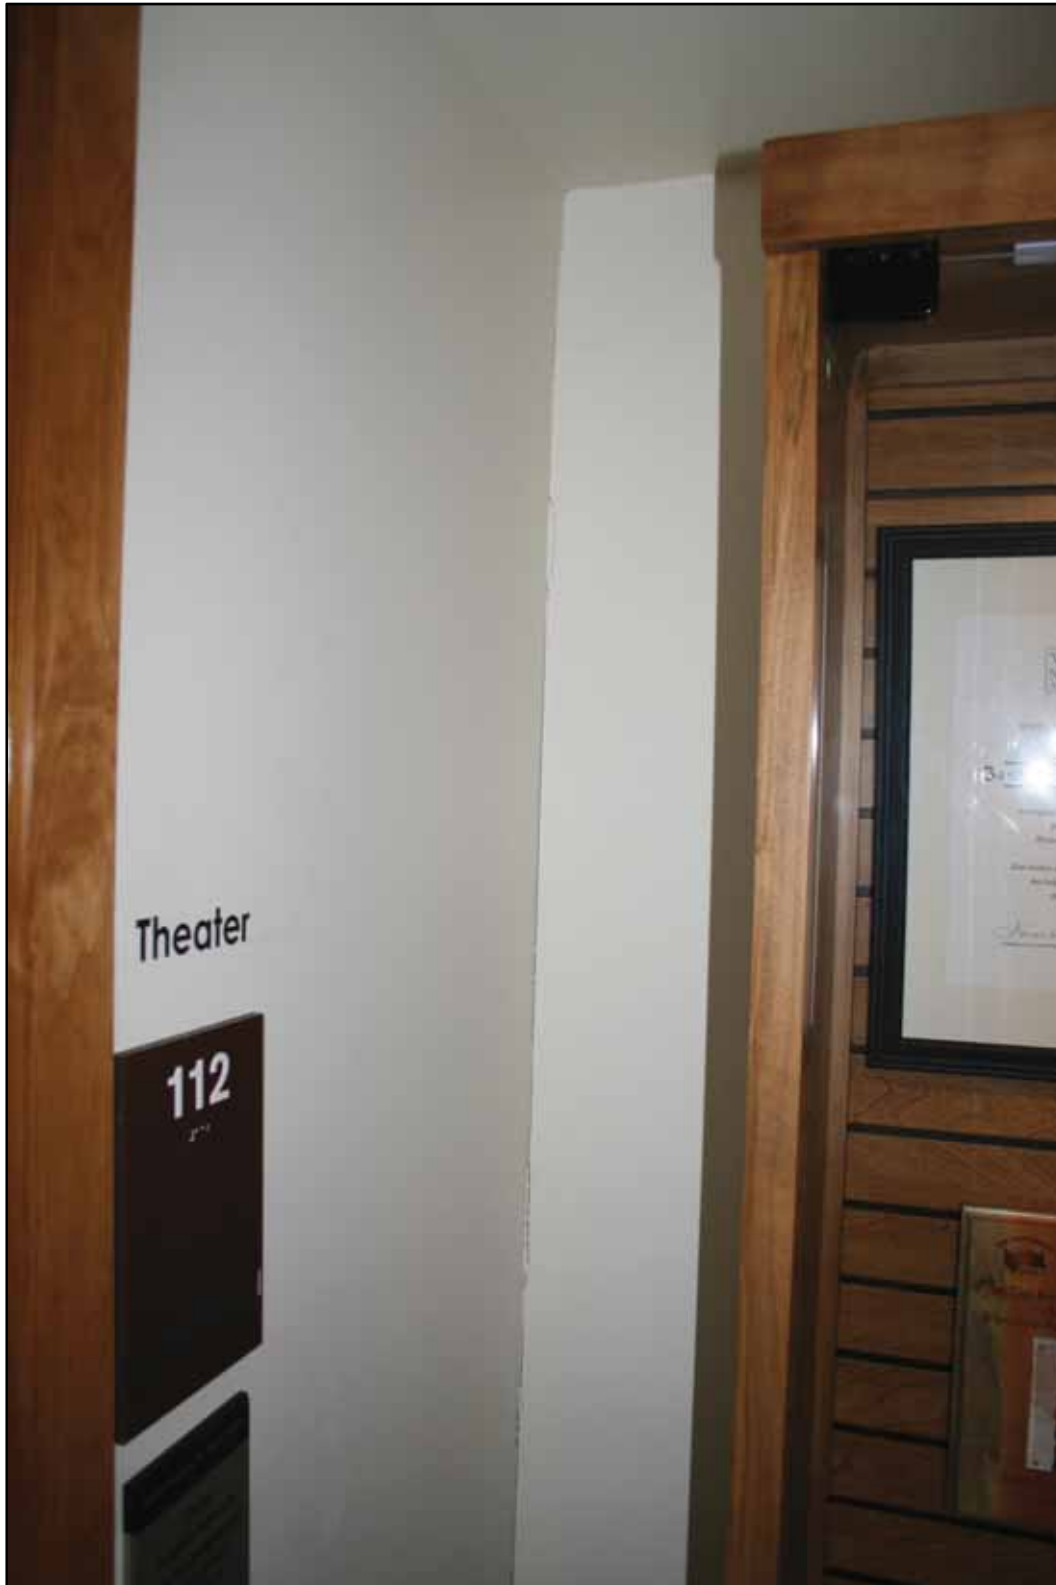
Figure 15 Photo of hall (Room 119) wall intersection with Theater (Room 112) showing minor separation at corner.
