# **Elkmont Historic District**

## **Great Smoky Mountains National Park**

## **Finishes Analysis Report**

March 31, 2016

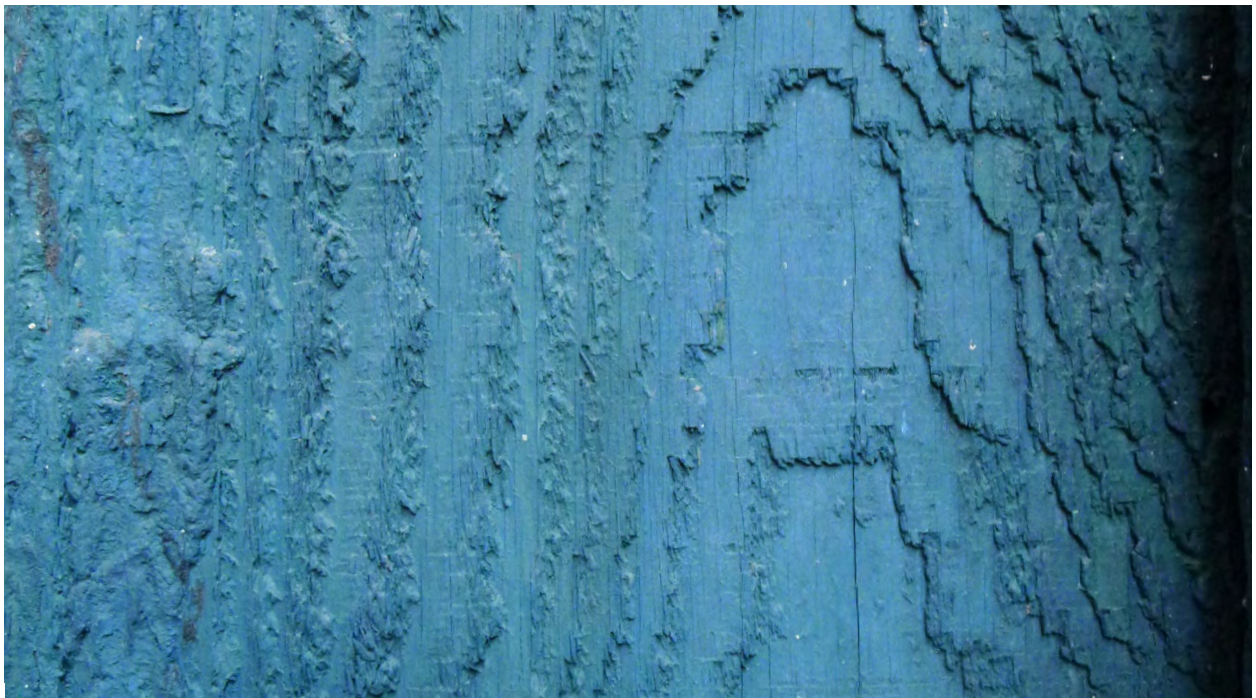
In addition, many of the wood substrates appear rough and weathered in the samples removed by BCA, a characteristic also visible on site (fig. 3). This type of rough surface was mostly found in the siding samples, where the wood appears uneven and dark, and the subsequent paint layers have seeped deep into the wood surface. This evidence suggests several possibilities: 1) the wood was unfinished originally, and later paint layers were applied to a weathered and oxidized surface; or, 2) the wood was finished originally, and the finish

**Figure 3:** Rough painted surface of the wood siding.

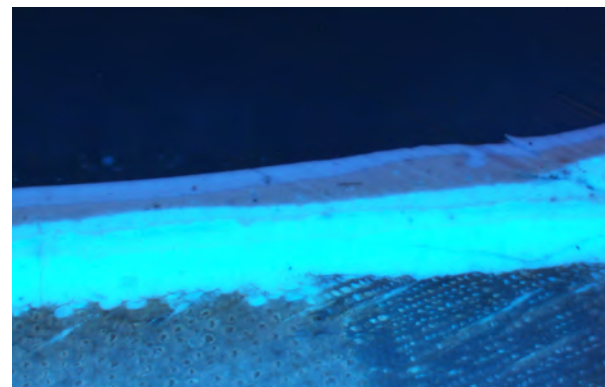
Figure 5: Sample ELK.1.2, 40x magnification, visible light (above) and UV light (below). All of the layers of this door surround are white.

The samples removed from the door surround and windowsill are similar when viewed in cross-section. Both contain approximately five campaigns of whites. While the wood surfaces appear slightly uneven, it is not clearly stripped or worn (fig. 5).

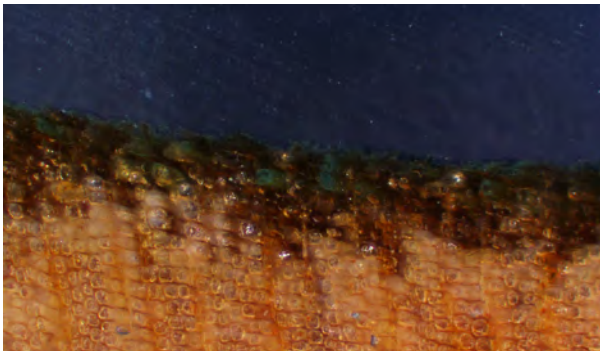
**Figure 7:** Sample ELK.2.1, 40x magnification, visible light (above) and UV light (below). The wood surface is worn and darkened, and the only paint is a dark green that is not a continuous layer and does not auto-fluoresce.

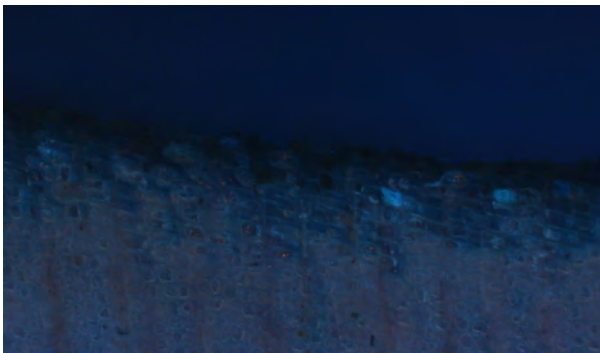
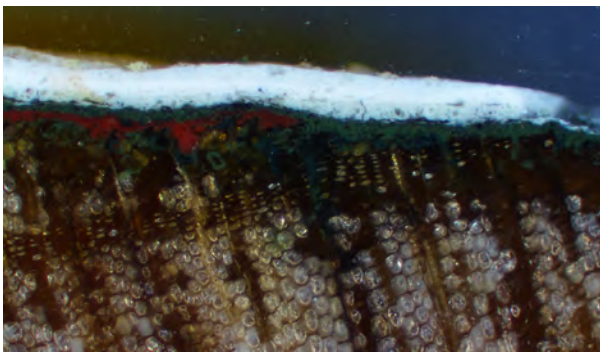
**Figure 8:** Sample ELK.2.6, 40x magnification, visible light (above) and UV light (below). Early colors include green and red.

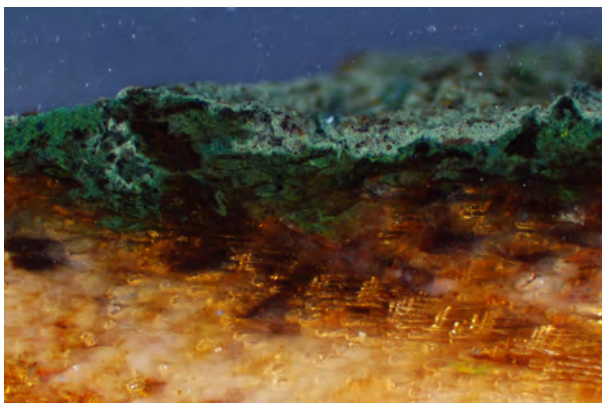
**Figure 12:** Sample ELK.3.4, 40x magnification, visible light (above) and UV light (below). The surface of this sample is rough and darkened. The green paints do not auto-fluoresce.

The substrate of sample 3.4, removed from the siding, is highly rough and discolored at the surface (fig. 12). The first layer is a damaged layer of olive green paint followed by a lighter green. The unevenness and discoloration of the wood substrate suggests that it was exposed for a period of time.

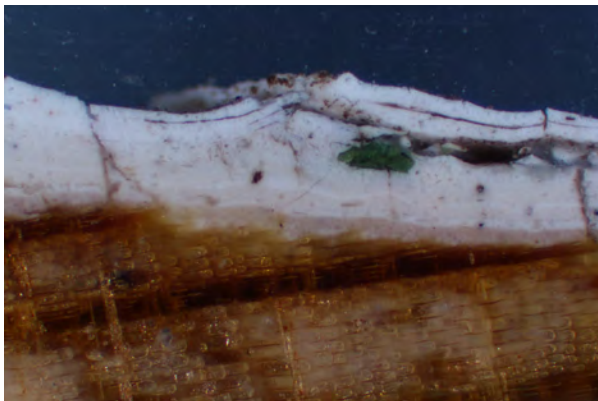
**Figure 14:** Sample ELK.5.1, 40x magnification, visible light (above) and UV light (below).

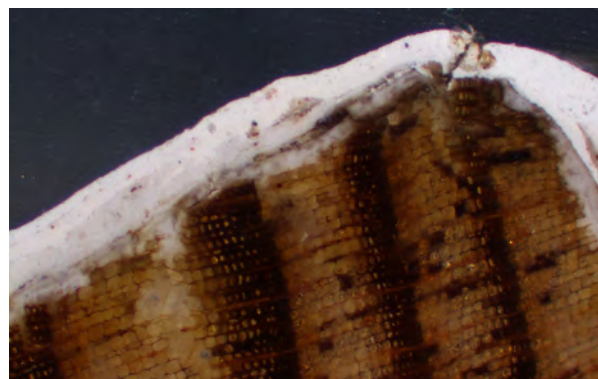
**Figure 22:** Sample ELK.7.1, 40x magnification, visible light (above) and UV light (below). The wood surface is worn and discolored, and the early green paint is soaked into the wood.

appears somewhat uneven, and the earliest white paint is visibly soaked into the wood. These siding samples, however, do not appear in general as worn and discolored as other siding samples in cross-section.

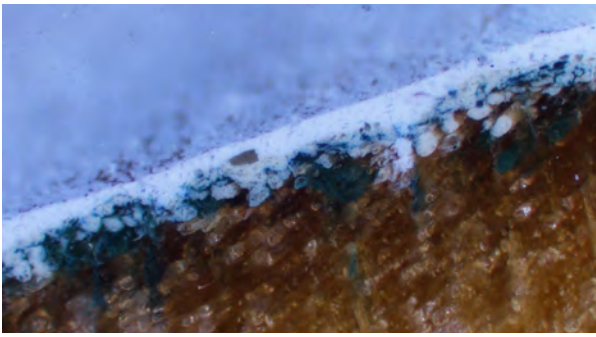
**Figure 23:** Sample ELK.7.2, 40x magnification (above), and Sample ELK.7.3, 100x magnification (below). Note the dark green layer soaked into the worn wood substrate in both.

The samples removed from the window sash and surround both show a rough wood substrate with the earliest paint layer soaked into the wood. The earliest paint is a dark green, and the paint layer itself is weathered or damaged. After the dark green, sample ELK.7.2 contains the current white, while sample ELK.7.3 contains a few layers of light blues and greens with the current dark green on top (fig. 23). Given the appearance of the wood substrate in cross-section, it is likely that these elements have either lost their original paint or, possibly, were originally unpainted.

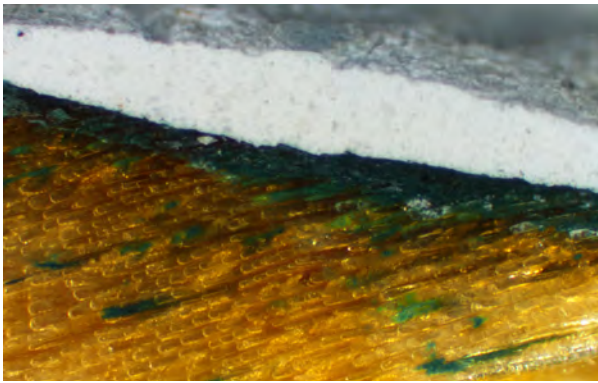
**Figure 27:** Sample ELK.8.4, 40x magnification, visible light (above) and UV light (below). The early green is found deep within the wood surface.

The samples removed from the original siding and window all show rough and darkened wood substrates with green paint soaked into the wood (fig. 27). This dark green paint does not manifest as a clear paint layer, as much of the paint is in the pores of the wood. Sample ELK.8.4 may have an additional brown or dark green paint on top of the early dark green. After this worn paint is the current paint finish.

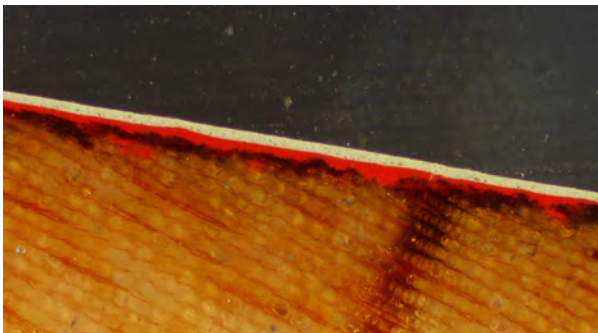
**Figure 28:** Sample ELK.8.5, 40x magnification, visible light (above) and UV light (below). The brown layer (arrow) is autofluorescent and may represent a resinous finish.

The front door contains evidence of several paint colors (fig. 28). The first color is a green, but it is only seen in traces in the pores of the wood, so it is unclear if it is an intentional paint layer. Following the green is a brown that is very thin and damaged. The layer may be a resinous finish as it is autofluorescent. After the brown is a red, also thin, followed by the current sea foam green, also thin. The surface of the wood appears somewhat worn but is not discolored.

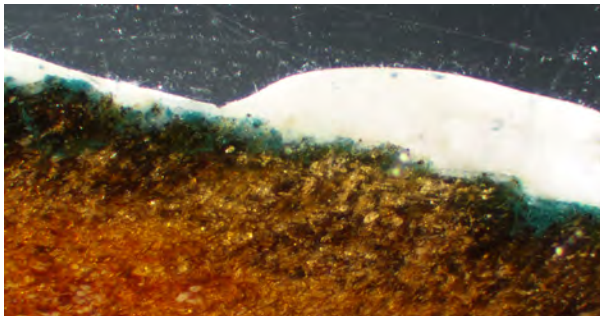
**Figure 29:** Sample ELK.8.7, 40x magnification, visible light (above) and UV light (below). The worn wood surface contains evidence of a green paint.

the substrate of the siding looks more like a stripped wood surface than is found on the other elements—the wood surface is feathered, without a distinct edge. The green on the siding appears different in cross-section than the current green paint on the east elevation, and is similar to the earlier paint. This could suggest that it was applied concurrent with or within the same era as the early green paint on the east elevation. The siding from the southwest addition also contains a later white, which appears similar to the later white applied to the window elements on the east elevation.

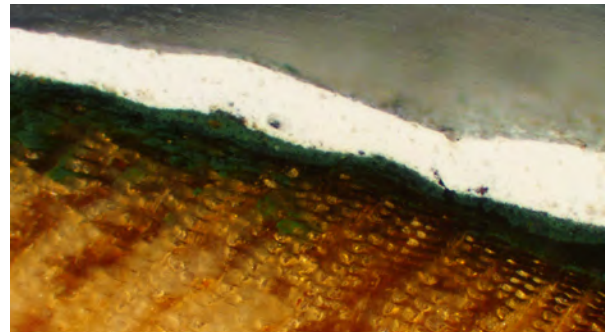
Both samples exhibit a worn wood surface and disturbed early paint layer. Sample ELK.10.1 shows a darkened and uneven wood surface typical of many board and batten siding samples, with dark green paint seeped into the wood (fig. 34). The layer is thin and damaged. Sample ELK.10.2 contains traces of a dark green paint, some of it encapsulated within the later white paint layers. Again, the surface is worn or stripped, but not as darkened as sample ELK.10.1.

**Figure 34:** Sample ELK.10.1, 40x magnification, visible light (above) and UV light (below). The sample has an uneven and darkened surface with a dark blue-green paint.

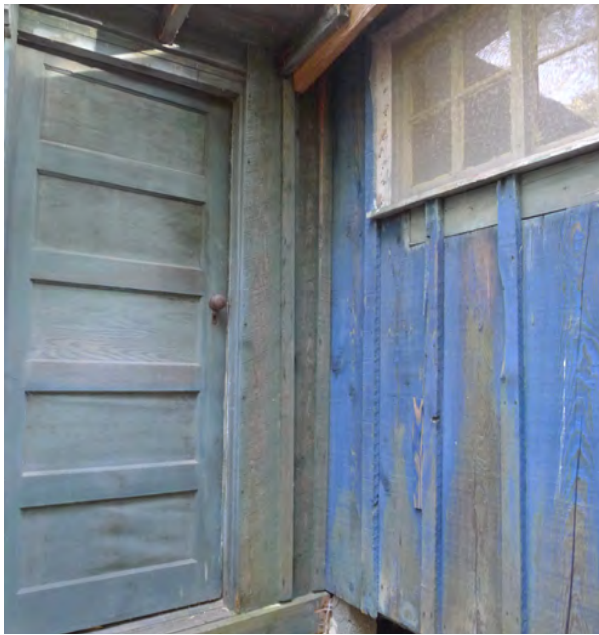
**Figure 37:** Various blues on different elements of the Scruggs-Briscoe cabin.

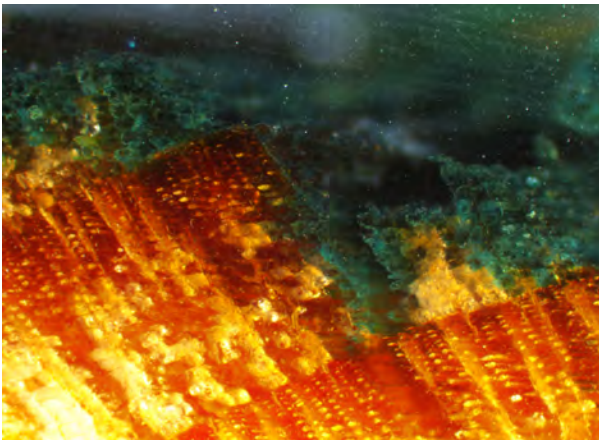
As on other cabins, the sample removed from the siding (ELK.11.2) showed a highly uneven wood substrate and an uneven/damaged dark green paint (fig. 38). The surface of the wood is darkened, suggesting long-term exposure. The rafter at the porch ceiling (ELK.11.3) appears similar in cross-section, as does the window surround, although the window surround is currently painted white.

**Figure 38:** Sample ELK.11.2, 40x magnification, visible light (above) and UV light (below). The wood substrate is uneven and had what appears to be one green paint.

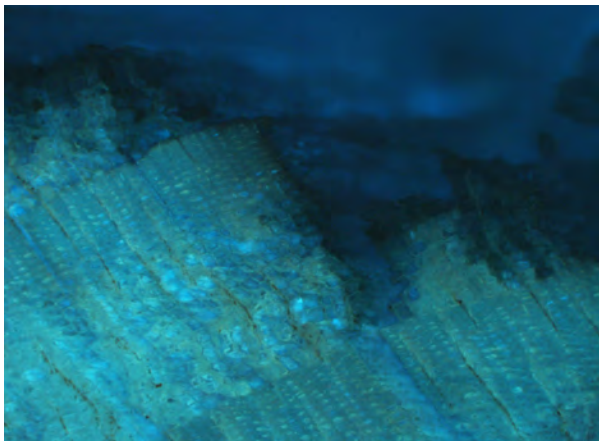
**Figure 39:** Sample ELK.11.4, 40x magnification, visible light (above) and UV light (below). The wood is uneven.

The screen door (ELK 11.4) contains several paint layers, mostly green (fig. 39). The surface of the wood is somewhat worn, possibly stripped. There may be a partial early brown paint or resinous layer on the surface, but is unclear in cross section—the surface of the sample appears to auto-fluoresce but it may be that the paint is separating from the substrate. Following the possible brown is a light green and a worn dark green. A thin white is on top of the dark green, and then two other greens.

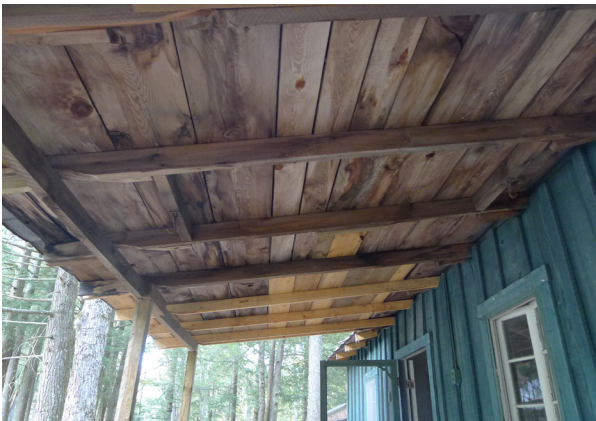
**Figure 41:** Unpainted porch ceiling with new repair wood.

green. The front porch floor is painted gray. There has been some selective replacement of elements, including part of the porch ceiling and floor, with new, unpainted wood. However, the rest of the porch roof ceiling is also unpainted (fig. 41). While this section of the porch is believed to be original, is not clear if these particular elements of the porch ceiling are original and were originally unpainted.

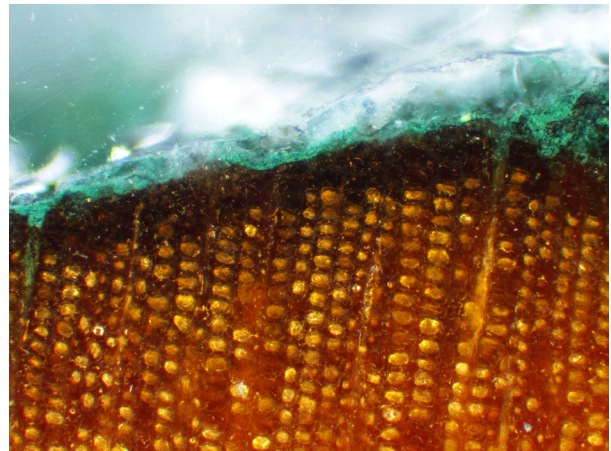
**Figure 42:** Sample 13.5, 40x, magnification, visible light (above) and UV light (below). The surface of the wood appears uneven.

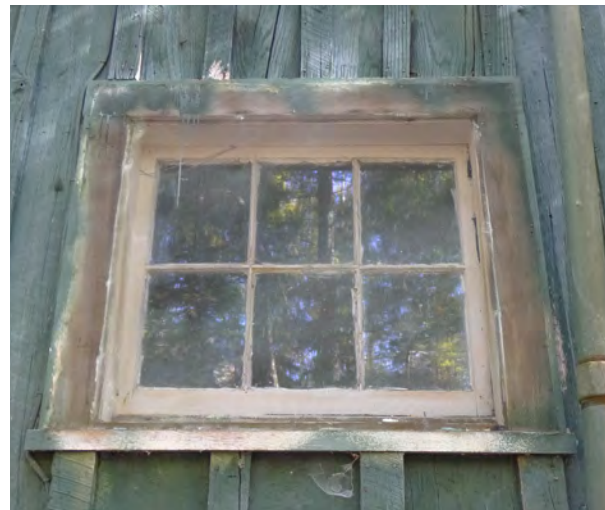
**Figure 48:** Evidence of a spray-painting campaign on the side of the Chapman-Byers cabin.

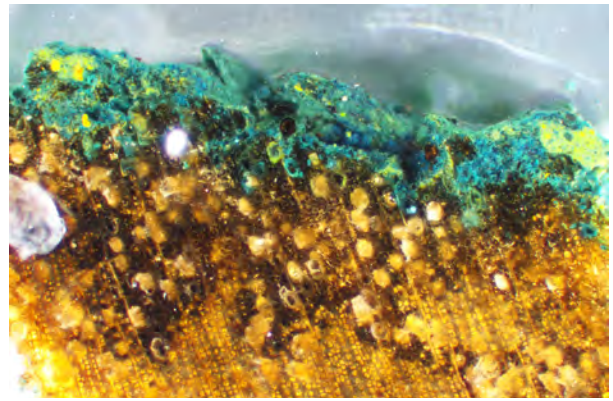
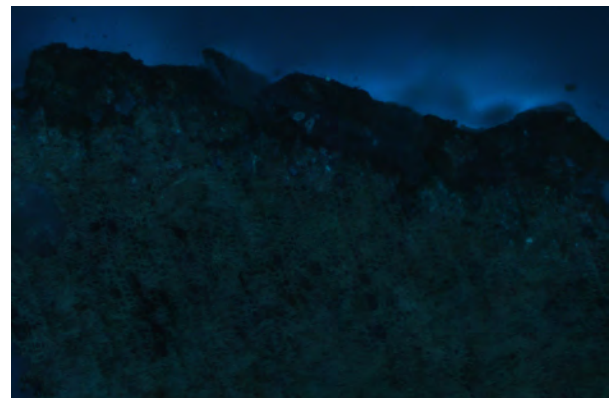
**Figure 51:** Sample ELK.38.5, 40x magnification, visible light (above) and UV light (below). This sample from the siding contains several layers, but they are very worn and it is difficult to decipher the layering. The wood substrate is worn and darkened.
