National Park Service  
Cultural Landscapes Inventory  
2010

Boca Chita  
Biscayne National Park

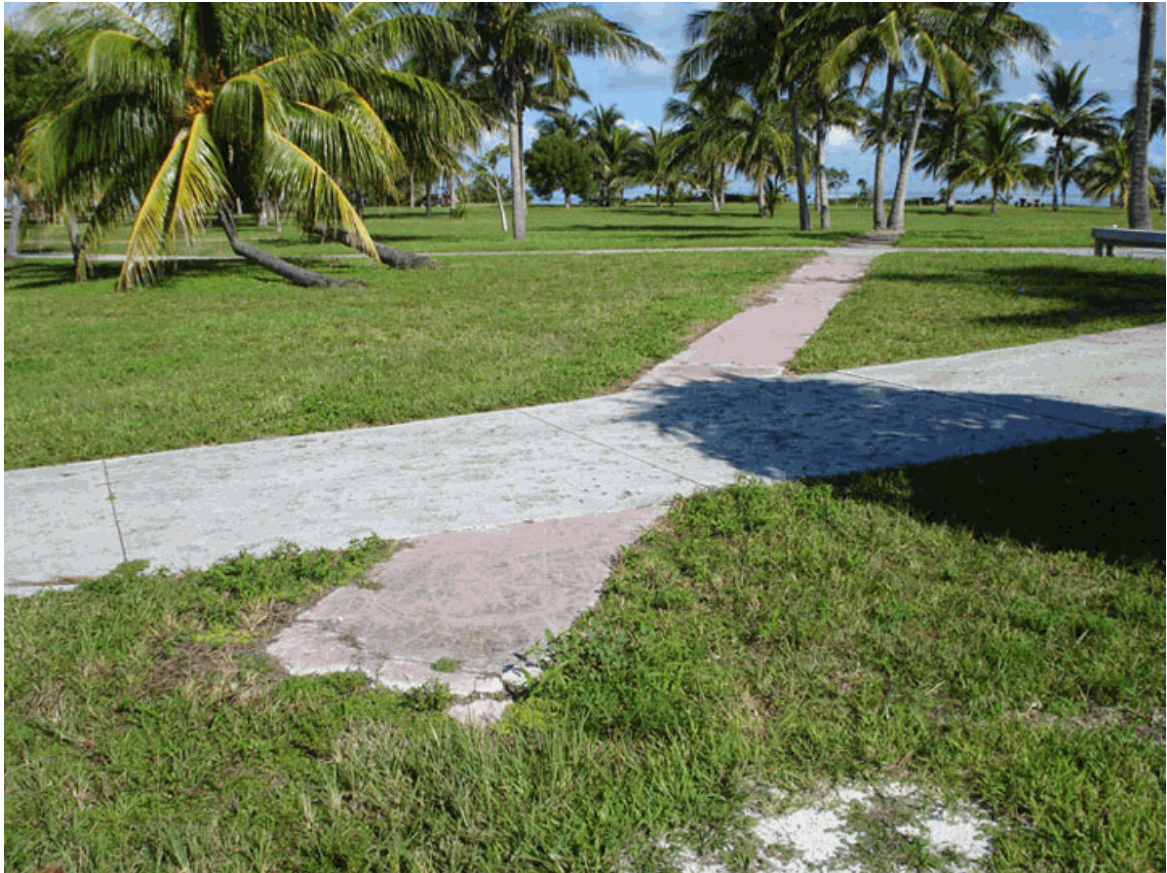
These historic walkways are constructed with a top layer of integral red coloring. The walks are cracked and faded to a pale pink color. Condition of the sidewalks is consistent with their age and constant exposure to harsh conditions. Threats to the sidewalks include unnecessary stress caused by maintenance vehicles and mowers driving across them and accelerated disintegration caused by the accumulation of lawn thatch. The 1994 rock salt finished concrete walks cut through the historic concrete walks, removing two ten-foot sections of the historic concrete.

*Graphic 35: Rock salt finished concrete and historic concrete walkways*

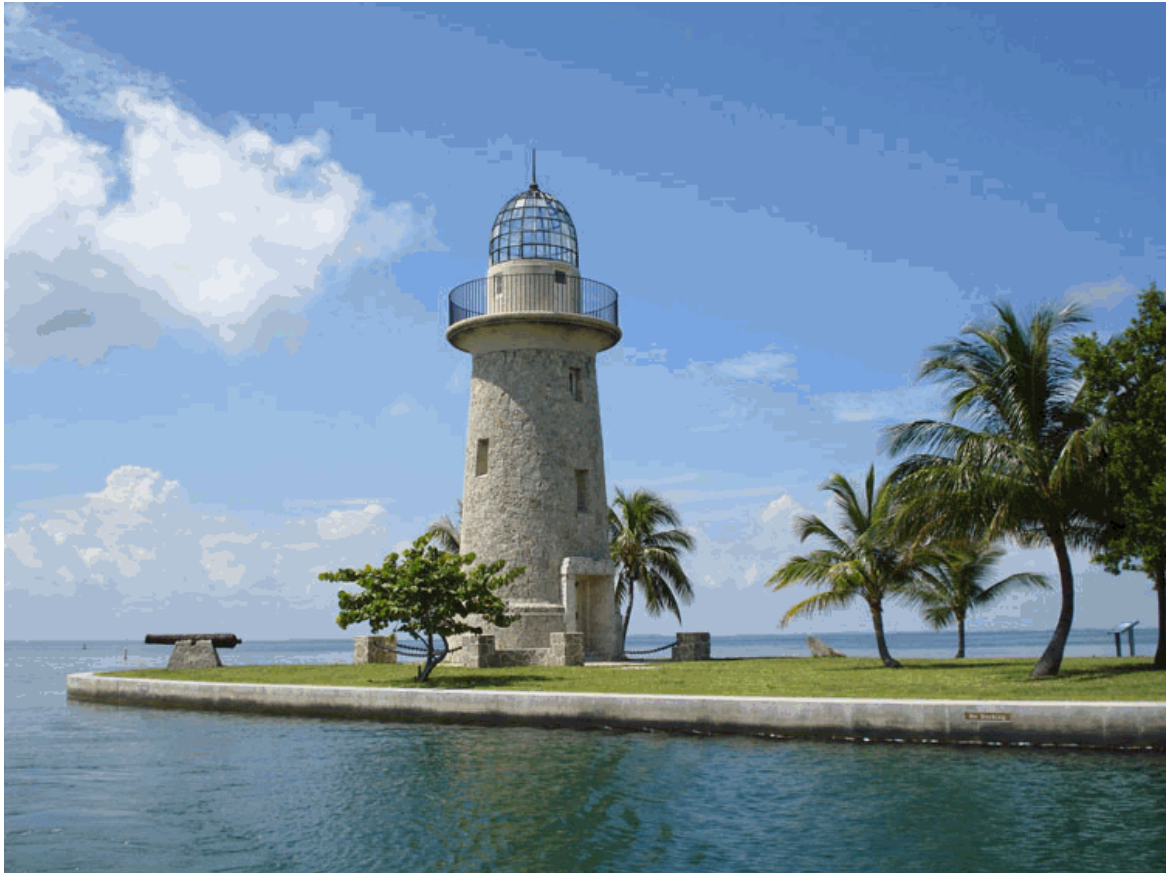
Winds associated with Hurricane Andrew in 1992 destroyed the glass panes in the lantern and the four vent windows. The NPS removed and repaired the lantern; however, they replaced the glass with Plexiglass vision panels and did not reinstall the four vent windows in the lantern. Maintenance of the lighthouse also included repointing joints and filling cracks in the exterior walls. The NPS continues to periodically maintain and repair the lighthouse and presently provides public access. The lighthouse is in good condition and retains historic integrity.

*Graphic 41: Boca Chita Lighthouse*

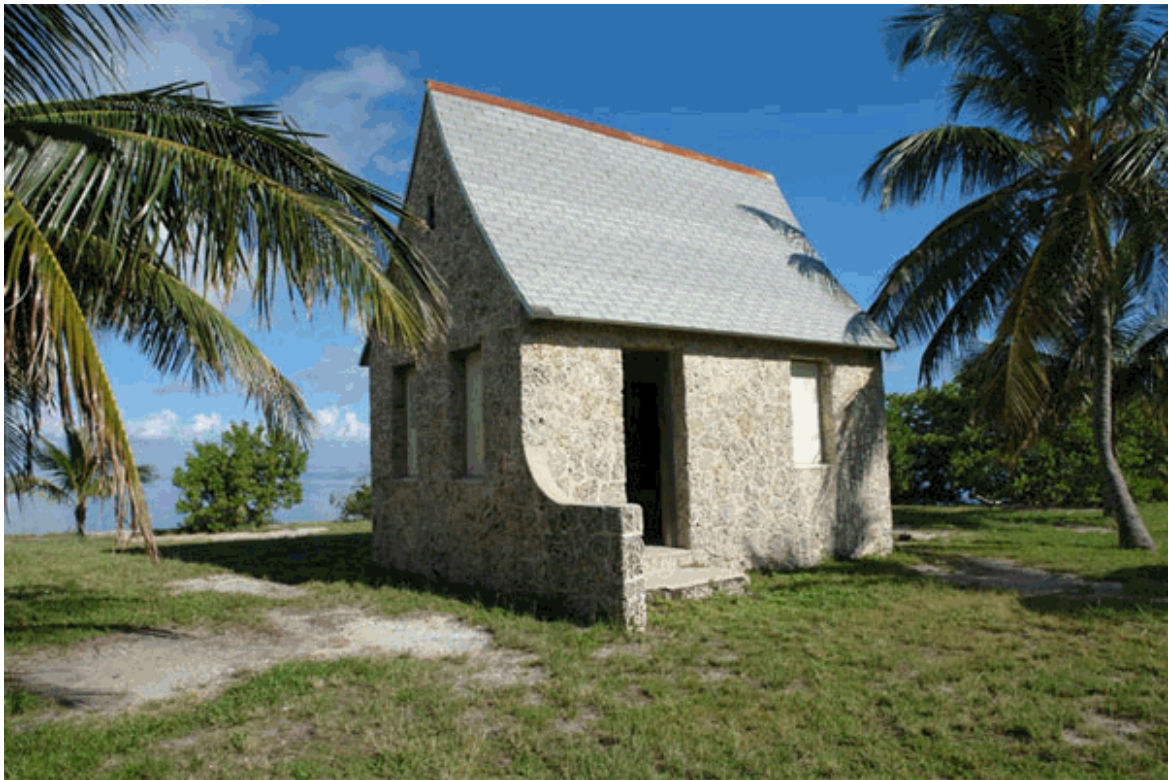
NPS repaired the roof prior to 1992, installing an asphalt shingled roof which survived Hurricane Andrew. NPS removed the door on the east elevation and covered this entrance and the building's windows with plywood. NPS added a deadbolt to the original door on the south elevation. NPS uses the chapel for storage. The chapel is in good condition and retains historic integrity.

*Graphic 42: Boca Chita Chapel*

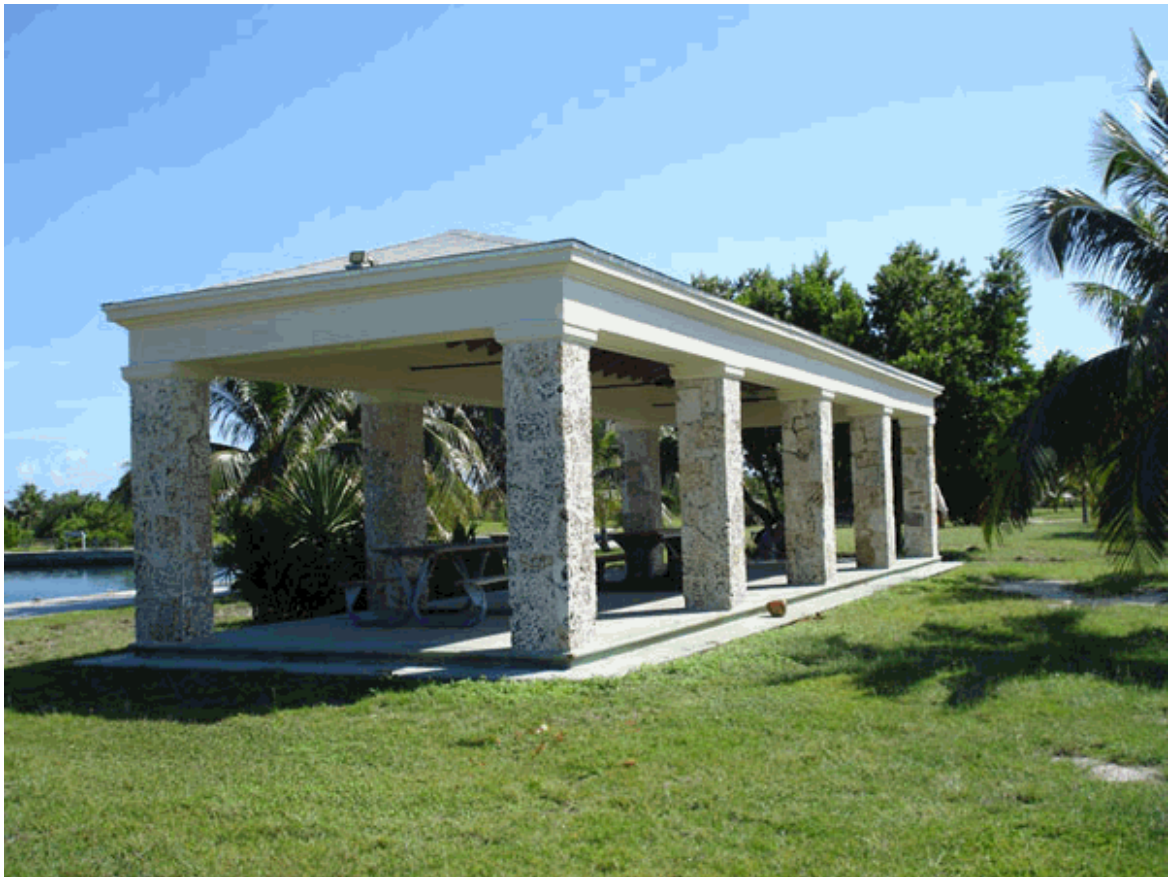
Sometime after the period of significance and prior to the NPS purchase of the island, owners of the island, likely the Rivers, added screen and a shed roof addition to the pavilion. These were destroyed during Hurricane Andrew in 1992. NPS repaired the roof, adding asphalt shingles. Participants with the Historic Preservation Training Center recently rebuilt the pavilion piers. NPS allows public use of the pavilion. The pavilion is in good condition and retains historic integrity.

*Graphic 43: Boca Chita Pavilion*

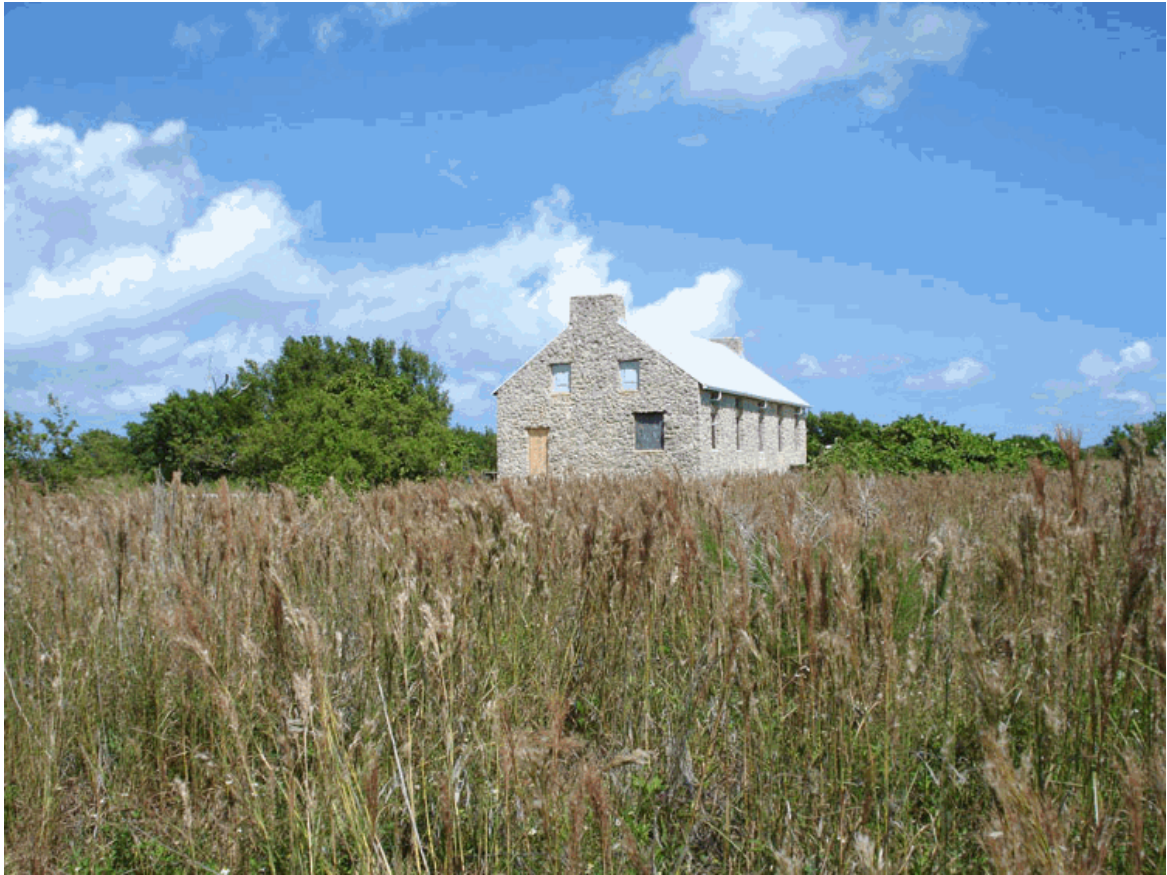
At the time of Hurricane Andrew, the garage had a corrugated metal roof, which was completely blown off during the hurricane. NPS replaced the roof with asphalt shingle. NPS replaced one of the bay doors with a roll-up garage door, covered the other doors with plywood, replaced several of the windows, and covered the windows with Plexiglas storm windows. NPS uses the building to house maintenance equipment. Except for the modern additions to the building, the garage is largely in good condition and retains historic integrity.

*Graphic 44: Boca Chita Garage*

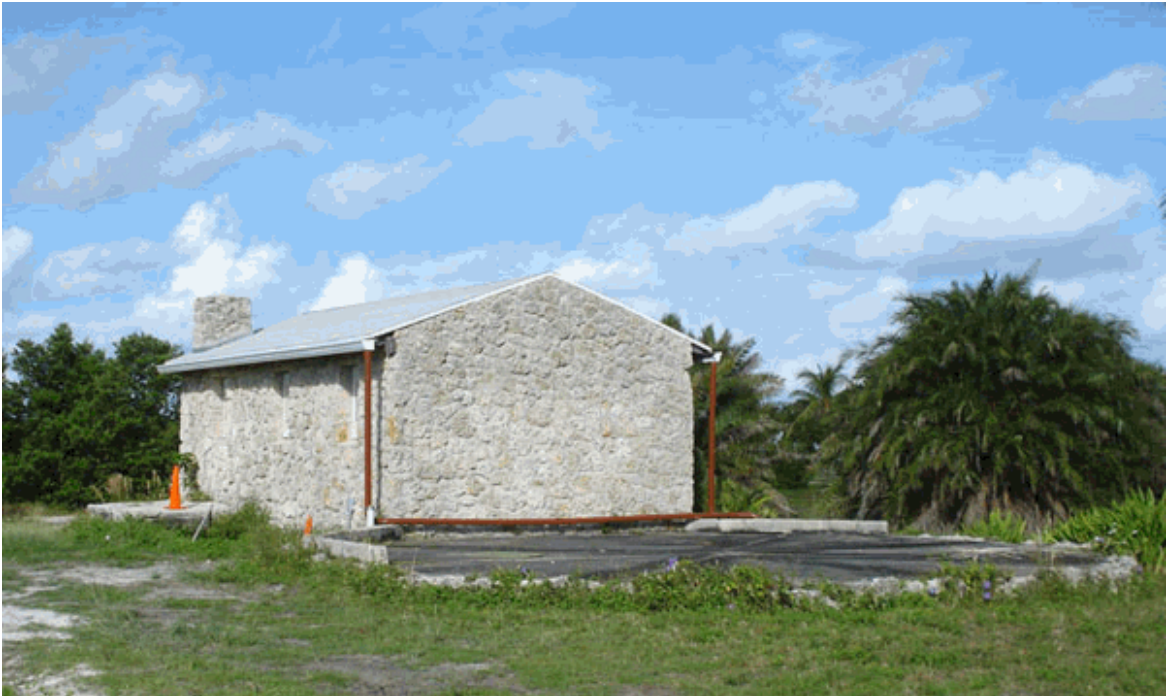
Hurricane Andrew severely damaged the roof of the engine house. NPS repaired the main roof with asphalt shingles. The small shed addition does not exist except for a concrete foundation. NPS has replaced three of the original, double hung windows with modern single casement windows, and has covered the exterior of the windows with plywood. NPS presently uses the building as storage and seasonal housing for park volunteers. Except for the use of contemporary materials for recent maintenance of the building, the engine house and cistern are in good condition and retain historic integrity.

*Graphic 45: Boca Chita Engine House and Cistern*
