# **Facilitating migration of coastal landforms and habitats by removing shore protection structures**

## *An adaptation strategy for Northeast Region units of the National Park Service*

Natural Resource Report NPS/NER/NRR—2016/1240

June 2016

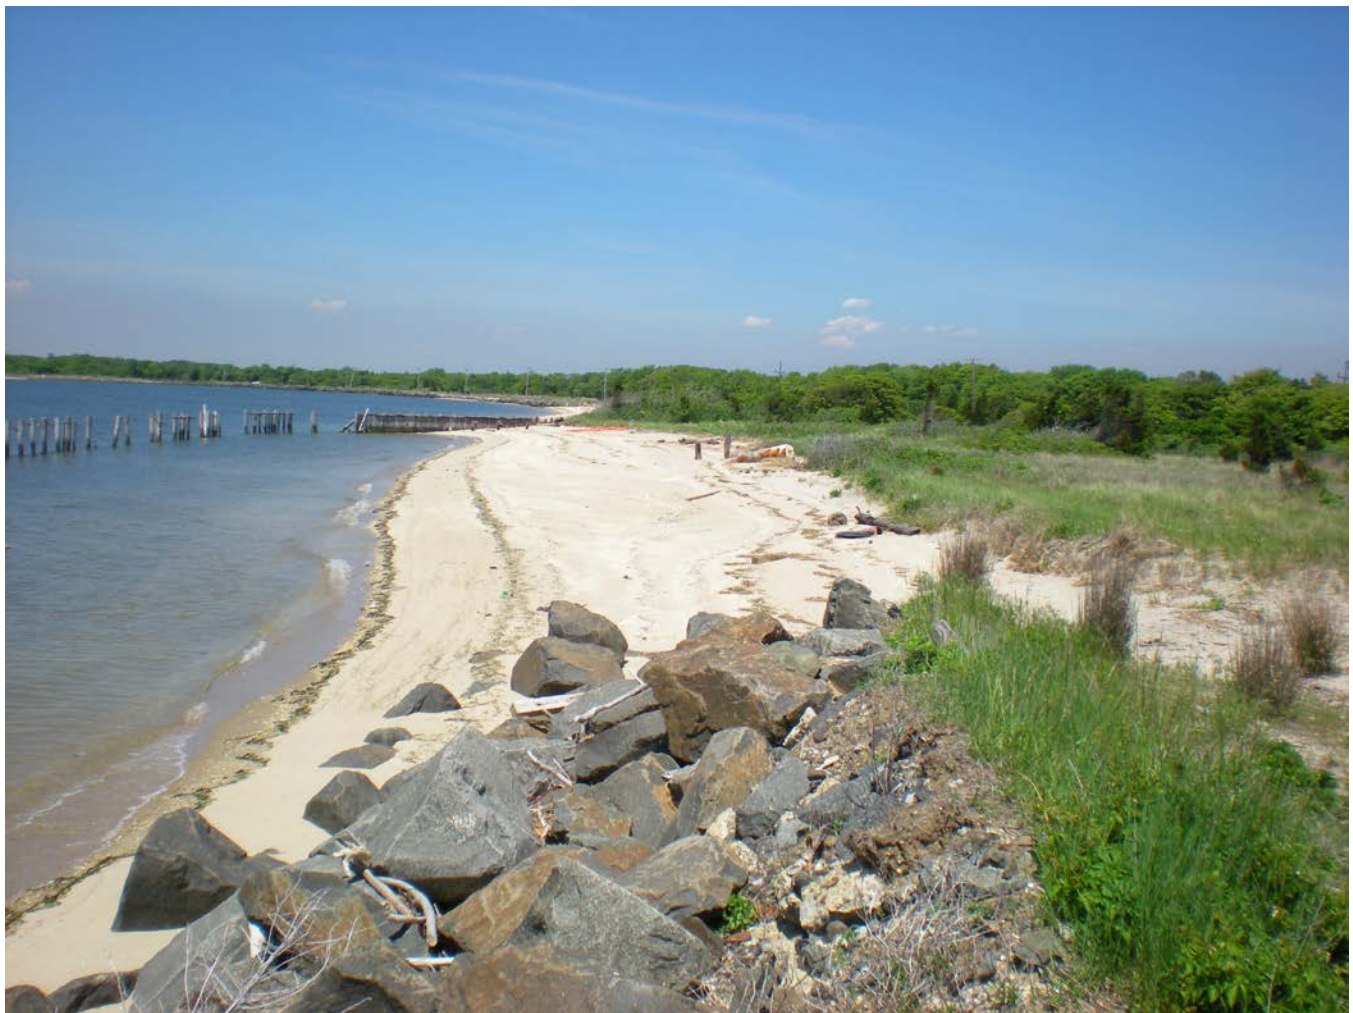
Photograph of seawall and deteriorated bulkhead near Battery Kingman, Sandy Hook Unit, Gateway National Recreation Area.  
Photograph by K.F. Nordstrom

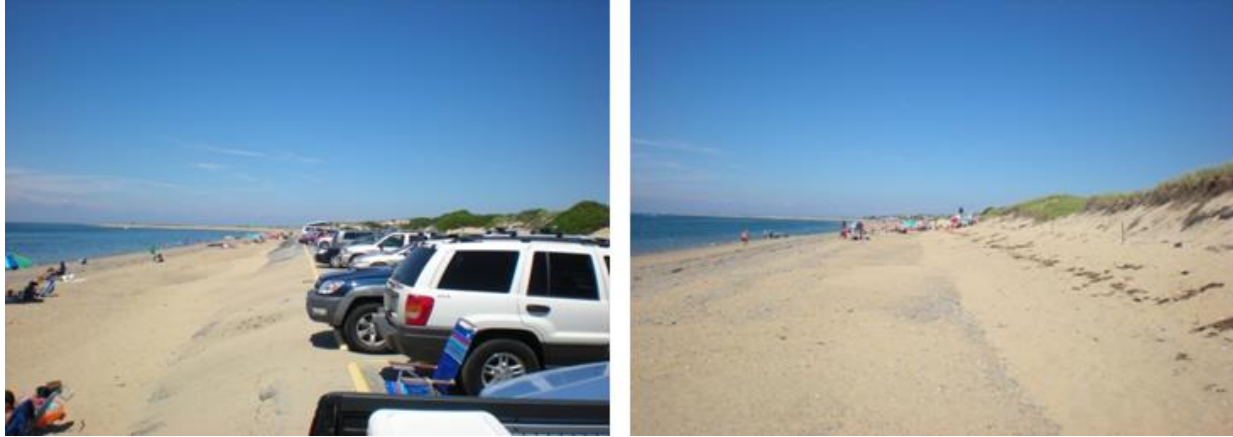
**Figure 2.** Two views of Herring Cove Beach, Cape Cod, showing effects of removing an asphalt revetment. The left panel shows the old road used as a parking lot and protected by the asphalt revetment (Wall 1, Table 5, Appendix A). The right panel shows the naturally-evolving shore where structures were removed.

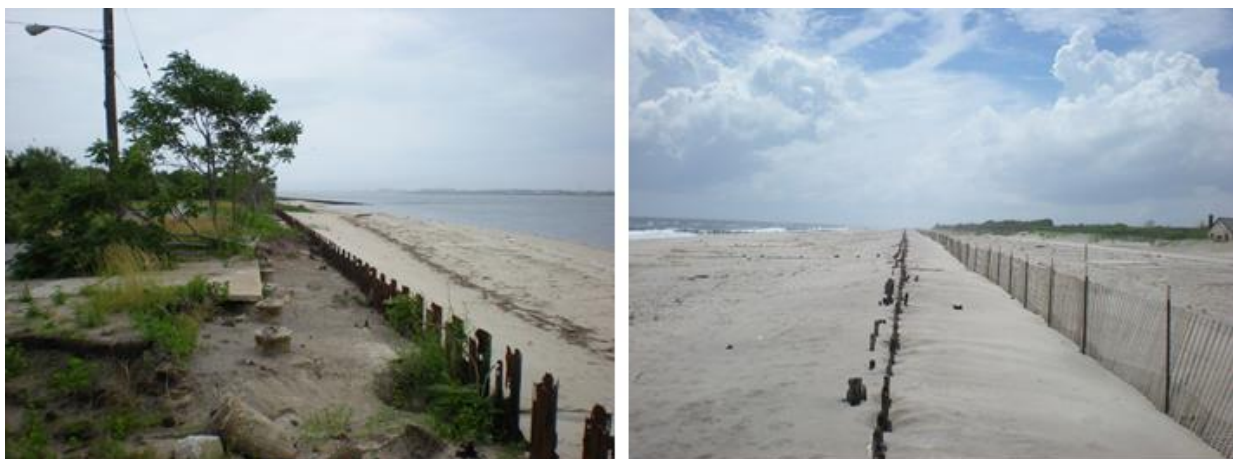
NPS is considering eliminating two deteriorated bulkheads at Gateway using post-storm rehabilitation funds following Hurricane Sandy in 2012 (Figure 3). In this case, the rehabilitation objective is the natural habitat not the bulkheads or the infrastructure they were initially designed to protect. Removal of the bulkheads and infrastructure landward would allow the beaches to become self-sustaining and more valuable for horseshoe crab spawning and bird foraging. The bulkheads could be allowed to deteriorate rather than being removed, but the intact remnants would remain as intrusive barriers between the nearshore and new upper foreshore and create safety hazards. One of the bulkheads considered for removal is on the exposed ocean side (Figure 3, right panel). Examples of managed retreat sites in estuaries exist, but demonstration sites that document the value of the approach on ocean beaches are lacking (Nordstrom et al. 2015), and removal of the ocean side bulkhead would have great pedagogic value.

**Figure 3.** Deteriorated bulkheads at Gateway considered for elimination using post Hurricane Sandy rehabilitation funds. Left panel is Wall 2 at Aviation Rd. and right panel is Wall 28 at Ft. Tilden (Figure 20, Table 7, Appendix A).

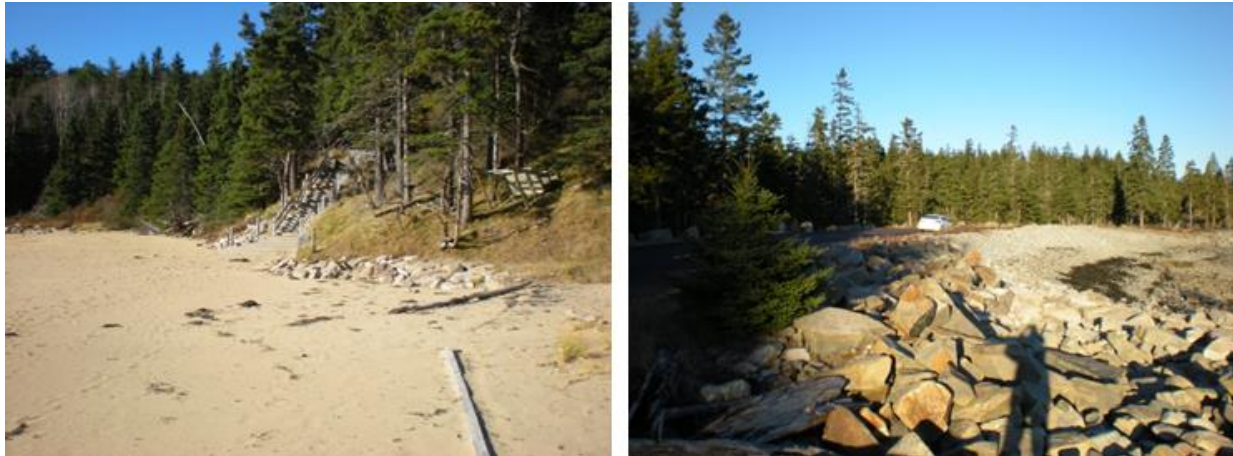
**Figure 6.** Acadia, showing Sand Beach, looking west toward the concrete walkway (left panel) and Wall 16 with angular riprap in the foreground contrasting with the gravel beach in the background (right panel).

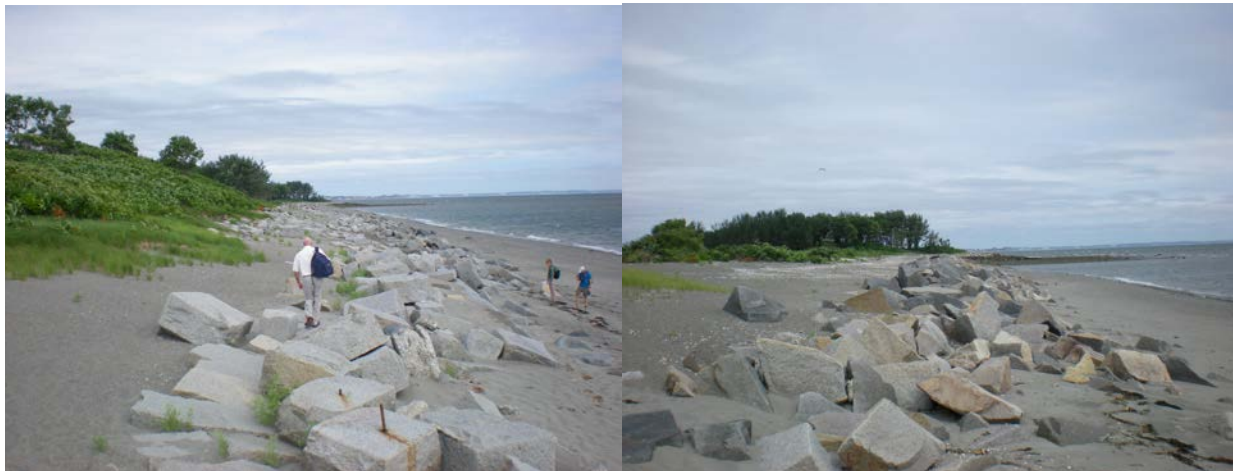
**Figure 12.** Riprap of Lovells Island Wall 1, protecting the east-central portion of the island (Figure 11C). Fort Standish is buried behind the high ground to the left on the left panel. The right panel shows the portion of wall north of Fort Standish. The wall here separates the foreshore from the storm beach and restricts overwash landward.

Re-use of the quarried stone riprap from the former seawall would provide a side benefit that could make removal of the wall more practical. The goal to provide increased protection to some high-priority facilities and the goal to allow other locations to evolve naturally provides the opportunity to remove stone from places where it is becoming ineffective and place it where it will be needed. Re-use of stone would reduce the combined cost of removal and re-acquisition of new stone. Using the stone to increase the level of protection on nearby Georges Island (where the low wall on the north side has resulted in bluff failure), would be a creative re-use of the material. Another option for the stone would be to use it to protect an eroding cemetery site on nearby Gallops Island.

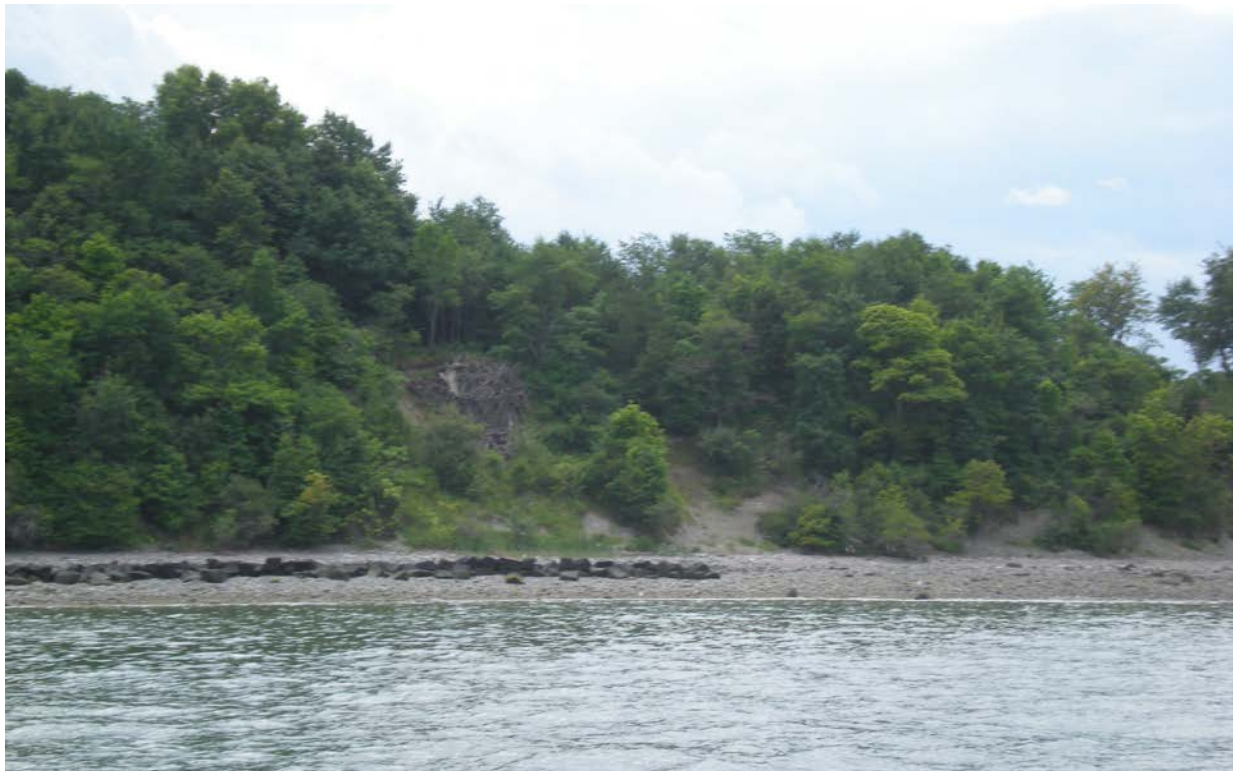
The wall at the north end of Thompson Island (Thompson Wall 1, Appendix A, Table 4) is now on the foreshore and functions more as a beach sill than a revetment (Figure 13). Rates of bluff retreat monitored by FitzGerald et al. (2010) over a 4 year period revealed an average rate of bluff retreat of  $0.51 \text{ m yr}^{-1}$  at the more exposed north end of the island. The greater amount of bare ground on the surface of the bluff just south of the south end of the wall (Figure 13) implies that removal of the wall would increase rates of bluff retreat. The top of the wall is about 0.8 m above the elevation of the foreshore fronting it. The wall now functions as a barrier to swash action, and it restricts movement of fauna. Removal of the wall would reestablish full connectivity between the upper and lower foreshores. The northeast side of Thompson Island is a spit/foreland/marsh complex built by sediment eroded from past erosion of the bluffs. Allowing greater erosion of the bluff, through removal of the wall, should contribute more sand and gravel to these types of depositional environments, but it is not clear where these environments would form or how large they would be. The north end of the island is designated as a conservation area. The shore is less geomorphically-complex than the east side of Lovells Island and has no historic structures close to the shore. Stakeholders may be willing to consider adapting current uses as a ropes course and recreational field to allow for natural processes to occur, especially if monitoring were incorporated into ongoing place-based educational programming.

**Figure 13.** Thompson Wall 1 (Figure 11E), showing greater erosion on the unprotected bluff on the south (right) side of the wall than on the bluff landward of the wall.

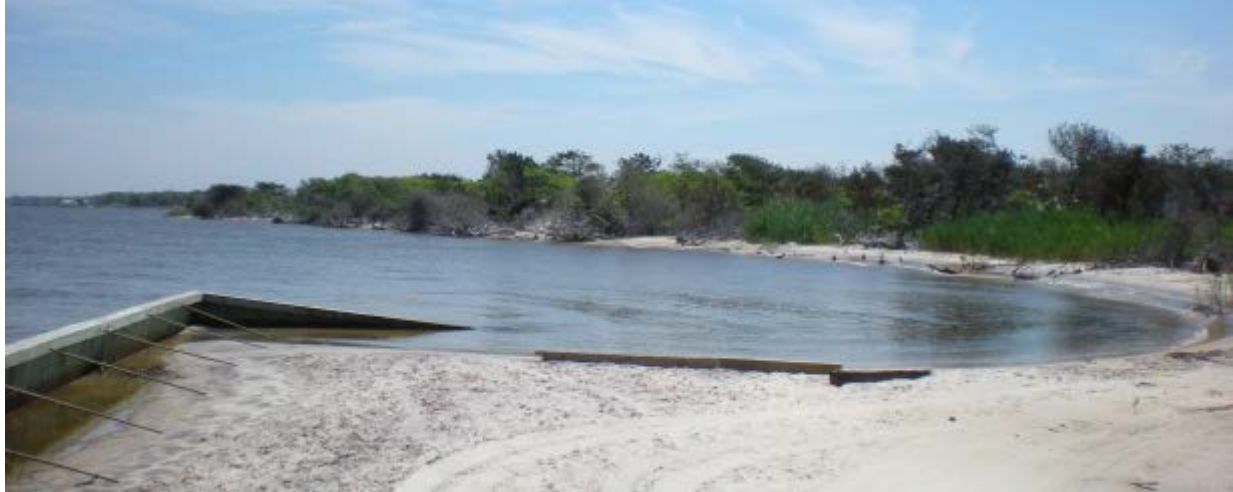
**Figure 17.** Eroding shore east of Sailors Haven Marina Wall 1b, Figure 16B, showing beach transgressing the marsh (far right) and undermined trees falling onto beach (center background).

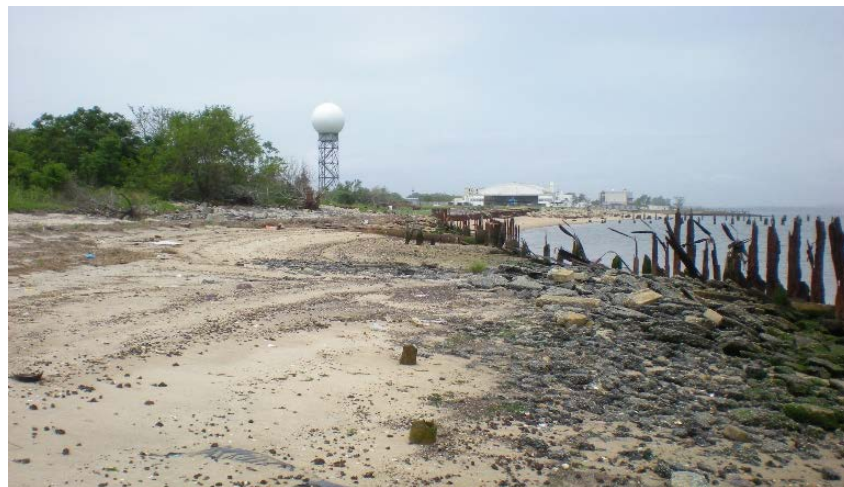
**Figure 21.** The evolving beach north of Ranger Road, showing the degraded bulkhead (Wall 4) and rip-rap that are interfering with exchanges of sediment and biota across the intertidal zone.

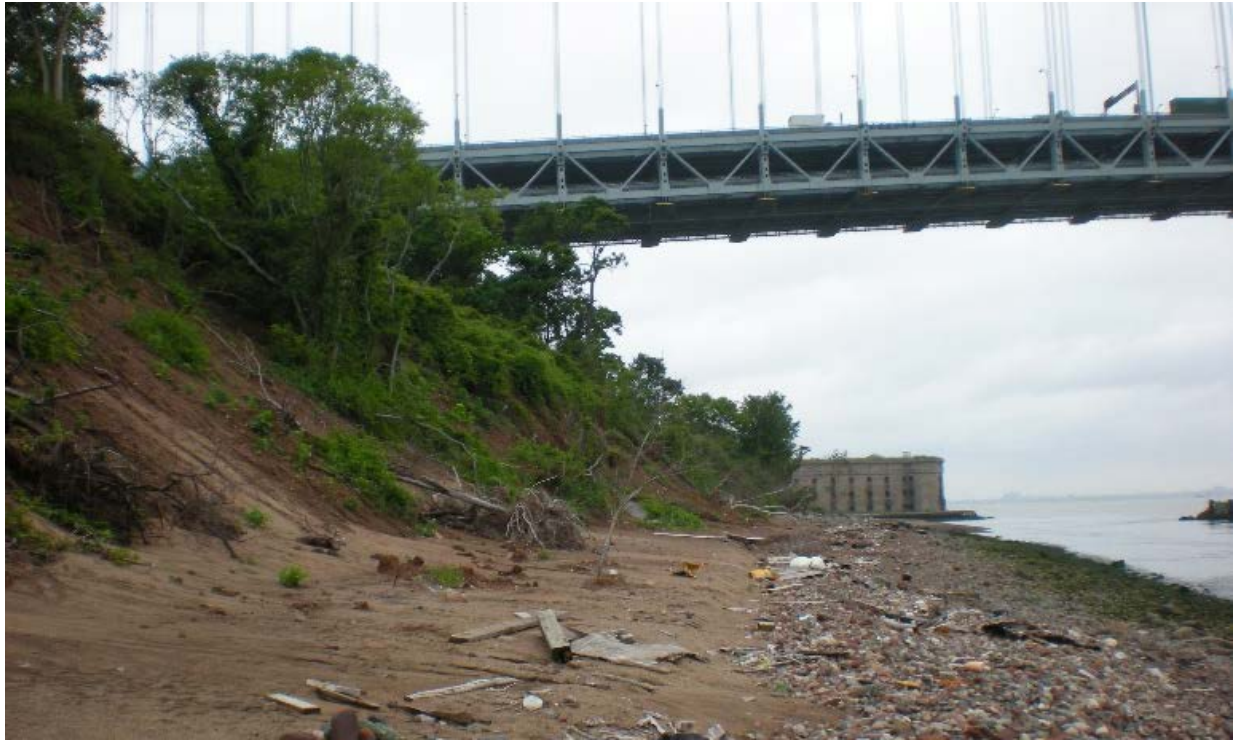
**Figure 23.** Eroding bluff at Battery Hudson, Staten Island Unit, showing protection provided by gravel at the base and delivery of sediment from the bluff face.

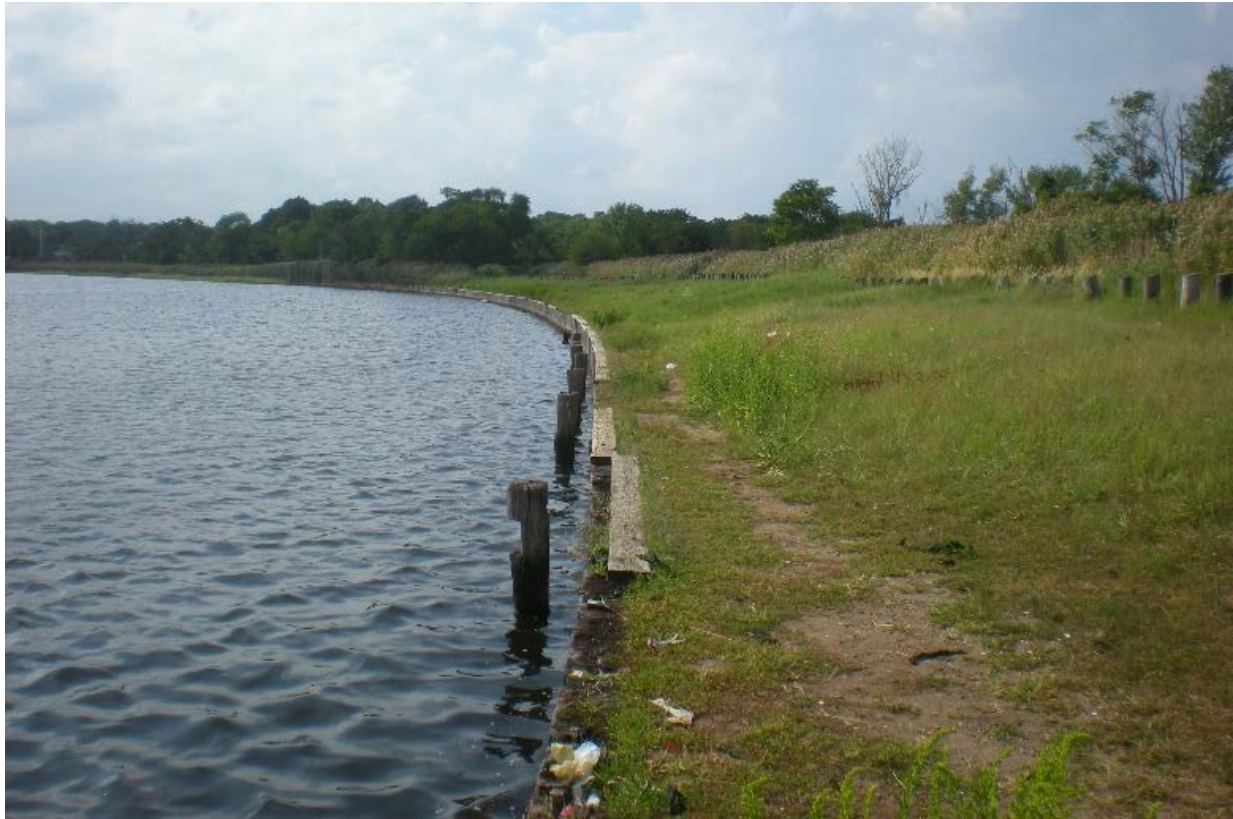
**Figure 24.** Deteriorating bulkhead near center of Wall 8, Great Kills Park area, Staten Island Unit.

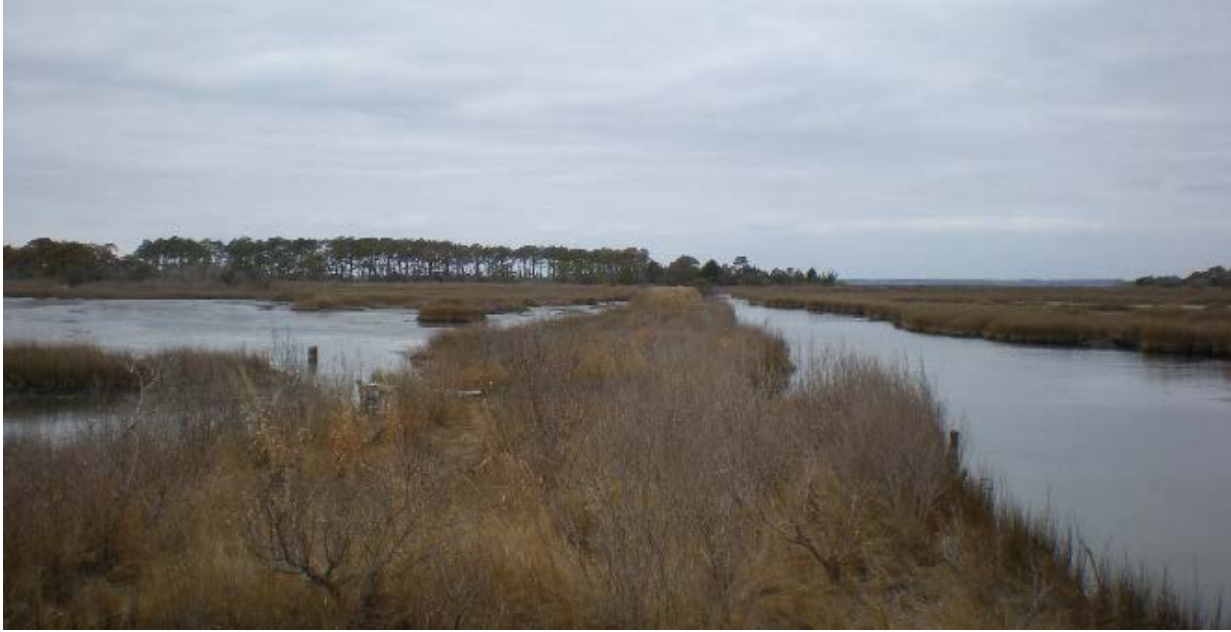
**Figure 29.** Causeway 1, High Winds area, Assateague Island, looking west, showing the expanse of water to the south and the parallel ditches created by mining sediment to build up causeway height.

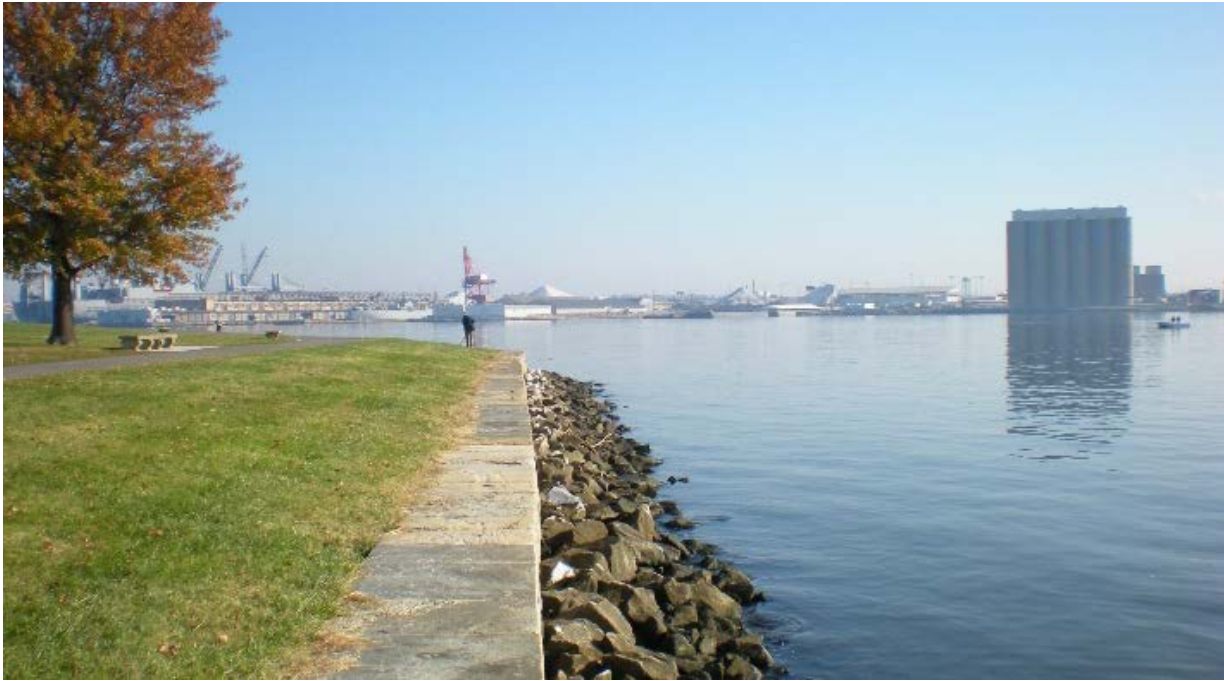
**Figure 31.** Wall 1, near the southern portion of Fort McHenry.

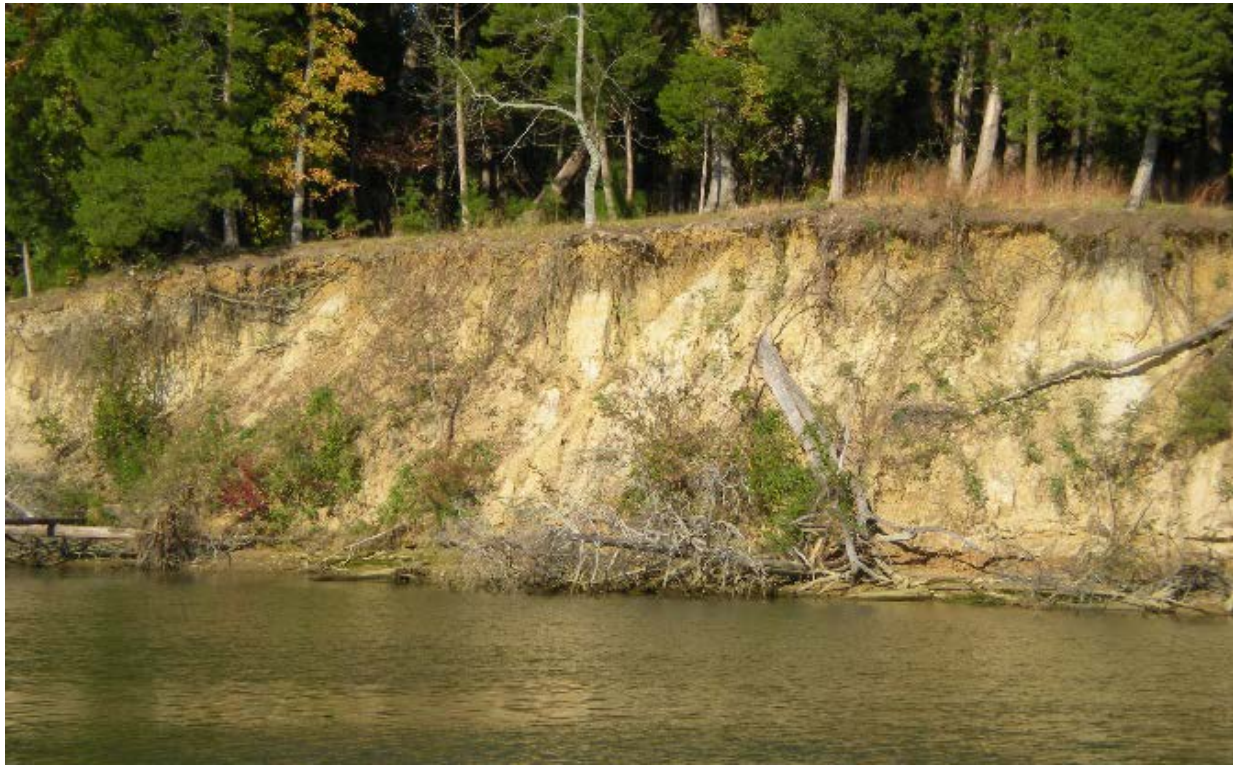
**Figure 36.** Bluff at the mouth of College Creek (Figure 35B), revealing the kinds of habitats that would form if static structures were removed from uplands along the shore. The beach at this site is narrower than beaches that would be expected to form along the more exposed portions of the York and James Rivers.

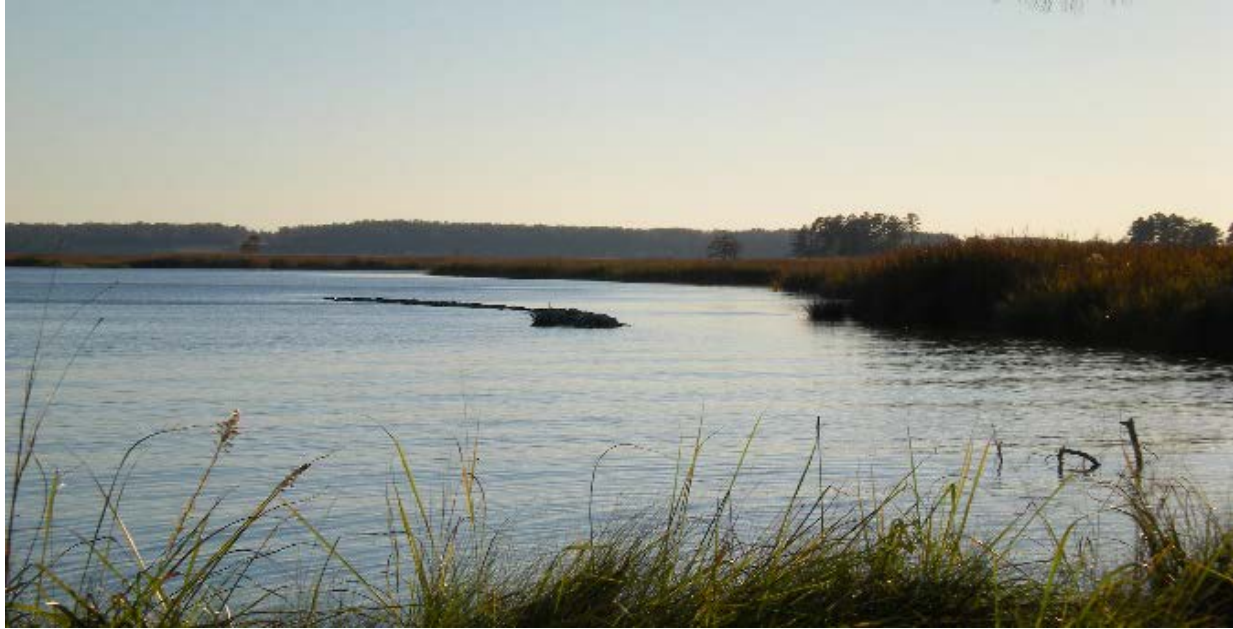
**Figure 37.** Offshore breakwater fronting marsh in the undeveloped portion of Jamestown Island southwest of Wall 5 (Figure 35A).

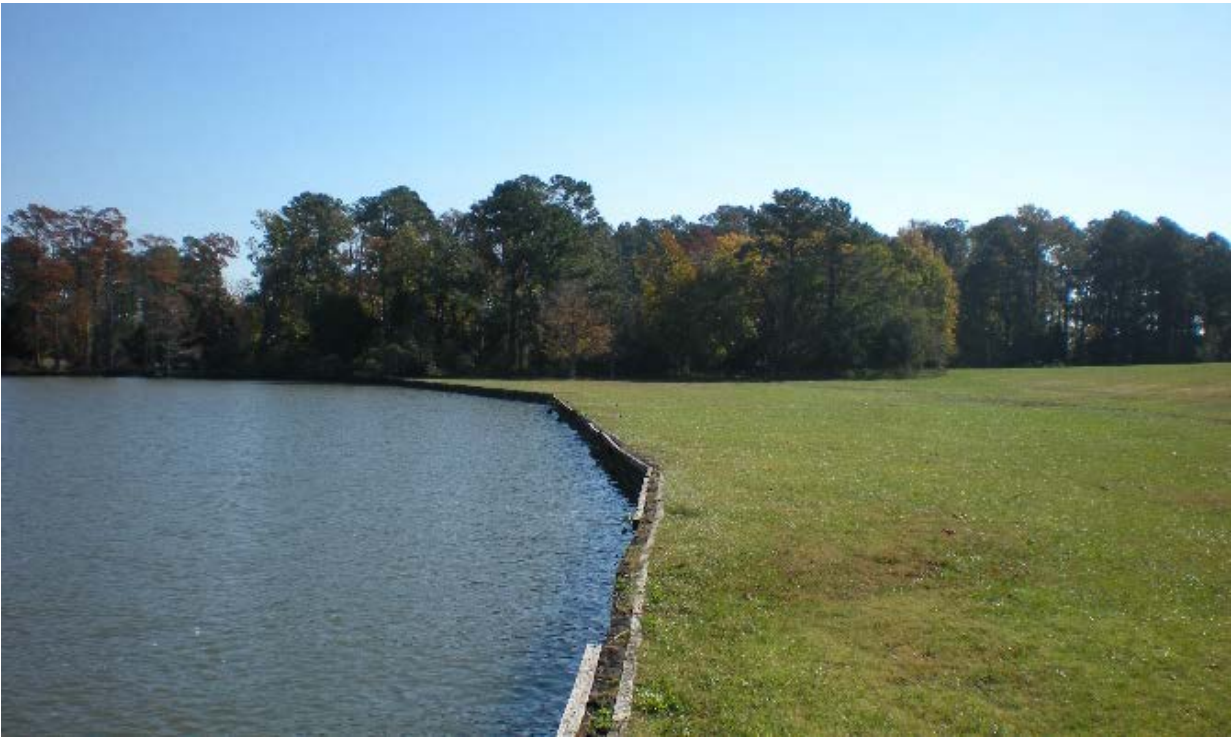
**Figure 38.** Bulkhead (southeast portion of Wall 6) protecting low grassy area landward of causeway to Jamestown Island in a location suitable for future marsh development.

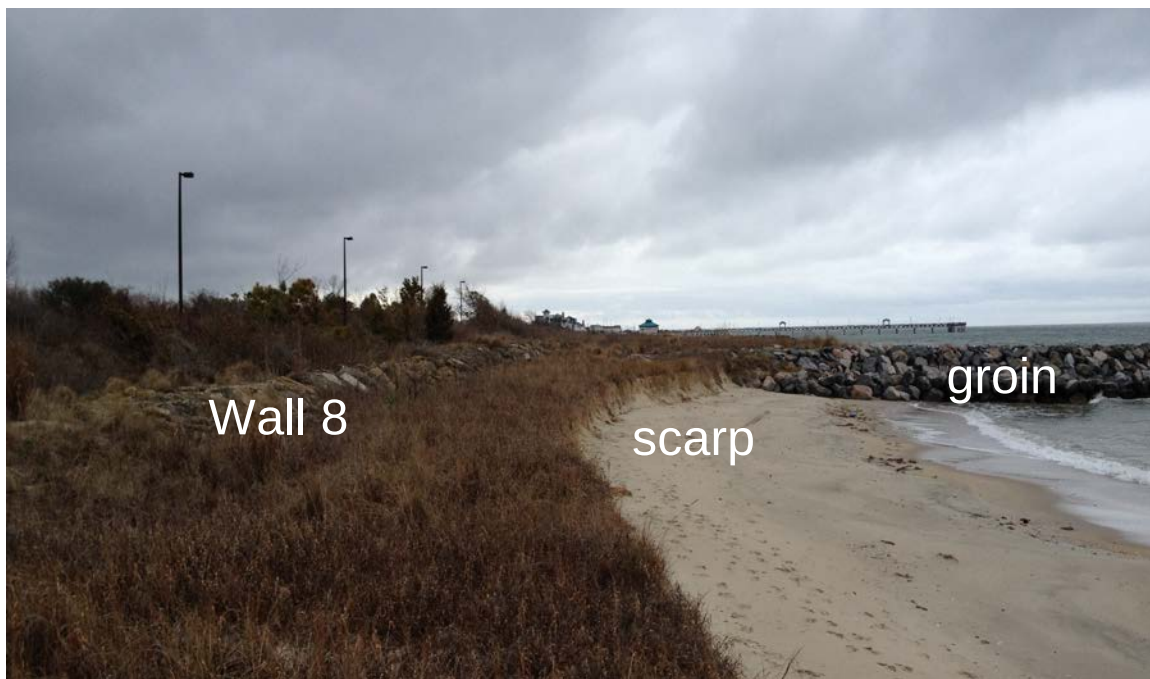
**Figure 2.** Shoreline downdrift of the middle groin in Groin Field 1, showing erosional scarp and concrete riprap in Wall 8 at left.
