**15 August 2005**

**Memorandum**

**Subject: Monitoring Alhambra Creek Morphology at Muir Gravesite**

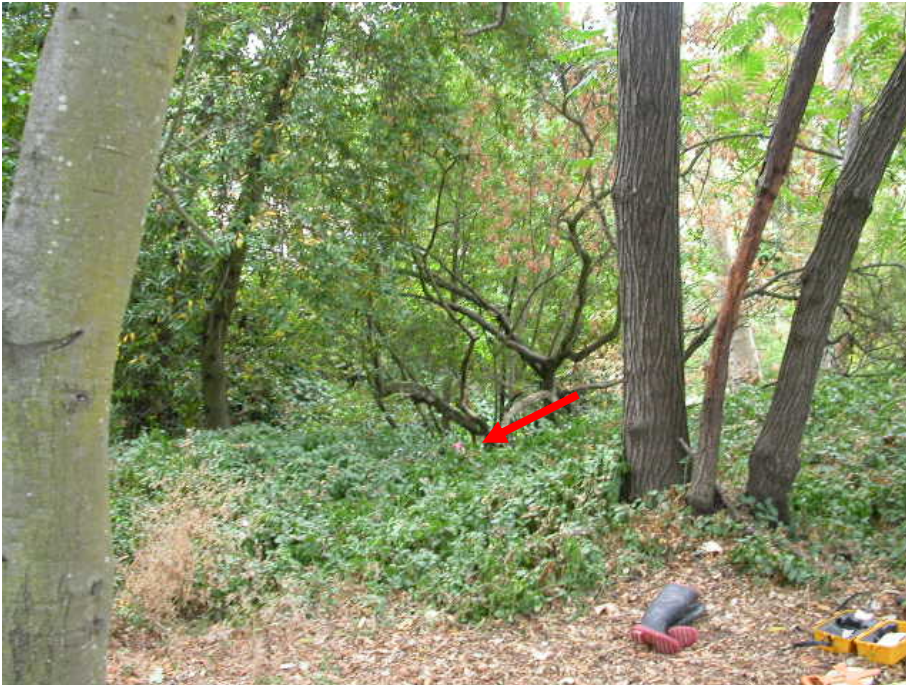
Photo1: Location of right-bank endpoint XS1

This cross-section endpoint is on the NPS-owned bank, above the channel on the floodplain. It's marked with a brass monument.

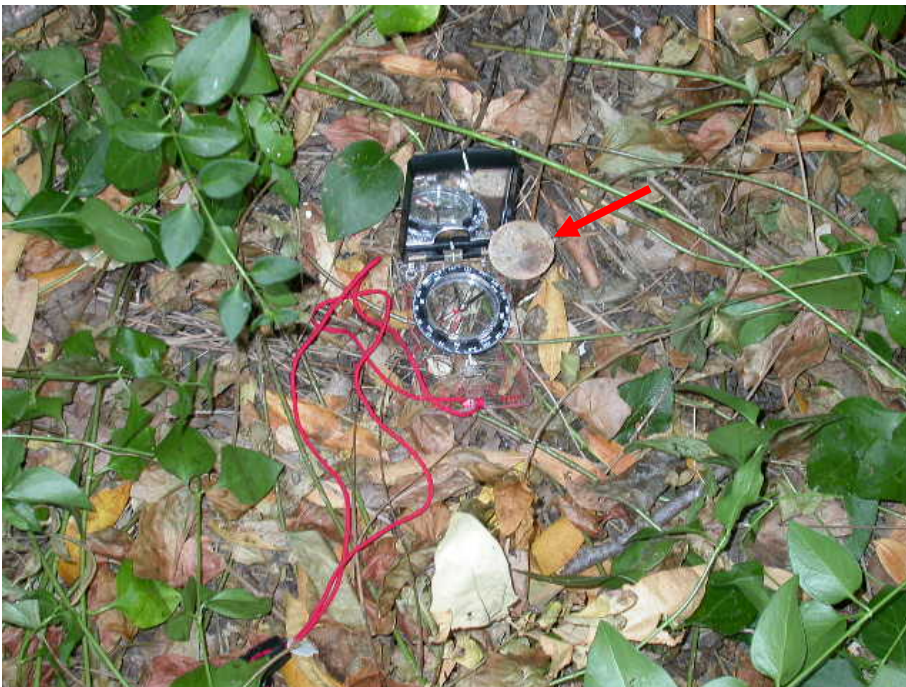
Photo 2: Close up of right-bank monument XS1 (brass cap)

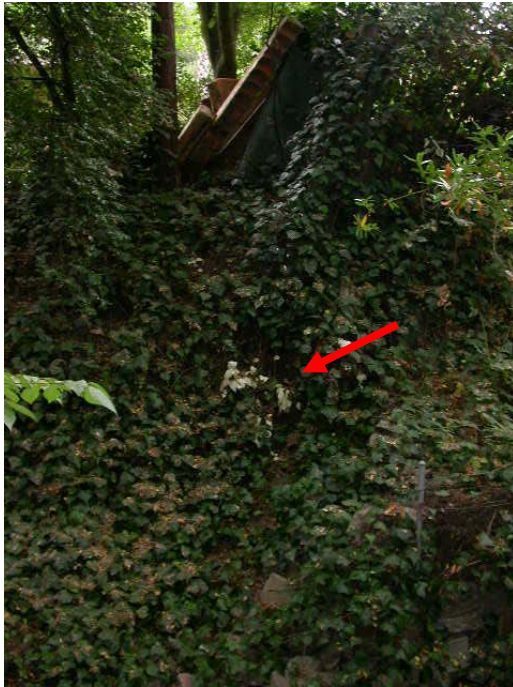
Photo 3: Location of left-bank endpoint for XS1

From the right bank monument, the left bank endpoint is 14.02 meters away at 164° (true-north corrected). The endpoint is marked with a temporary metal 'chain pin.'

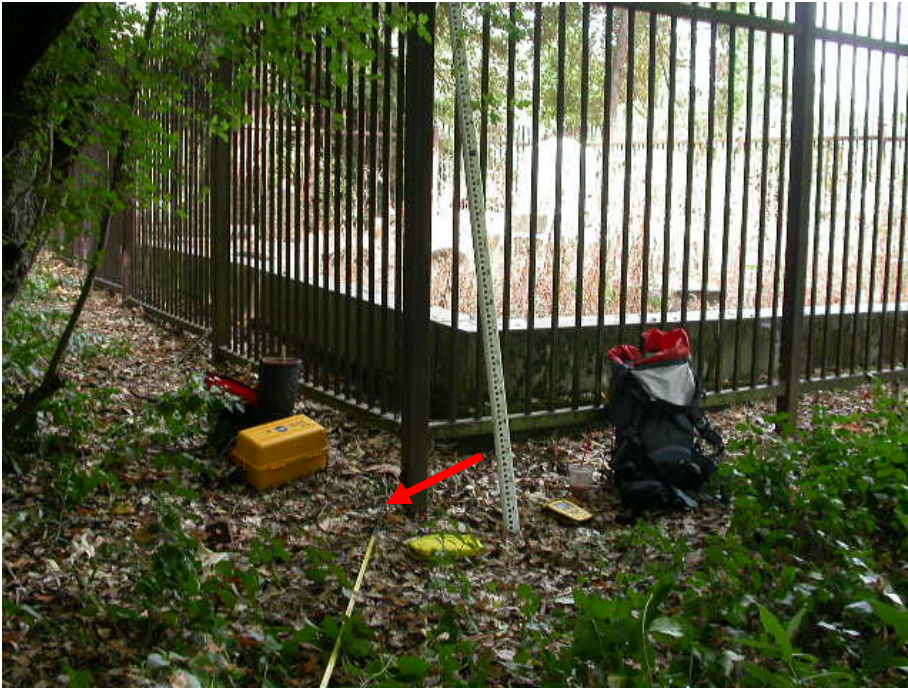
Photo 4: Location of right-bank endpoint XS2

The endpoint for cross-section 2 is on the NPS-owned bank, directly next to the southeast corner post of the graveyard. It's marked with a brass monument (the chain pin shown in photo above has been removed).

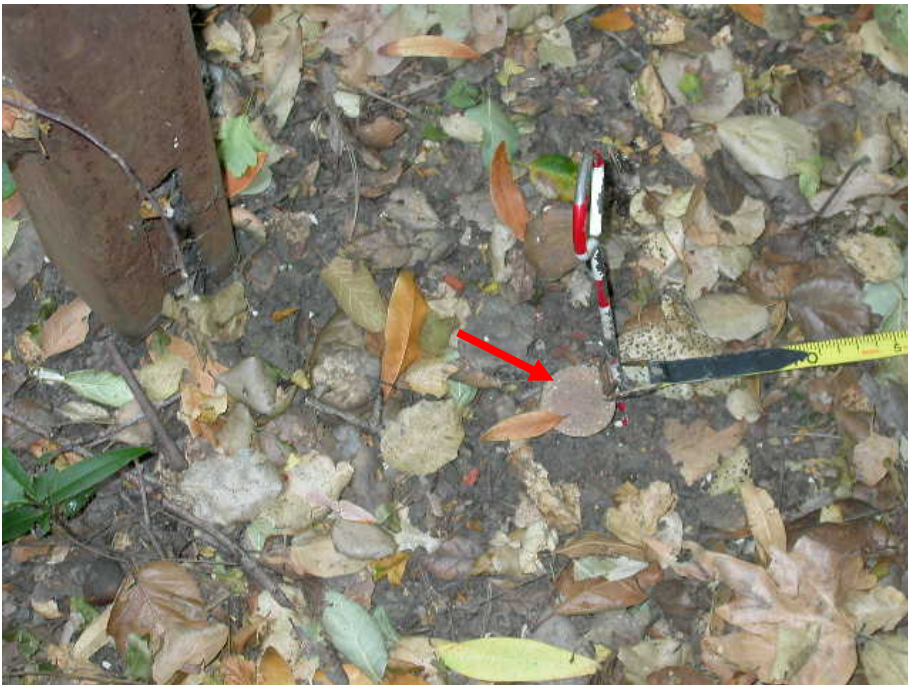
Photo 5: Close up of right-bank monument XS2 (brass cap) with temporary red-and-white chain pin

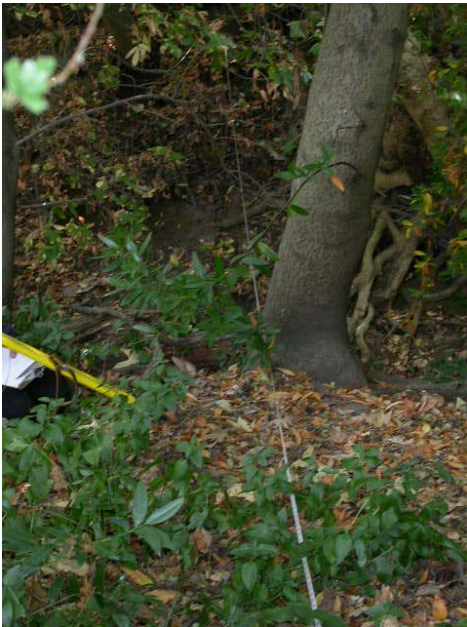
Photo 6: Tape runs to the left of the bay tree on the bank  
(photo from right-bank endpoint toward left-bank endpoint)

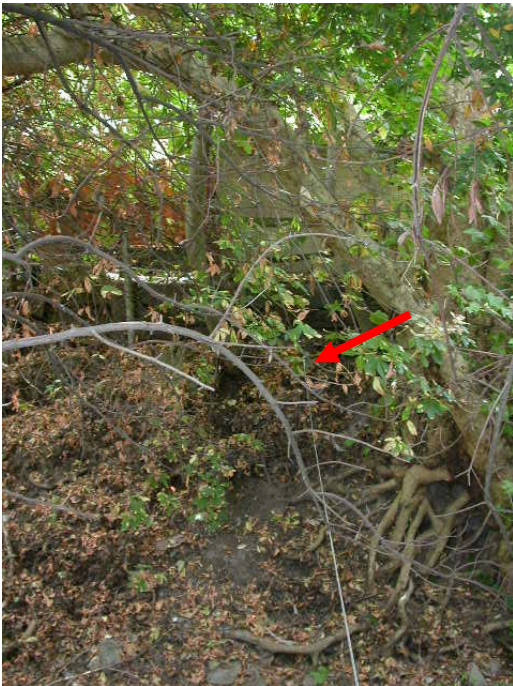
Photo 7: Location of left-bank endpoint for XS2

From the right bank monument, the left bank endpoint is 17.07 meters away at 144° (true-north corrected). The endpoint is marked temporarily with a metal chain pin.

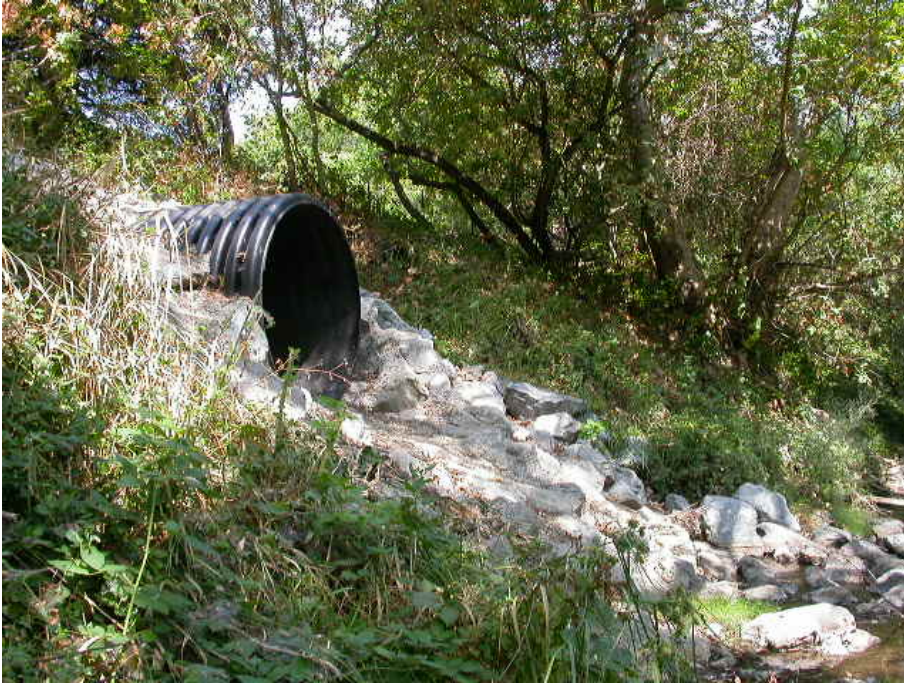
In 2001 and 2002 Inglis had surveyed a third cross-section downstream of the gravesite. Subsequently that section of the bank was heavily modified with the installation of a 1.5-meter diameter culvert that carries stormwater runoff under the NPS-owned property to discharge into Alhambra Creek. Installation of the culvert demanded heavy armoring of the bank with concrete and stone. Currently this section of bank is under consideration for further modification: the Central Contra Costa Sanitation District proposes to install a sewer line through the culvert right-of-way and under Alhambra Creek as part of a neighborhood development upstream. We determined that reoccupying the third 2001/2002 Inglis cross-section was impossible due to the substantial recent bank modification. Furthermore, the property owner across the channel from the NPS property requested that we conduct no further surveys on his bank. Finally, we concluded that a survey of a 'half cross-section' on NPS-owned property alone would have limited utility, particularly due to the potential for future bank modification. Instead, in order to allow the NPS to monitor any future channel bed downcutting, we measured the elevation of the creek bed at the point where the culvert discharges into the creek. The elevation of the channel bed was measured relative to a fixed-elevation structure: a known point on the railing of the graveyard fence. Data and photos from the measurement are in Appendix B of this document.

Photo 8: Stormwater culvert

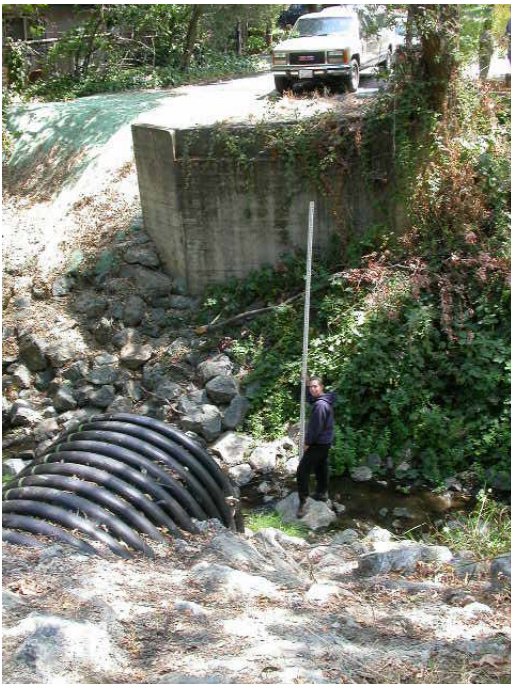
The elevation of the lowest point in Alhambra Creek opposite the stormwater culvert was surveyed relative to the bottom rail of the northwest corner of the graveyard fence. The thalweg is 5.25 meters below the top of the rail.

Photo 9: Position of survey point in Alhambra Creek

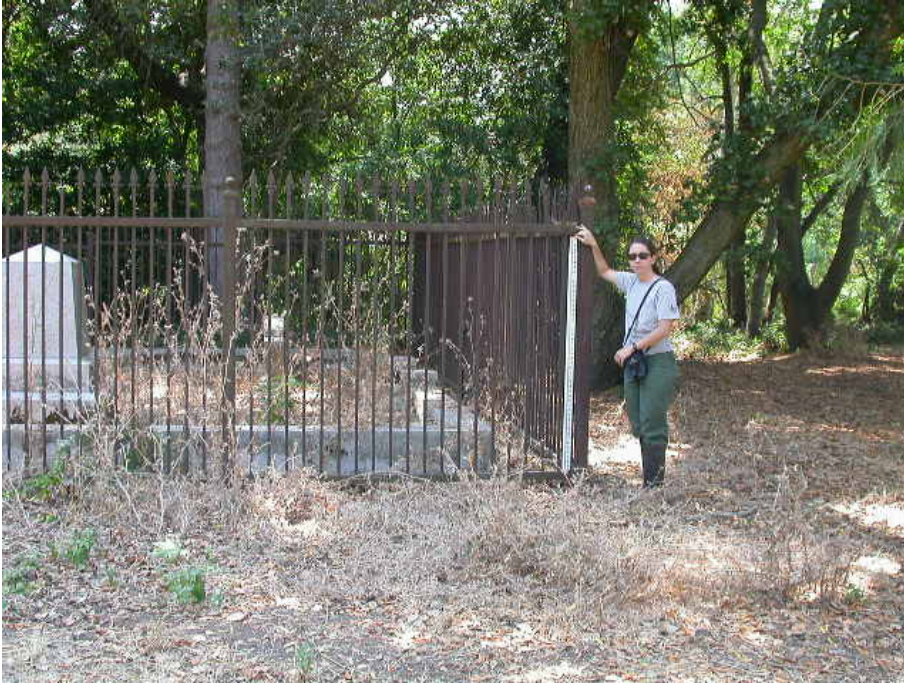
Photo 10: Location of reference point for measurement of creek bed elevation  
(rod sits on top of the bottom rail of the fence)

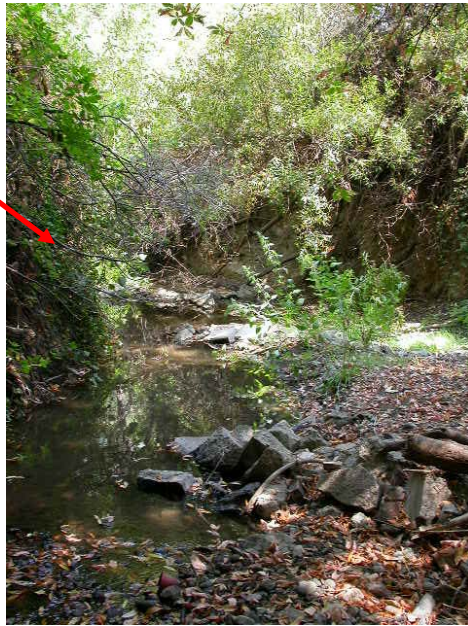
### Appendix C: Newly-Installed Revetment in Alhambra Creek opposite Muir Gravesite

Photo 11: Looking downstream at toe of NPS bank below gravesite

- The NPS should continue to work with the Alhambra Creek Valley Coalition and the Alhambra Watershed Council to monitor for and remove any illegal revetment in the creek which may cause creek degradation.

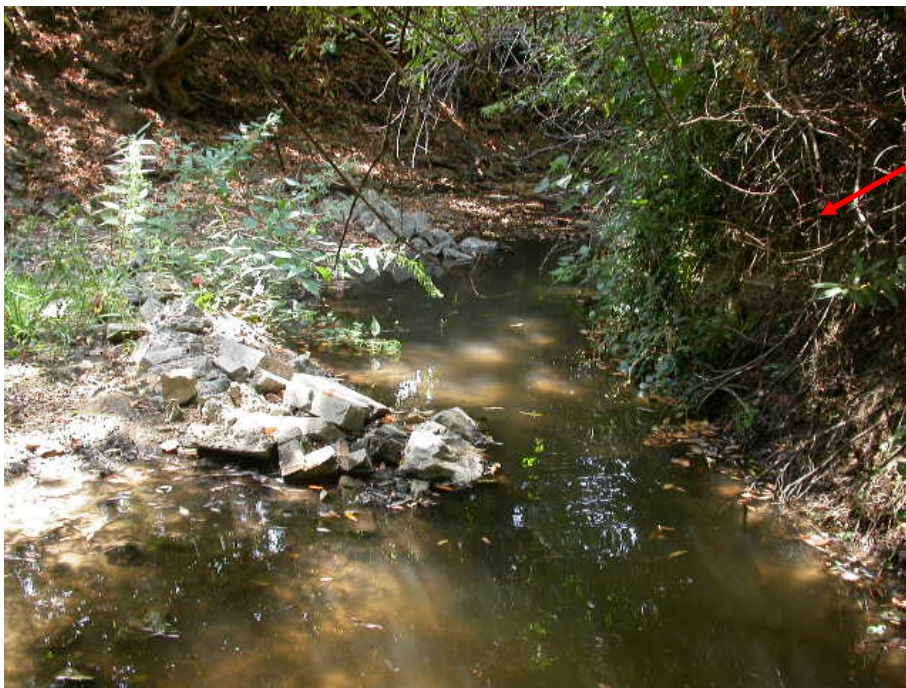
Photo 12: Looking upstream, from just downstream of the gravesite
