Summary Report  
Watershed Rehabilitation Unit 03-01  
LB500, AA2, and PT1 Road Complexes

Ingrid Corson  
Redwood National and State Parks  
December 2003

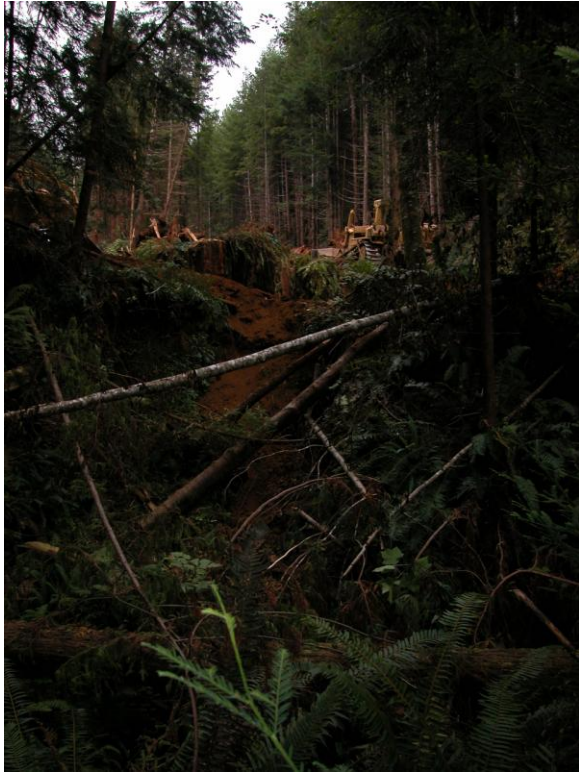
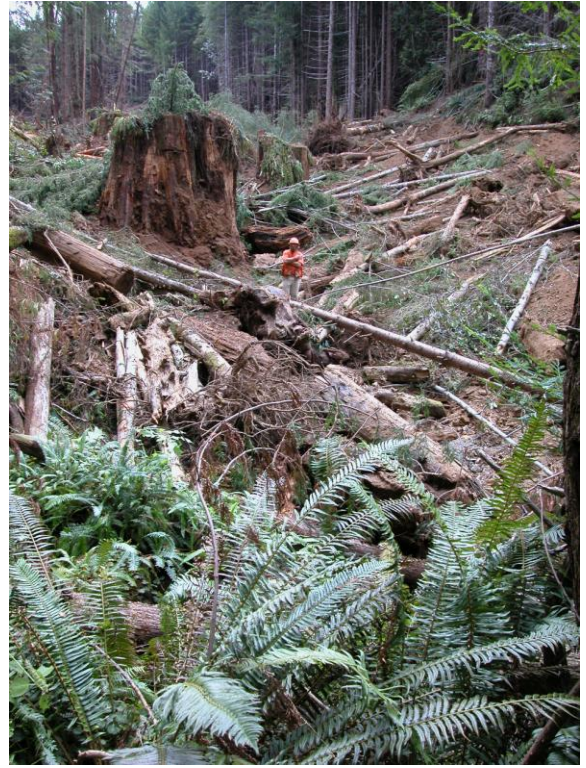
Prior to excavation flow in RX1 (WI6) was diverted to the left side of the valley by the LB500 causing active gullying, sediment transport down the road for over 600 feet and subsequent delivery to Larry Damm Creek (LDC). There were a number of buried stumps along the outboard edge of the road (OBR) and in the buried channel of RX1. At the bottom of the stream crossing near the confluence with Larry Damm Creek there was a large buried stump, a number of large sink holes, tension cracks, and a 12 foot wall of fill perched along side LDC. The middle portion of the buried RX1 channel had a gentle gradient, lots of large pushed-in stumps and was not much of an erosional threat in itself. However, once the upper sections of RX1 were excavated it became apparent that the middle section needed to be excavated as well as there was a depression in the channel just below the road crossing. The whole RX1 basin looked like an old landslide and the above mentioned depression was where two landslide lobes joined and continued down slope to form the shallow middle channel of RX1. The final excavated fill volume was approximately 8,200 cubic yards (yds<sup>3</sup>) and the production rate was 107 cubic yards per hour (yds<sup>3</sup>/hr). This production rate reflects the relatively short pushes and gentle terrain.

**Figure 4.** a) A during -excavation view of bottom of RX1 looking upstream from PP6 and b) a post-excavation view from the same photo point.

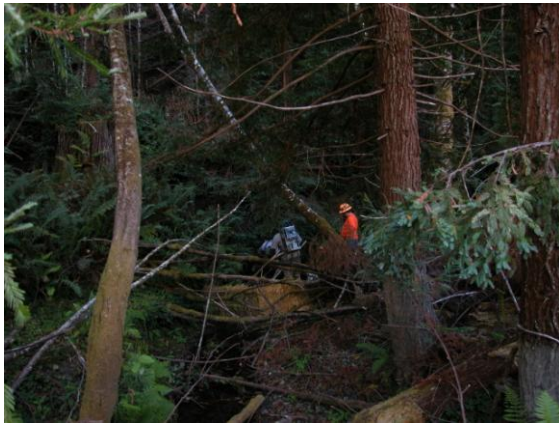
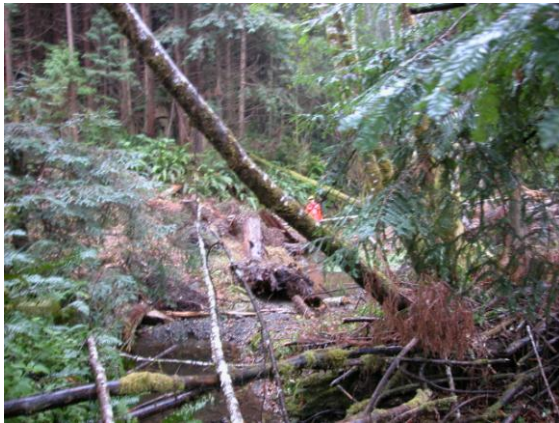
Parking Lot Stream Crossing, or RX2 (WI10) was a small and discreet crossing on the mainstem of LDC. The existing culvert was rotten and the upstream side of the crossing was being undercut as water no longer flowed in through the inlet. Water did flow through the outlet. This crossing was electro-fished by RNSP fish biologists prior to excavation and then de-watered by pumping the flow around the excavation. The excavation was strait-forward; the total volume removed was 745 yds<sup>3</sup> with a production rate of 47 yds<sup>3</sup>/hr. The low production rate reflects the efforts taken to de-water the channel and to finish the channel with alder mulch, locally available LWD, and gravel from inside the culvert.

**Figure 5.** Stream Crossing 2, WI10, looking downstream from PP9 to culvert inlet a) prior to excavation and during electro-fishing, and b) after excavation.

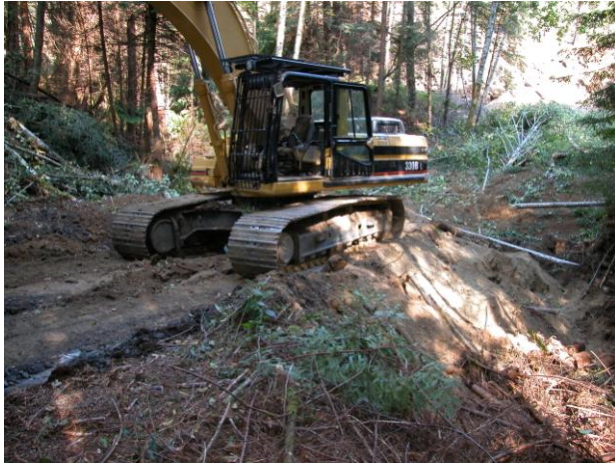
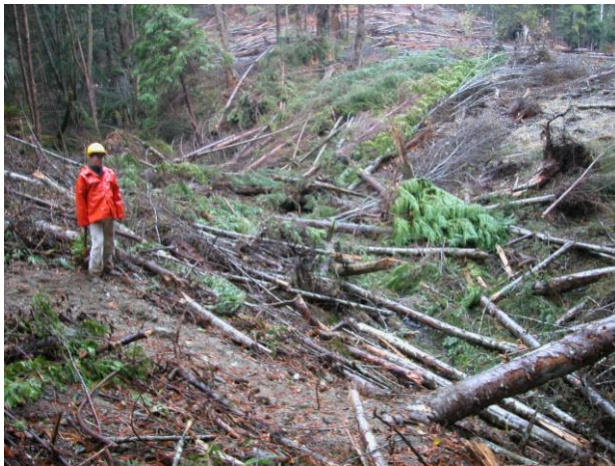
Stream crossing three (WI13, Chicken Foot Crossing) was a small crossing on the perennial German Creek, a tributary to LDC. The undersized culvert was failing and the channel upstream of the culvert was aggrading, while the channel below the culvert was scouring. Also, the LB500 was calving off above the culvert inlet. This excavation was terminated on the upstream end near some in-stream LWD. The LWD was deemed a stable channel element and the remaining wedge of fill was of little volume. Leaving the upper wedge of fill also helped to maintain the riparian vegetation in that area. Approximately 1050 yd<sup>3</sup> of fill were removed from this crossing. The production rate of 120 yds<sup>3</sup>/hr reflects the shallow excavation, short pushes and easy excavator reaches. Fill was placed on the old AA2 parking lot between RX2 and RX3.

**Figure 6.** Chicken Foot Stream Crossing (WI13, RX3). Looking upstream from PP10 a) during excavation of the road prism, and b) at the finished site.

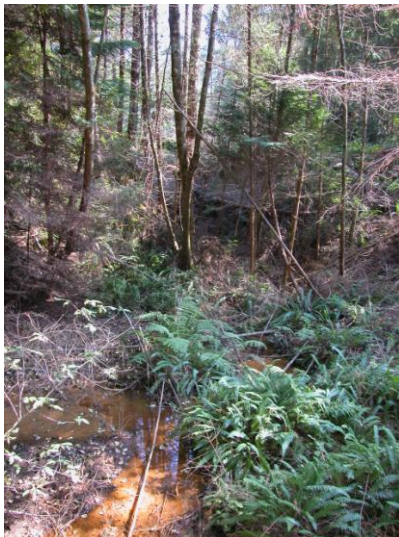
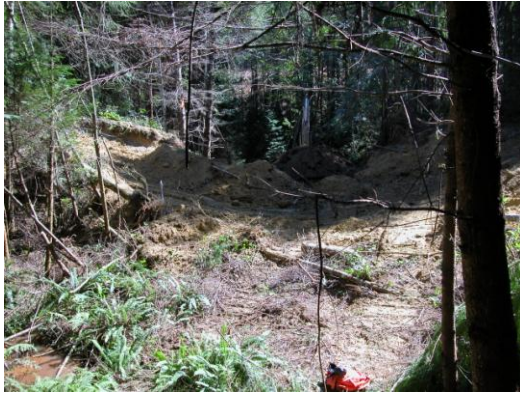
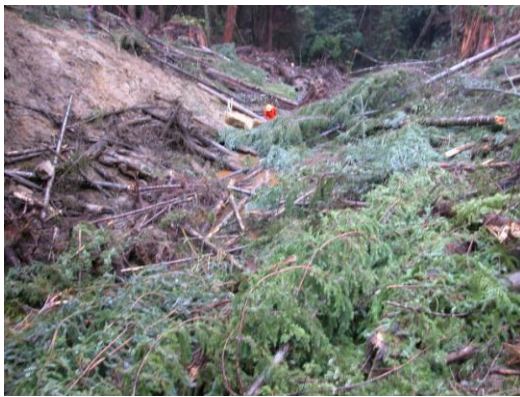
Work Item 16 (RX5, PT1RX) was the largest of the LB500 crossings in Unit 03-01. This crossing was on a perennial tributary to LDC. The channel above the culvert was aggraded and had year-round standing muck with a high organic content, and flowing surface water (Figure 7). Downstream of the LB500 road prism there was a second, older road bench with a two foot deep meandering channel carved into its surface. This meandering channel was only wet during high flows; water flowed subsurface to LDC during the dry months. There were lots of holes and cracks where the ground was being eroded away by the subsurface flow. There were also lots of chunks and LWD between the lower road bench and LDC. Due to the presence of these chunks and the proximity of the LDC, the excavation of the bottom section of this work item was minimal and involved pulling back the wall of perched fill over LDC while not excavating below the LWD or disturbing the riparian buffer zone. The LB500 road prism yielded clean fill (no LWD), indicating the lower road was the first road and the LB500 was pushed in later.

The upper section of WI16 was very wet and very slow. The contractors deflated the LB500 road prism and excavated the bottom section a few weeks before excavating the upper section in an attempt to dry out the upper section. The surface flow was pumped around the excavation but it was difficult to intercept the subsurface flow above the excavation. To intercept the subsurface flow within the excavation, a large hole was dug above the culvert and the water that ponded here was periodically pumped around the excavation and out onto a brush pile on the OBR away from the stream channel. This method helped dry out the crossing and seemed to keep sediment laden water from being pumped into the creek.

**Figure 7.** PT1RX (WI16, RX5) looking downstream from PP13 to LB500 road prism a) prior to excavation, b) during dishing down of road prism, and c) the final finished slope.

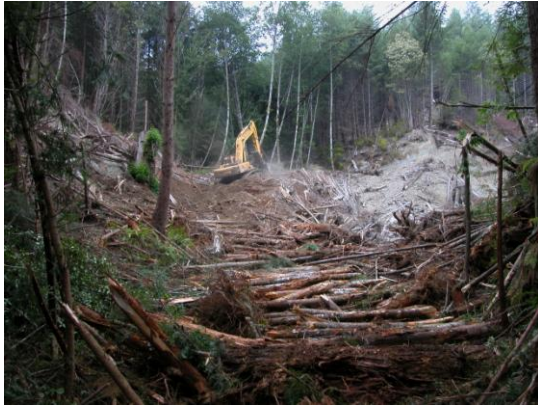
To gain access to the Landslide Creek landing the contractors rebuilt an old skid road that ran along the left side of German Creek below the pond. Then they build a humboldt crossing to cross German Creek below the pond (Figure 8). After deflating the landing the contractors excavated the left side of Landslide Creek up to a mid channel buried stump. A large old log jam was the top of the excavation and flow was subsurface below the logjam for about 40 feet. The excavation was rather slow due to the steepness of the finished slopes, the moisture of the last portion of the fill, the 1000 foot push, and because the each piece of equipment had to wait for fill or for a place to work. There were a number of buried stumps exposed during the excavation and these helped to define the channel. There were also lots of large logs oriented streamwise in the channel. The natural side slopes were steep and wet and were difficult to mulch.

**Figure 8.** Humboldt access road across German Creek downstream of the AA2 pond. Looking upstream to RX15.

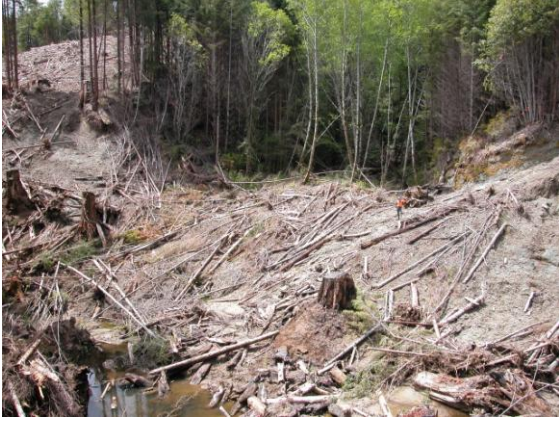
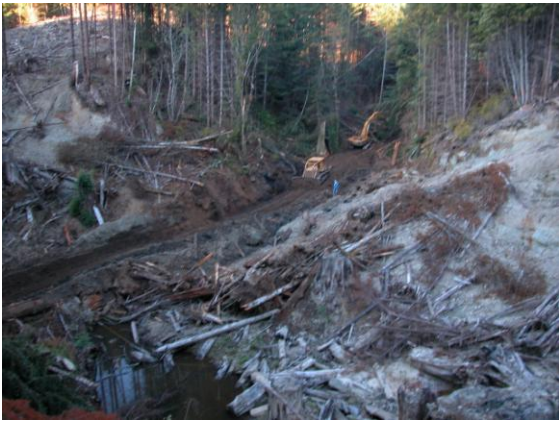
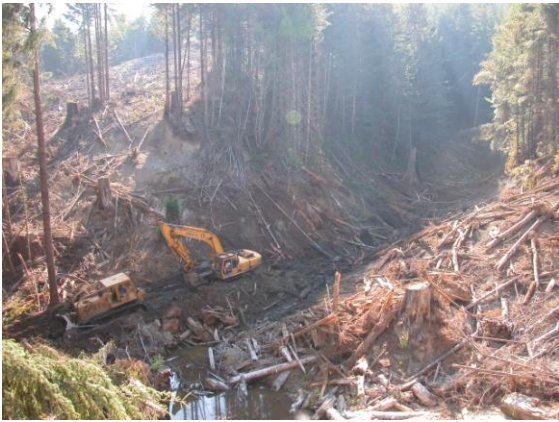
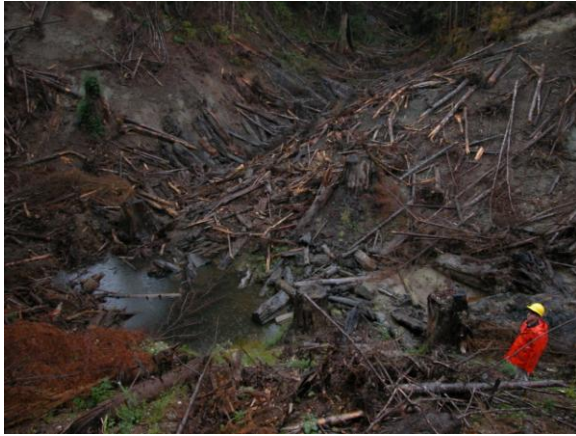
Landslide Creek stream crossing (RX15, WI11) was a continuation of an excavation begun in 2002. Landslide Creek flows into German Creek at the site of a large midstream landing that was excavated in 2002. This season's excavation involved removing a large mound of fill that was part of a landing in the middle of Landslide Creek channel and joining this channel to the already excavated German Creek channel. Prior to excavation water was piping through the middle of the mound of fill along a number of large buried logs. There were active gullies as well as numerous sink holes on the upstream side of the mound where the landing was subsiding and eroding away. There were also seepy wet spots upstream of the mound.

The final volume for this crossing, 3931 yds<sup>3</sup>, was much smaller than the original estimate of 8152 yds<sup>3</sup> because the channel was not as deep as designed and because some of the original estimate turned out to be a ridge nose that was not necessary to excavate (Figure 9). The production rate for RX15 was 58 yds<sup>3</sup>/hr, reflecting the long push and, tight working conditions and steep finished slopes.

**Figure 9.** Work item 11, (RX15, Landslide RX). Looking upstream to RX15 from PP1 a) prior to 2003 excavation, b) and c) during excavation, and d) finished work item.

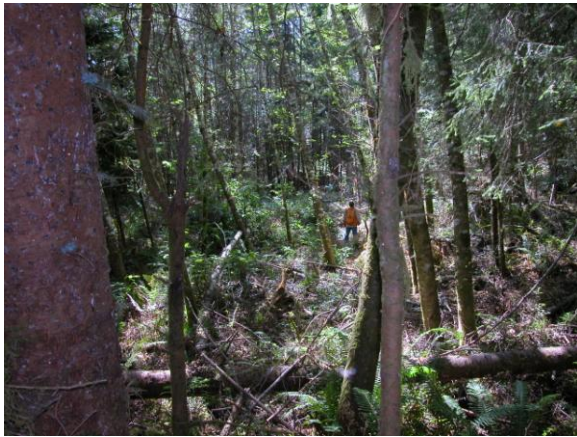
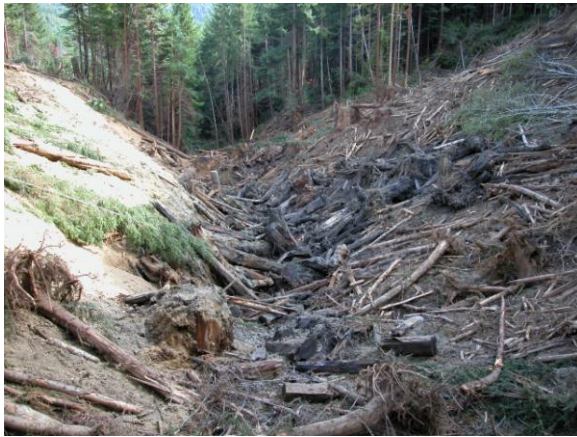
The upper landing (RX8, WI20) on PT1 Creek was a large in-stream landing similar to those excavated on German and Landslide Creeks (Figure 10). There were four swales/streams that entered WI20, two in the upper end and one on each side in the middle of the work item. There was a high-flow channel carved onto the landing surface extending from WI9 to the outer edge of the landing where there was evidence of both old and new erosion, but most of the flow was subsurface. At the bottom of the downstream wall of fill at the outer edge of the landing there was a landslide deposit from right bank landslide caused by water diverted down a skid road. This landslide probably occurred in 2000-2001 given the size of the alders and the fern ground cover. There were holes, tension cracks, gullies and leaning trees all along the outer edge of the landing as well as along the lower right and left banks where the fill

was failing. There were also a handful of buried stumps visible on the lower right bank above the landslide scar.

**Figure 10.** Work item 20, (RX8, ULRX). Looking downstream from PP2 a) prior to excavation and b) after excavation. Same camera, lense and frame, 17,159 yds<sup>3</sup> later...

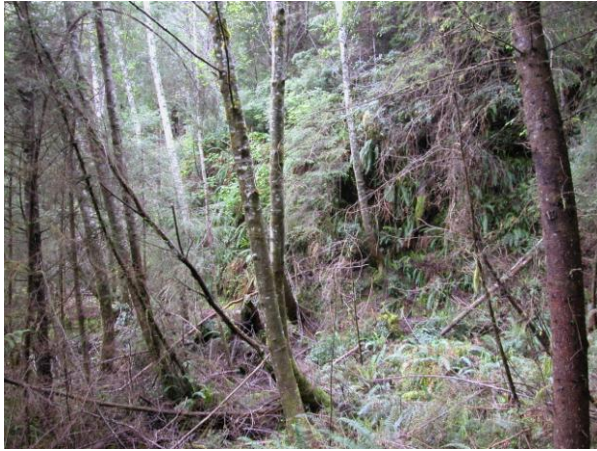
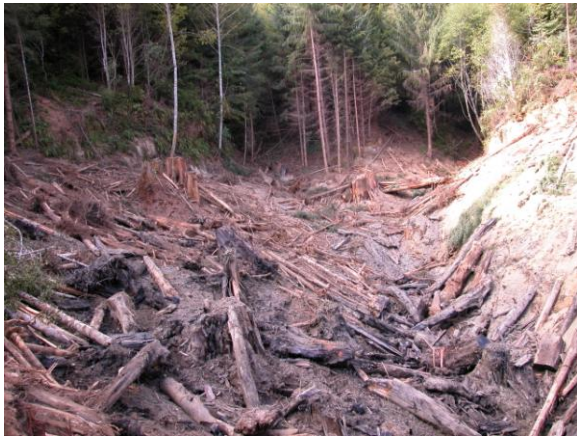
There was one very odd landscape feature worth mentioning; a 20 foot high bank with a thick growth of lady finger ferns (Figure 11). At first glance it looked like a cutbank, but on second glance one noticed the clump of three in-place stumps at the bottom of the bank, making it impossible for this to have been a cut bank as the stumps were too close to the bank for a dozer blade to pass between the stumps and the bank. Also, there were no blade marks on the bank as there are on all the other cutbanks in the valley. An interesting feature.

**Figure 11.** Work item 20 (RX8, ULRX). Looking to fern covered vertical bank from PP2 prior to excavation, and to the same bank from PP3. Note the triple in-place stumps at the bottom of the vertical bank, and PP2 on top of the in-place stump just to the right of center at the top of the channel.

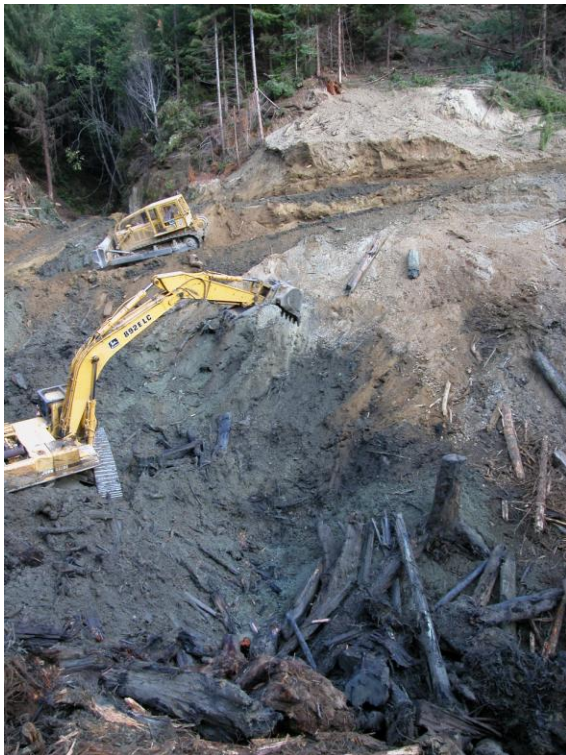
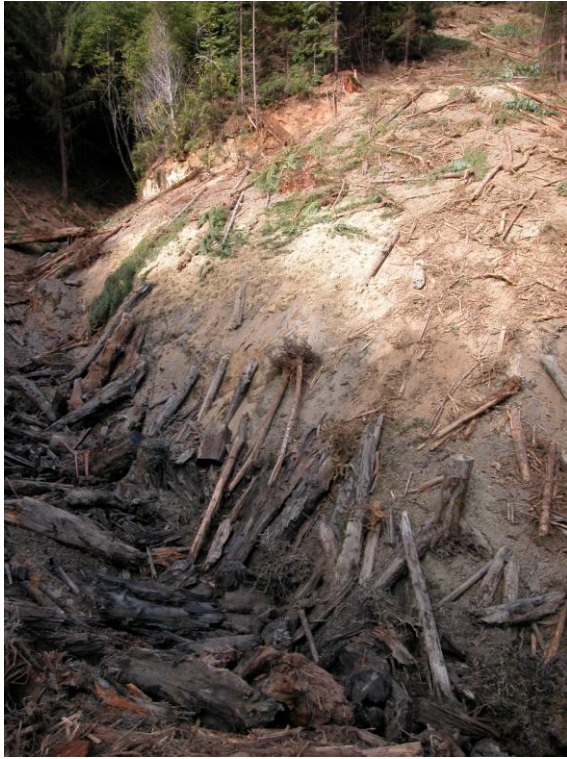
The finished channel was considerably deeper and had steeper side banks than originally estimated (Figure 12). The final volume for WI20 was 17,159 yds<sup>3</sup> (compared to an estimated volume of 9888 yds<sup>3</sup>) and the production rate was 53 yds<sup>3</sup>/hr. This production rate is low and represents the difficulty of the excavation despite the fact that there was a lot of easy cat dirt in the early stages of this excavation.

**Figure 12.** Work Item 20 (RX8, ULRX). Looking upstream from PP3 a) during excavation, and b) at finished excavation.

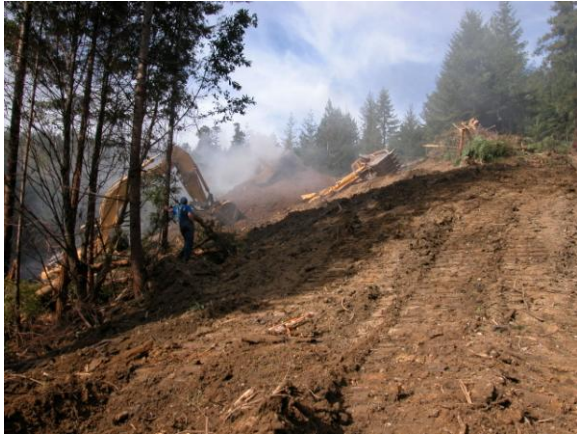
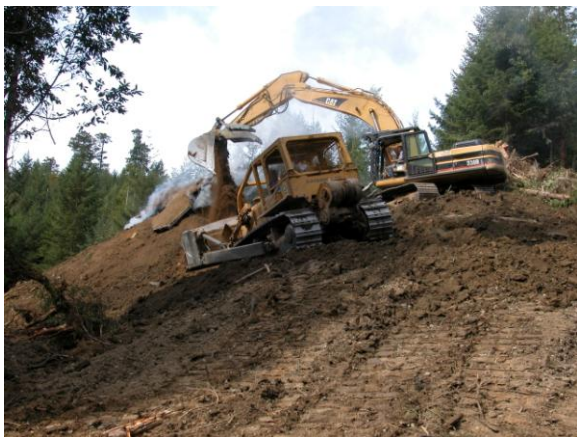
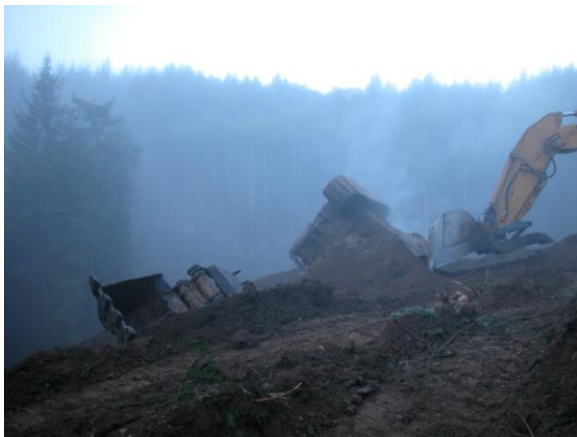
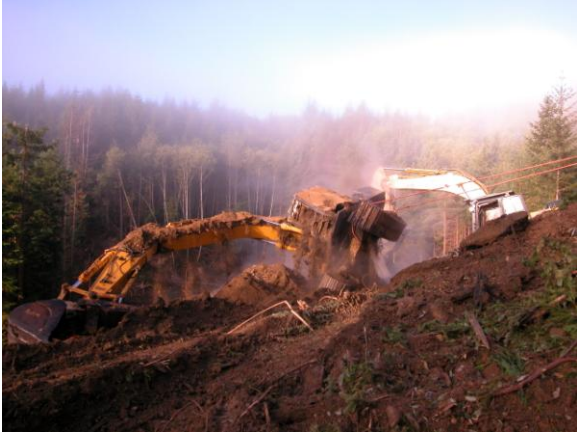
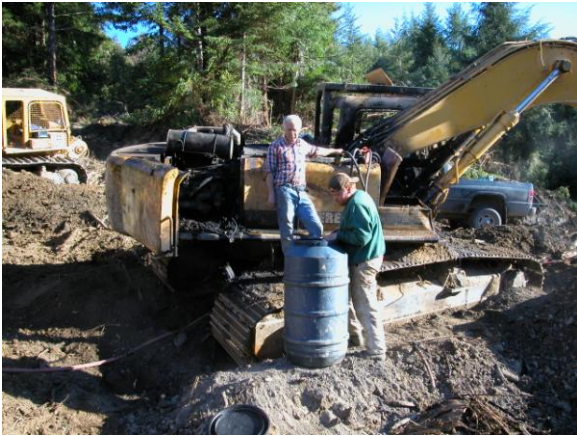
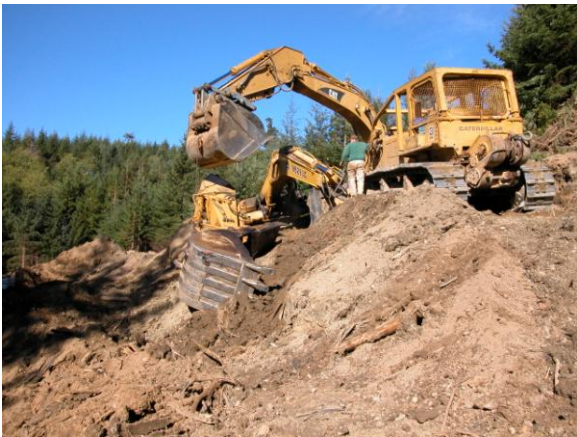
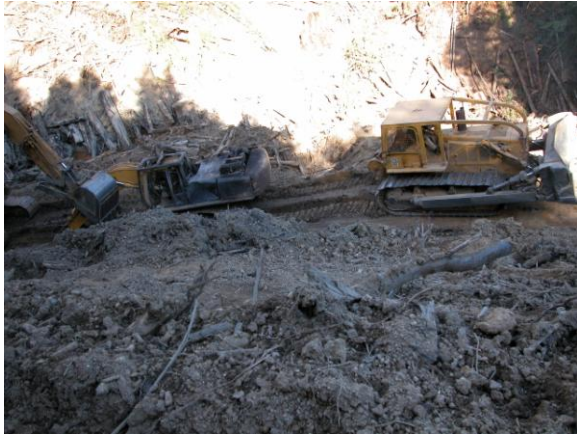
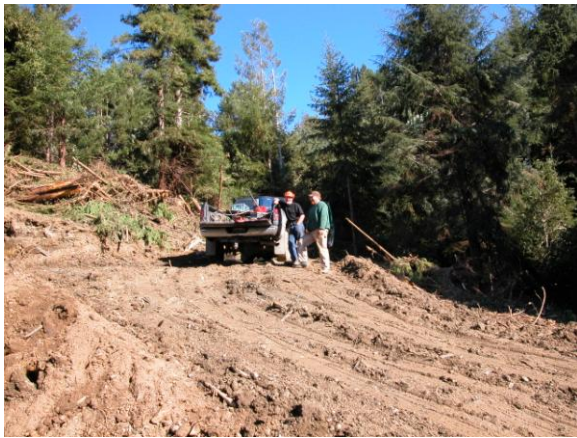
The excavation proceeded smoothly except for one event worth mentioning. Walt Lara rolled the 892 while spreading brush on the last day of work on WI20, October 20, 2003. Thankfully, he was not hurt. Again, thankfully, despite the fact the he was not wearing hi seat belt, he was not hurt. However, the 892 burned up and was almost a complete loss (some new track motors may have been salvageable) (Figure 13). Apparently, Walt was sitting on an almost flat surface helicopter spreading brush. On the third swing he began to tip down slope, tried to arrest the tip by swinging his bucket back under him but caught some bucket teeth on the ground and accelerated the flip. The machine came to rest on the arm side and Walt was able to jump out of the cab quickly. As the ground was sloped below the work pad Walt had been sitting on, both tracks were off the ground. The machine caught on fire before Walt was free of the cab and despite his efforts with the onboard fire extinguisher, was unable to control the flames. Wendell and Warren Larkin arrived on site moments after the flip and buried the burning excavator to smother the flames. The next morning the excavator was unburied, righted, disassembled and towed off the hill to the LB500. More than 50 gallons of diesel fuel were recovered from the 892 and pumped into the D8. The ground around the excavator was dry and it is presumed that all the volatiles that may have leaked out of the engine were burned up. Later on the 21<sup>st</sup> Walt reshaped the fillsite where the 892 was buried and finished mulching WI20. In hind site, getting the 892 off the hill was perhaps more dangerous than the actual flip

considering the number of pieces of heavy equipment it took, how steep the ground was, and how far it was to the LB500 and the vulnerability of those few assisting on the ground.

**Figure 13.** Work Item 20 (RX8, ULRX). Pictures depicting the October 20, and 21 892 excavator roll accident. Photos depict a) the burning excavator on its side, b) burying the excavator to smother the flames, c) the early morning unburying, d) righting, e) disassembling, f) pumping warm diesel from the burned excavator, and g) pushing and pulling the excavator to the LB500. Figure 13h is a bonus picture featuring the extremely lucky 2002 and 2003 excavator rollers comparing notes.

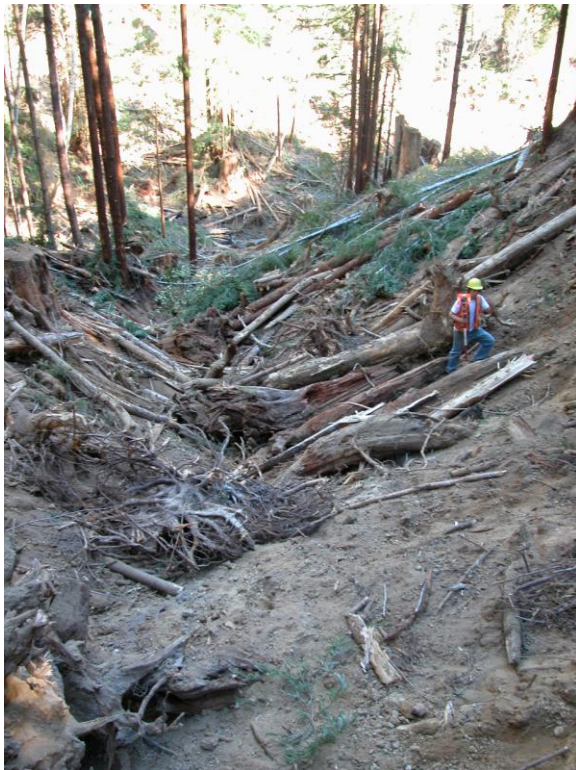
SBRX (RX10, WI23) was a skid crossing on a steep tributary to PT1 Creek and joined PT1 Creek directly across from the RX9 tributary (Figure 14). The top of this excavation was a large pushed in stump in the narrow channel. This work item was also very steep. Because of this, some fill was not excavated from the channel in the lower middle section where there was a considerable change in slope. The post-excavation volume was 1128 yds<sup>3</sup> at a production rate of 53 yds<sup>3</sup>/hr; think steep and slow!

**Figure 14.** Work Item 23 (RX10, SBRX). Looking downstream from PT1 PP4 to finished RX10 and RX11 channels.

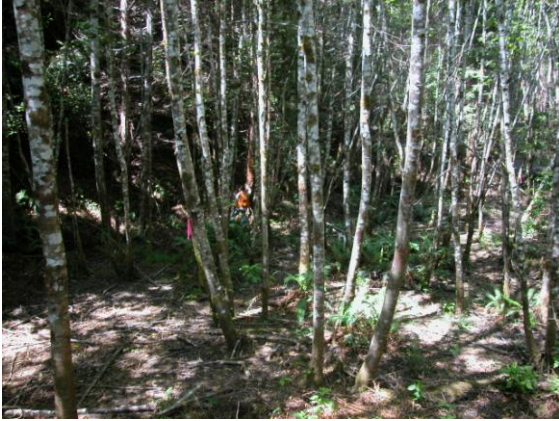
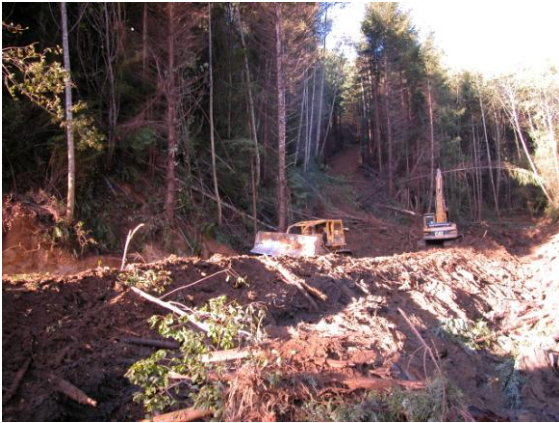
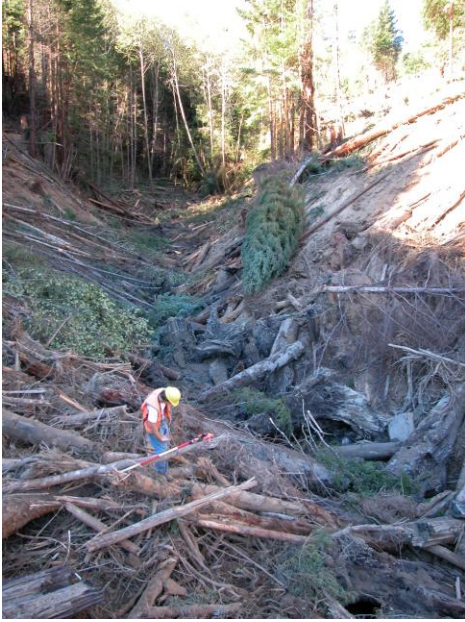
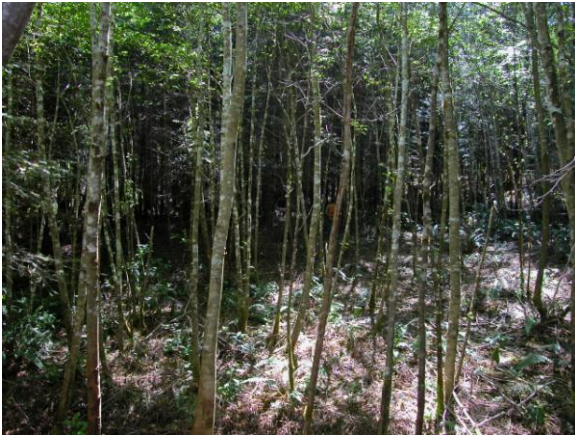
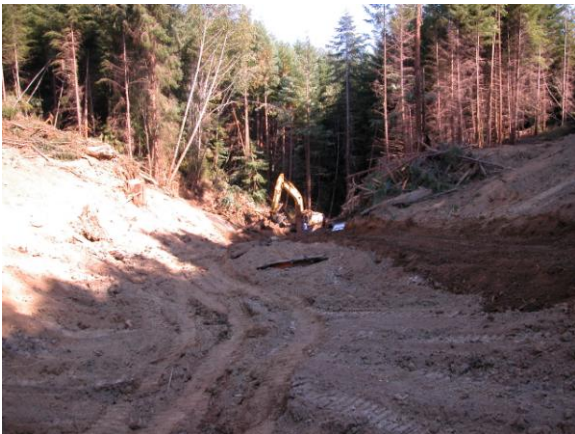
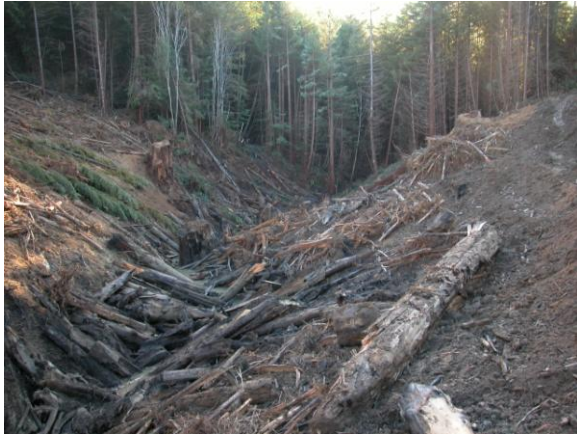
Prior to excavation WI20 was a big flat landing that sloped slightly downstream from the halfway point to the edge of the landing (roughly 300 feet) (Figure 15). The whole landing was covered in standing water during the winter rains with areas of

flowing water. There were even areas of standing water in June. There was a gully down the middle of the landing that grew from two feet deep at the halfway point to over 12 feet deep approximately 300 feet downstream. There were tension cracks, slumping, leaning trees and an amazingly active sinking hole that grew from 6 feet in diameter to 9 feet in diameter in three weeks with no rain and appeared bottomless.

**Figure 15.** Work Item 24 (RX11, LLRX). Photos take from PT1 PP1 looking upstream and down stream respectively a) and d) prior to excavation, b) and e) during excavation, and c)and f) after excavation.

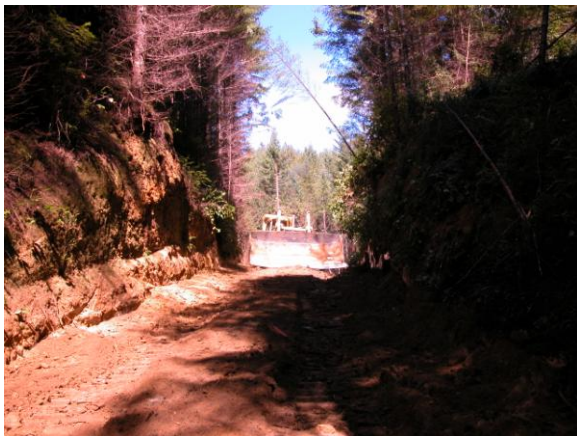
**Figure 16.** Work Item 24 (RX11, LLRX). The D9L backing out of the access road throughout fill site used for much of the fill from WI24.

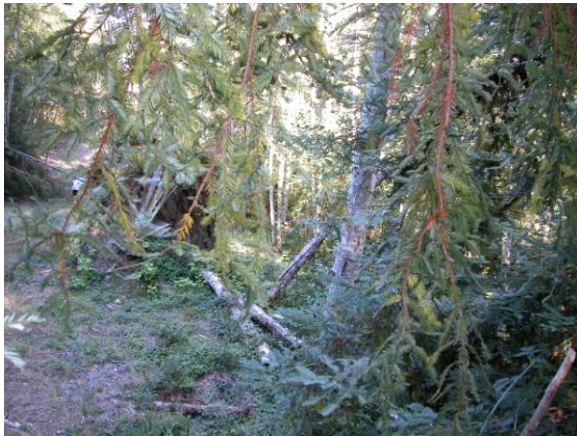
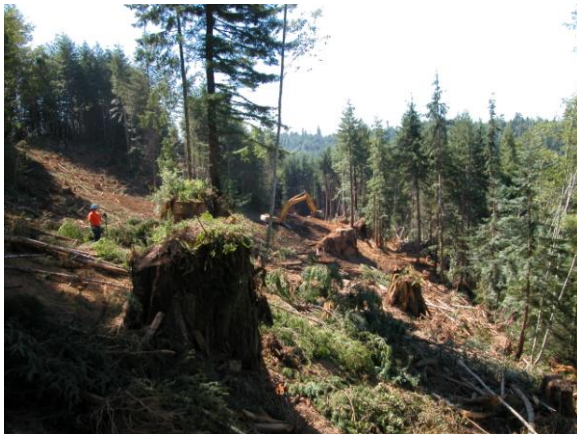
Pat's Parking Lot EOS (WI3, EOS1) extended from approximately the hairpin landslide that marked the end of 2002 LB500 work to the down-road end of a roadside landing. This section of road was perched high above Larry Damm Creek and the road had already outsloped it self to some extent with gullies coming off the OBR, leaning alder trees and general slumping (Figure 17). On the outboard edge of the landing there were large tension cracks and active gullies.

**Figure 17.** Work Item 3 (EOS1, Pat's Parking Lot). Looking down road from LB500 PP1 to Pat's Parking Lot landing a) before, and b) after excavation.

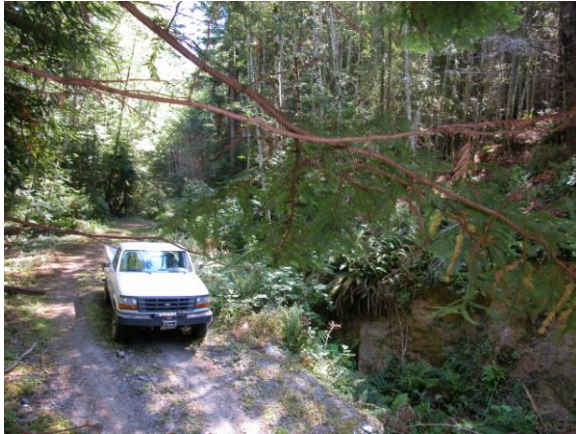
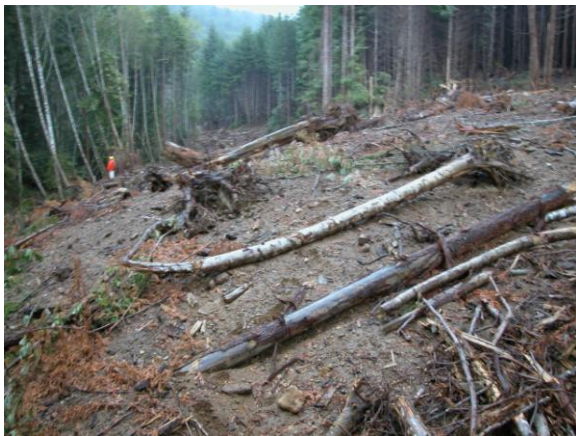
Work Item eight (EOS3) had a large and active IBR gully created from water diverted by the LB500 (Figure 18). The gully was over 10 feet deep and 8 feet wide where it cut through a ridge nose on the boundary of WI8 and WI9 (see below). There were also some OBR sink holes that indicated active sediment transport and delivery to LDC. This road reach ran along the east or left bank of LDC and had large fill pockets that overhung LDC, posing a high erosion potential. There was also a section

**Figure 18.** Work Item 8 (EOS3). Looking up road from LB500 PP8 a) before and b) after excavation. Note the gully in the before picture.

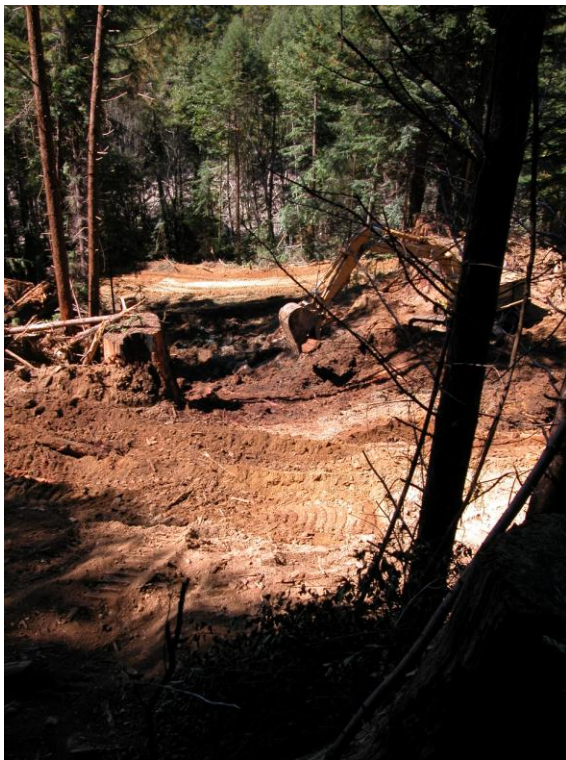
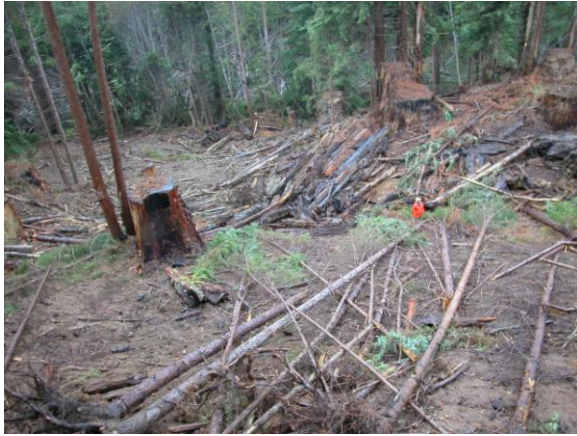
Bobby Brady EOS (WI9, EOS4) was the excavation of an upslope landing that was failing onto the LB500 road bench. This landing was above the deepest and largest gullied section in WI8 and included an odd piece of ground that was melting but with no clear reason why prior to excavation. This piece of ground was complete with leaning trees, big tension crack along the outer edges and as mentioned above, slumping and melting ground.

Approximately 5,450 yds<sup>3</sup> of fill were excavated from this work item and spoiled to a series of adjacent gentle upslope through cuts. The excavation exposed a steep wet swale that began on the ridge that was the base of the landing (Figure 19). The swale had ponding water and very wet soil during the excavation. There were lots of buried chunks and a couple of buried stumps exposed. The swale did not connect to the LDC, and instead, shallowed out and dried up about halfway across the road bench. The fill was pushed up a steep hill and to the adjacent through cuts on the upslope side of the excavation. The production rate of 70 yds<sup>3</sup>/hr reflects the long steep push.

Figure 19. Work Item 9 (EOS4, Bobby Brady). Looking down slope from LB500 PP7 a) during, and b) after excavation.

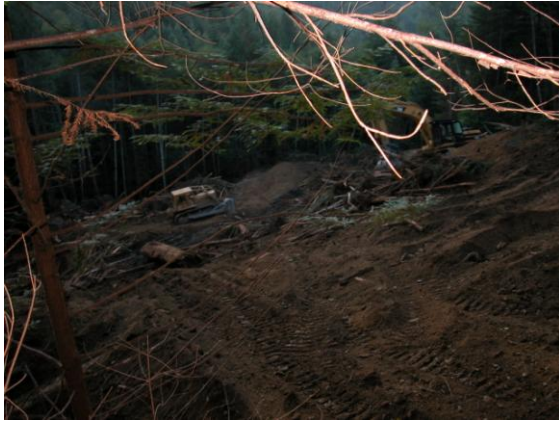
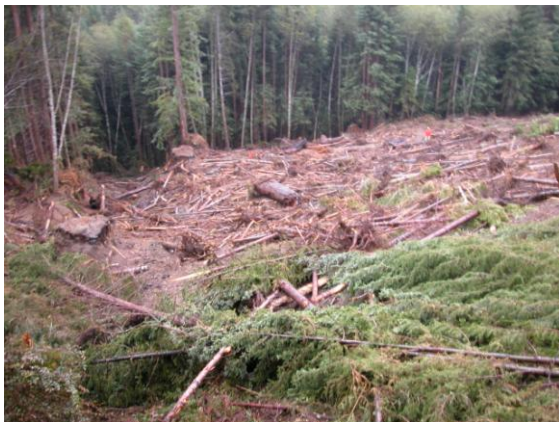
Utah EOS (WI17, EOS5) was another above-road landing excavation and, like Bobby Brady, Utah was failing onto the LB500. The LB500 was also sinking in one area though this work item. On a broad landscape scale this area looked like an old massive slump forming a shallow bowl. Prior to excavation there were areas of ponding water on the landing, and an active but shallow head cut where the ponding water flowed down onto the LB500. There were a number of skid roads entering the landing from the upslope side bringing diverted water with them. These skids were both shallow swales that were skidded and regular skids that focused surface flow onto the landing. These areas were shaped to drain so as to pose less of a threat to slope stability.

The sinking section of the LB500 turned out to be a narrow steep stream channel that had flowing water in it from just above the road prism to the confluence with LDC (Figure 20). There was a small plugged culvert in the road fill and the bottom of the channel was about 12 feet below the road surface. Except for the narrow channel excavation that went to the flood plane just above LDC, the downstream extent of this excavation was minimal and most of the adjacent riparian buffer was left intact.

**Figure 20.** Work Item 17 (EOS5, Utah). Photos looking down slope from LB500 PP12 a) during and b) after excavation. Note the narrow channel on the left side of Figure 20b.
