## Watershed Restoration Project 04-01: Removal of the 570 Road, Anthrop's Landing

Watershed Restoration Project 04-01 was the final phase of equipment operations in Larry Damm Creek, a tributary of Lost Man Creek. This project removed the 570 Road and the last culvert on Larry Damm Creek. While there is still approximately 0.75 miles of the Lower B500 located along the lower portion of Larry Damm Creek, no more restoration work is planned for Larry Damm Creek.

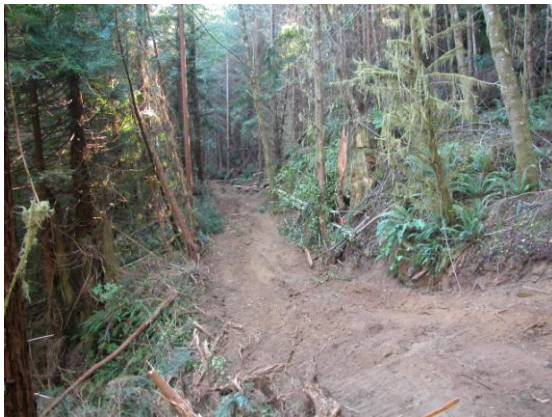
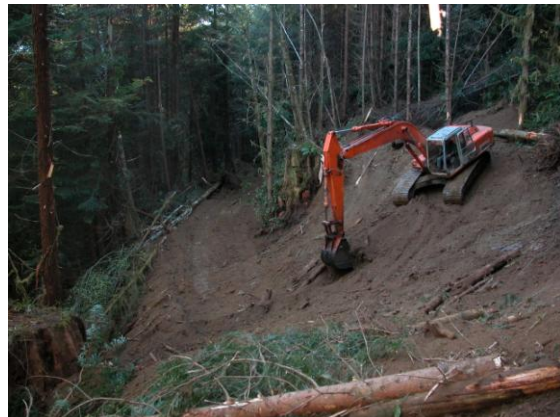
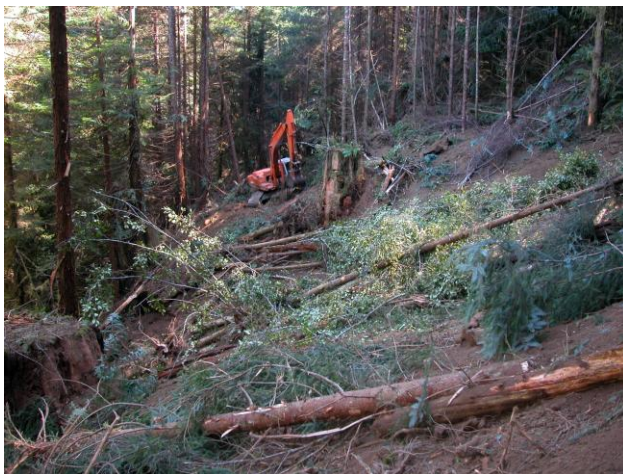
**EOS 1:**

to the east. This section of the 570 was located along the inner gorge of Larry Damm Creek, and was situated on fairly steep hillslopes. Several recent failures were evident along the outboard edge of the road as well as portions of the road showing prominent incipient fractures. The location of the road in relation to Larry Damm Creek resulted in past failures having a 100% delivery rate to the watercourse.

This portion of the 570 was more or less a glorified skid road but its location above Larry Damm Creek warranted being treated. The road was initially brushed open using the Cat® D8H bulldozer. Once the brushing was complete, the Hitachi® EX220 excavator began removing the outboard edge of the road. Due to the road's location along the inner gorge, the original estimate included the possibility of retrieving a greater amount of sidecast should underlying conditions warrant. However, once excavation began, it became very apparent that there was no need to disturb the bulk of vegetation that had established itself between the road and Larry Damm Creek. Consequently, the estimated volume for this work item was considerably less than the actual.

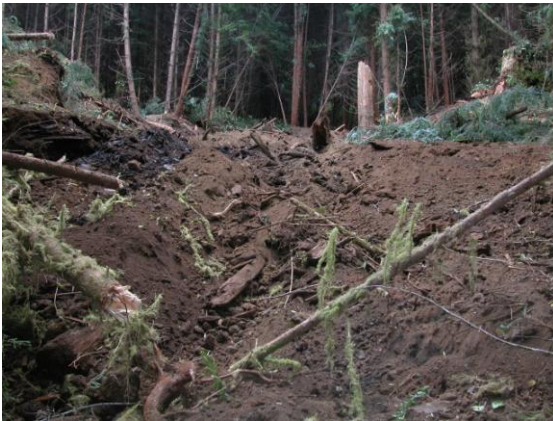
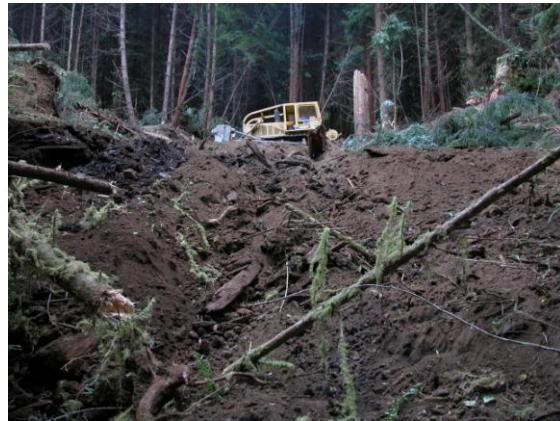
ANTHRX1/EOS2:

ANTHRX1, the first stream crossing treatment, required the excavation of a large landing that was constructed at the bottom of a draw. This crossing/landing was located right above Larry Damm Creek. No drainage structure was located within the crossing and considerable flow was diverted over the crossing and down the outboard edge of the road. This had resulted in gullying of the outboard edge of the road. The close proximity of Larry Damm Creek resulted in 100% delivery of eroded sediment.

ANTHRX1 allowed for the use of the Cat® D8H bulldozer to do considerable amount of dishing of the crossing. However, unlike EOS1, all fill had to be pushed down the 570 to the prominent landing associated with EOS3. This push, approximately 250 feet, resulted in a reduced production rate, even though the bulldozer was able to move the material. In addition, the initial workspace was very confined owing to the amount of vegetation. Clearing the vegetation required suitable sites to stockpile and most of those sites were located within the work zone. Thus the contractor chose to keep things relatively confined in order to establish finished areas which would then be stockpiles with vegetation.

Major dilemmas associated with this excavation were uncovering the channel bottom and the lack of channel definition on the right side of the crossing. The channel bottom was difficult to determine owing to the amount of material that had been pushed out on to the flood plain of Larry Damm Creek and the absence of a drainage structure within the crossing. Since flow was diverted over the crossing, it had gullied the outboard edge and developed a channel below the road and out to Larry Damm Creek. This was taken as a default for the design of the excavated channel which proved to be incorrect. The actual

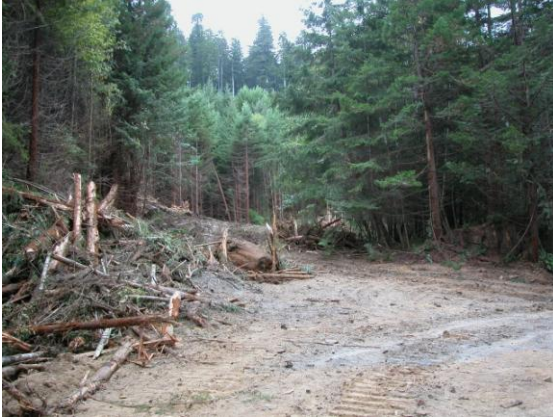
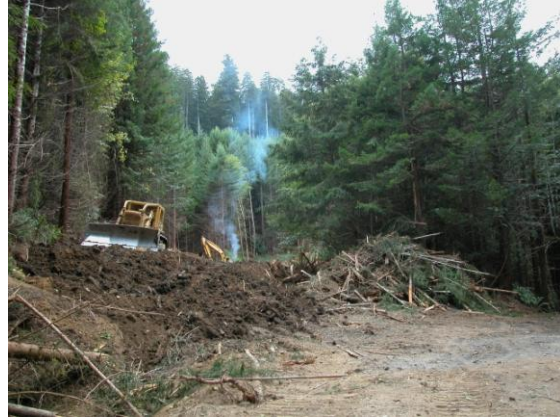
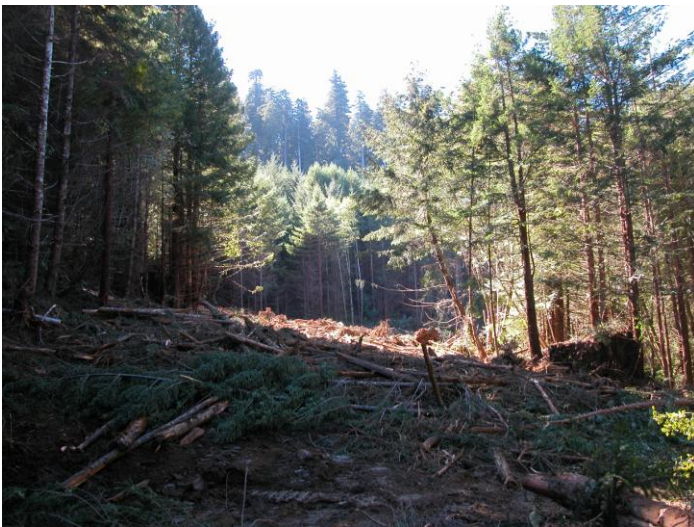
These photos were taken from the intersection of the 570 and Lower B500 roads. Large vegetation pile in top left photo needed to be relocated to accommodate additional fill from down station work items. Top right photo shows bulldozer atop of growing fill pile. Bottom left photo shows finished surface, with groomed fill site and dispersed vegetation. Note that most of the finished surface is fill site and not recently excavated side slopes.

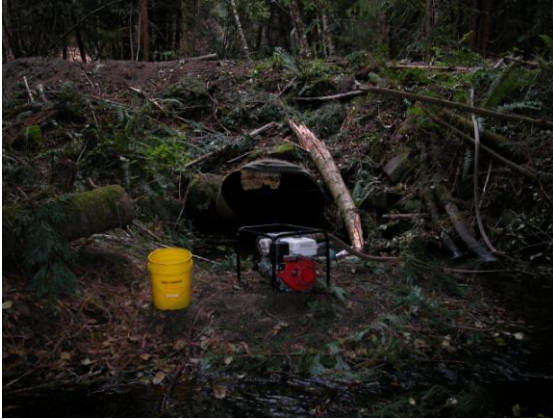
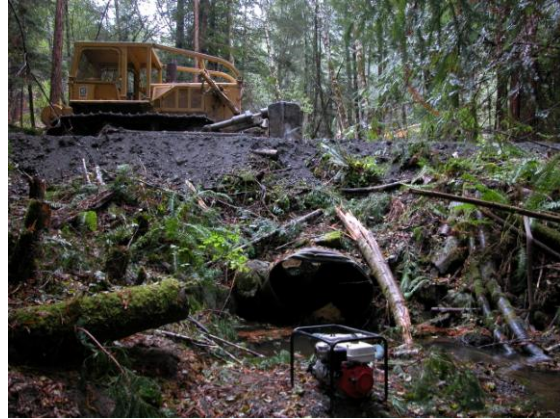
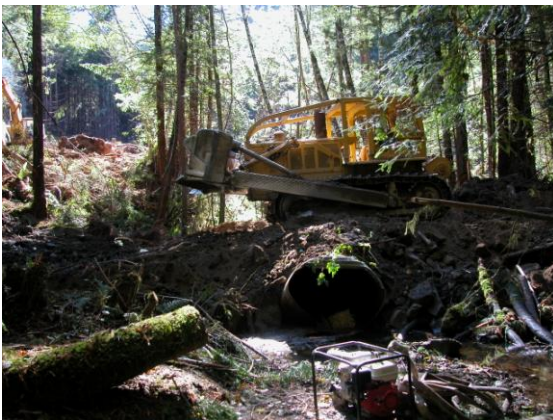
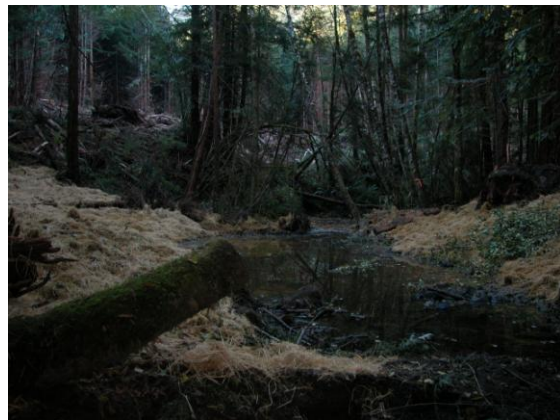
#### CULVERT 1:

CULVERT 1 was the final work item on the project and also the final work for the immediate future in Larry Damm Creek. CULVERT 1 crossing is also the last obstructed

crossing on Larry Damm Creek and its removal will hopefully herald in fish passage to the upstream portions of Larry Damm Creek. This crossing was constructed using a 48'' corrugated metal pipe. This crossing experienced frequent blocking by woody debris transported down Larry Damm Creek during storms. In addition, fish surveys along Larry Damm Creek implicated the culvert as a probable fish barrier. Downstream of this culvert, coho and Chinook salmon have been observed but none have been detected or observed upstream of the culvert. Erosionally, this crossing was not too problematic, but the potential for the culvert to plug was high. Excavation and treatment of this site was a benefit predominately to the fisheries of Larry Damm and Lost Man Creeks.

Excavation of CULVERT 1 was initially performed exclusively with the Cat® D8H bulldozer. The initial surface of road rock was scraped off and bladed along the remaining portion of the Lower B500 road while the underlying fill was pushed into the fill site on the treated side of the crossing. This fill was evenly spread along the old road surface of the Lower B500, located east of the B570 intersection. The Cat® D8H bulldozer worked almost exclusively on the crossing, until the culvert was uncovered at which time the excavator was used.

After excavation, the culvert was flattened and buried. The entire surface of CULVERT 1 was winterized with straw for erosion control. This straw had been used to construct barriers in Larry Damm Creek to keep fish from swimming into the work site. After excavations were completed, the straw was recovered and spread along the finished surface.
