# **Summary Report**

## **Watershed Restoration Project 07-03:**

**Manning Creek Out – 0703**

Project 0703 was comprised of three separate road segments within the Lost Man Project Area (LMPA). Task Order 8482070025 picked up on the A140 where the project 0603 work had ended in October of 2006. Task Order 8482070025A focused on a short remnant of the A142 which was located just down slope of the A140 portion being completed in this project. Task Order 8482070025B addressed some high risk sediment sources in the northern portion of the project area on the North Branch of the North Fork.

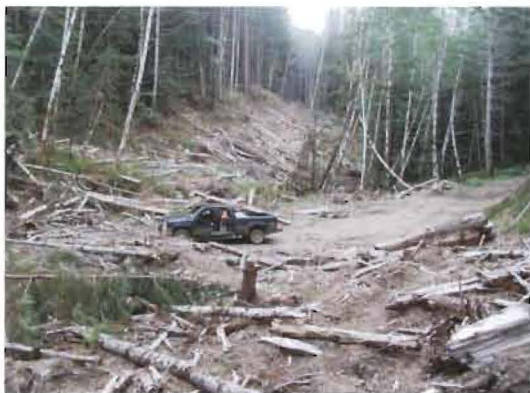
May 2007

Main Manning crossing / landing (Work Item 3)

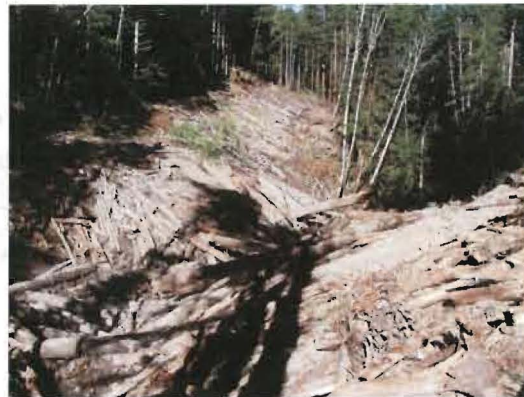
July 2007

The first phase of work on the A140 began on June 19th. Large 40 ton off highway dump trucks were used to end-haul excavated fill to a large quarry pit approximately 1500 feet north of the dig. The trucks were used to end the excavated fill from work items 3 through 5. Upon the completion of work item 5, the heavy equipment moved to the North Branch North Fork portion of the project on the 12th of July. The phased project was planned in order to maximize efficient use of the trucks. The off-highway trucks are relatively expensive, and often hard to acquire mid season. By concentrating all the hauling work into single time frame, the contractor (and the park) did not have to incur rental payments while equipment sat idle, or alternatively risk losing the returned equipment to another renter.

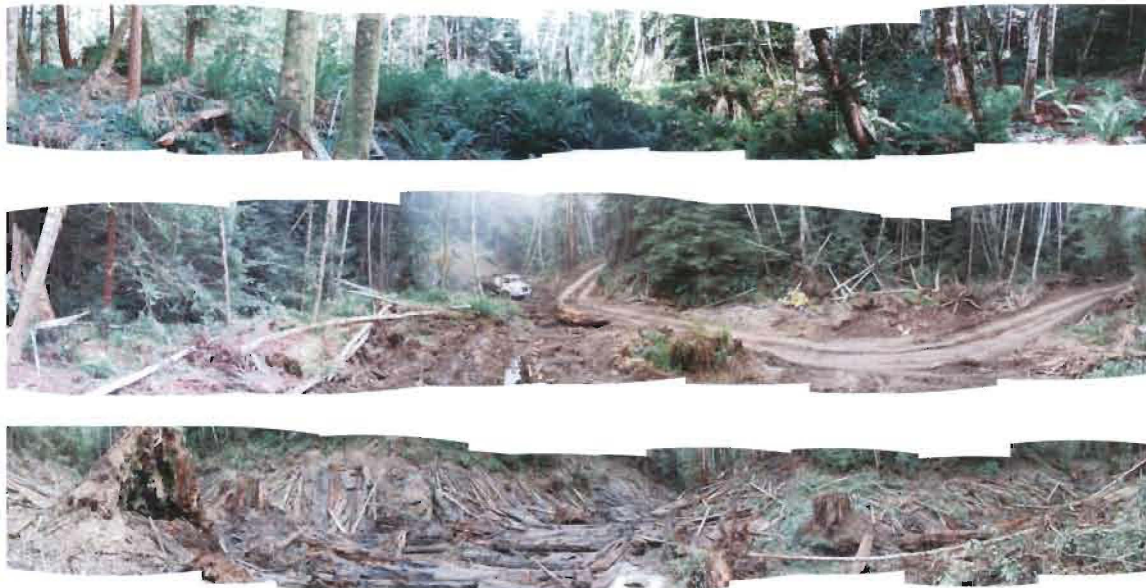
Panorama (approx. 300°) of lower landing (Work item 2) looking downstream from above the confluence.
