# Summary Report

## Watershed Restoration Project 08-03:

- Upper B500 – 0803a
- A111 – 0803b
- A112 – 0803c
- A350 – 0803d
- A200 – 0803e
- A100 north – 0803f

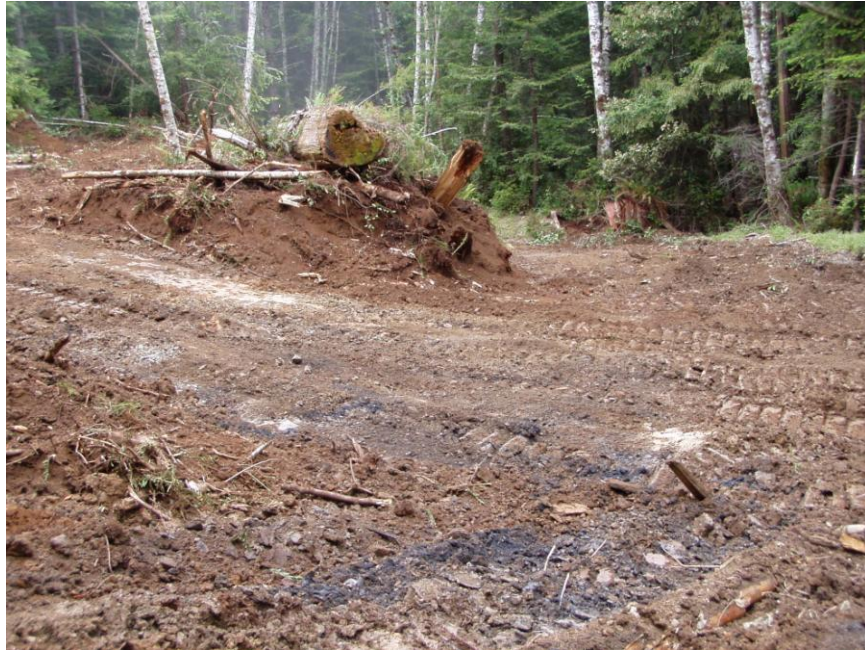
Photo 1A, Work Item A3 following initial vegetation removal.

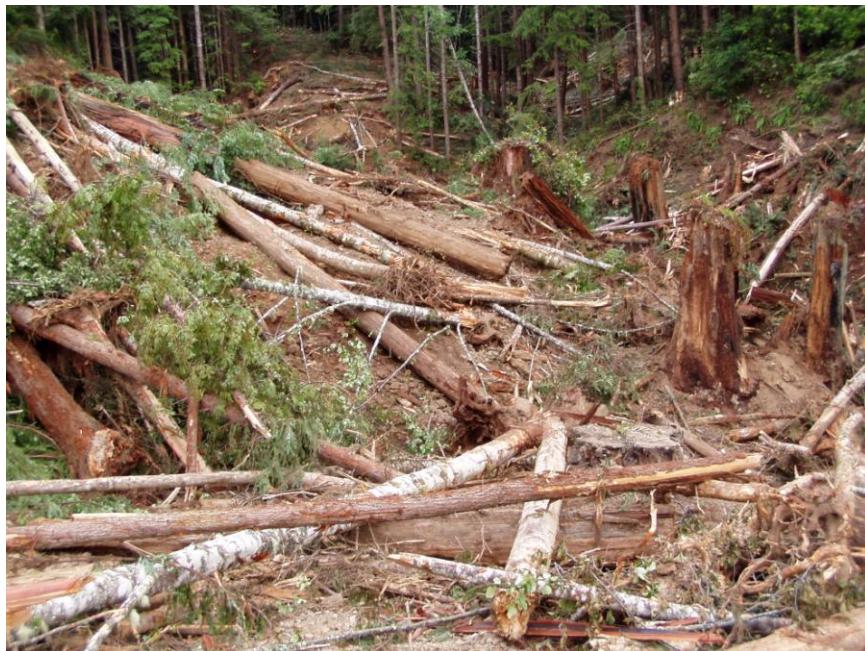
Photo 2A, Work Item A3 from same view following excavation.

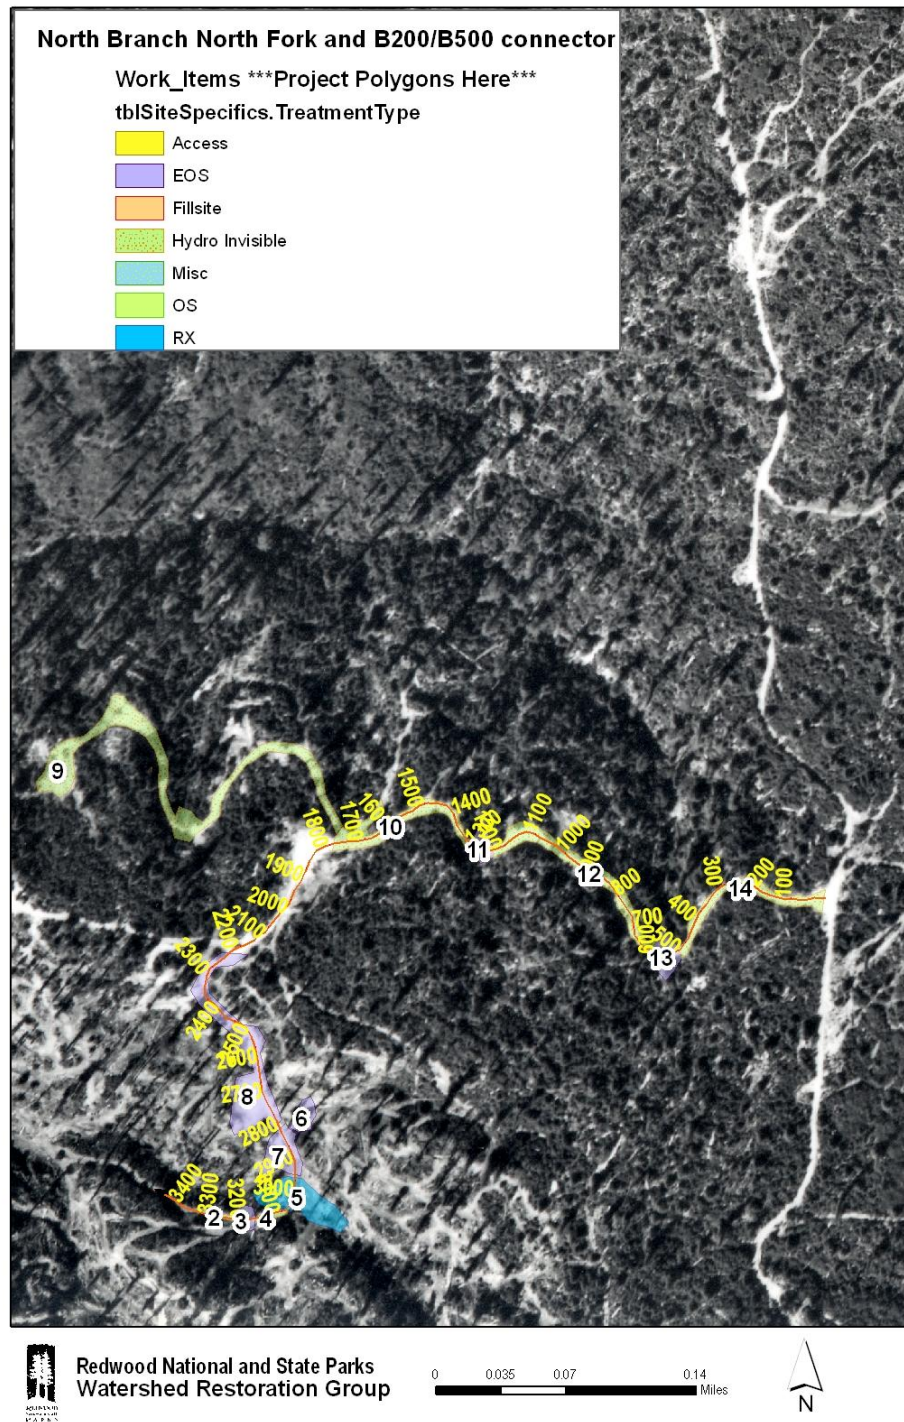
A112 As Built map shows work items completed for 08-03C

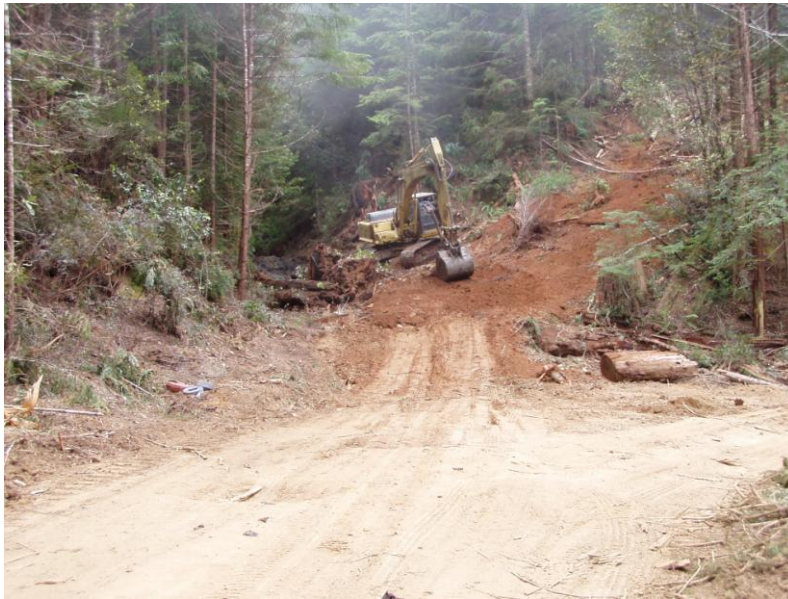
Photo C1, the upper portion of Work Item C5 RX excavation

Following the 2007 season, the stream diversion practices were somewhat upgraded. Photo C1 shows an excavator working just below the drafting pond at the stream crossing excavation labeled as work item C5. The red hose, visible just upslope from the excavator, is carrying the stream flow around the work site allowing excavation work anywhere within the isolated channel reach. One of the key factors for effective diversion of channel flow requires capturing all upstream water. This typically means that the drafting hole will be below original channel grade to ensure that all woody debris or other elements that might participate in subsurface routing of water are eliminated.

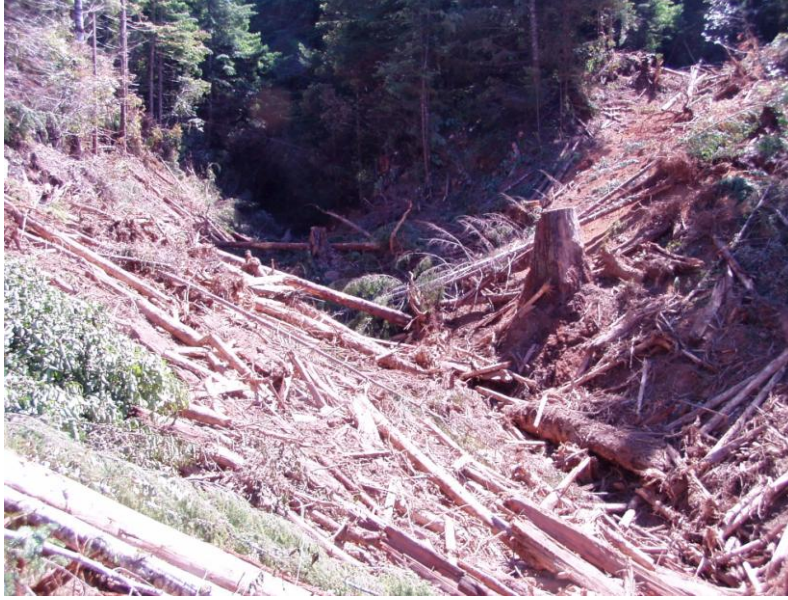
Photo C2, the completed Work Item C5

The stump visible in the photo C2 is the same stump that is downslope of the excavator in photo C1. Most of the mud from this excavation was end hauled to a ridge road approximately one quarter of mile away.

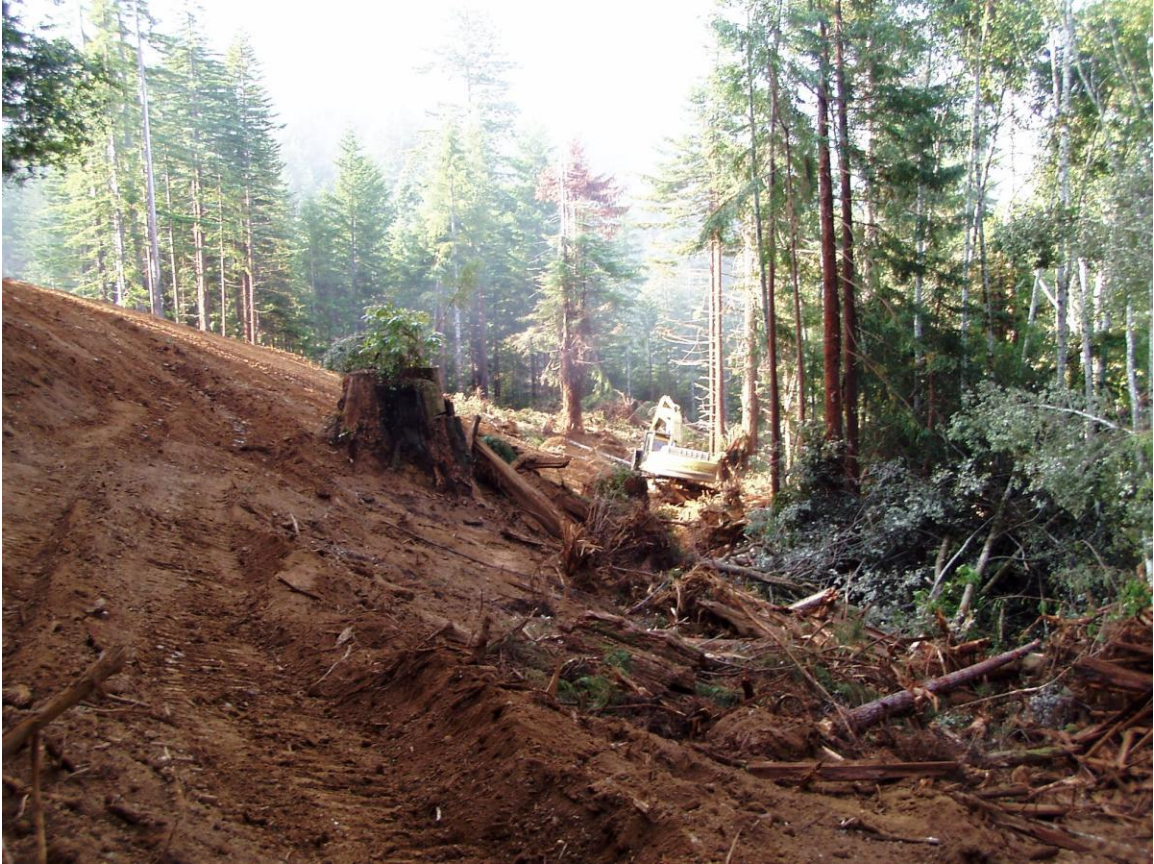
Following the large crossing and swale excavations (C5 and C7) was a segment of road that had prescribed as a mild outslope or 'hydrologic invisibility' reach (Work item C8). While cleaning up the edge of a ridge landing between C7 and C8 that was being used as a fill site for the earlier crossing and swale fill, a headwater swale became apparent requiring a more extensive excavation the slope. The final outslope product was beautiful, but generated an extra week of work at the site.

Photo C3, looking back at the ridge landing that instigated the additional excavation volume for work item C8.

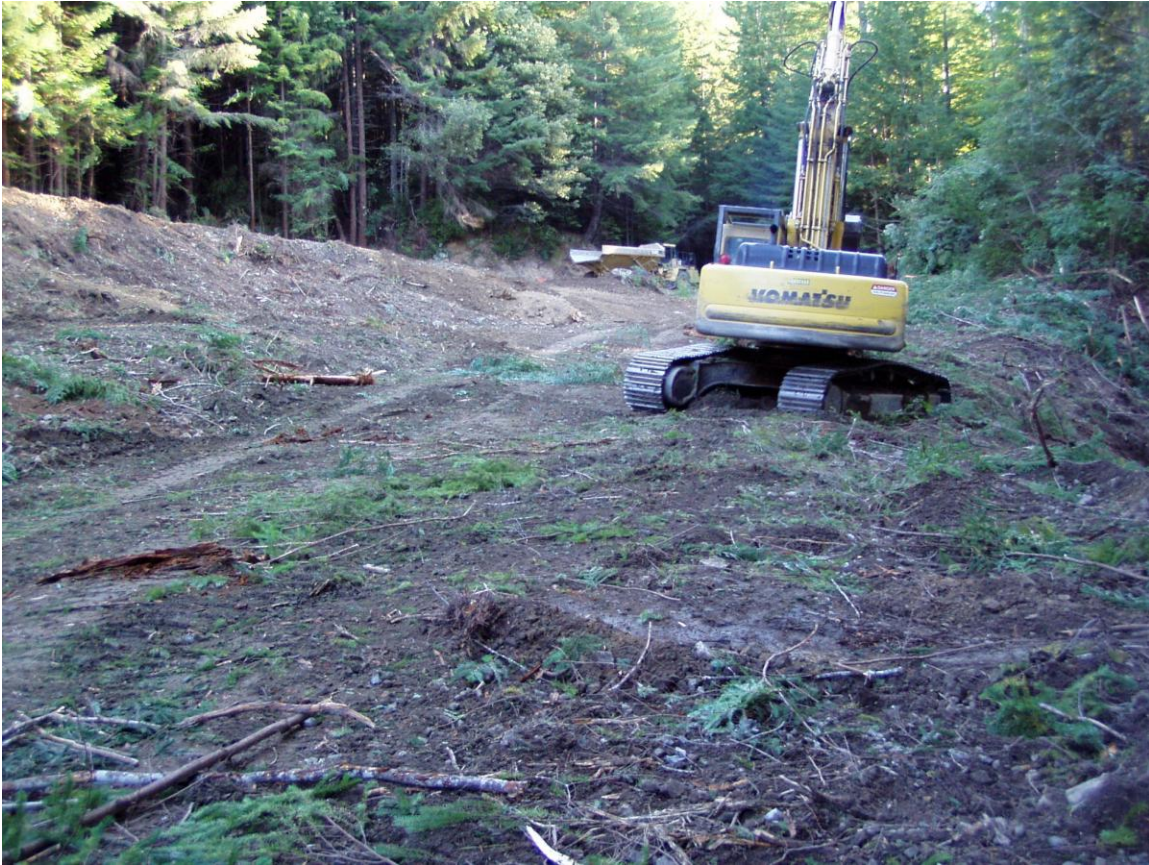
Photo E1, work item E14 where over 12,000 cubic yards of road fill was excavated and a new rock fjord crossing was installed on the Geneva road.

A portion of the Geneva road had to re-routed for a 12,000 yd<sup>3</sup>s channel excavation. The portion of Geneva had shown signs of failure over the recent decade. In 2006, during a culvert replacement, some of the fill had been relocated with the intention of lessening the resource threat from the site. The re-aligned segment of Geneva now crosses the channel with a small rock ford.

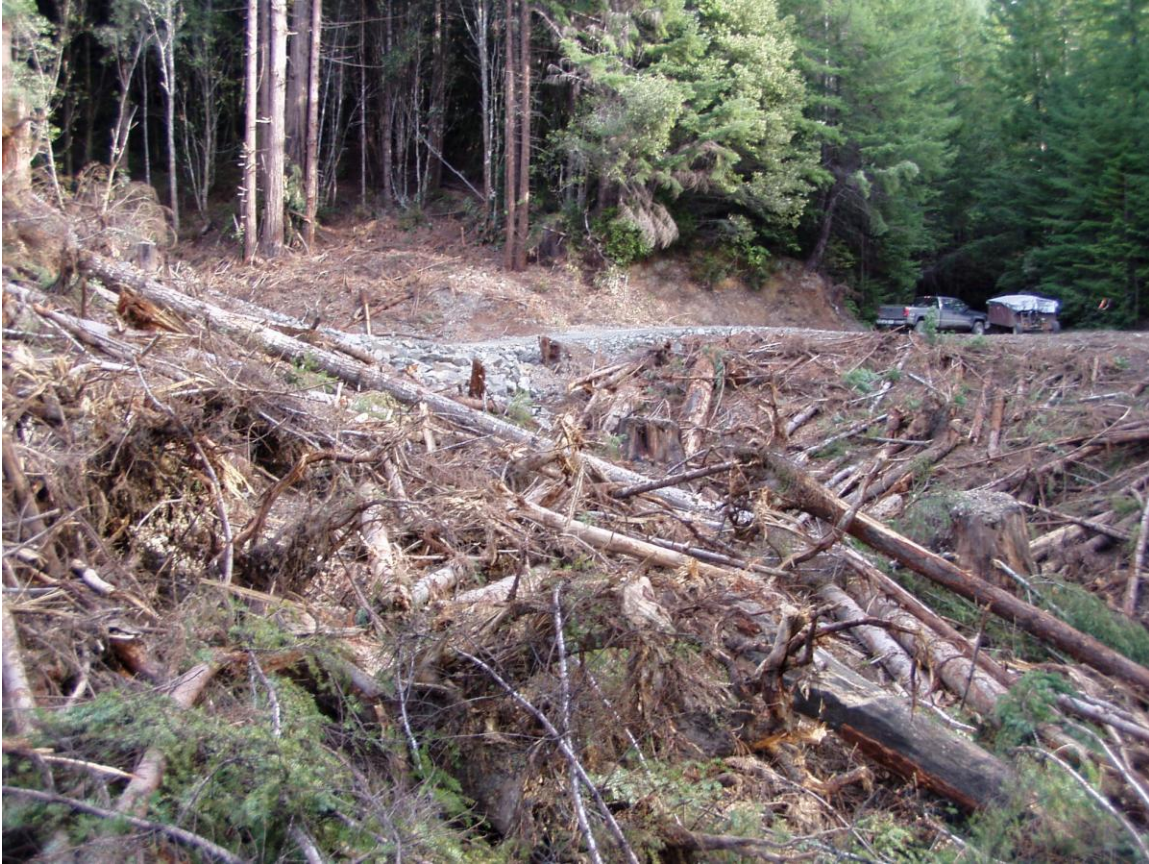
Photo E2, completed work item E14 with rock ford crossing.

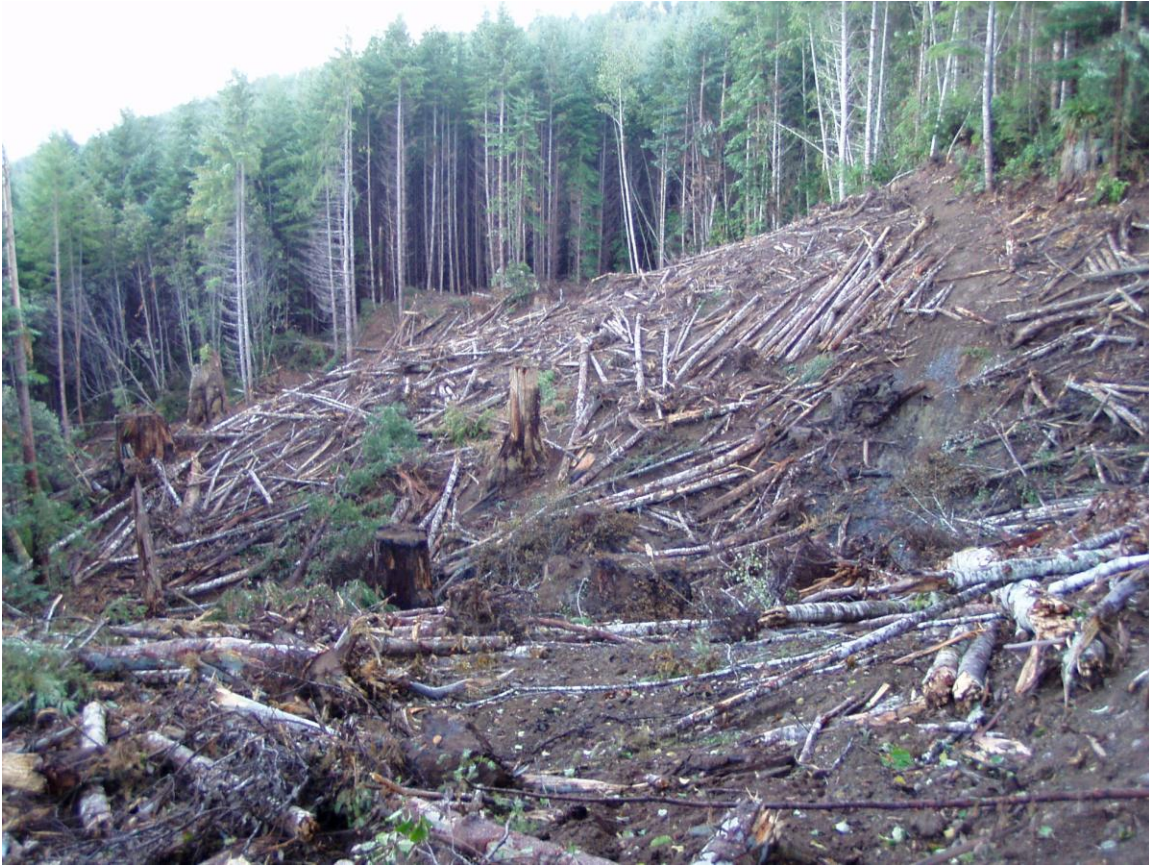
Photo F1, terminal landing for the A100 north segment (work item F2)

The landing at the end of the A100 was identified for treatment due to steep fill around the outer edge and a swale crossing on the southern edge. During the excavation, a headwater swale was identified on the northern portion of the landing, dramatically increasing the excavation volume.

As the contract the Ford Logging had with State Parks finished, the additional heavy equipment was moved onto the A100. Production increased dramatically allowing the additional fill encountered on Work Item F2 to be relocated in a timely manner.

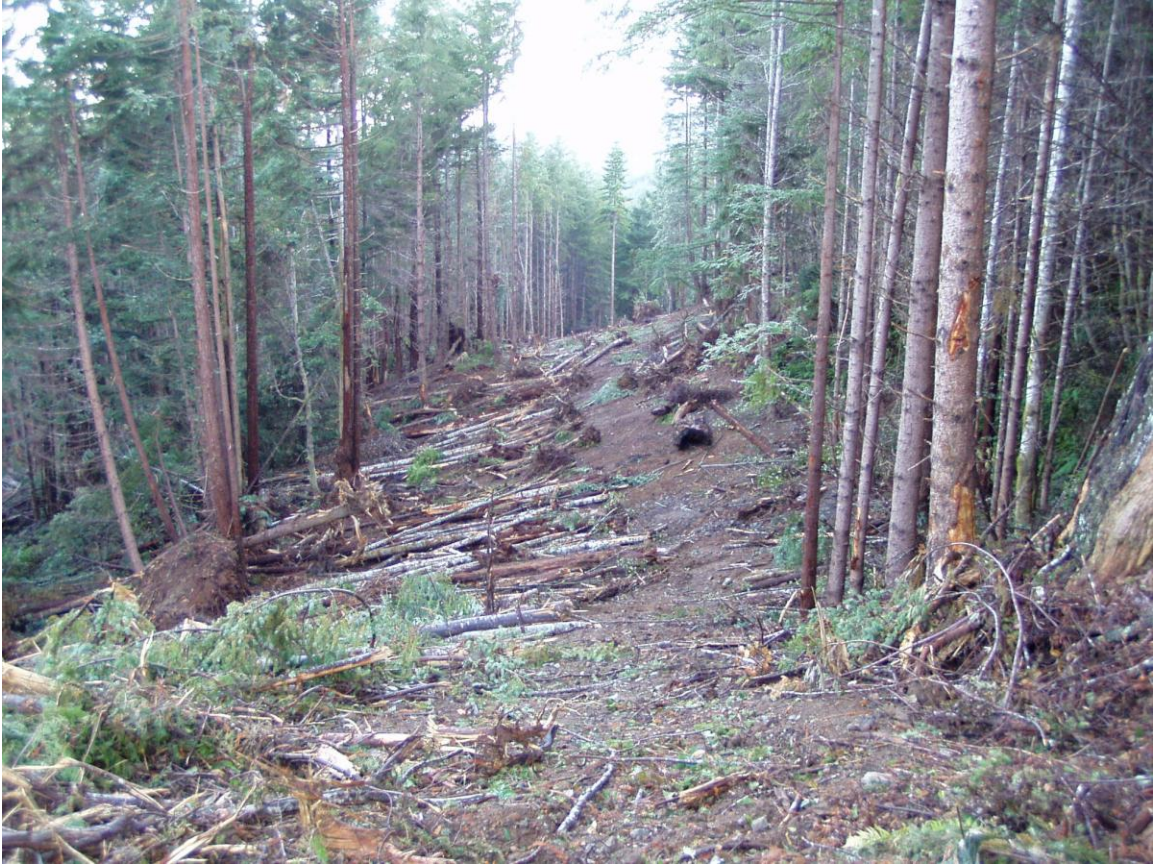
Photo F2, smaller swale above a skid road crossing excavation (work item F5)

A swale above a small skid road crossing was the only other significant fluvial feature on the northern segment of the A100.
