SUMMARY REPORT  
OF WORK PERFORMED ON  
REHABILITATION UNIT, SITE 80-3  
BRIDGE CREEK

by  
Gregory Bundros  
Teri Huber

January, 1981

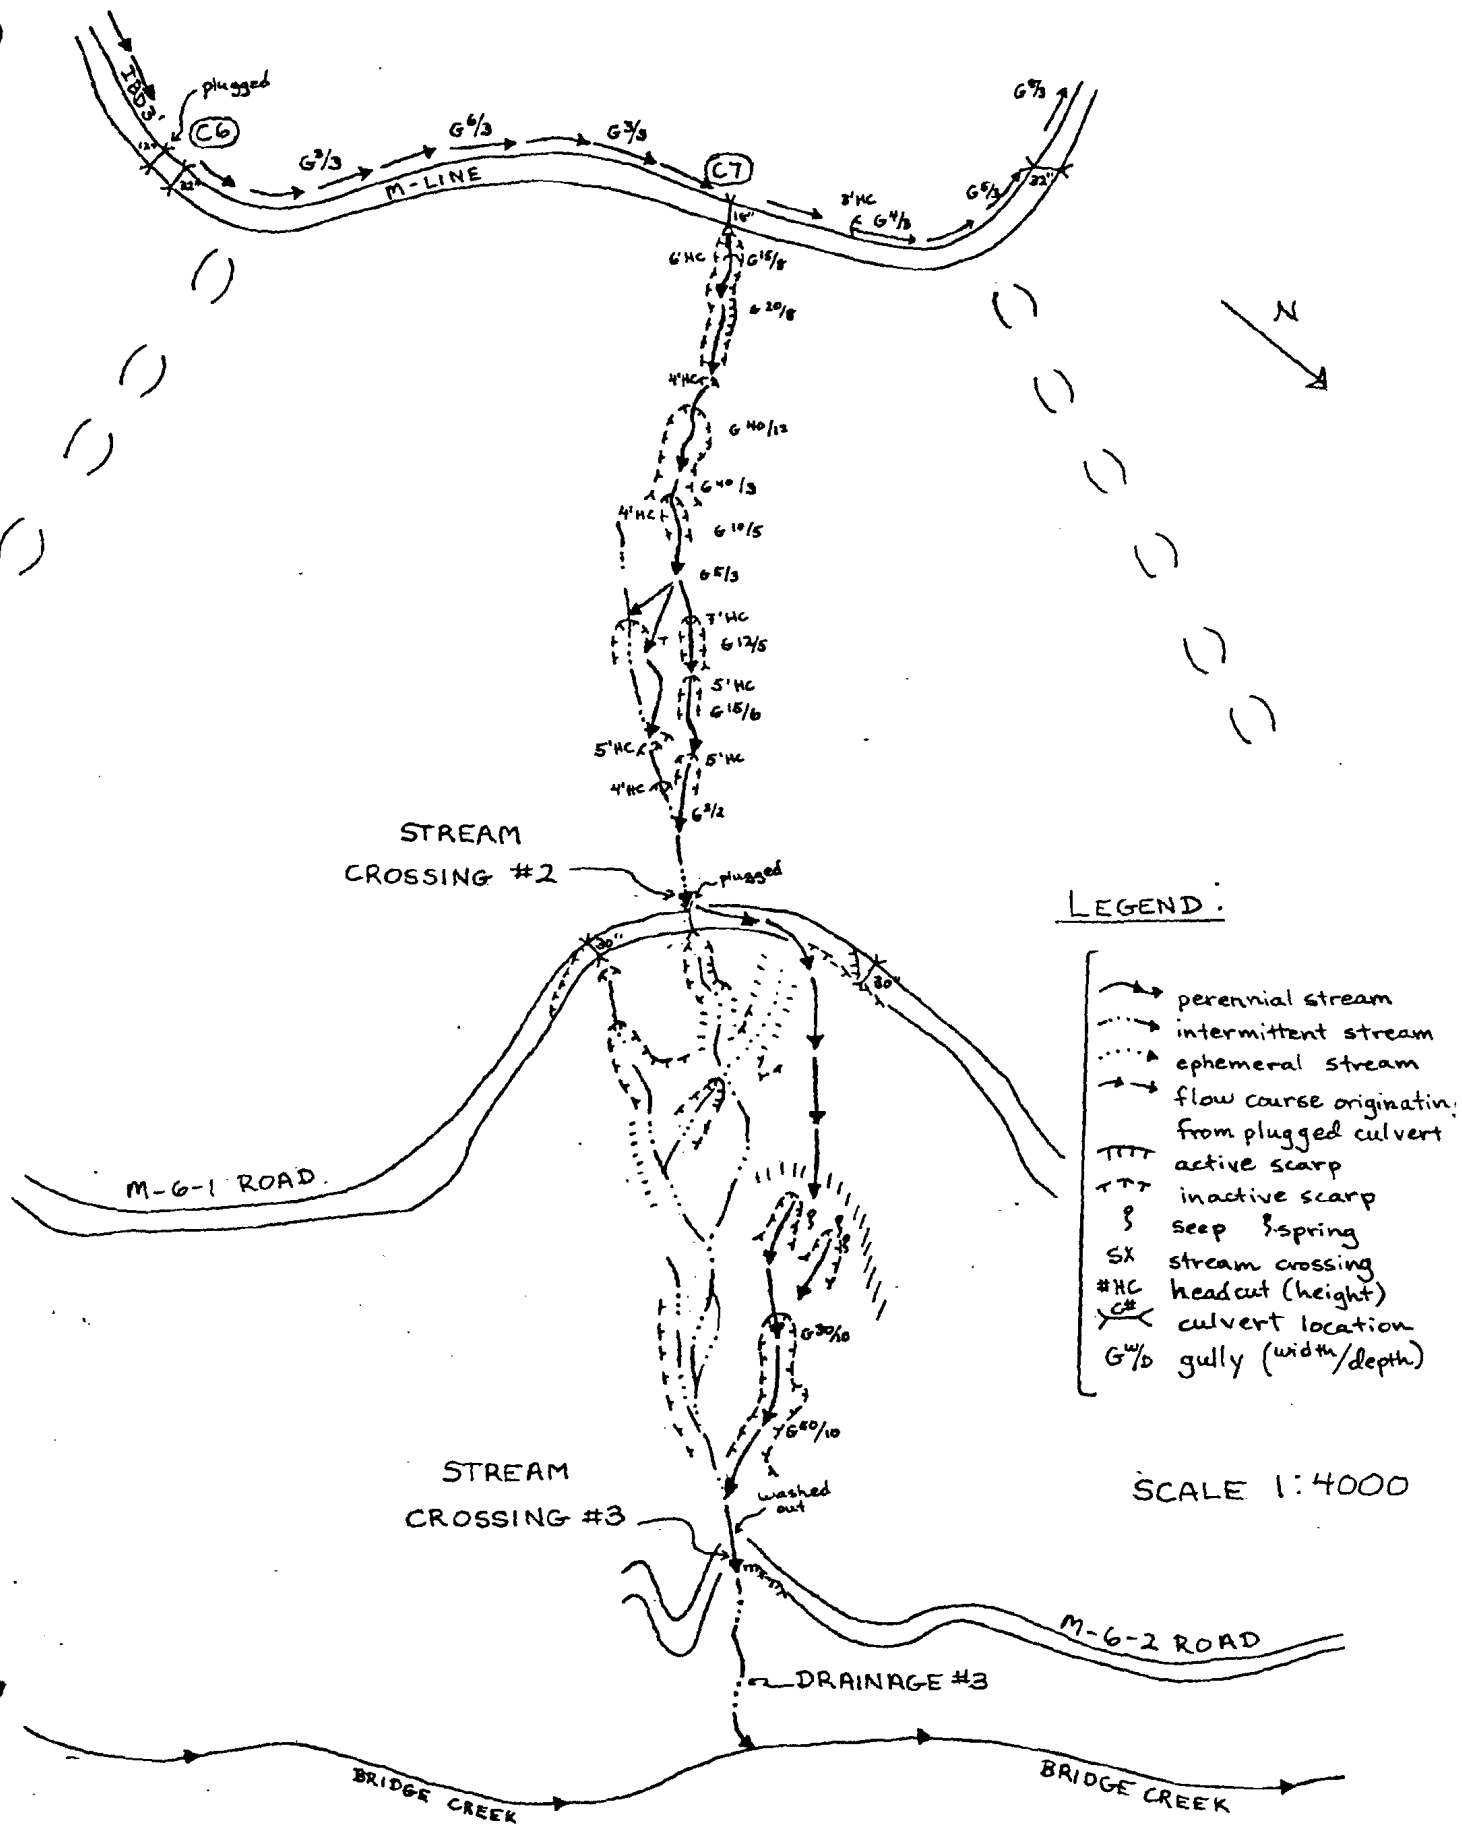
FIGURE 4. GULLY EROSION ORIGINATING FROM CULVERT 7

Improper culvert size and placement frequency along haul roads pose a more serious threat to gully erosion. Within this physiographic unit, hillslopes above the M-Line are drained by eight culverts, Culverts 3 through 10 (see Figure 1, page 2). Culverts 3, 6, and 10 are old, 12-inch diameter, failed culverts which were buried in the road bed, and have been replaced by 30-36 inch diameter culverts with trash racks. Culvert 4 has also plugged in the past and is likely to be a more recent addition along with Culverts 8 and 9. Severe gully erosion downslope from Culverts 5 and 7 has contributed a large amount of sediment to tributary streams, and is due to uproad culvert failures. The effects of gully erosion below culverts can be transmitted downslope to other culvert locations. For example, Culverts 6 and 7, M-Line, provide a possible scenario explaining the hillslope gully erosion found downslope of the M-6-2 Road (see Figure 4, page 8). Culvert 6 failed and sent its water to Culvert 7. The increased flow gullied a course downslope which initially paralleled Drainage #3, but merged with the stream just above the M-6-1 Road. Streamflow, exceeding culvert capacity, with high bedload concentrations and float debris plugged the culvert at Stream Crossing #2, M-6-1 Road. The plugged culvert diverted streamflow down and across the road, causing severe gully erosion to the lower hillslope. Severe gully erosion has also taken place downslope of Culvert 10, M-Line, but is more a result of stream diversion than of uproad culvert failures.

With the exception of a few isolated reaches, culvert fed gullies on the hillslope above the M-6-1 Road are inactive features, having downcut to either bedrock or basement material. The gullies downslope of Culverts 5 and 7, M-Line, are related to up-road culvert failures. Today, inboard ditches along the M-Line are no longer downcutting and trash racks are constructed at every culvert inlet. In addition, hillslope areas above the M-Line are revegetated with conifers. Assuming no future culvert failures, the peak flows which formed these gullies should not reoccur.

Two labor intensive treatments were prescribed for treatment of these culvert-related gully features. First, a channel (Site A) was manually excavated to de-water the lower reach of the gully downslope from Culvert 7, M-Line, delivering gully flow to the channel of Drainage #3. Here, slash dams (i.e., crude check dams) were constructed in the diversion channel from on-site material. Secondly, a 36-inch diameter culvert with downspout was added to the M-Line in the natural stream course of Drainage #1. This re-established a natural drainage course and de-watered the active gully below Culvert 10, M-Line.

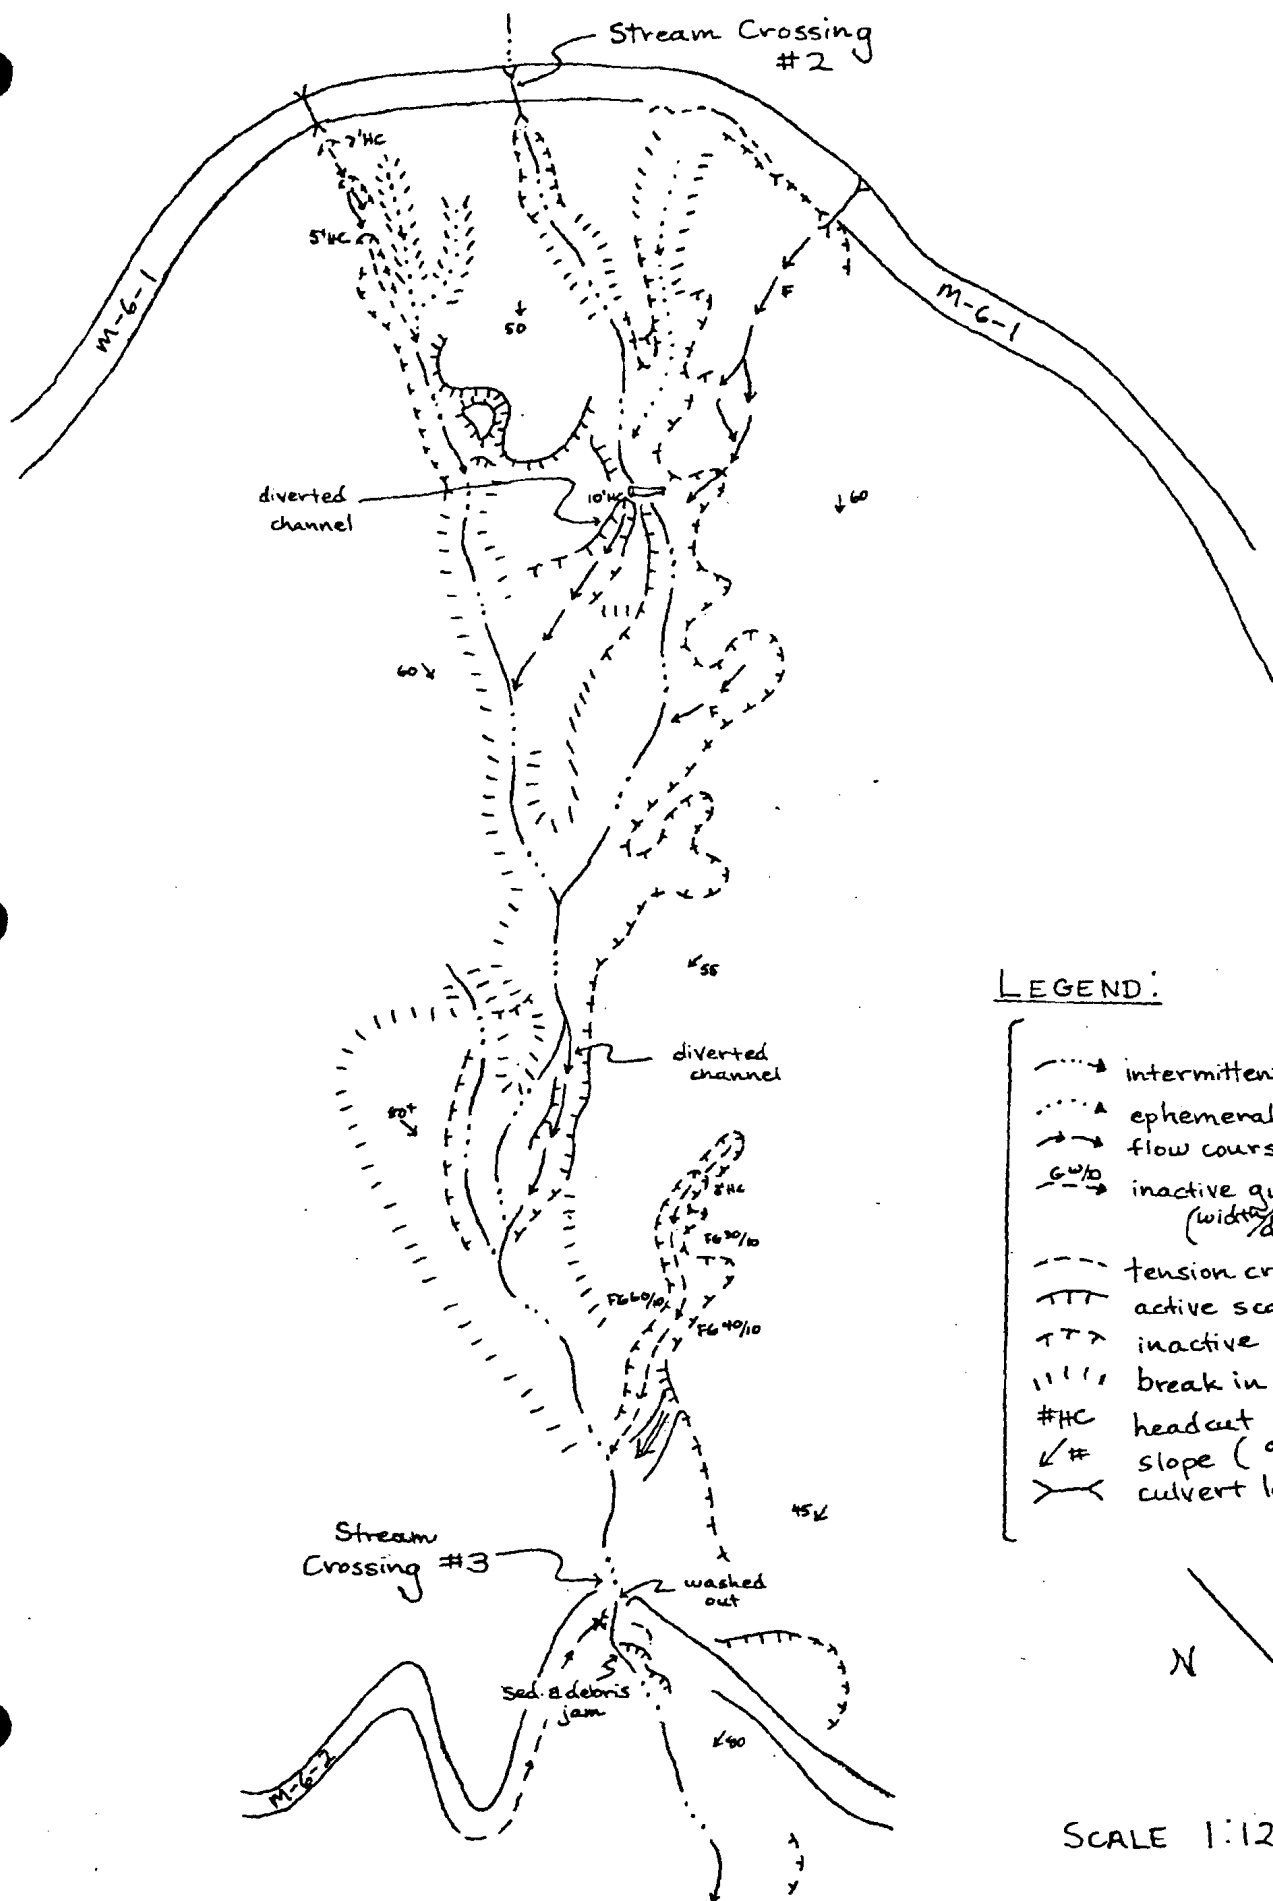
FIGURE 5. DRAINAGE #3 BELOW THE M-6-1 ROAD

This lower reach between the M-6-1 and M-6-2 Roads is a high sediment source area. Major sediment sources, however, are no longer on the streamside hillslopes but are in the stream channel itself. Channel erosion of this stored sediment is the primary source of sediment today. No treatment is prescribed at this location because it is inaccessible to equipment and the downstream reaches of the stream would be severely impacted should large volumes of stored sediment be released.

Secondary sediment sources are two channel diversions within this reach (see Figure 5, page 11). The upstream channel diversion is downcut to a grade consistent with the abandoned channel's grade. Only the left bank remains oversteepened. No treatment is prescribed for this channel diversion because even if equipment could access this area, it would be extremely difficult to retrieve and maintain the original flow course due to the depth of downcutting at the point of diversion. The second, downstream channel diversion is not treated for similar reasons.

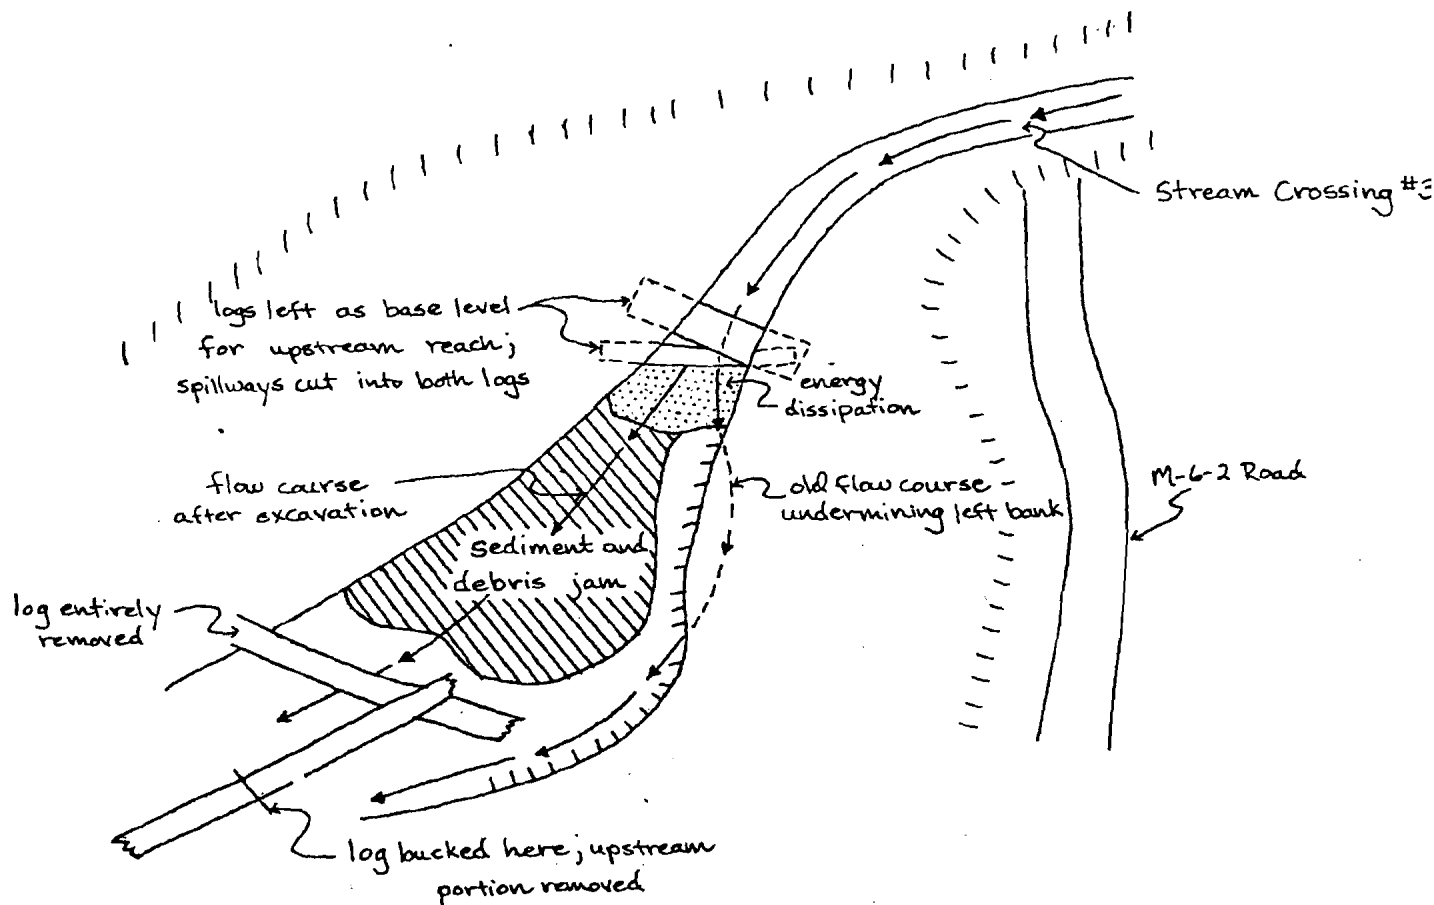
FIGURE 7. SEDIMENT AND DEBRIS JAM  
BELOW STREAM CROSSING #3, M-6-2 ROAD

A small debris-sediment jam was located immediately downstream of Stream Crossing #3, M-6-2. The jam diverted high flows against the left bank, undermining the fill-slope above it (see Figure 7, page 16).

The following treatments were prescribed at this site: 1) key logs were removed and stored slash and sediment were excavated from the channel leaving upstream logs keyed into the banks as a base level for the upstream reach; 2) spillways were cut into these keyed-in logs to direct flow towards the center of the channel; and 3) energy dissipation was installed in the form of large slash placed at the base of keyed-in logs to prevent them from being undermined.

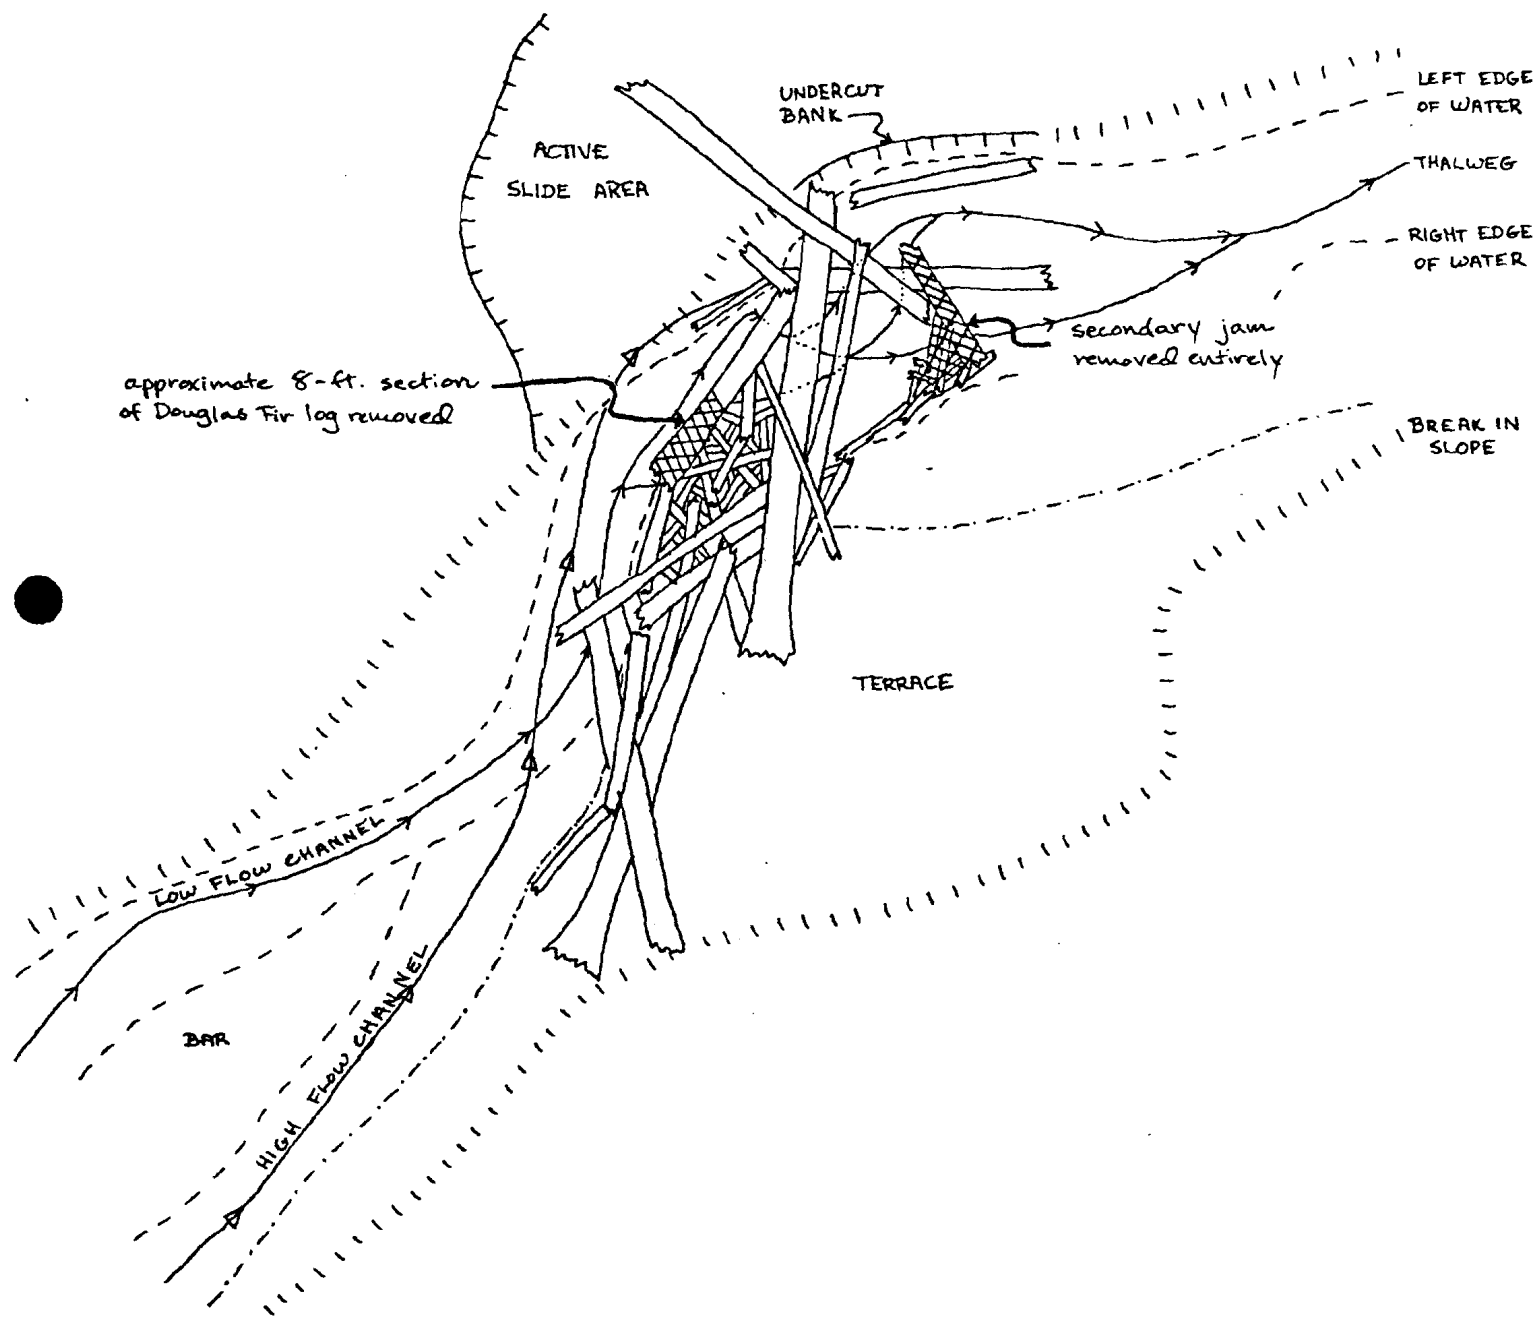
FIGURE 8. MORPHOLOGIC MAP OF BRIDGE CREEK LOG JAM - SITE E

Anyone familiar with the large upstream log jam will realize the futility of trying to remove this feature. No treatment was prescribed. The downstream log jam, downslope from Road Failure #1, was a bit more treatable. During high flow regimes, a single log spanned the channel, and directed streamflow into the left bank (see Figure 8, page 20). Just downstream, a second jam, composed of float debris and no stored sediment, also encouraged streamflow into the left bank. The result was active streamside sliding into Bridge Creek.

Treatments prescribed to control streamside erosion at the downstream log jam site include: 1) the removal of an 8-foot section of the Douglas-fir log which encouraged streamflow towards the left bank; and 2) removal of the entire float debris jam.
