SKUNK CABBAGE CREEK:  
An Evaluation of 1980 Rehabilitation  
Training Sites and Techniques

Annette M. Parsons  
Robert B. Rohde

Redwood Community Development Council  
Forest Improvement Center  
Eureka, California  
April, 1981

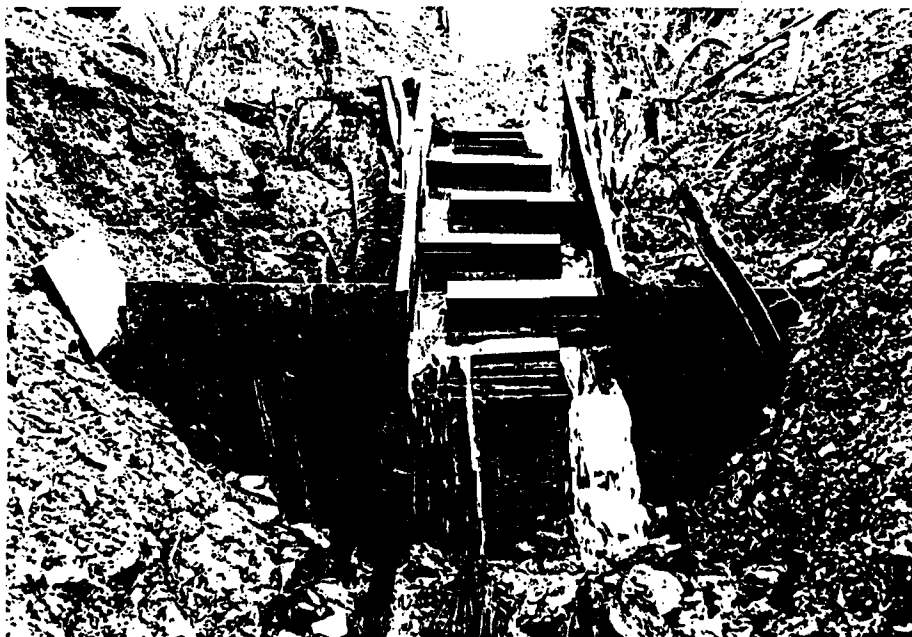
no sidecutting has occurred. The riffle box is effectively conducting flow and slowing water velocity with no significant leakage, but at the base of the energy dissipator below the riffle box, a plunge pool has developed. This is undermining the stakes which secure the rocks, and eventual failure is inevitable unless maintenance takes place. Some overall channel downcutting has occurred.

FIGURE 16. Riffle box at Site 2.

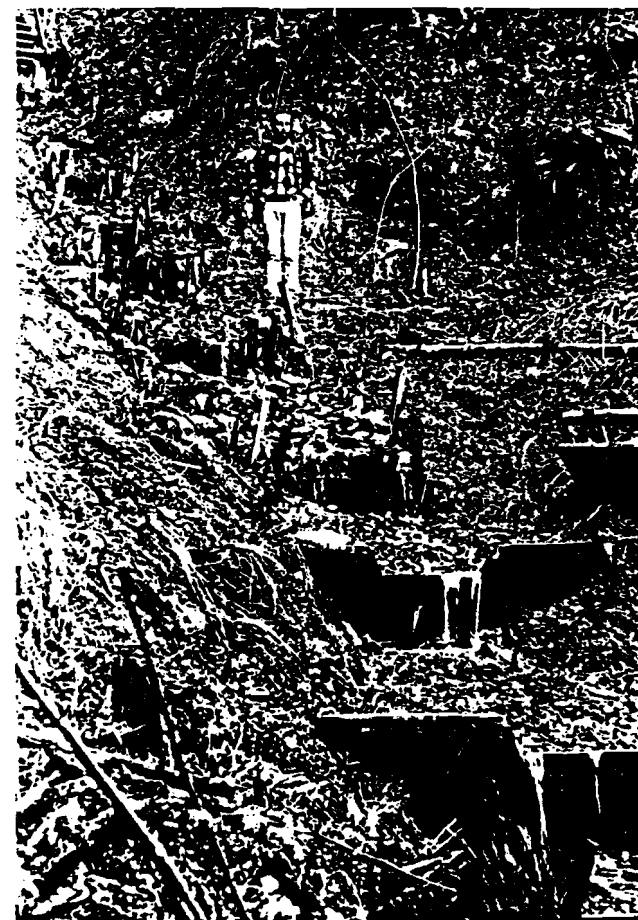
Near the lower end of this stream section, slab check dams were installed. They have all filled with sediment, and no sidecutting or plunge pool development has occurred. The lowermost check dam at Site 3 is the largest check dam built on the drainage; it too is functioning well. The next dam down from the uppermost check dam at this site should be watched closely. It appears to be retaining a disproportionately large volume of sediment and is exhibiting signs of stress; the slab is slightly bowed and is developing cracks. Higher flows than have occurred to date may side cut this dam.

FIGURE 18. Site 3 after treatment  
and first winter's rains.

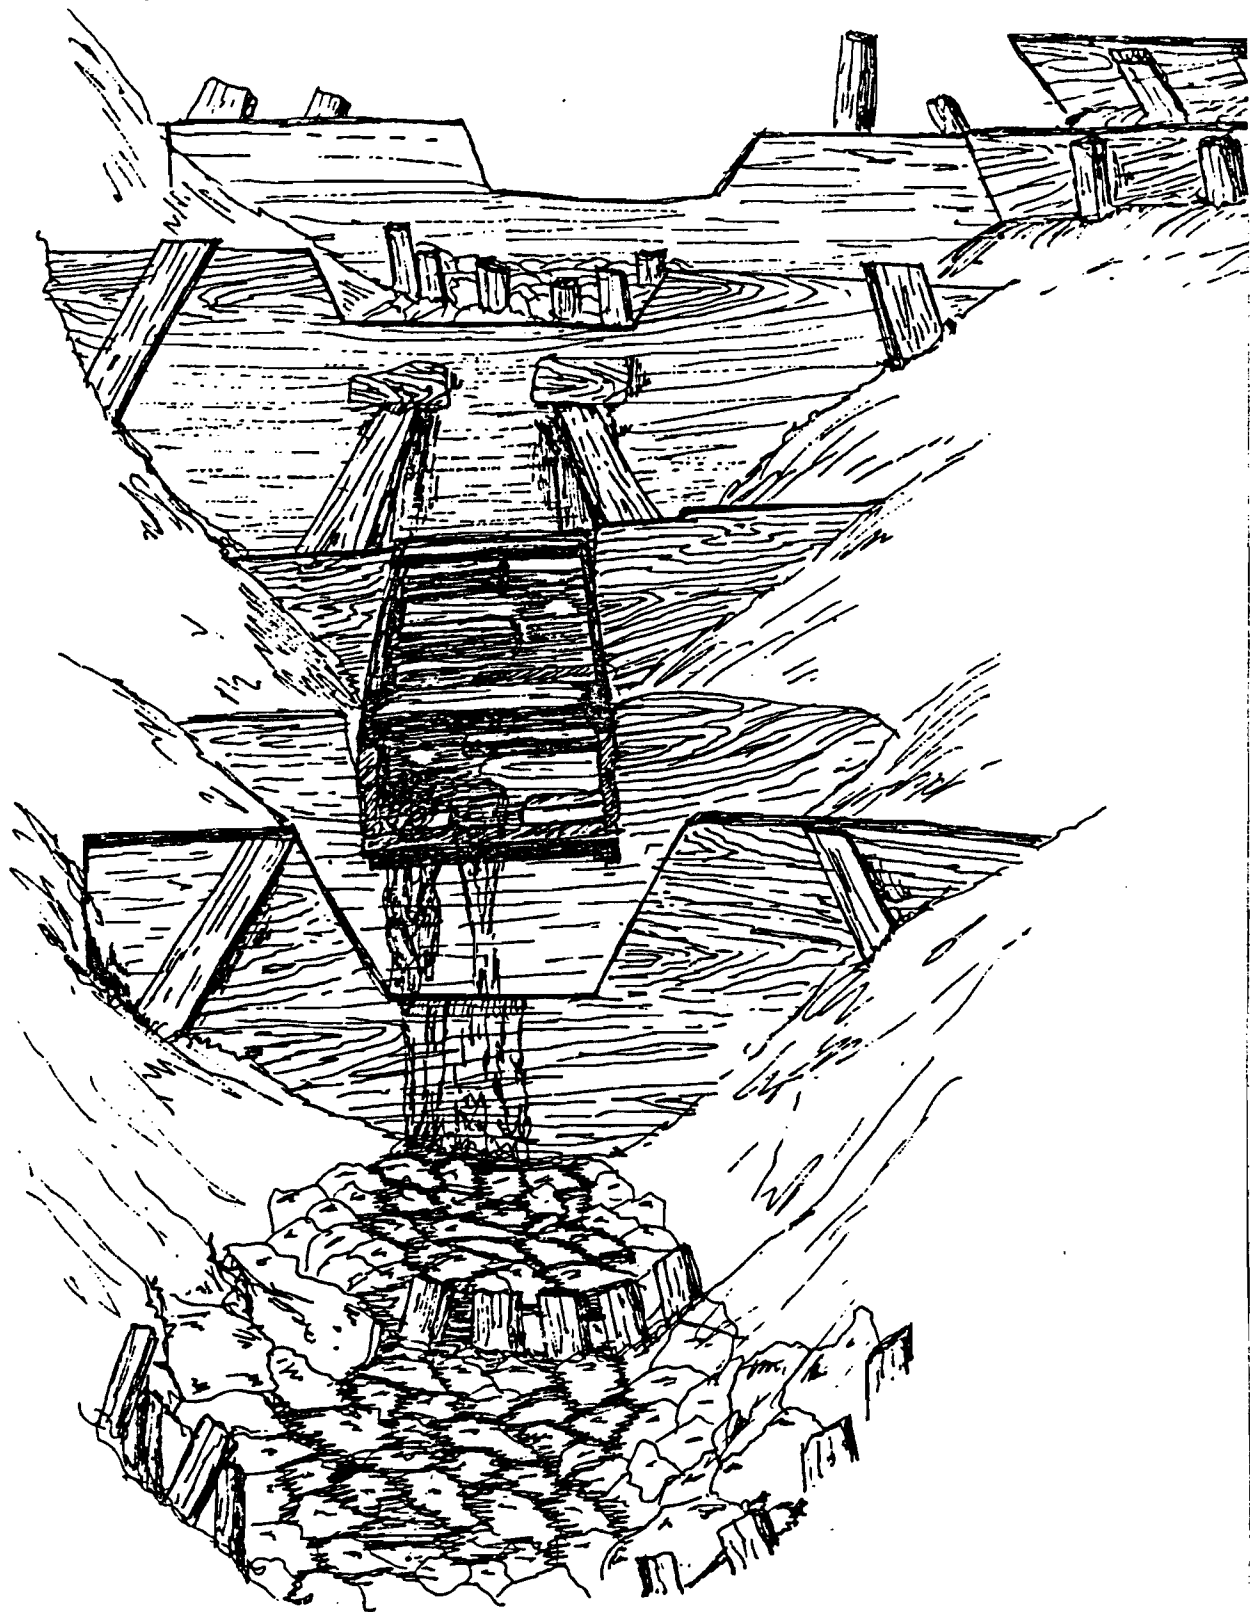
Large pieces of logging debris prevented complete excavation of the stream channel at Site 4. After as much of the fill material as possible was removed, streamflow went underground into a hole in the remaining fill. This created potential for instability due to soil piping and subsurface saturation. The structures built at this site were designed to keep streamflow above ground to minimize this hazard. The uppermost structure is a riffle box approximately eight feet long. The slabs which support this and other riffle boxes and water ladders are expected to act as check dams. These dams act as a foundation for the other structures. In case of significant leakage beneath the structures, a V-notch has been cut into these slabs to discharge any water that may build up behind them (Figure 19).

The riffle box at Site 4 functions as designed, with no significant leakage. Cotton fiber caulking was used to seal joints in flow-conducting structures and has proven to be effective. Below the riffle box, a series of slab dams and rock and stake dams help to

prevent channel downcutting and trap sediment (Figure 19). The dams appear to be large enough to handle most high flows, and little or no plunge pool development can be observed. A foot bridge was constructed across the stream channel at Site 4 for the observation trail. Below this bridge, steepness of slope and depth of excavation, beyond the limits of the equipment, prevented complete channel excavation. Streamflow began to flow subsurface at the top of the scarp headwall created by the slide of March 1980; saturation and piping here would greatly increase potential for further sloughing of the oversteepened scarp. To avoid this, a slab check dam and riffle box series was built to conduct flow above ground and into the water ladder at Site 5. Some water flow is creeping back through the V-notch under the riffle box and saturating the ground beneath the box. The degree of saturation does not appear great, and the problem can be easily treated by nailing a small bat under the lip of the riffle box, or by closing off the V-notch under the riffle box altogether.

FIGURE 19. Erosion control structures at the lower end of Site 3, upper end of Site 4.

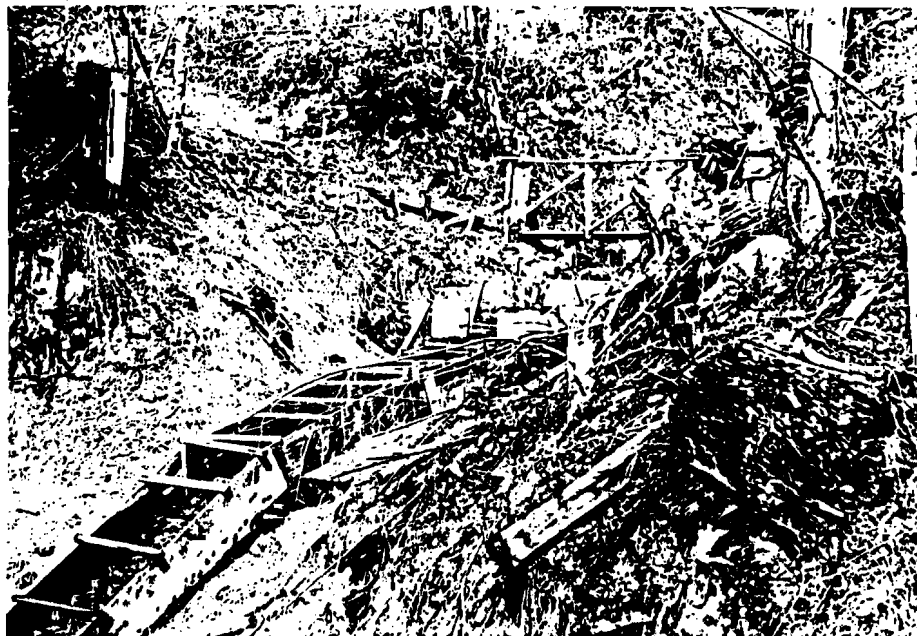
FIGURE 21. Site 4 after manual labor and after first season's rains.

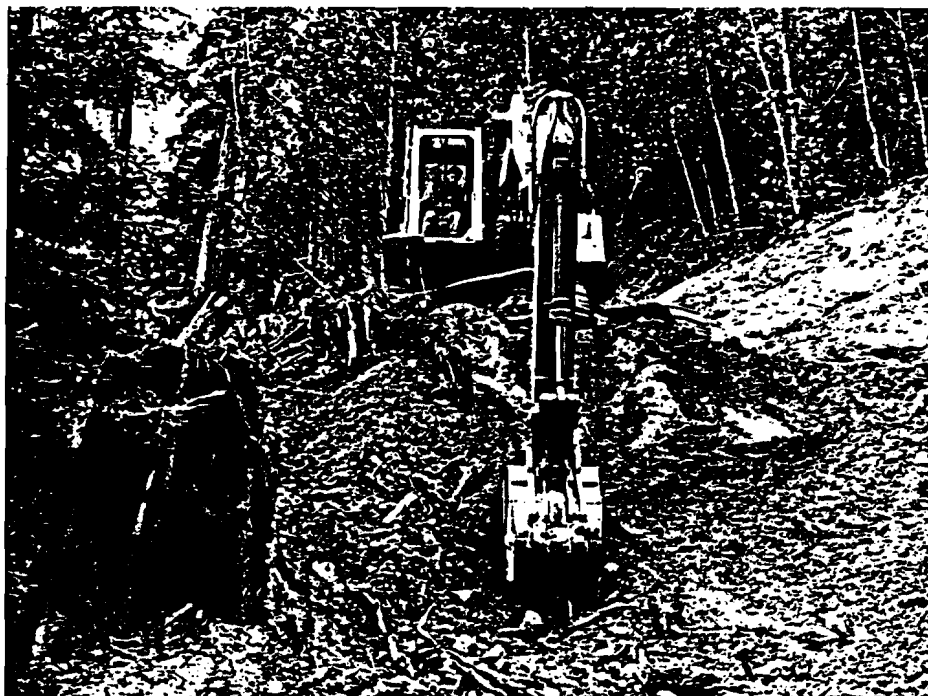
FIGURE 24. Site 5 during heavy equipment.

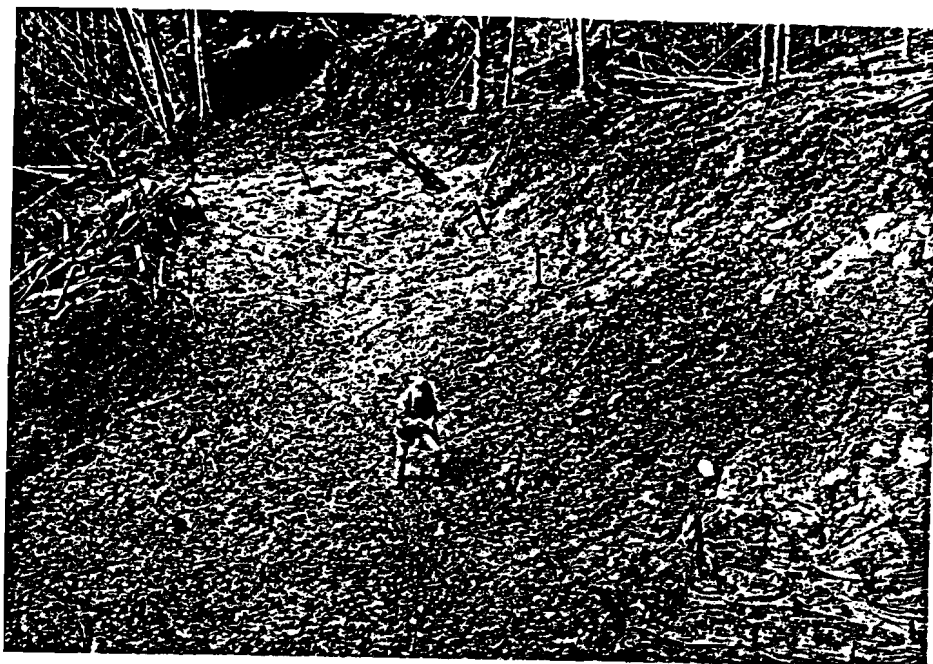
sides of the water ladder and rock armor was mulched with straw secured with jute netting. These areas are natural seep areas; therefore, alder and rushes were planted to rapidly establish a good vegetative cover with adequate root strength to help stabilize the area. The former skid trail was treated as previous sites, with straw mulch and planted tree seedlings.

FIGURE 25. Site 5 after heavy equipment and manual labor.

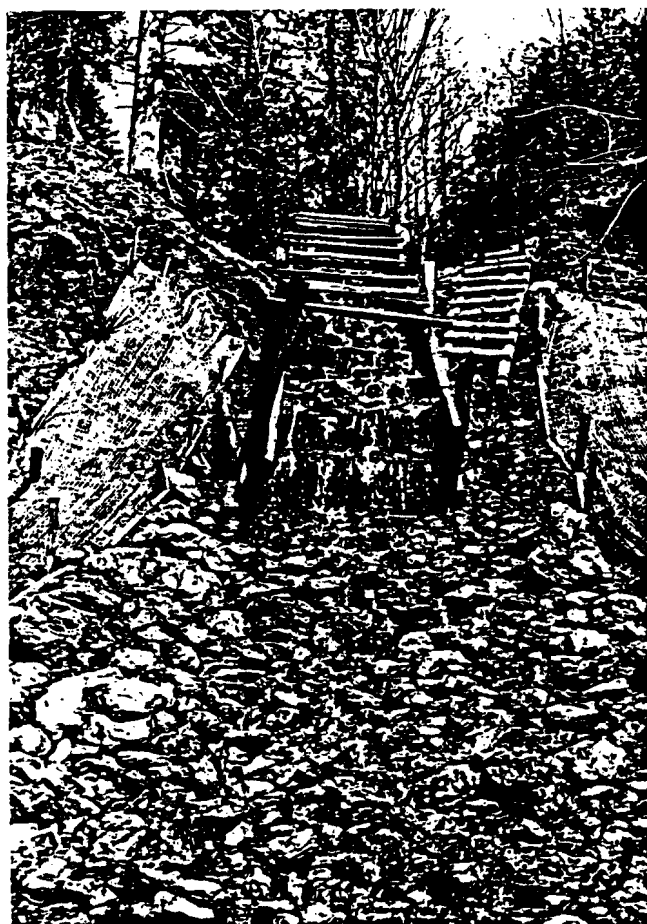
This reach of channel consists of the March 1980 slide headwall area. A water ladder about thirty feet long conducts water from the above riffle box, over the oversteepened scarp, and onto an extensive area of shingle-lapped rock armor. No significant leakage from the wooden structures is evident. Regular inspection and maintenance of the water ladder will be necessary to insure against serious leakage and malfunction, as ground saturation at this point could result in another deep-seated failure, destroying all structures downstream. The rock armor, which is anchored firmly into bedrock at the base, is functioning well to prevent channel and bank degradation. A small amount of side cutting at the base of the armor does not appear to be undermining the support base. The steep area on both

FIGURE 26. Water ladder, jute netting, and rocking at Site 5.

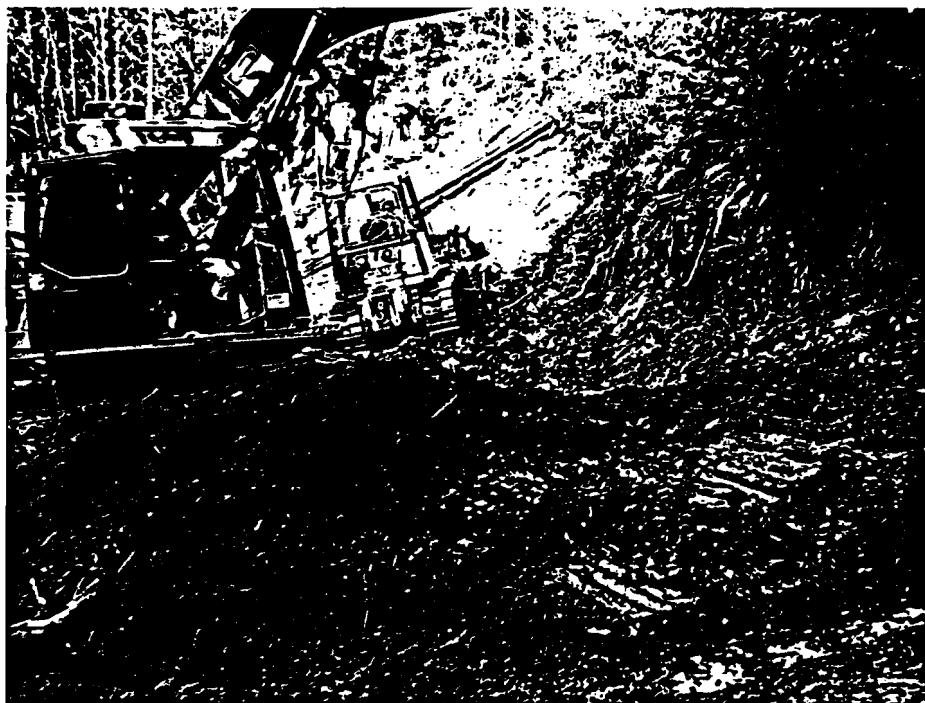
FIGURE 28, Heavy equipment at Site 6.

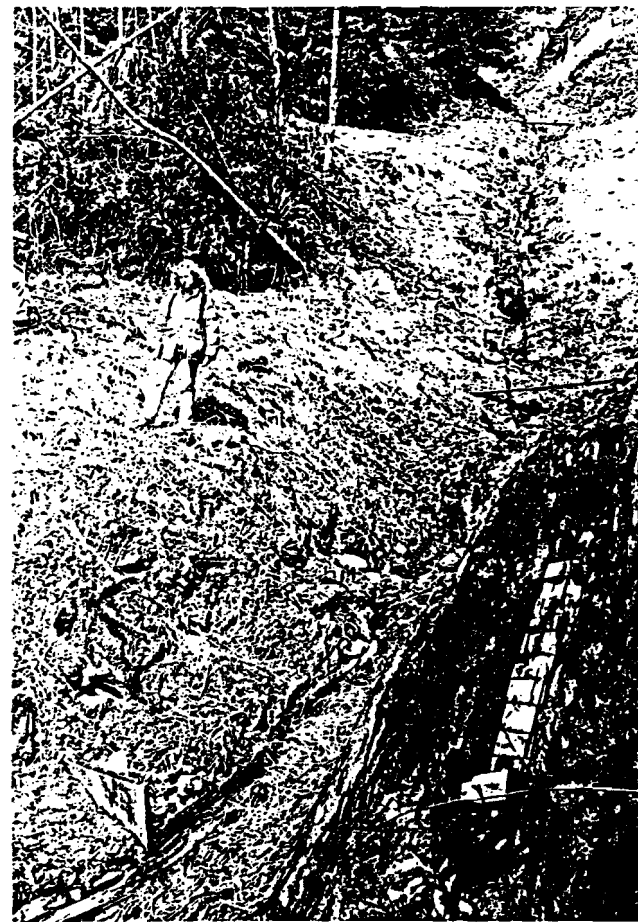
FIGURE 31. Heavy equipment and manual labor work completed, Site 6.

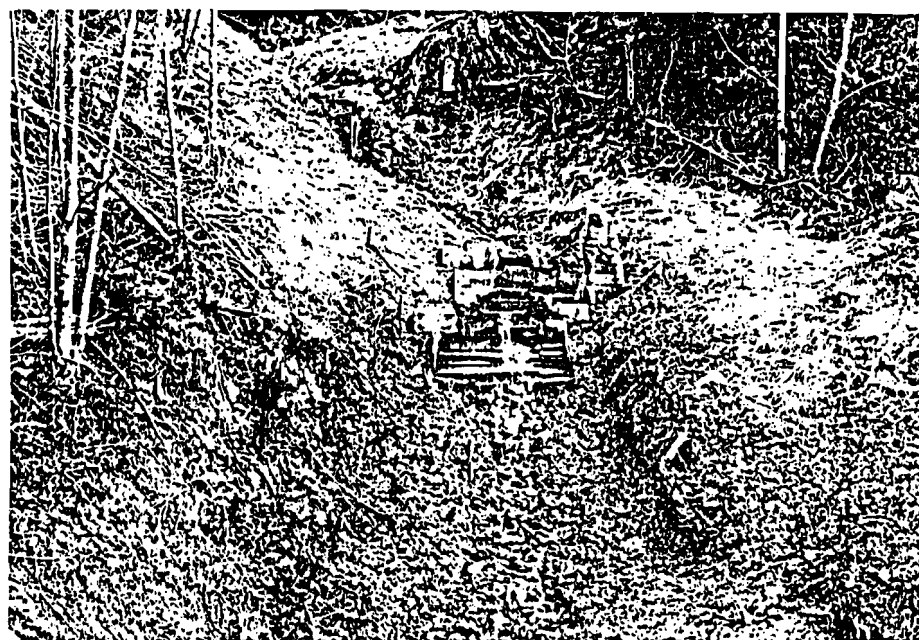
FIGURE 35. Site 7 after manual labor and first winter's rains.

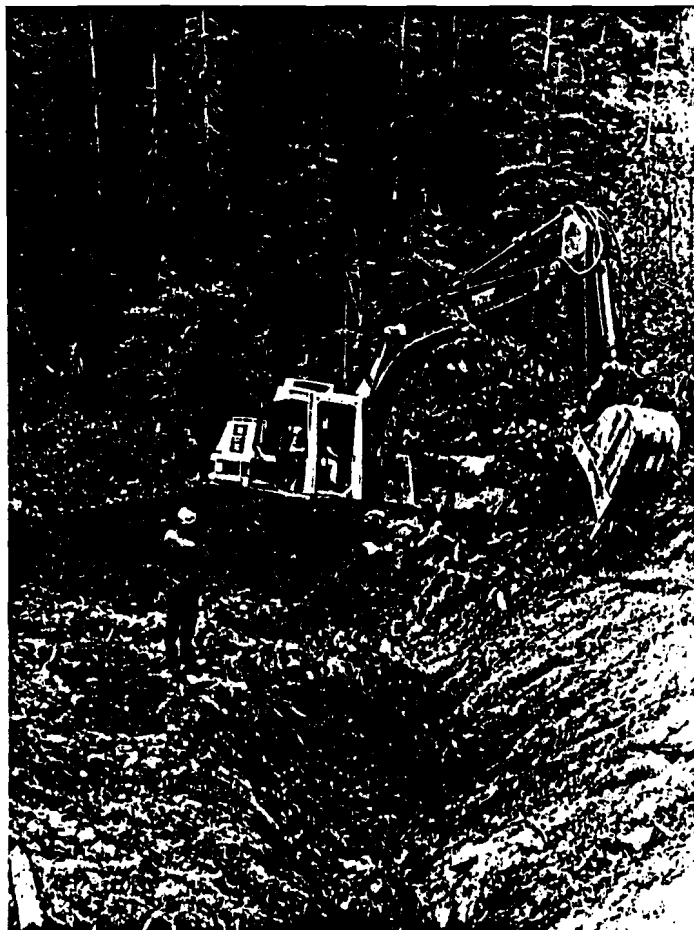
FIGURE 37. Heavy equipment at Sites 9 & 10.

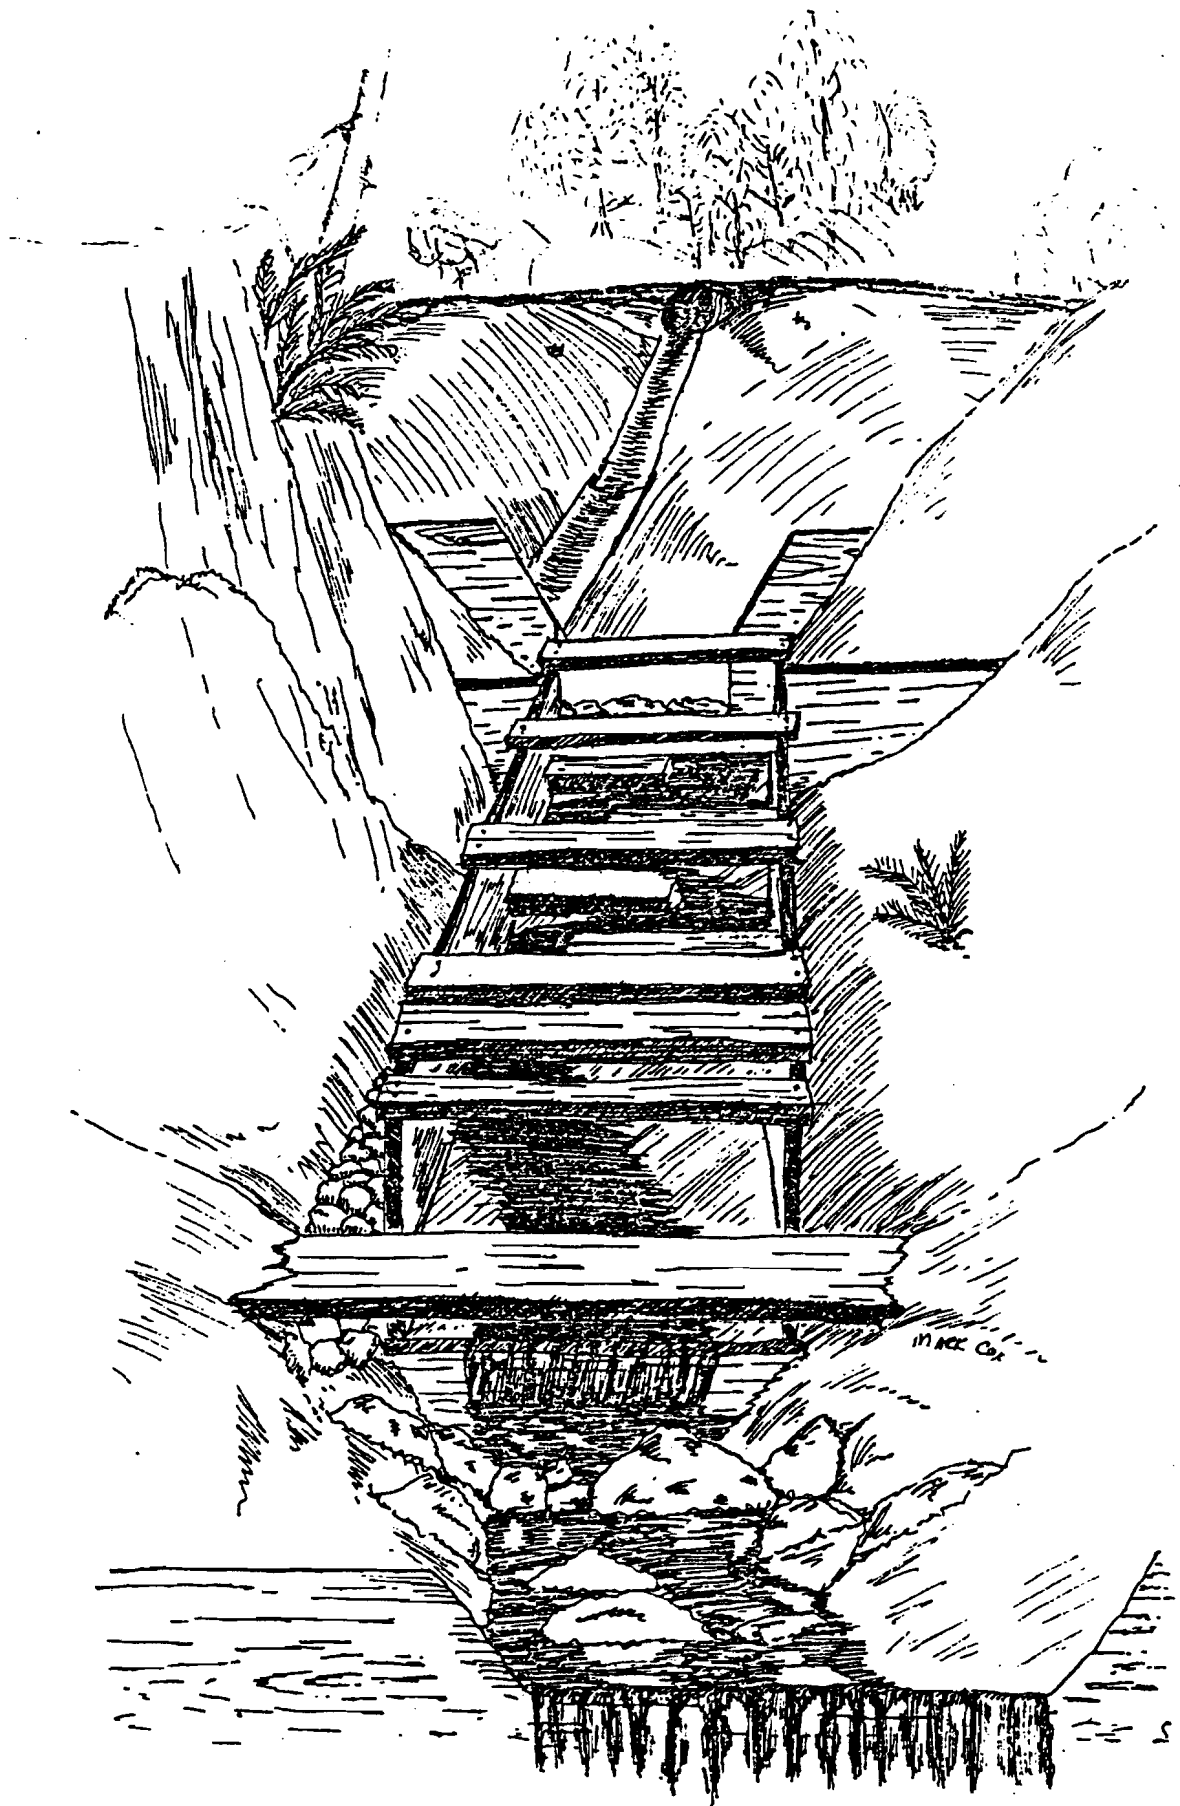
At Site 10, a riffle box about 15 feet in length conducts flow over a steepened channel reach. The only apparent problem is a slight plunge pool developing at its base. A submerged spillway which was intended to

halt development of a nick point has been severely undercut, threatening the structure and adjacent channel banks. From this point on down, no further channel structures were built. The stream flows onto bedrock, to a drop of about 15 feet. The contour terraces constructed on raw exposed slopes at this site were constructed of shorter poles, and are not continuous across a terrace level. Rills and gullies are developing where gaps in a terrace occur. These terraces need some repair, and perhaps should be replaced with longer poles to form a continuous terrace at each level. Planted seedlings look good, and horsetails (Equisetum sp.) are returning to the slopes in abundance.

FIGURE 40. Riffle box at Site 10.
