**Appendix 2:**  
**2007 Watershed Restoration Projects,**  
**Lost Man Creek**

# **Watershed Restoration Project 07-01: Removal of the West Side Roads---07-01A, Removal of the A111 Road---0701B**

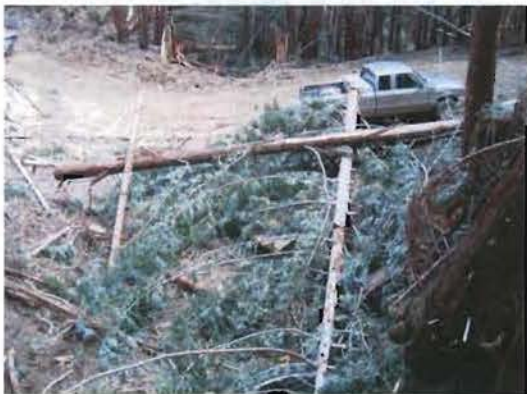
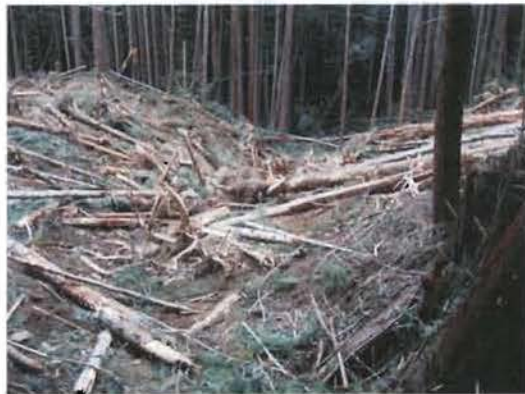
Photos 1 and 2: RX10, A150 Road.

For the low-order stream crossings, excavations were typified by moderate channel development, subtle channel morphology including relatively shallow side-banks, and relatively low volume of fill. These crossings were also typically dry or contained minimal flow. Photos 1 and 2 show the typical conditions associated with these low-order stream crossing excavations.

Left photo depicts initial conditions after equipment opened road for access and excavation.

Right photo depicts conditions of crossing after excavation, showing magnitude of excavation and typical application of woody debris.

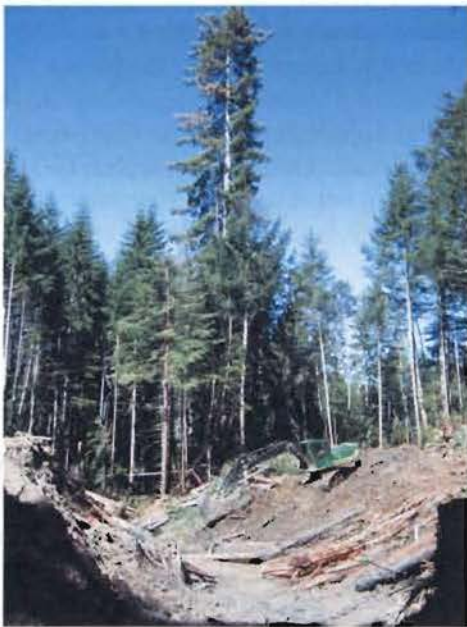
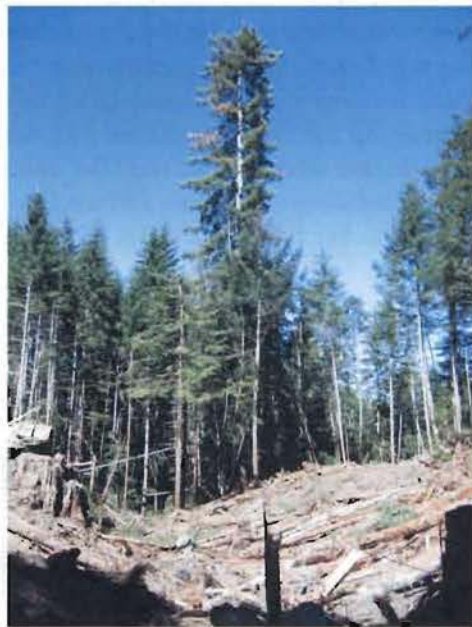
Photos 3 and 4: RX 6, A100 Road, looking downstream

Higher order stream crossings had greater degree of difficulty associated with the excavation, typically due to increased moisture, greater volume and more developed channel morphology. For many of these crossings, flow was present but not located on the existing surface. Thus, excavations were usually initiated at the top of the crossing in order to capture existing stream flow. However, initiating excavations at the top of a crossing could have the adverse consequence of saturating fill, greatly adding to the difficulty of the excavation. For excavations with a more voluminous flow, excavations were usually initiated with the goal intent to capture and divert existing flow and then at a later time, begin formal excavation of the crossing itself. This allowed for a dewatering of the excavation site as well as minimizing the generation of turbid water. Photos 3 and 4 represent an excavated channel of a higher order stream.

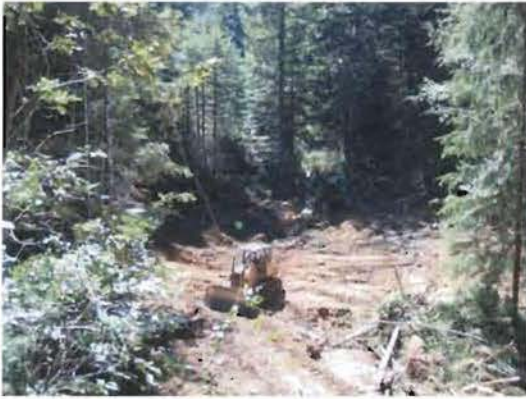
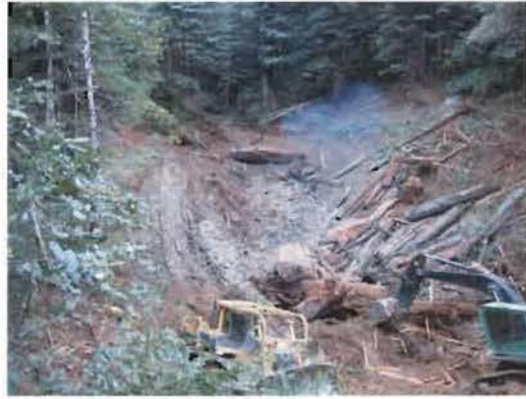
Photos 5 and 6: RX1, A111 Road

Photos 5-7 document the excavation of RX1 on the A111 Road. This stream crossing was a large landing that was located at the end of the A111. An added difficulty to this excavation was the need to export fill to a suitable fillsite which was located in the foreground of these photos. This required the excavation of the top of the crossing before completing the bottom, which allowed moisture to increase in the excavated material. Normally, it would be preferred to start excavation at the bottom of the crossing to allow for free drainage but in this case, doing so would have

truncated access to the fillsite. Instead, initial excavation removed the upper portion of the crossing, which intercepted stream flow. This was then diverted around the worksite and excavation then resumed at the bottom of the crossing.

Photo 5 shows crossing shortly after landing has been brushed and initial excavation has begun. Photo 6 taken during the excavation of the channel. The upper portion of the crossing has been excavated.

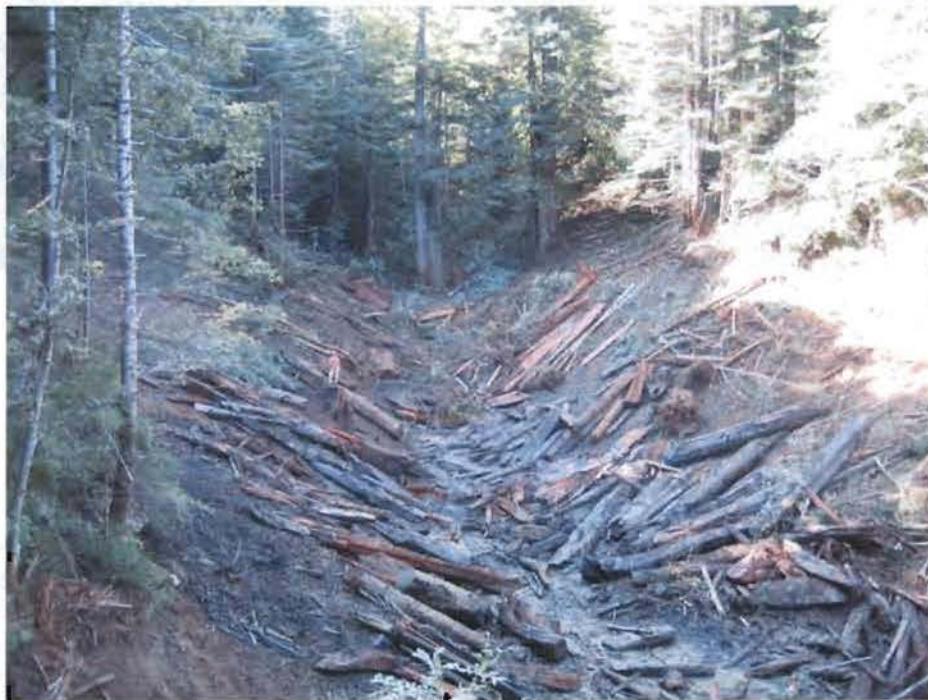
Photos 7: RX 1, A111 Road.

Completed crossing excavation. Note the individual standing on an exhumed stump in center left of the photo.

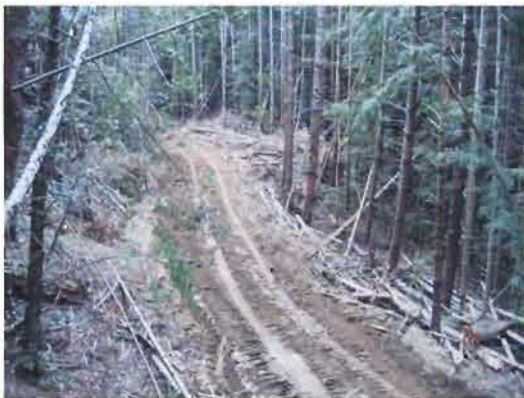
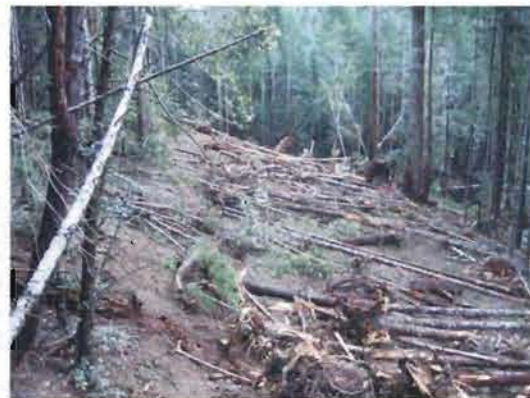
Photos 8 and 9: EOS prescription on the A100 Road.  
Left photo shows pre-existing condition with the center of the swale demarked by flagged (pink) tree on outboard edge of the road. Right photo is the final condition after swale has been excavated.

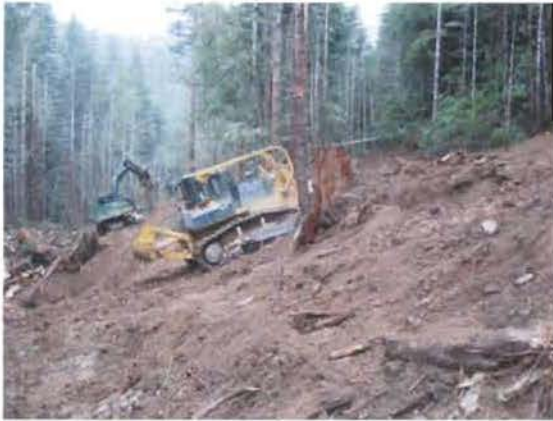
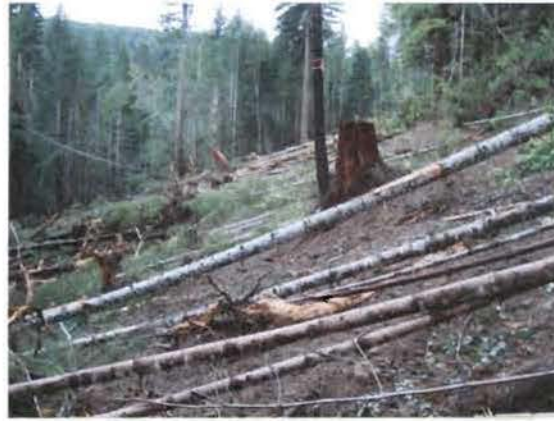
Photos 10 and 11: Outslope prescription, A100 Road.  
Left photo shows equipment in process of outsloping road. Right photo shows condition after excavation was completed.

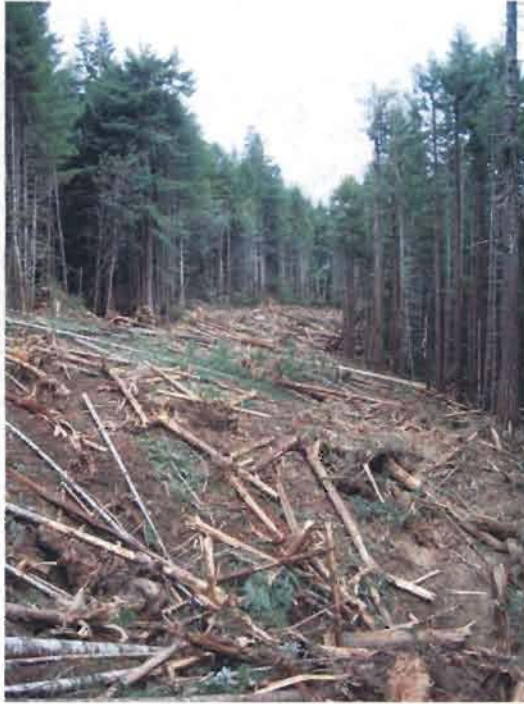
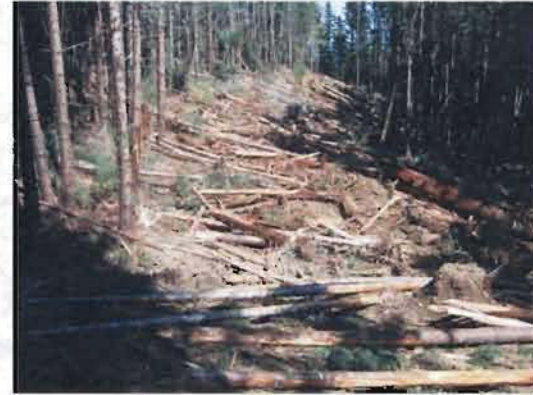
Photos 11 and 12: These are depictions of stand density and woody debris application, typical of treatments on project 07-01.

The west side roads are located in second growth forests that have grown after timber harvesting in the late-50s and early to mid-60's. Prior to the initiation of equipment on this project, these roads have been essentially undrivable owing to the thick regrowth of vegetation. Gaining access into the project area required a considerable amount of time just removing vegetation for access. In addition, the stand density along many of the roads is considerably greater than typical restoration projects and this stand density requires more equipment time to remove and subsequently scatter the vegetation. Photos 11 and 12 show typical conditions that border the roads; these photos also show how the vegetation is subsequently lopped and scattered at the completion of a prescription.
