# **Fort Matanzas National Monument**

## **Structural Condition Assessment Report**

**October 2016**

Structural Engineers:  
Faisant Associates  
810 Light Street  
Baltimore, Maryland 21230

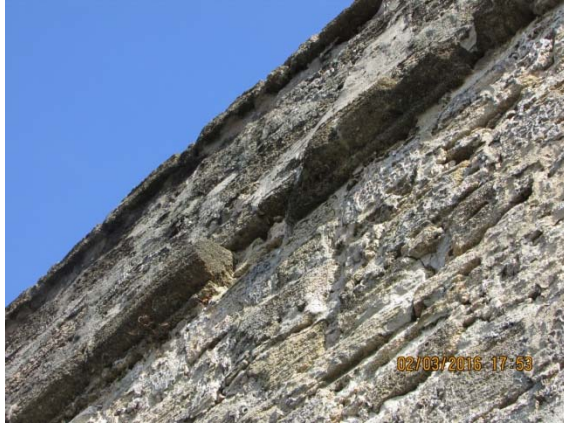
**Photo A-1:** Cordon course deterioration, at north tower wall (2016, Faisant Associates).

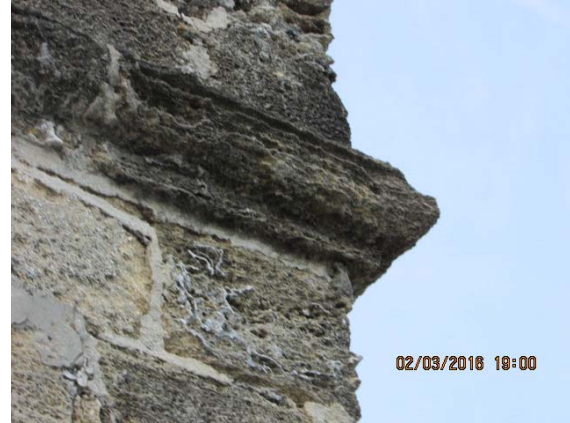
**Photo A-2:** Cornice erosion at southeast tower corner (2016, Faisant Associates).

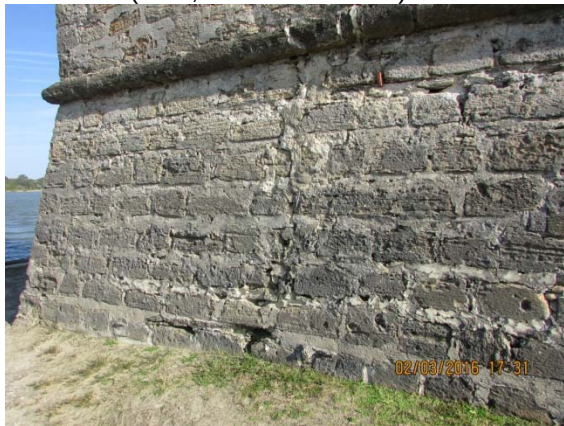
**Photo A-3:** Crack at north scarp (2016, Faisant Associates).

- e. A vertical crack was noted near the northeast corner and it extends from the cordon course down to grade. It follows the mortar joints and shows evidence of past repairs (*photo A-3*).
- f. Erosion of the coquina is most severe along the northeast corner and at the base of the scarp wall near the northwest corner (*photos A-4 and A-5*).

- b. Repoint all existing open mortar joints and cracks.
- c. At locations where older repaired cracks are telegraphing through the repair mortar, remove the existing mortar and repoint.

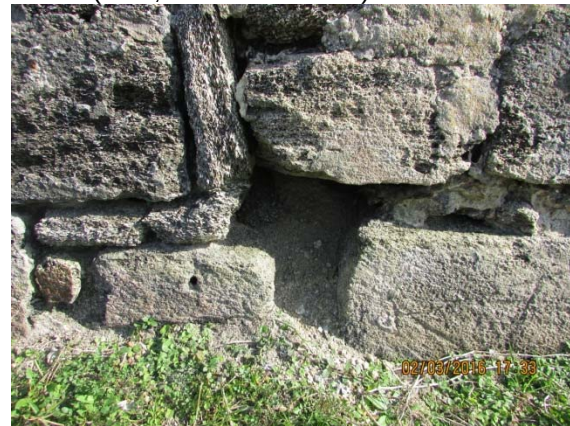
- d. Voids at the bases of the scarp walls were noted along with evidence of mortar washing out from adjacent joints and from the fill soil within the body of the walls.

**Photo A-4:** Void at base of north scarp (2016, Faisant Associates).

- d. Where not a preexisting, historic condition, install new stones where voids have occurred or stones are missing. At locations where cracks run through individual stones, remove and replace the stones.

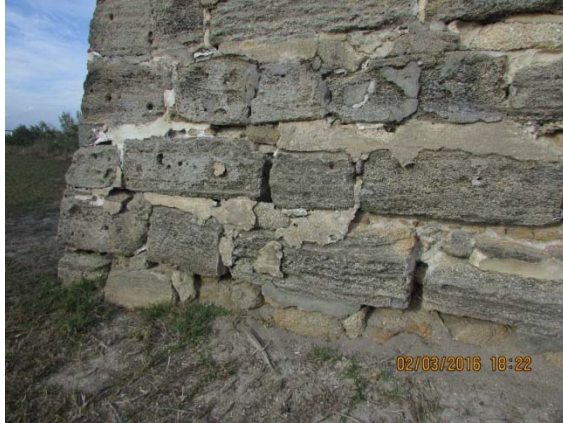
**Photo A-5:** Coquina erosion at northwest scarp (2016, Faisant Associates).

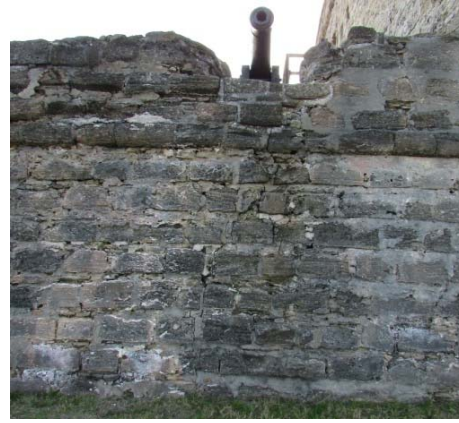
- g. A vertical crack was observed below the embrasure and it extends from the cordon course down to grade. It follows the mortar joints and shows evidence of past repairs (*photo A-6*).
- h. Small voids were observed at several locations where repointing mortar lost its bond and has fallen away.

**Photo A-6:** Crack at east wall embrasure (2016, Faisant Associates).

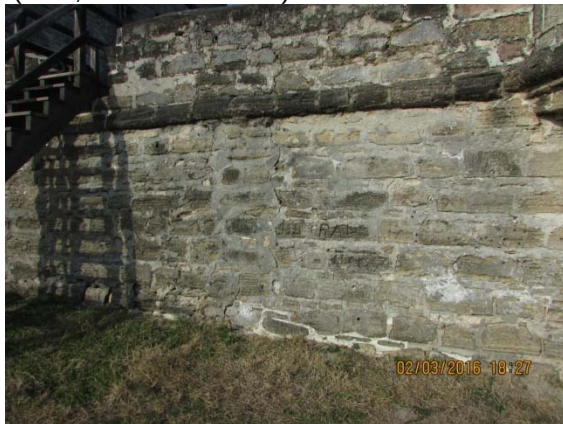
- i. A vertical crack was observed in the scarp wall midway between the stair and southwest corner. The crack is telegraphing through a previous repointing repair (*photo A-7*).
- j. Erosion of the coquina is most severe at the base of the scarp wall near the northwest corner.

**Photo A-7:** Settlement crack at west scarp (2016, Faisant Associates).

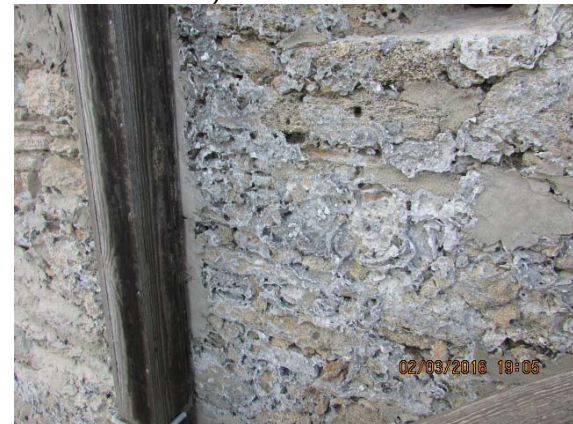
**Photo A-8:** Coquina erosion at south tower wall (2016, Faisant Associates).

- l. Advance erosion of the coquina was observed on the south tower wall, adjacent to the downspout (*photo A-8*). This erosion may predate the installation of the downspout during the 1979-80 renovations. The currently installed downspout dates to 2008.
- m. A mortar joint crack was observed next to the keystone in the head of the second floor doorway. The crack extends through the wall thickness (*photo A-9*).
- n. Severe erosion of the coquina was noted at the southeast scarp corner (*photo A-10*).
- o. Cracks were observed in the tower wall east of the doorway. They are telegraphing through old repairs (*photo A-11*).

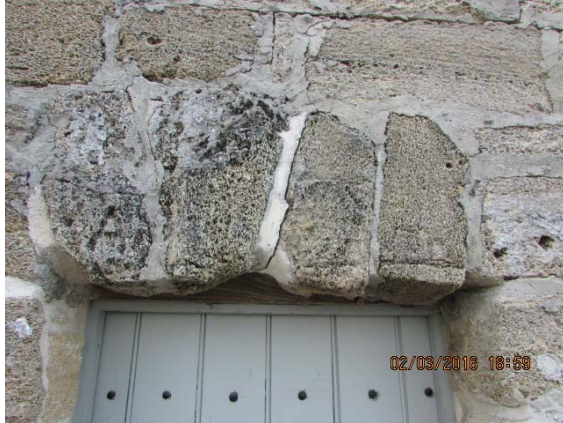
**Photo A-9:** Second floor door head crack (2016, Faisant Associates).

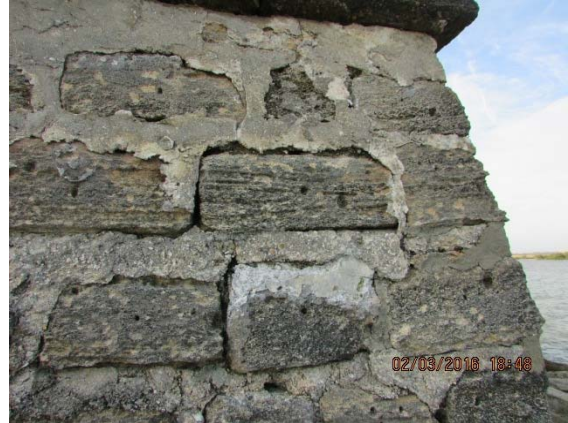
**Photo A-10:** Coquina erosion at portland cement mortar repointing at south scarp (2016, Faisant Associates).

- a. At historic repair locations where a Portland cement-based repointing mortar was used and the adjacent coquina has eroded enough to create ledges along the mortar joint, remove the old mortar and repoint the joints with a compatible mortar. (*Note: During discussions and meetings with maintenance personnel at the Fort, the compatible mortar mix currently in use has a record of satisfactory performance.*) A second option is to remove all Portland cement-based mortar repairs and repoint with compatible mortar. This was discussed with the park and they would prefer to leave the older repairs intact where local coquina deterioration has not occurred.

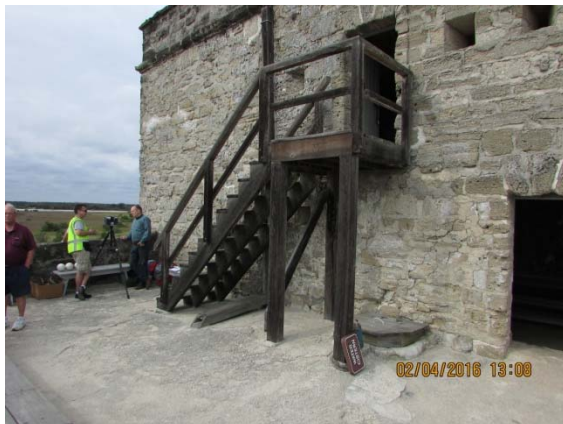
**Photo A-11:** South tower wall cracks (2016, Faisant Associates).

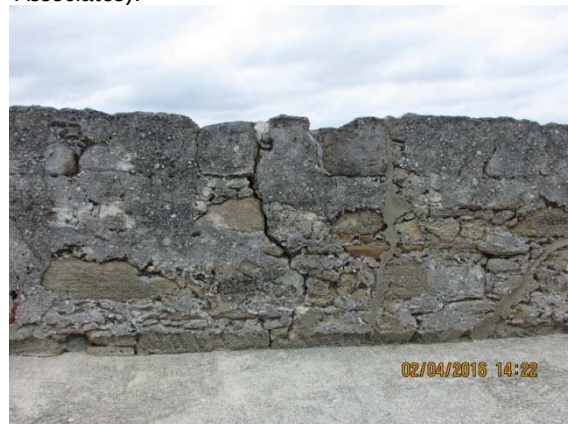
- p. A crack has reopened at a previous repair at the north wall (*photo A-12*).
- q. A large crack was observed on the north wall, at a point approximately midway between the roof hatch and chimney. The crack extends for the full height of the parapet and is confined to the mortar joints.

**Photo A-12:** Crack in north tower parapet wall (2016, Faisant Associates).

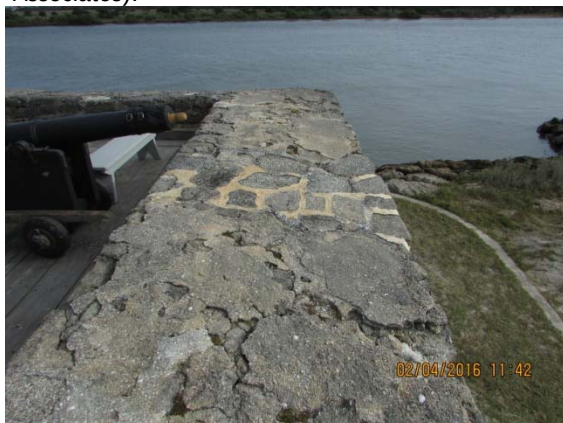
- r. Numerous cracks were observed in the parging on the top surface of the south parapet wall which is allowing the infiltration of water into the body of the wall (*photo A-13*).
- s. Extensive erosion of the coquina was observed along the tops of the east and west walls.

**Photo A-13:** Cracks in parging at top of south scarp (2016, Faisant Associates).

- e. Remove old and cracked parging from the top of the terreplein parapet and repoint cracks and open joints.
- f. Develop a stockpile of high quality coquina. Although maintenance and repair of existing stones are always preferable to pursue prior to considering stone replacement, it is likely that selective stone replacements will be required over a 50 to 100-year maintenance period. The park indicated availability of coquina of comparable density and hardness to that present in the existing structure is limited. It may be beneficial to the park to maintain a moderate quantity of overhead stock in protected storage to facilitate ongoing and future repairs.

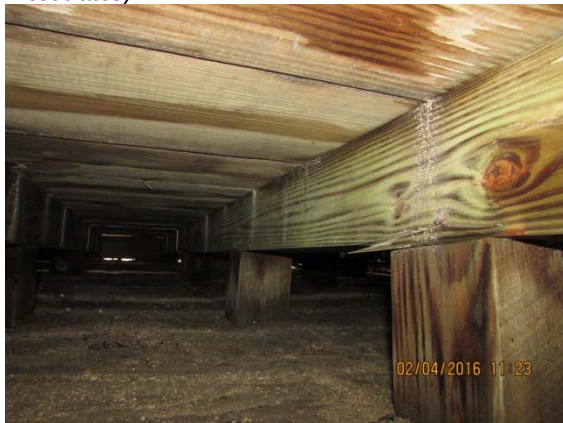
**Photo B-5:** Wood deck framing (2016, Faisant Associates).

approximately 9'-7" and 11'-6" respectively. The decking shows signs of wear but is in generally good condition. Limited observations of the framing did not uncover any deterioration due to weather or insect attack (*photo B-5*).

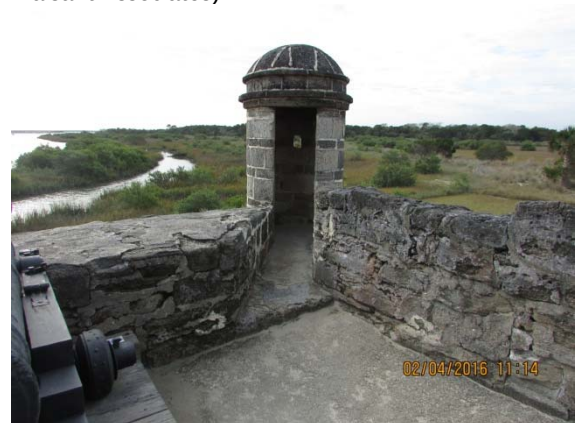
**Photo B-6:** Sentry box (2016, Faisant Associates).

- c. The sentry box underwent two reconstructions in 1926 and 1929, and its corbelled base was repaired during the 1979-80 restorations (*photo B-6*). Though in relatively good condition, the masonry exhibits erosion adjacent to the mortar joints due to the use of a Portland cement based mortar during the 1929 reconstruction.

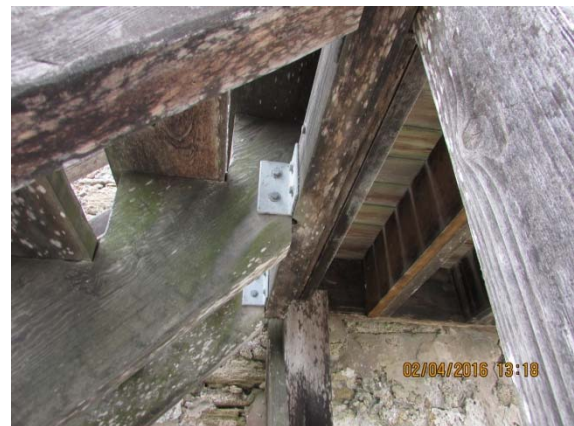
**Photo B-8:** Biological growth on stair framing (2016, Faisant Associates).

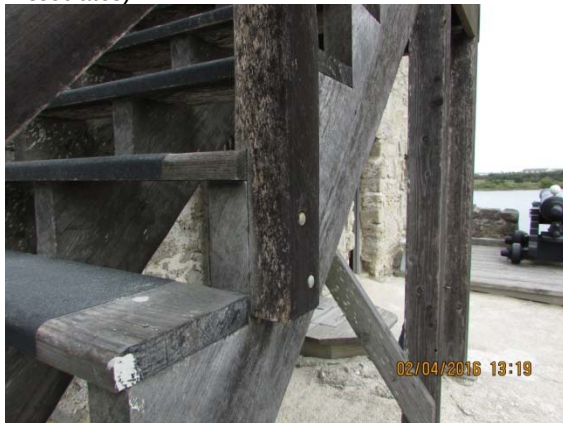
- e. Carriage bolts were used at the connections between the rail posts and the stair framing. The Park has indicated that the bolts were added after the stair reconstruction to reinforce the connections. The National Design Specification for Wood Construction (NDS) does not publish values for this type of bolt nor does it specifically recognize their use; however, past experience with the analysis of similar rail post connections indicates that it is unlikely that these connections would be sufficient to resist current code requirements for guardrail loading. Additionally, this type of post anchorage causes

**Photo B-9:** Stair rail post connection (2016, Faisant Associates).

cross-gain bending in the stair stringer, a condition that should be avoided per recommendations in the NDS (*photo B-9*).

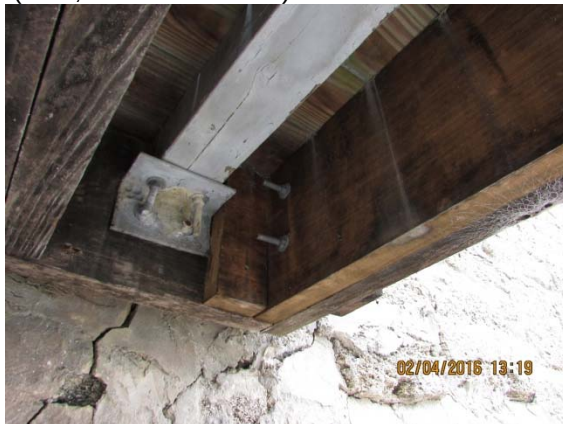
**Photo B-12:** Wall crack at beam seat connection (2016, Faisant Associates).

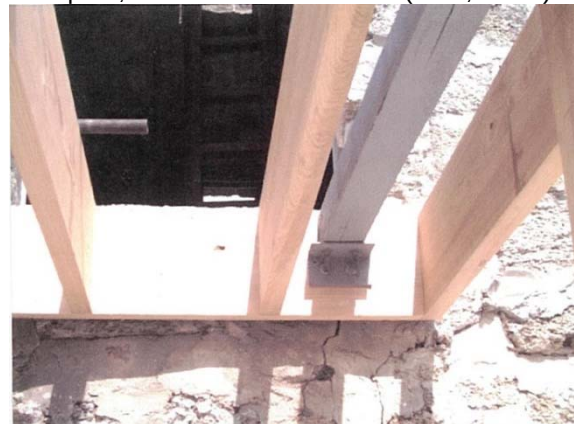
**Photo B-13:** Wall crack at beam seat connection, 1998 stair reconstruction (1998, FOMA).

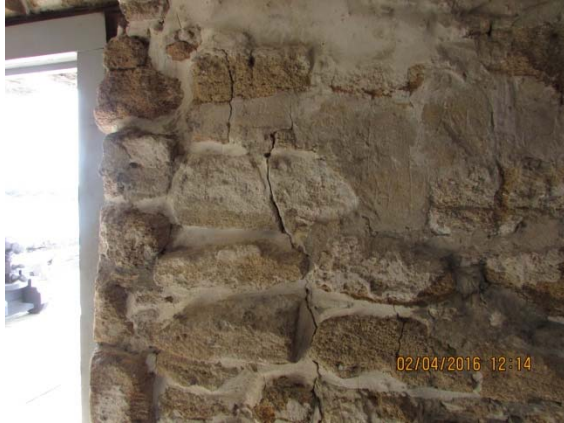
**Photo C-3:** Wall crack, west side of doorway (2016, Faisant Associates).

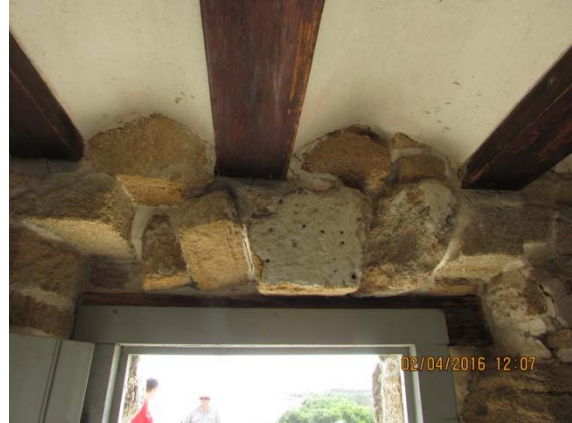
**Photo C-4:** Crack at door head (2016, Faisant Associates).

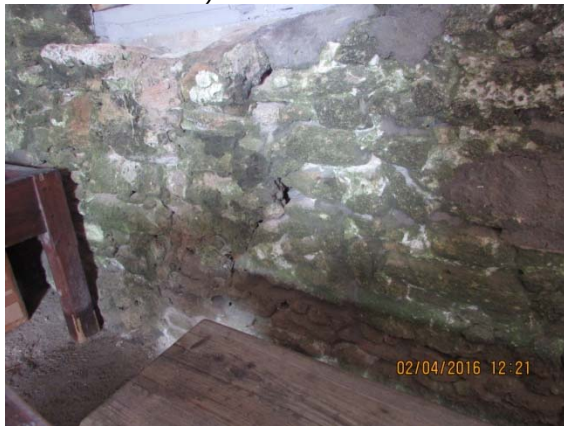
**Photo C-5:** Biological growth on north wall (2016, Faisant Associates).

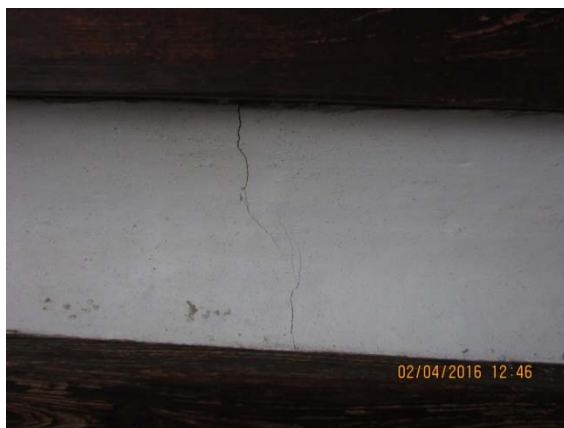
- a. A crack was observed in the vaults that span between the second floor joists. The crack runs east/west, appears in each vault, and is located 3'-0" to 3'-6" north of the south wall (*photo D-1*).
- b. A small area of the tabby concrete has delaminated at the fourth vault east of the west wall at a location near the south wall (*photo D-3*).
- c. The first, second, and fourth joists east of the west wall, replaced during the 1979-80 restorations, and the historic joist, are 6 inches wide across the bottom surface and have a flange thickness that varies between 1¼ to 2½ inches. The remainder of the joists measure 7 inches across at the bottom and have a consistent 2½-inch thick flange. No decay or deterioration of the wood was noticed, however, most of the joist depth is

**Photo D-1:** Crack in ceiling vault (2016, Faisant Associates).

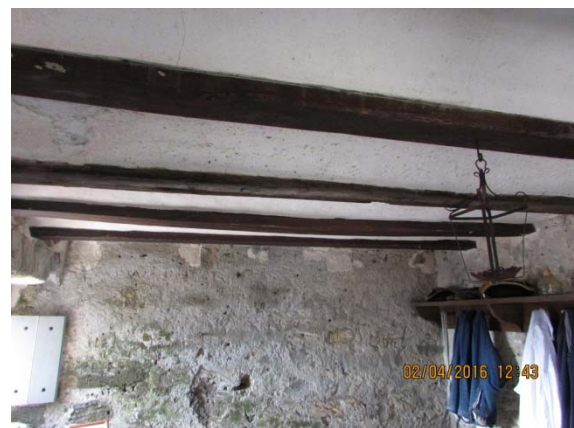
- d. A noticeable vertical deflection was observed in the second and fourth joists east of the west wall (*photos D-2 and D-3*). A coquina partition wall is located above this area on the second floor and the weight of the wall may be contributing to the deflection by way of load sharing through the arched floor slab (*photo E-6*)., though the main factors affecting the deflection are: the thickness of the slab in this area, replaced in 1916, appears from the 1979-80 drawings to be greater than the adjacent, newer slab; the concrete used in 1916 was most likely higher density normal weight versus the light weight concrete used for the 1979-80 slab; and these joists have a smaller cross section than the other joists replaced in 1979-80 (i.e. the bottom flange thickness and width are less than those of the joists at the newer floor area). It is notable that the historic joist, located between these two newer joists, is not deflecting as much. This may be due to the possibility that the species of wood used for the historic joist has a greater elastic modulus (stiffness) than the wood used for the newer joists. The second joist east of the west wall appears in a photograph from the park archives taken in 1983 which shows that the deflection at that time was less than observed today (*photo D-5*). This may be due to the tendency of timber members to continue to deflect or creep over time under sustained dead loads, as they continue to season and age in place.

**Photo D-2:** Deflecting floor joist (2016, Faisant Associates).

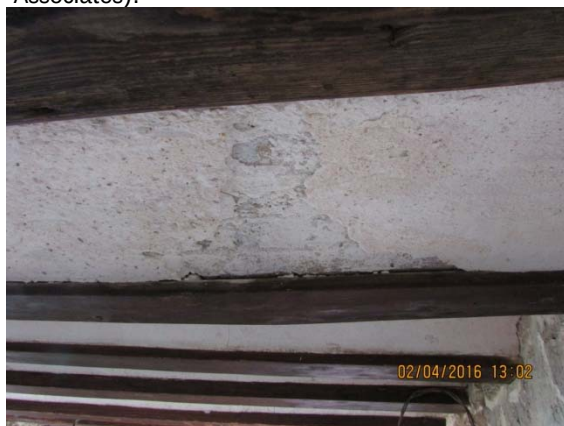
**Photo D-3:** Deflecting floor joist and delaminated tabby ceiling vault (2016, Faisant Associates).

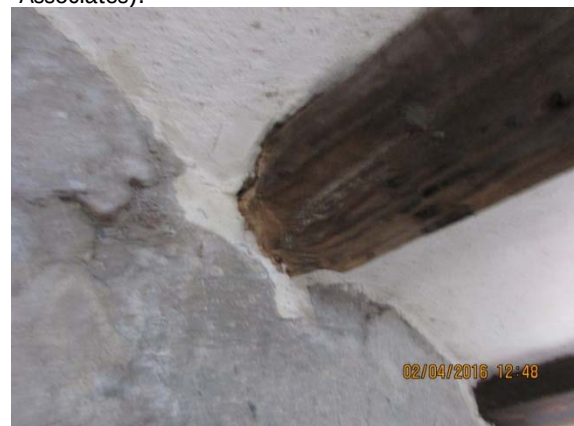
concealed by the concrete vaults. The joist ends are embedded in the coquina masonry walls and could not be observed. The historic joist exhibits some splitting and a reduction in its width (most likely dating from its fabrication) at its bearing on the south wall (*photo D-4*). The historic joist also shows signs of deterioration or wood softness at its north and south bearings.

**Photo D-4:** Historic joist, bearing at south wall (2016, Faisant Associates).

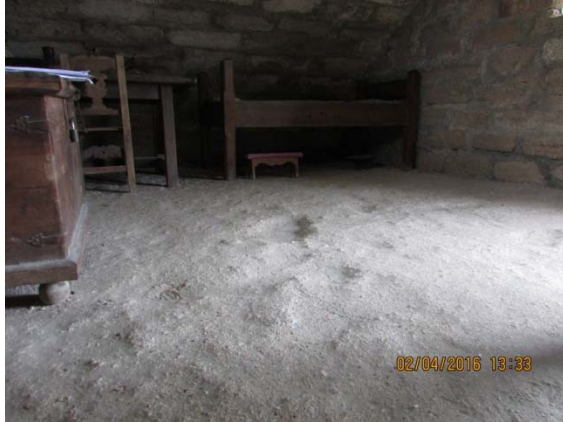
**Photo E-3:** Deteriorated second floor tabby topping (2016, Faisant Associates).

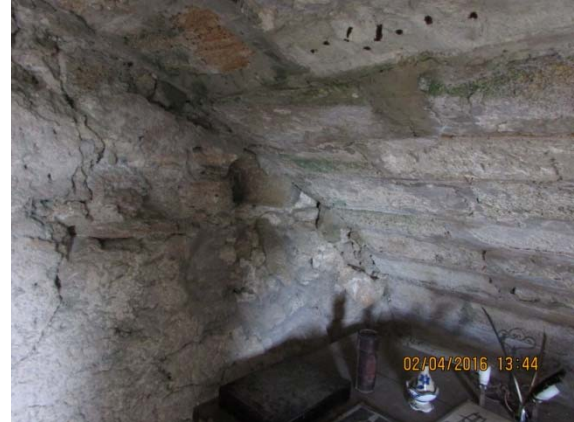
**Photo E-4:** Wall cracks, northeast corner (2016, Faisant Associates).

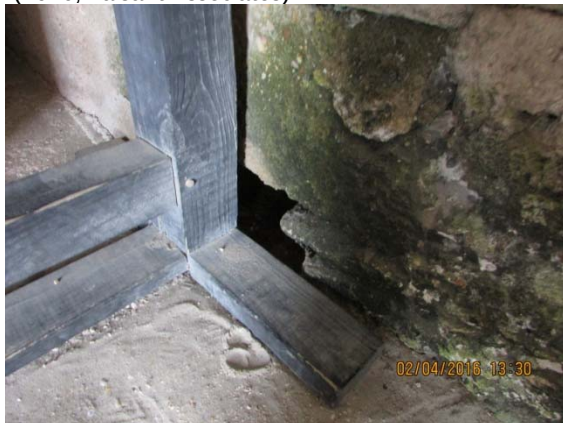
**Photo E-5:** Void in north wall and biological growth (2016, Faisant Associates).

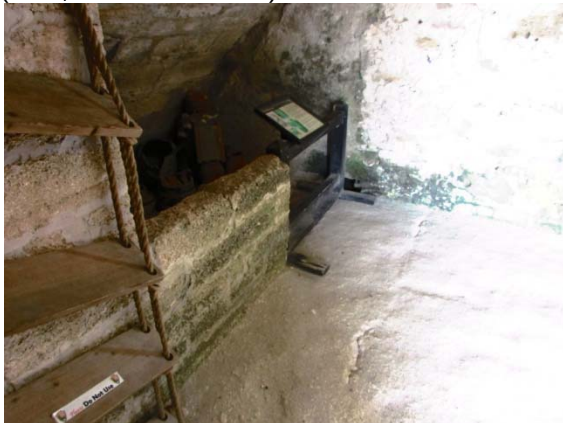
**Photo E-7:** Crack in tabby floor topping (2016, Faisant Associates).

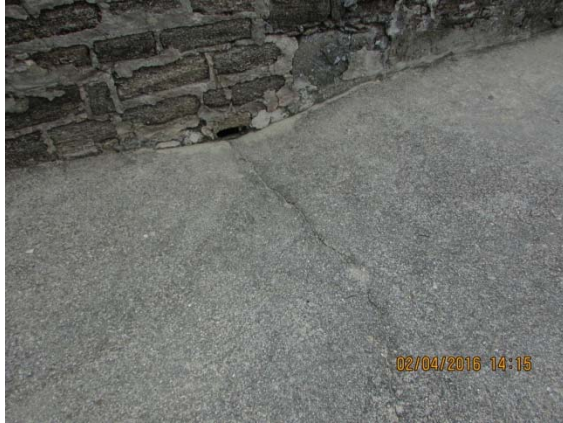
**Photo F-1:** Roof tabby crack at scupper (2016, Faisant Associates).

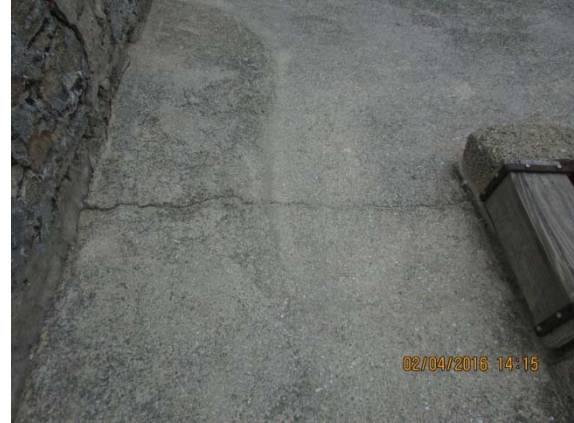
**Photo F-2:** Roof tabby crack at hatch opening (2016, Faisant Associates).

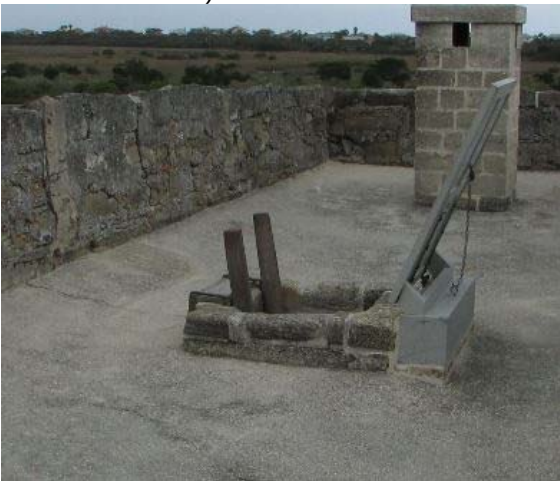
- e. Minor cracks and voids are present in the mortar of the coquina curb at the roof scuttle.

**Photo F-3:** Roof scuttle (2016, Faisant Associates).
