# FORMER SULLIVAN OPERA HOUSE

252-254 Main Street, McGregor, Iowa  
Predevelopment Project

**MARCH 2015**

**DOUGLAS J. STEINMETZ**  
**A R C H I T E C T**

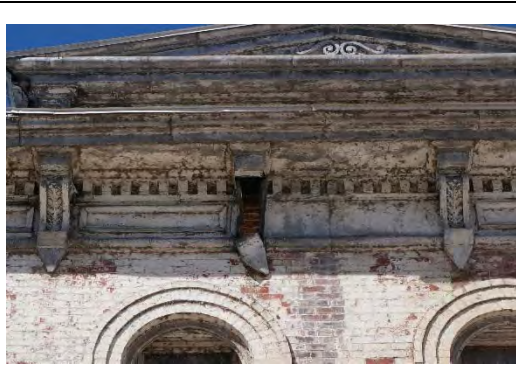
| <p>PHOTO 19: OVERVIEW OF BLOCK</p> | <p>PHOTO 20: OVERVIEW OF BLOCK</p> | <p>PHOTO 21: BUILDING CORNICE</p> |

- Building and Storefront Cornices ..... *Existing metal cornices will be retained and repaired with missing pieces replicated from similar surviving pieces.*

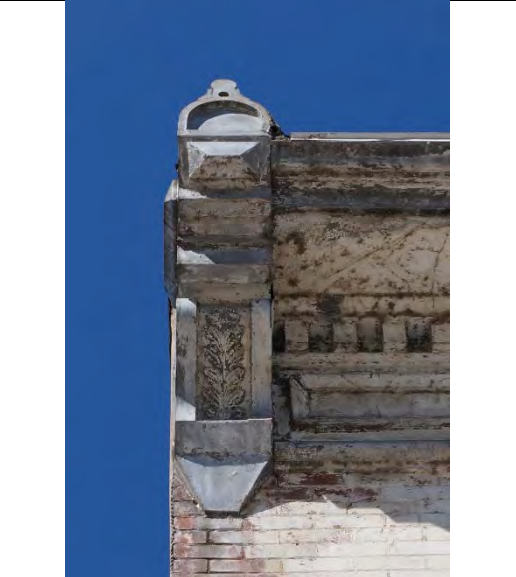
| <p>PHOTO 22: TYPICAL WINDOW ON<br/>PRIMARY FACADE</p> | <p>PHOTO 23: DETAIL OF STOREFRONT<br/>CORNICE</p> | <p>PHOTO 24: DETAIL OF BUILDING<br/>CORNICE</p> |

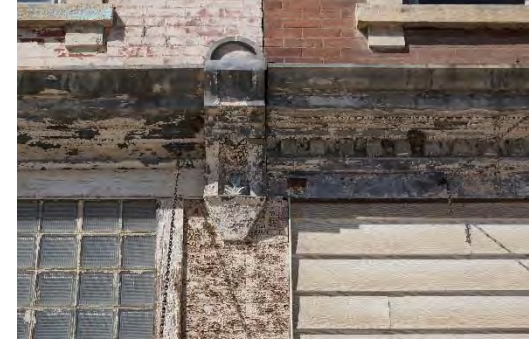
PHOTO 27: DETAIL OF STOREFRONT CORNICE

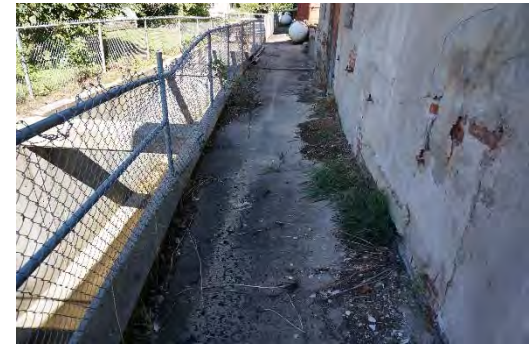
PHOTO 30: WALKWAY BETWEEN BUILDING AND STORM SEWER IN NORTH YARD

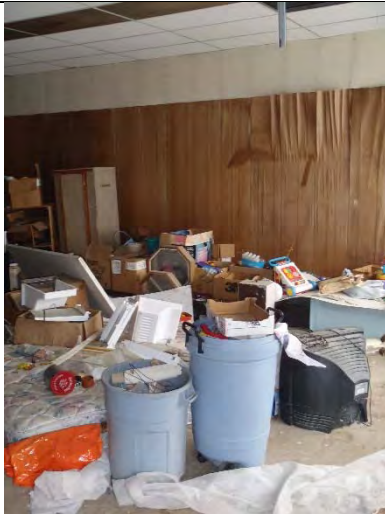
PHOTO 31: DEBRIS IN BUILDING BEFORE CLEANOUT

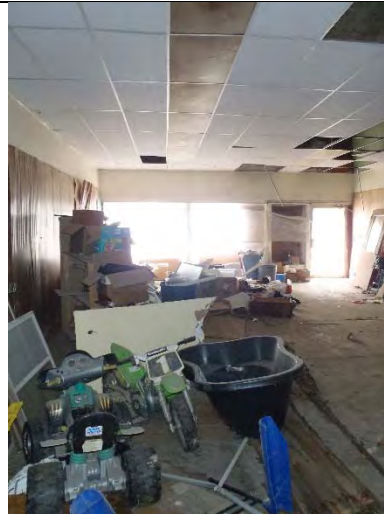
PHOTO 32: DEBRIS IN BUILDING BEFORE CLEANOUT

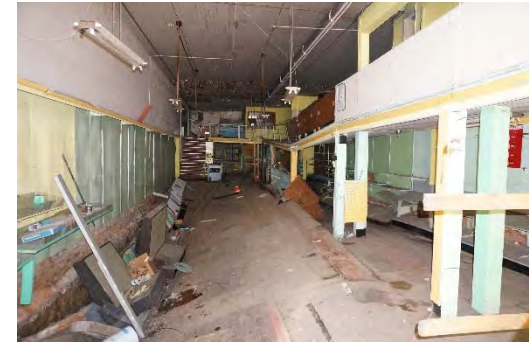
- Due in large part to the building's close proximity to an open storm sewer located immediately north of the property, the first floor wooden structural system has completely failed and is no longer safe. To avoid similar failure in the future the cellar will be filled creating a slab on grade main floor. Aside from this exception the building appears structurally stable and suitable for rehabilitation.

PHOTO 33: COLLAPSED FIRST FLOOR

- 2.1. Remove non-historic partitions and deteriorated plaster that cannot be repaired throughout building.
- 2.2. Remove collapsed floor and loft structures throughout first floor. Clear cellar of all debris.
- 2.3. Remove non-historic storefront materials.
- 2.4. Remove fire escape landing and steps

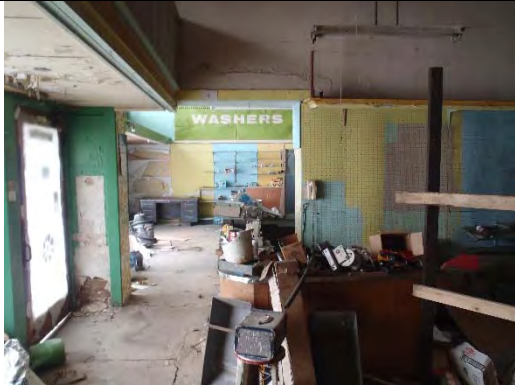
PHOTO 34: DEBRIS IN BUILDING BEFORE CLEANOUT

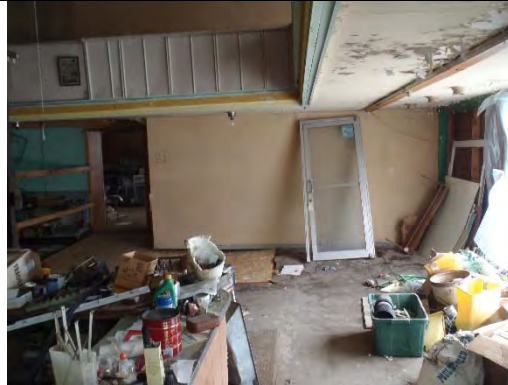
PHOTO 35: DEBRIS IN BUILDING BEFORE CLEANOUT

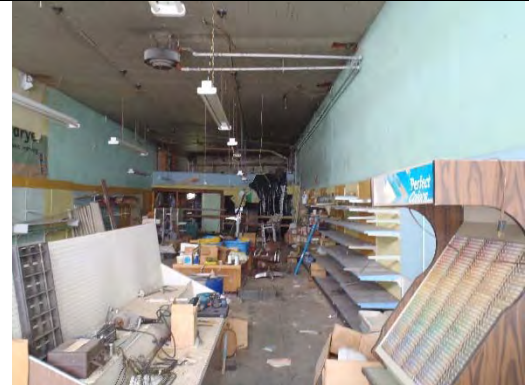
PHOTO 36: DEBRIS IN BUILDING BEFORE CLEANOUT

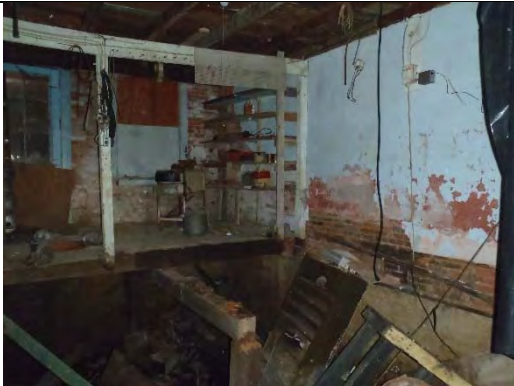
PHOTO 37: COLLAPSED FIRST FLOOR

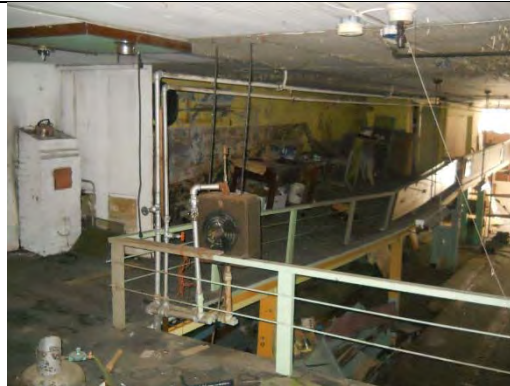
PHOTO 38: COLLAPSED MEZZANINE

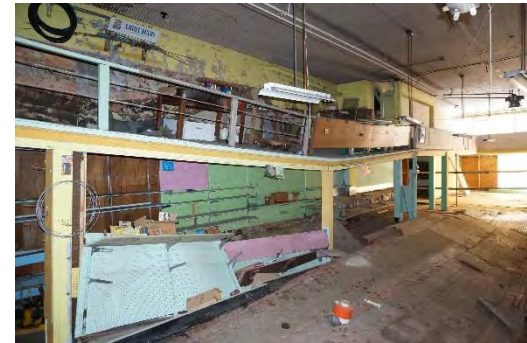
PHOTO 39: COLLAPSED MEZZANINE AND FIRST FLOOR

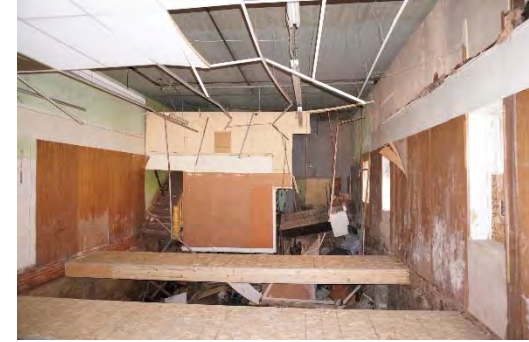
PHOTO 45: STRUCTURAL BRACING AT FIRST FLOOR LINE IN AREA OF COLLAPSED FLOOR

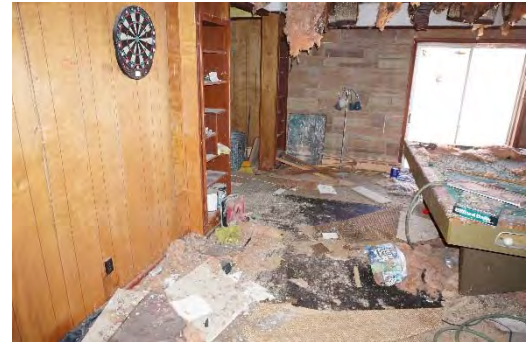
PHOTO 48: DEBRIS AND PIGEON GUANO SECOND FLOOR APARTMENTS

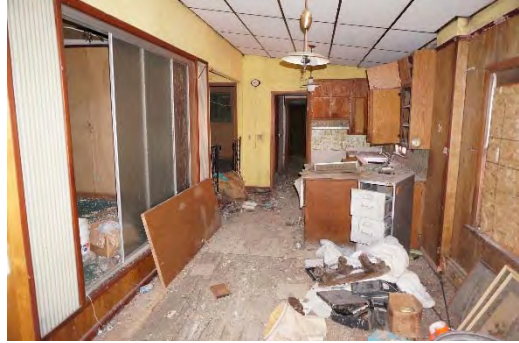
PHOTO 49: DEBRIS AND PIGEON GUANO  
SECOND FLOOR APARTMENTS

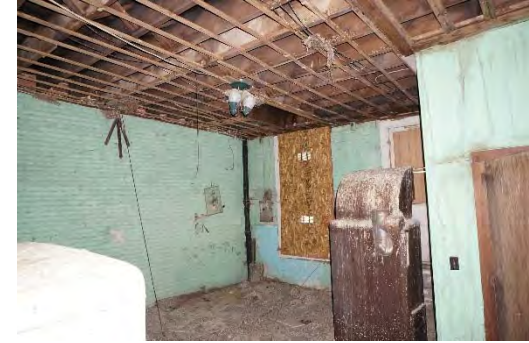
PHOTO 51: DEBRIS AND PIGEON GUANO  
SECOND FLOOR APARTMENTS

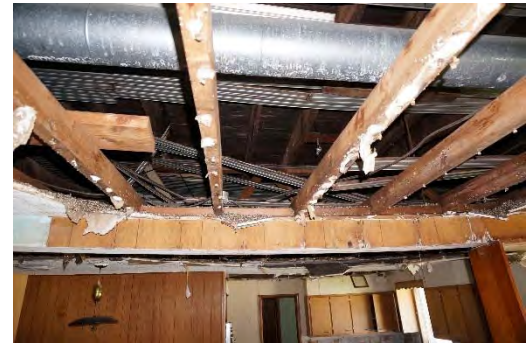
PHOTO 54: COLLAPSED CEILING  
FRAMING AND FINISHES IN APT AT ROOF  
LEAK
