# New Fairfield Creamery

## Structural Engineering Assessment

31 Route 37  
New Fairfield, Connecticut

October 14, 2015  
Freeman Project No. 2015-0604

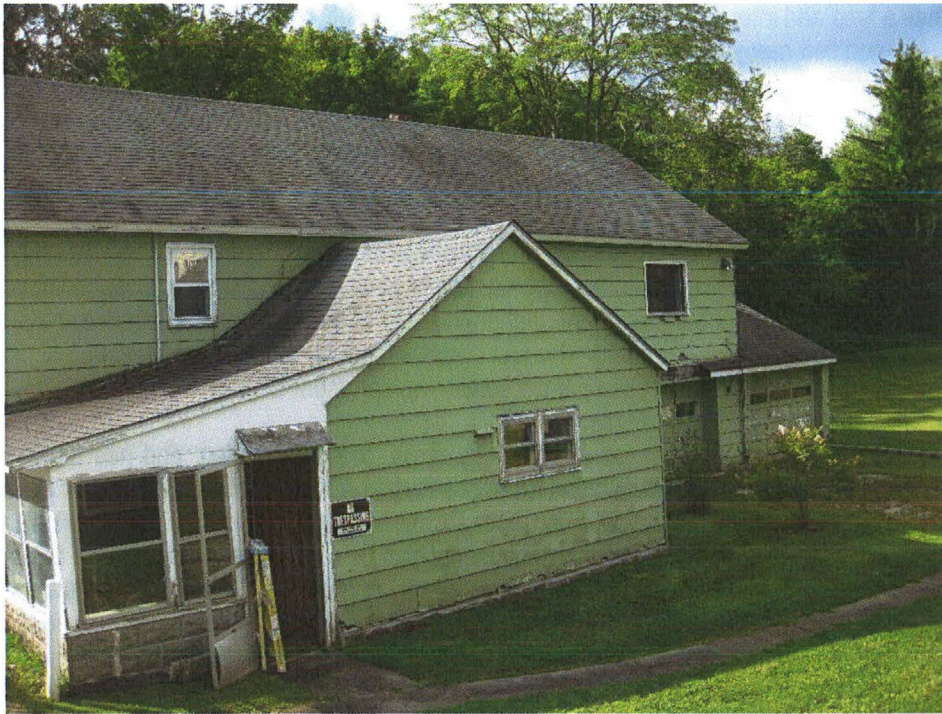
The two-story portion of the building is limited to the original structure, mechanical space and repurposed garage. The garage bay at the west end and kitchen are formed with single story gable roofs, with shed roofs over the rear deck and enclosed porch (see photos #1 and 2). Overall dimensions of the original structure are approximately 24' x 26'.

**Photo #1 – Roof forms at north side**

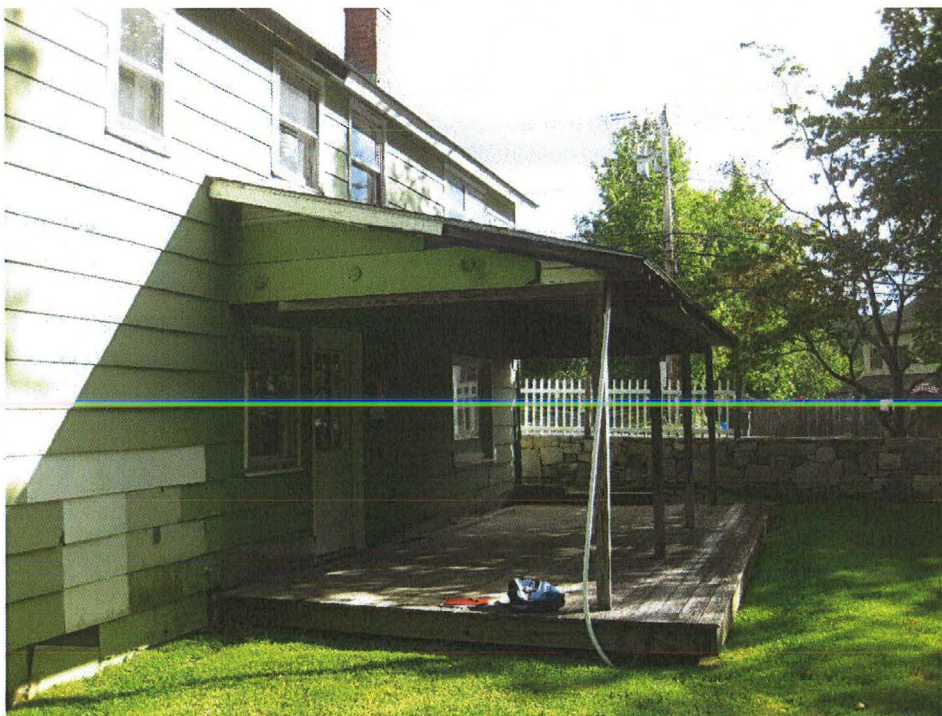
1. A wood deck with a wood framed canopy above was added to the east end of the south face of the building subsequent to the original construction (see photo #2).
2. The canopy is framed with 2x6 rafters running down the slope, supported on the main structure and a perimeter 4x6 girders over wood posts.
3. One of the posts has a splice and a notch approximately 2 feet from the top (see photo #21). The splice detail does not appear capable of providing stability.
4. The details where the rafters are supported by the girder along the lower edge appear to be deteriorated at some locations.
5. The structure of the deck floor could not be observed directly, but appears to be deteriorating. Deflection and sponginess were detected.

**Photo #2 – Roof forms at south side**

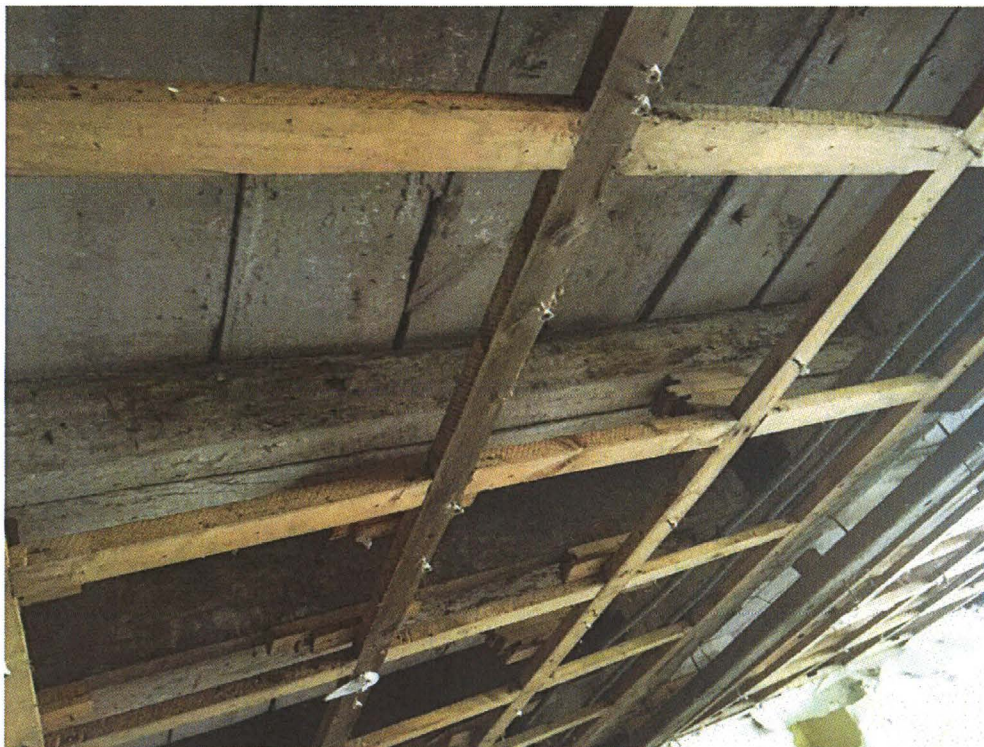
1. Much of the walls of the lower level and the majority of the second floor walls and ceiling were concealed by plaster finishes. The second floor framing, however, was exposed to view for most of the original building area, partially concealed by a modern wood ceiling grid (see photos #3 and #4). The framing was whitewashed, likely in conjunction with its conversion to a creamery in the early 20<sup>th</sup> century. The framing details, however, suggest that the framing may have been reclaimed from other sites. Members generally have been modified to fit the dimensions of the building, and many revisions and retrofits to the original structure were apparent.

**Photo #3 – Second floor framing at original building**

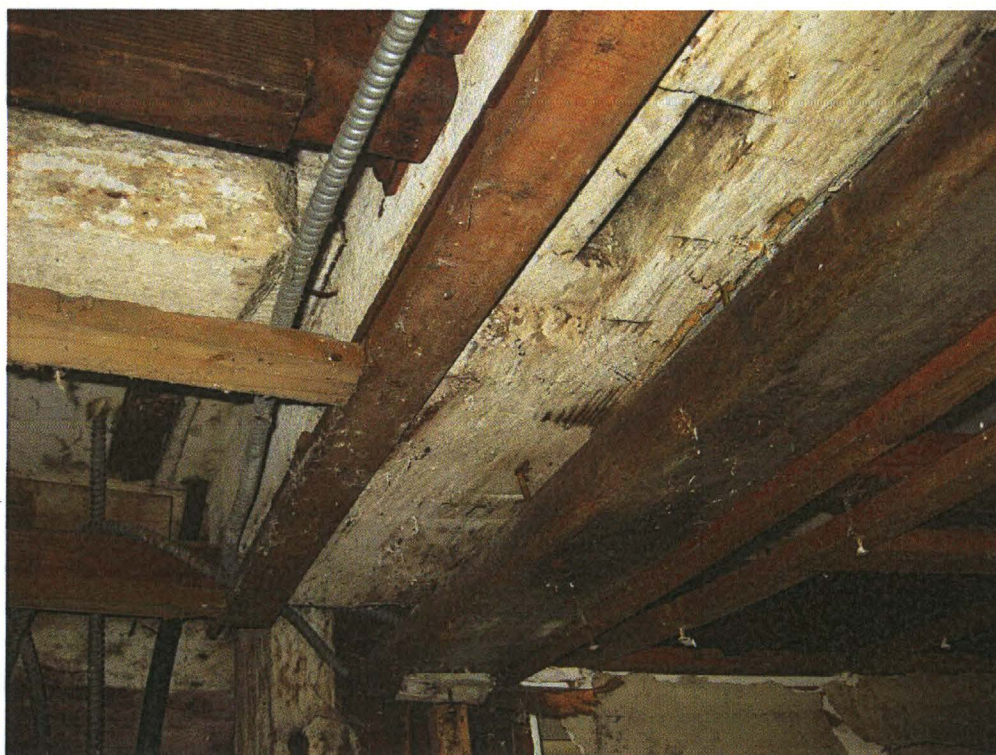
3. At several locations, mortises were found in the second floor girders oriented along the length of the member (see photo #4). This suggests that either a post had been positioned at this location in the past, or more likely, these members were reclaimed from other structures. Similar details were found at posts.

**Photo #4 – Second floor framing at original building with mortise at bottom of girder**

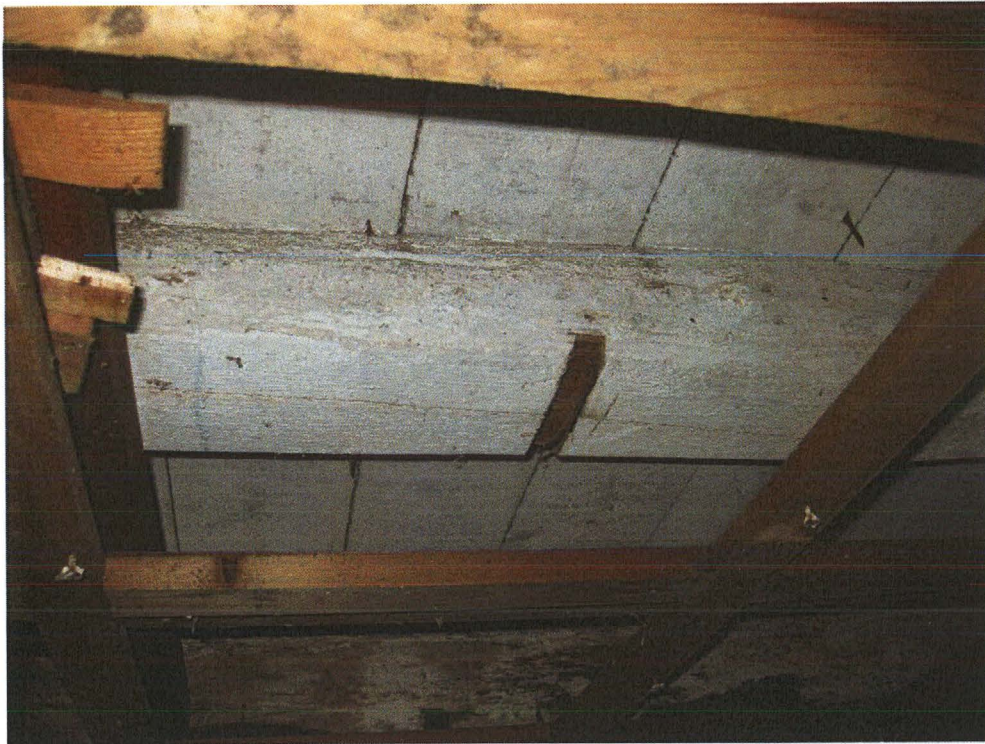
2. The second floor framing in the original building consists of two bays of 4x6 joists supported on ledgers mounted on each side of a 6x8 central girder. The ledgers are whitewashed, indicating that although they may have been added to the girders at some point, they were part of the Creamery construction. All but one of the 4x6 joists in the north bay have a  $\frac{3}{4}$ " deep notch in the bottom near the center of the span (see photo #5), presumably to permit passage of wiring without encroaching on the ceiling.

**Photo #5 – Notch in second floor joists**

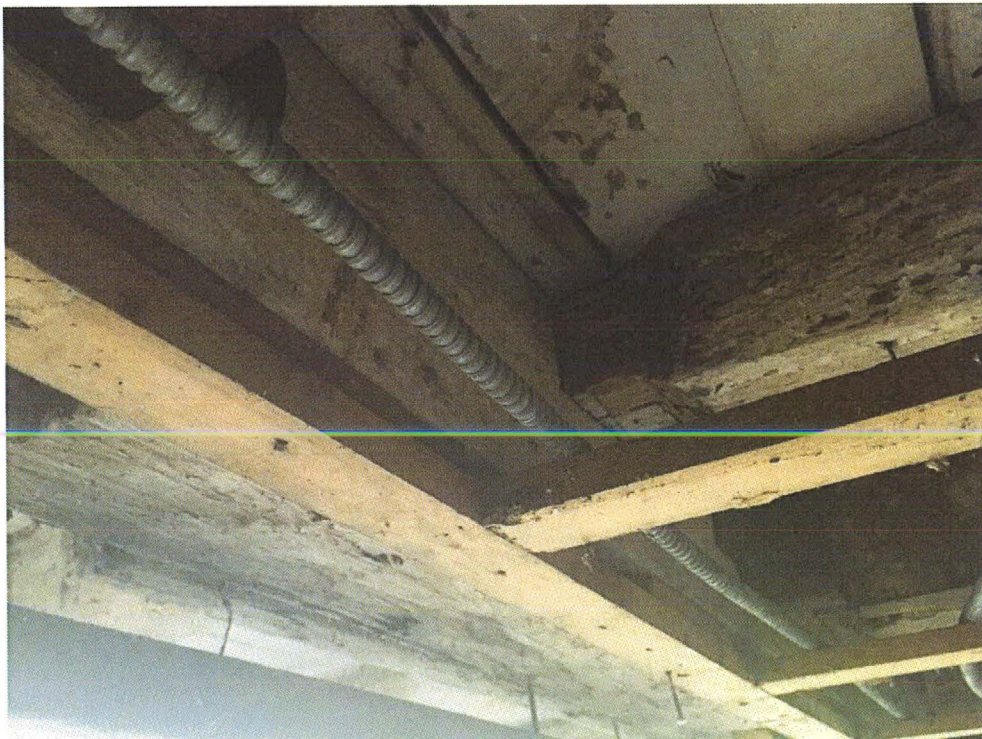
4. The girders supporting second floor joists each have a 2x4 ledger mounted on each side to support the joists (see photo #6). This further suggests that the framing is not original to the building.

**Photo #6 – Bearing at joists on ledger mounted to perimeter girder**

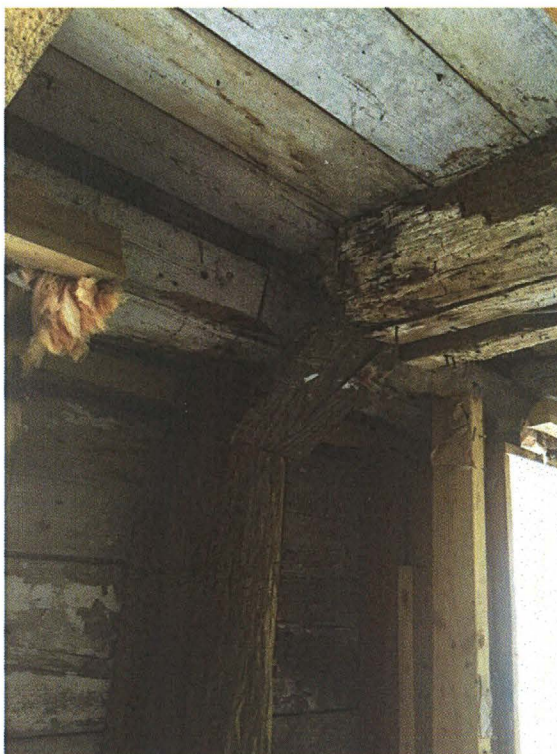
5. Near the center of the north bay, a girder runs east to west that receives framing around what is likely an old stair location. This girder is badly deteriorated near the north end, and the bearing detail has been modified by the addition of a diagonal member to connect into a notch in the post (see photo #7).

**Photo #7 – Damaged and modified bearing detail at girder and supplementary posts**

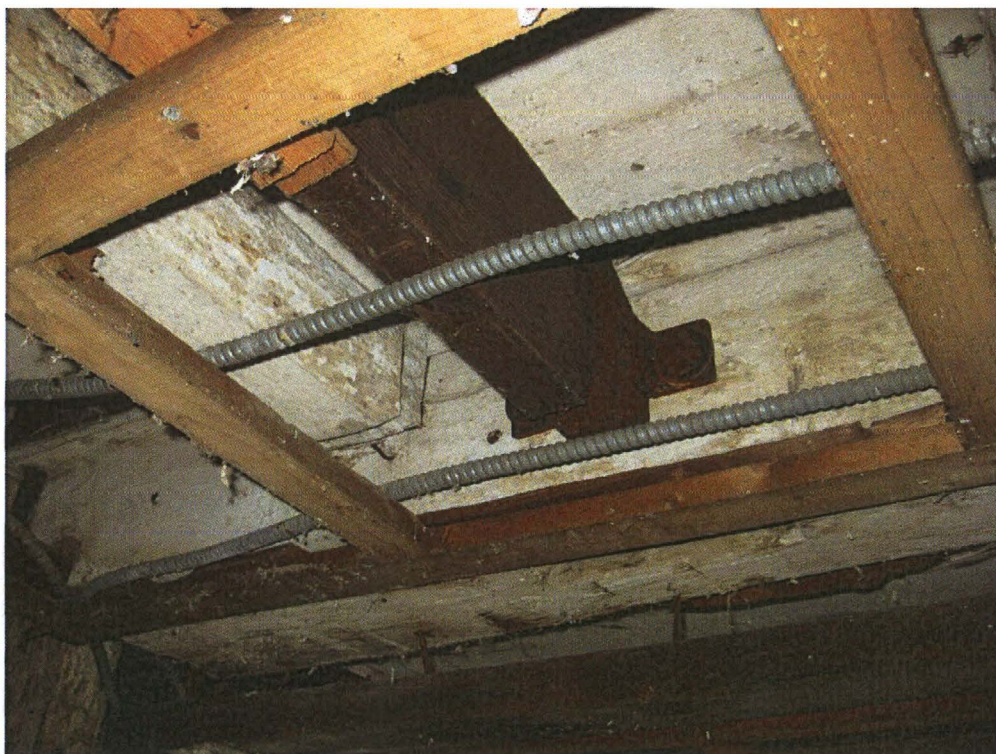
6. Supplementary framing has been added over the years to the second floor structure, including sister joists (see photo #8) and additional lumber posts added to walls (see photo #7).

**Photo #8 – Sister joists at second floor**

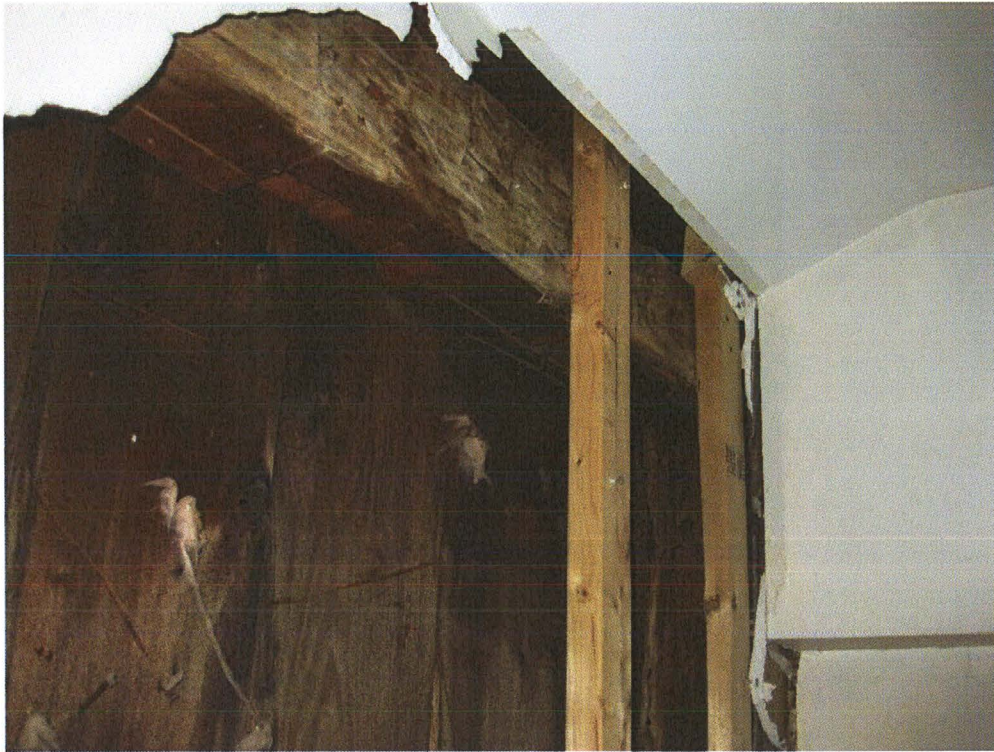
7. At isolated locations, the original wall construction was visible (see photo #9). The wall construction consisted of horizontal rough hewn timbers spanning between posts and supporting exterior wall boards. The horizontal boards had unused mortises on top and bottom surfaces, suggesting that they were also reclaimed from other sites.

Photo #9 – Original wall framing

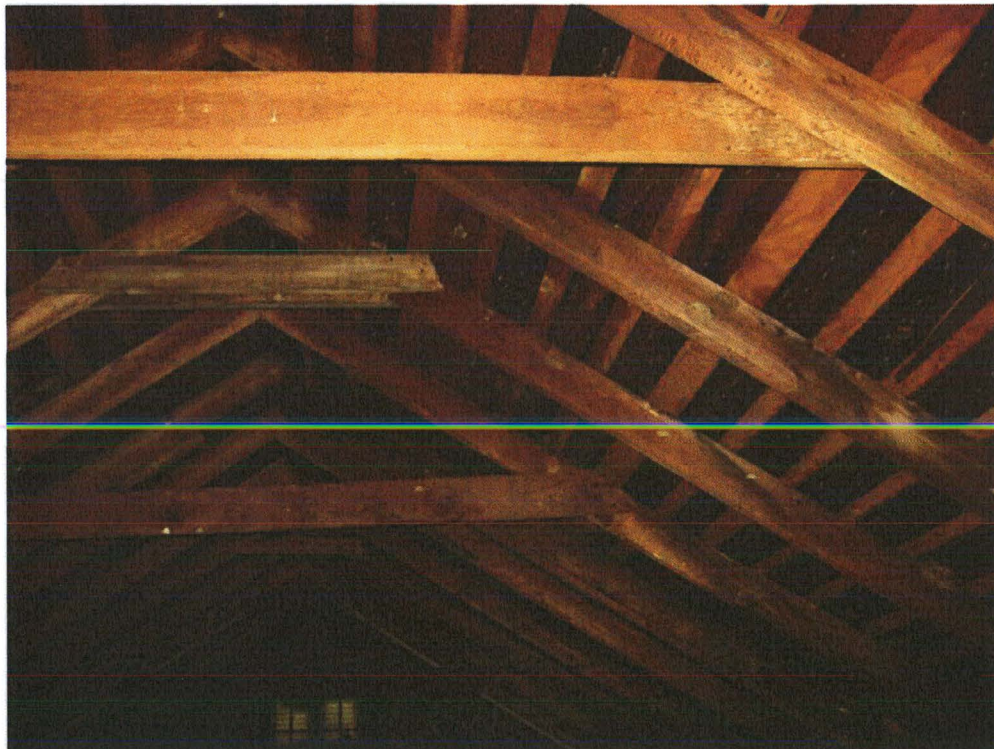
8. At the second floor, sections of the original wall structure were visible, but it was clear that the ceiling and roof structure over the original second floor are not original. Roof rafters that form the full gable over both the original building and reclaimed garage appear to all have been added at a later time, possibly more recent than the garage (see photo #10).

Photo #10 – Roof framing at main gable

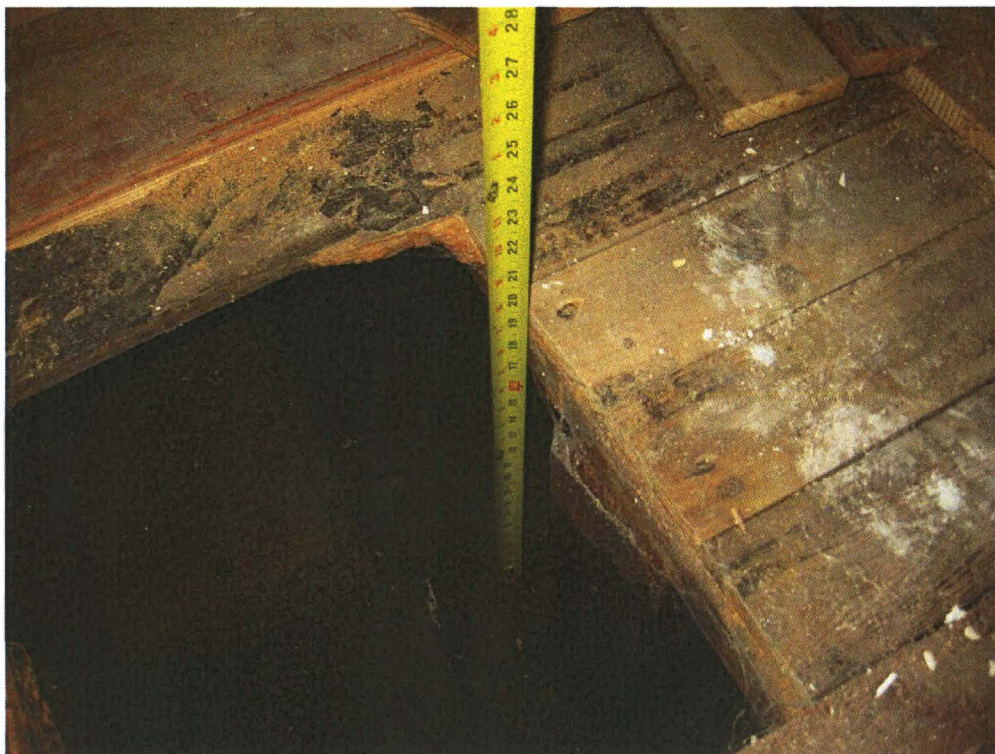
9. The first floor of the original building is built on a wood framed floor on joists and furring set on shims directly on the ground in the northern portion, but the floor framing is set 19 inches above a mud slab in the center of the original building (see photo #11). The floor in this area is supported on wood posts and concrete walls, which were clearly part of building retrofits. It is not clear how much variation there is elsewhere in the building, but most of the remainder of the first floor appears to be on a slab on grade.

**Photo #11 – Supported first floor and mud slab**

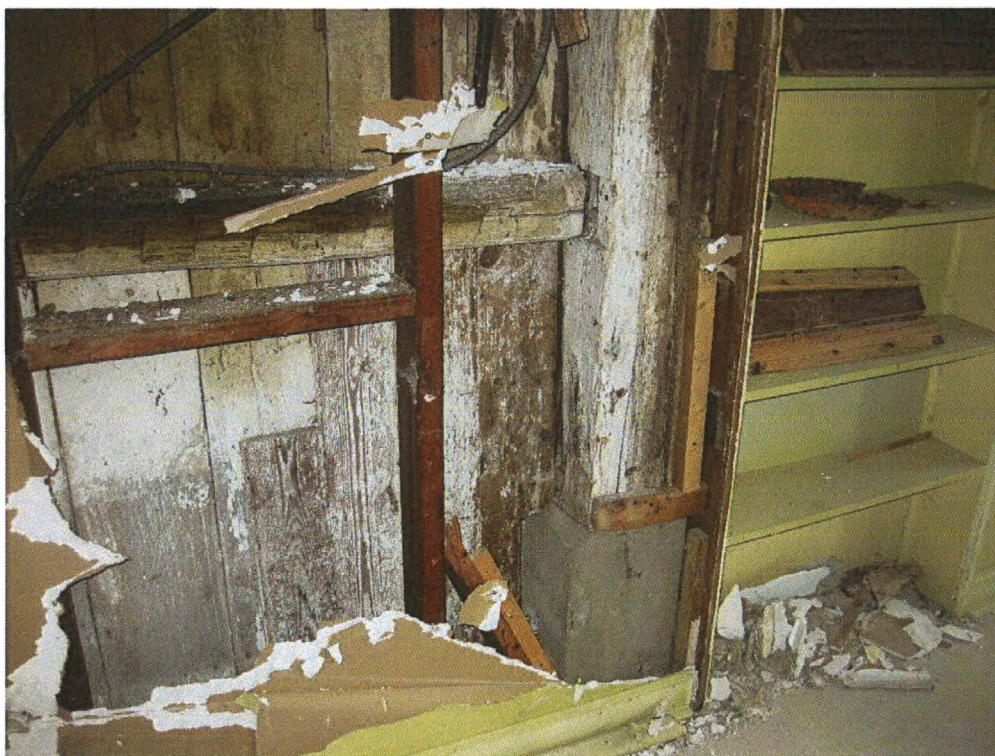
10. At the bases of two of the exposed posts in the original building, a concrete pier was found (see photos #12 and 13). It appears that the bases of these posts were reinforced or reconstructed at some point during the life of the building.

**Photo #12 – Concrete pier at base of post**

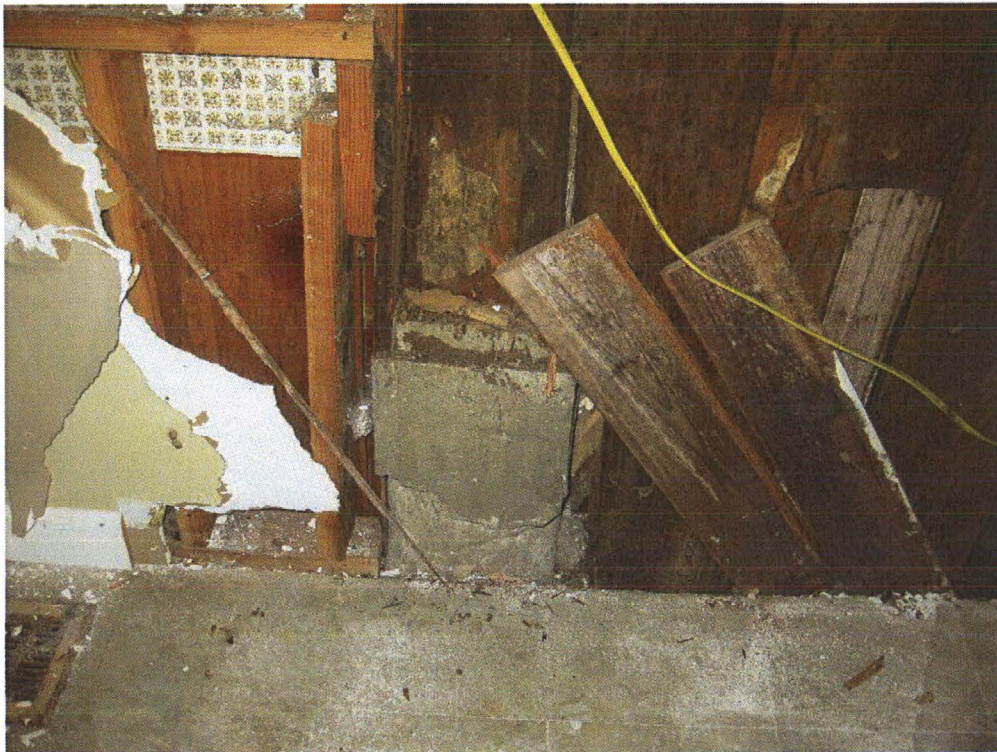
Photo #13 – Exterior wall viewed from kitchen

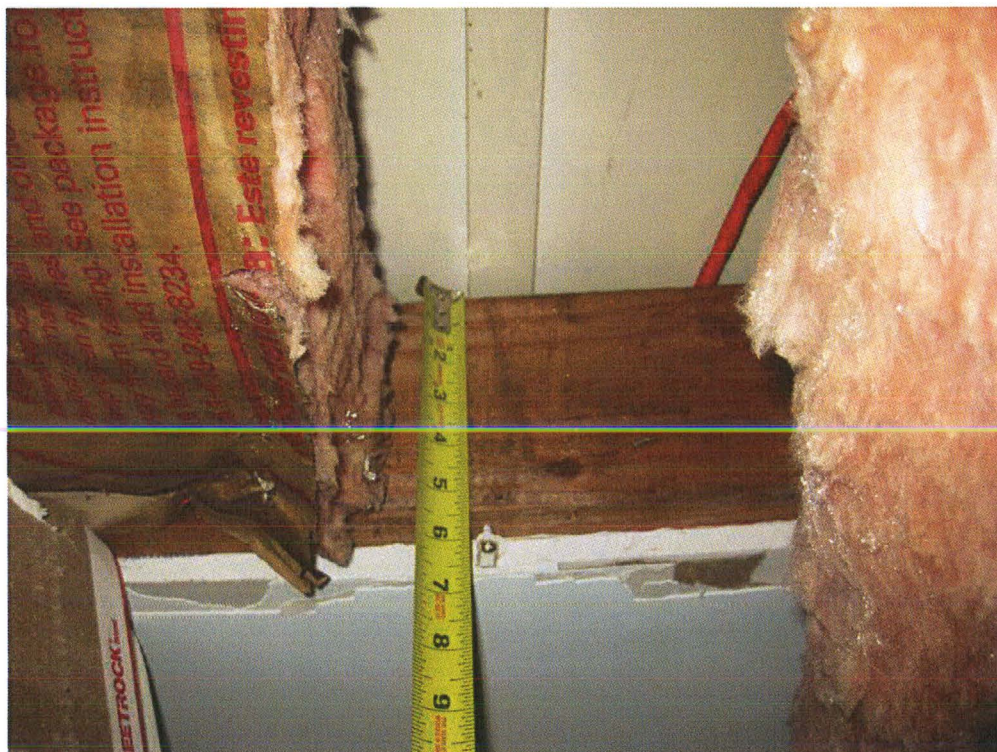
Photo #14 – Ceiling joists at kitchen

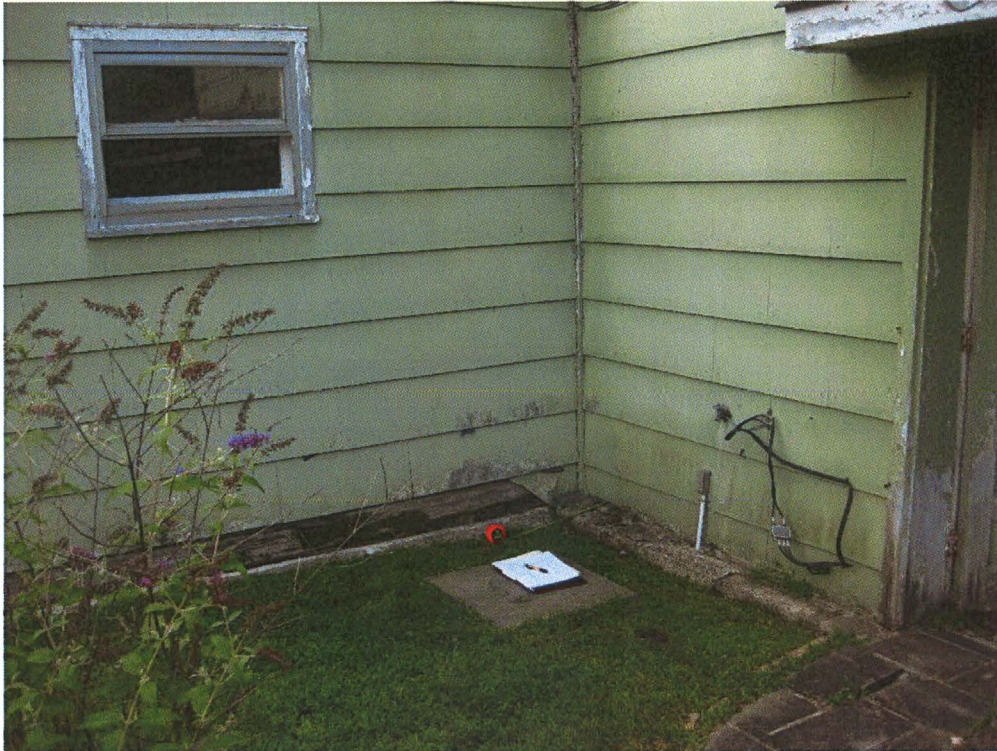
**Photo #15 – Support of first floor and foundations at kitchen**

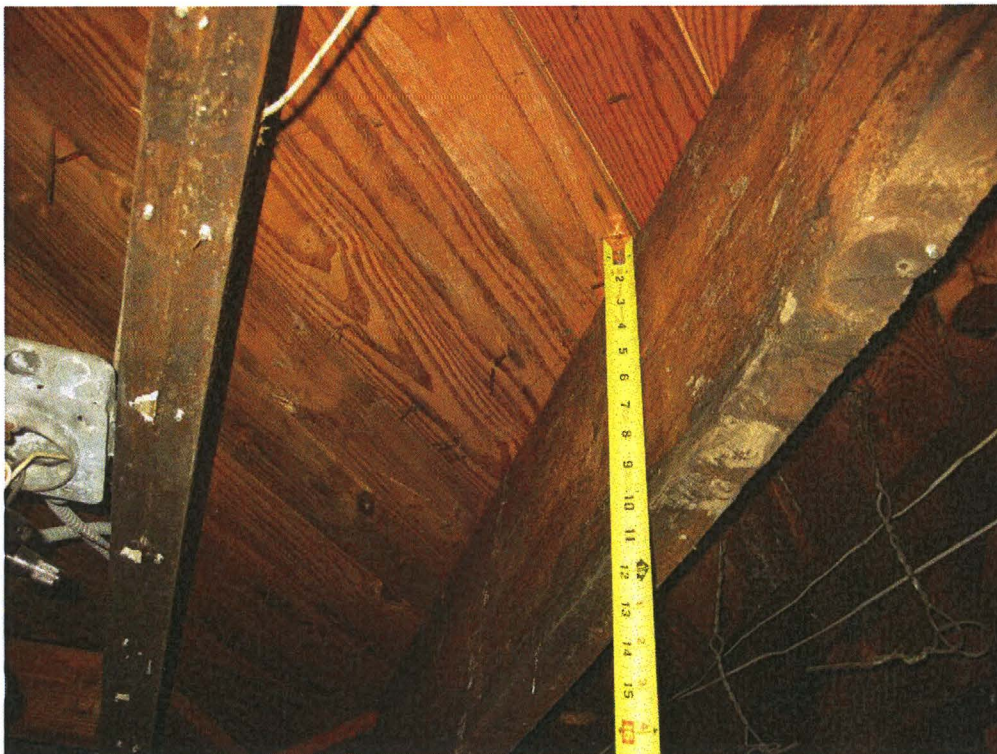
3. The second floor joists above the mechanical space appear to be adequately sized and in good condition based on visual observation from below. Many of these members should be salvageable and may be used in their current configuration.

**Photo #16 – Second floor framing above mechanical space**

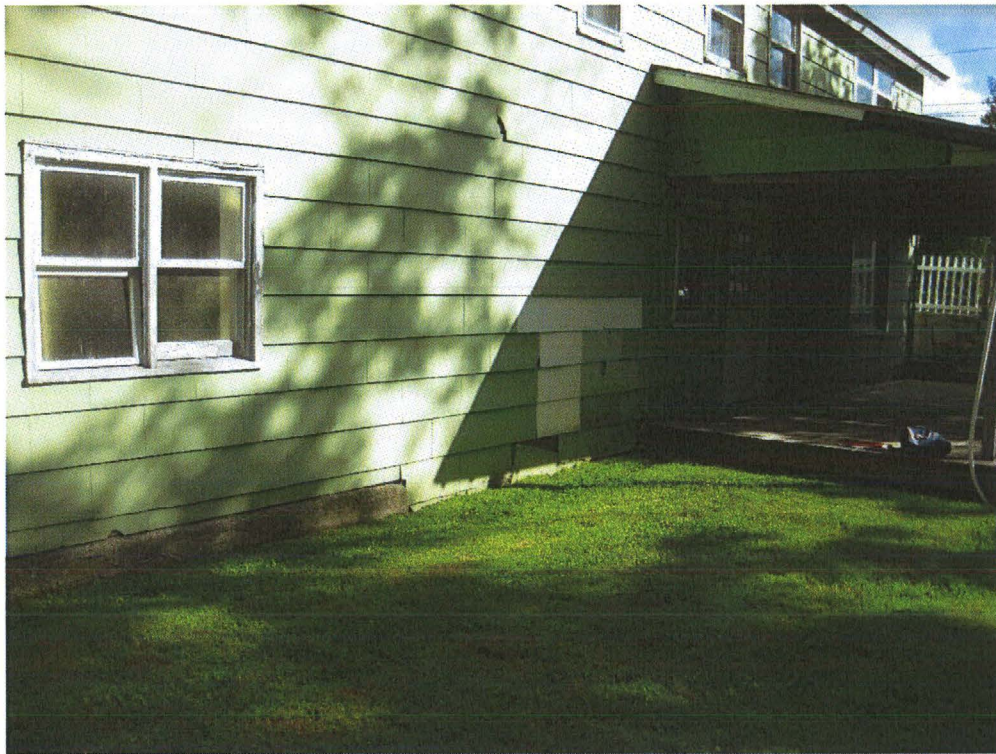
**Photo #17 – Bulge in wall at rear of repurposed garage**

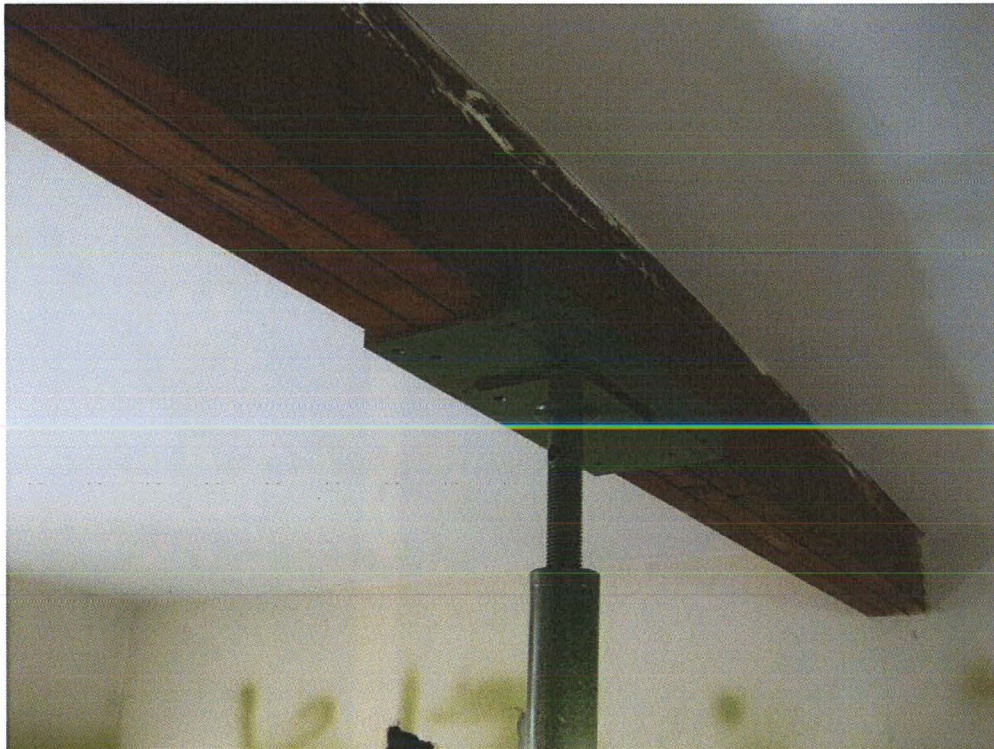
1. The area noted as the Repurposed Garage appears to be a garage bay with a pass door on the exterior, but the pass door functions as the main entrance to the building, and this area is a large open room extending the full width of the building. A stair near the front entrance leads to the western half of the upper level.
2. The rear (south) wall of this element appears to be bulging out near the bottom, as though it was struck by a vehicle at some point (see photo #17).
3. A triple 2x8 girder supports the second floor joists across the center of this space. A screw jack has been inserted 4'-8" from the west wall to support this member (see photo #18), presumably in response to noticeable distress or excessive deflection in the member.

4. The second floor framing at the repurposed garage includes a large opening in the middle of the floor, and while not directly visible, the noticeable bounce and deflection in the floor, combined with the use of a screw jack bolster for the central girder, suggest that the floor members are inadequate. In any case, this section of the building does not appear to have historical value.

**Photo #18 – Screw jack supporting girder at repurposed garage**

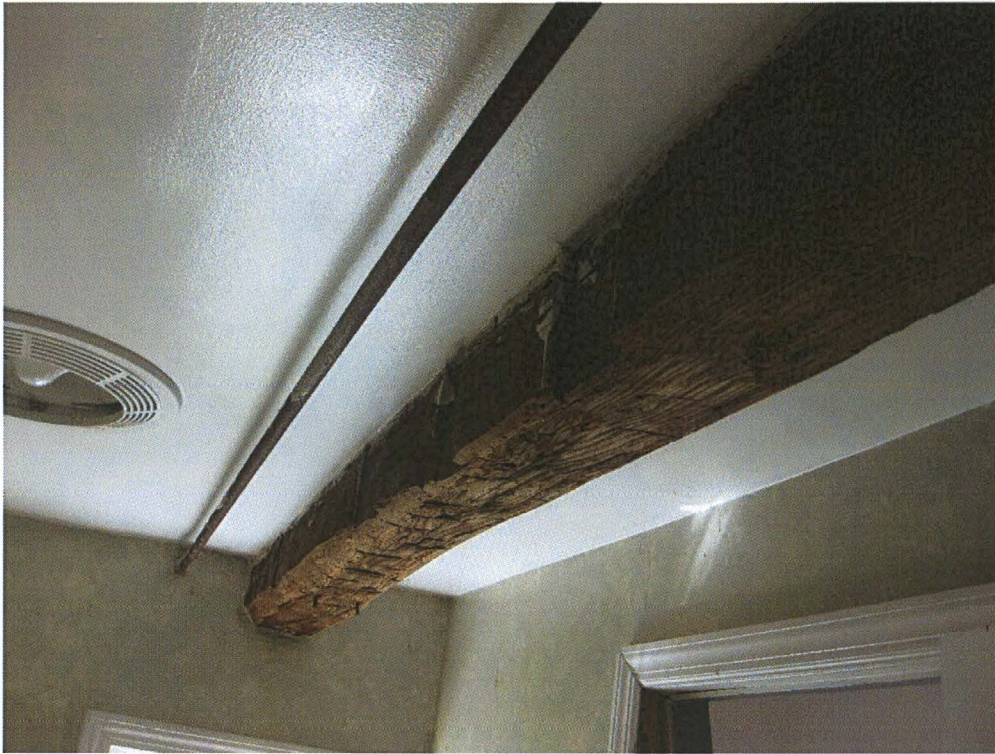
4. The ceiling construction includes an exposed timber member that appears to be a reclaimed column (see photo #19). The member projects below a modern gypsum board ceiling.
5. A steel tie rod was found below the second floor ceiling, presumably part of a retrofit to address spreading of the eaves of the main gable (see photo #19).
6. The second floor framing is mostly concealed in this area, but modern 2x8 joists were found in a ceiling probe, indicating that this is not part of the original construction.

**Photo #19 – Reclaimed ceiling girder and tie rod at second floor**

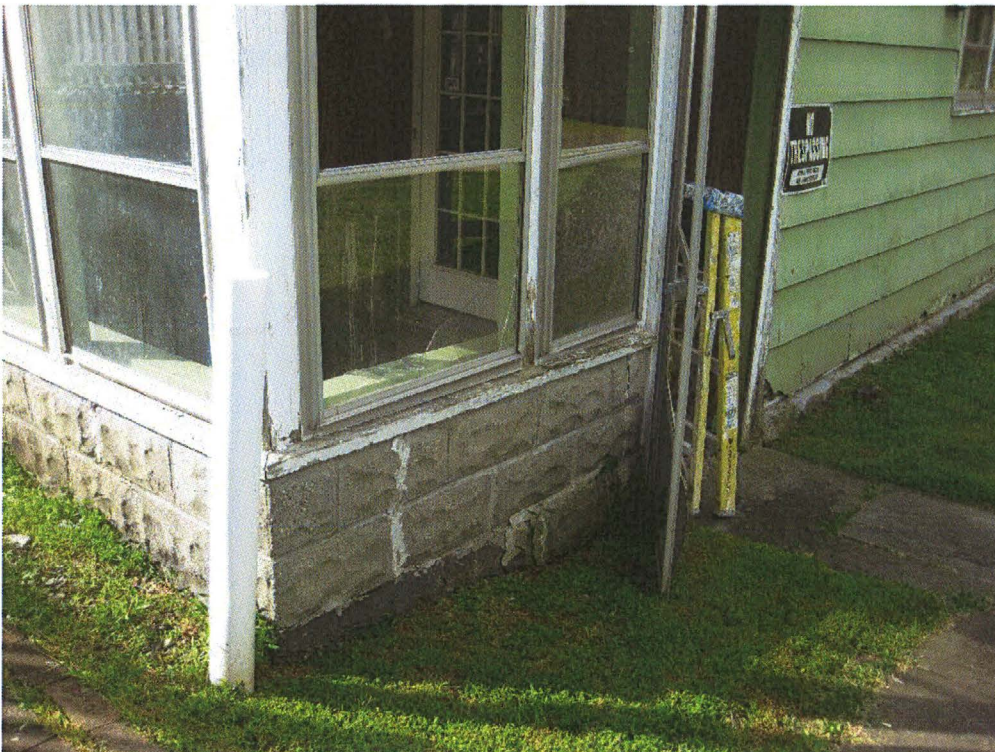
1. The porch floor appears to be constructed on wood framing, which is settling and feels spongy. There is likely significant deterioration in the floor.
2. The porch roof is framed with 2x6 rafters at 18" on center. Visible access to the roof framing was limited, but it appears to be in adequate condition.
3. The exterior window wall of the porch is supported on a split face concrete masonry wall (see photo #20). The wall is damaged in some areas, and has undergone repairs in the past that are beginning to fail.

**Photo #20 – Split face block knee wall at enclosed porch**

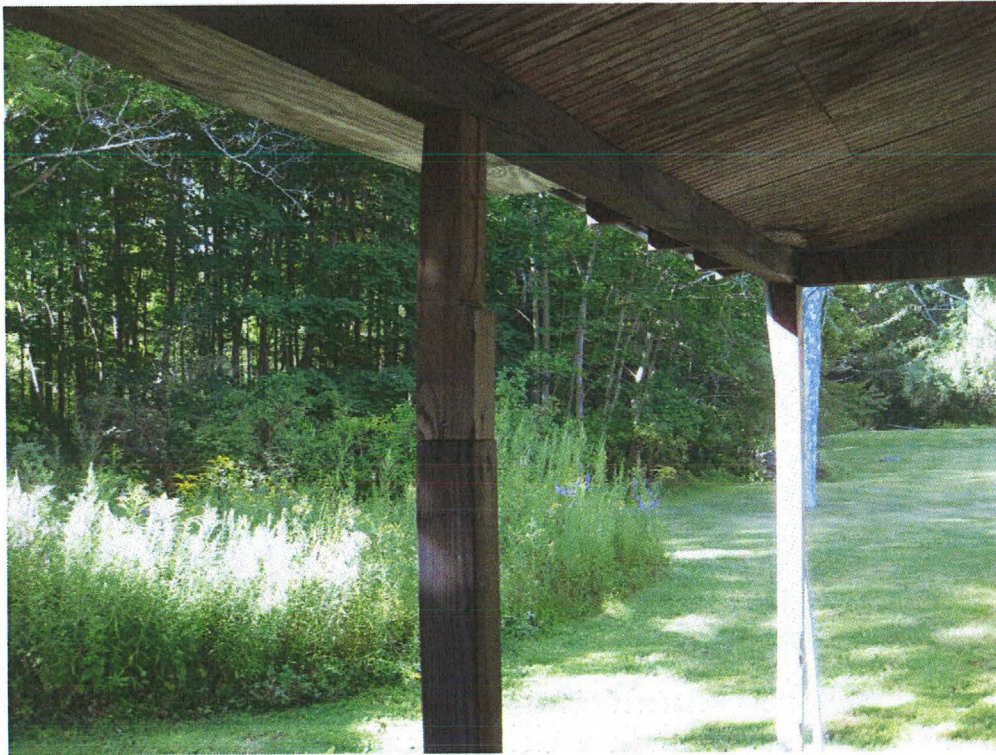
**Photo #21 – Splice and notch at canopy post**
