**TRUE FRIENDS MUTUAL BENEVOLENT ASSOCIATION HALL  
Donaldsonville, LA**

**Building Conditions Report  
MAY 31, 2013**

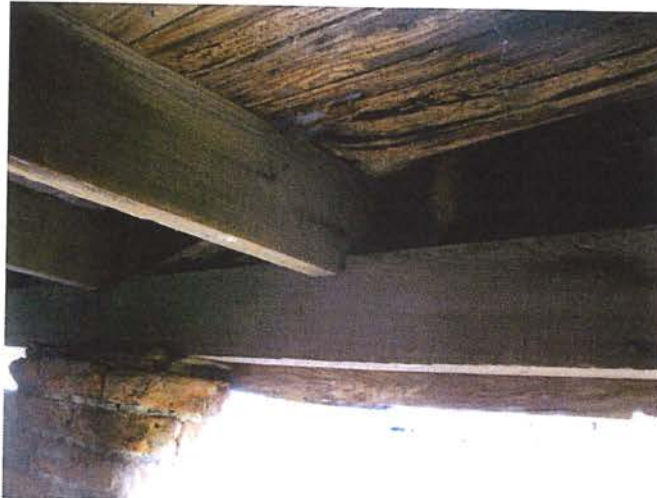
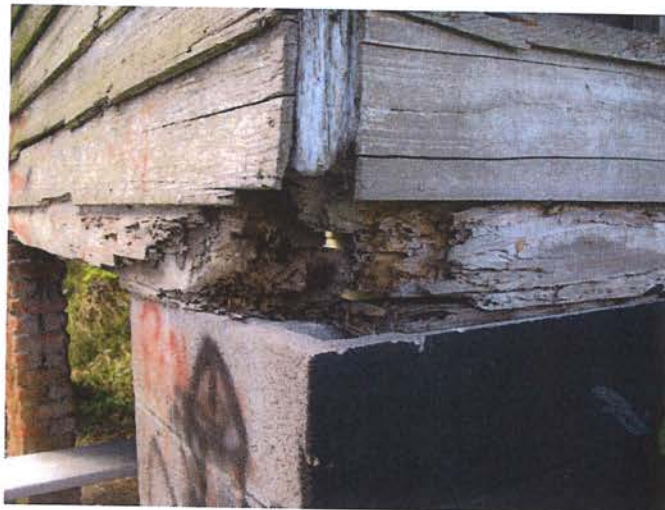
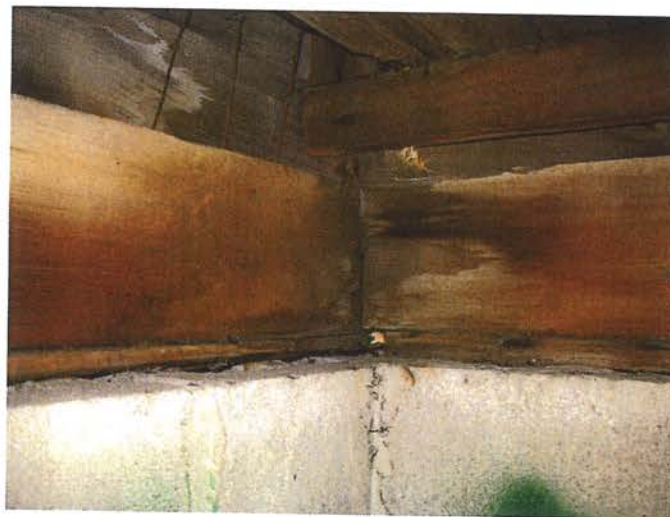
# Floor Joists and Foundation Damage:

The sill plate of the buildings is a series of sections of 6x6 inch lumber. There is a seriously deteriorated section of sill at the rear corner of the rear appendage, band area. The side walls of the building are made of 2x4 full dimension lumber. The floor of the main and second level is supported by 2x10 joists with center pier support. The finish floor is tongue and groove  $\frac{3}{4}$ "x1-3/4" finish pine flooring.

The interior of the building has around one third of the roof, roof rafters, wall system damaged by fire. The lower level floor joists have had a lot of water damage. Several joists are deteriorated and in need of replacement. The upper floor joists are in re-useable condition. The side walls are mostly covered by modern medium brown interior paneling. This paneling appears to be covering original horizontal boards on the upper level and a vertical bead board side walls.

**Foundation** – The foundation piers need some re-pointing. Mortar should match original in strength and sand texture. The rear CMU block replacement piers should be replaced with brick ones to match original one remaining.

**Building framing systems** – The framing of the building needs to be replaced in the rear/fire affected spaces.

Floors – The floors need demolishing. Floor joists replaced where needed. New wood flooring installed and finished.

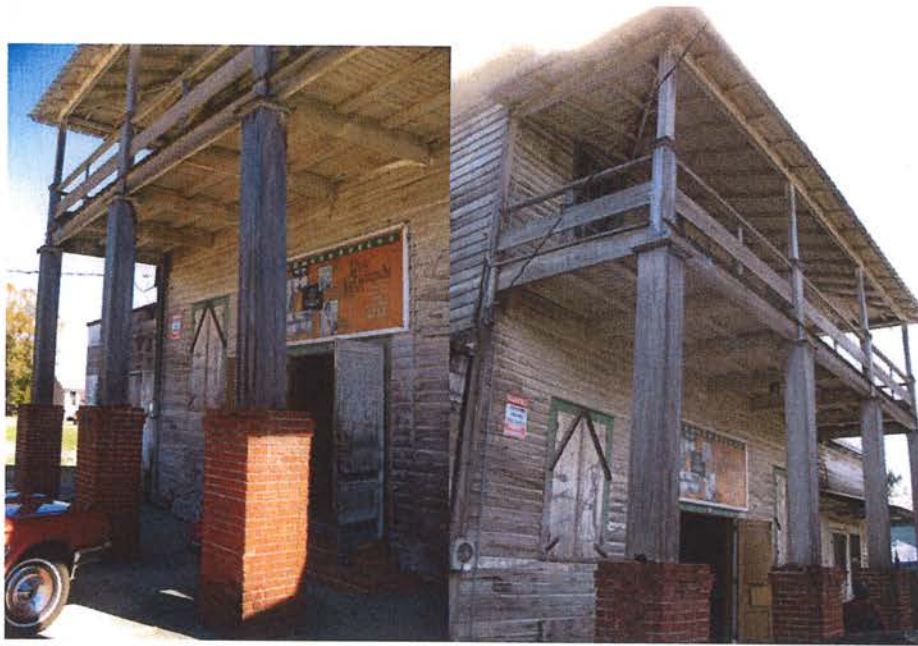
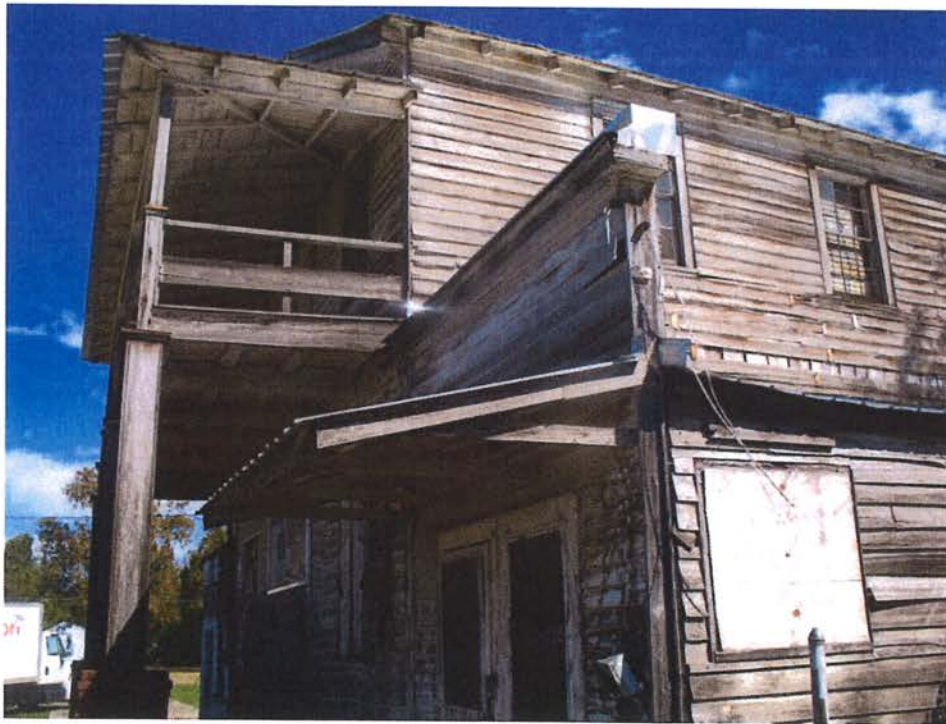
Front Gallery:

The lower porch roof/upper porch floor needs repair. The upper and lower porch wood needs prep and painting.

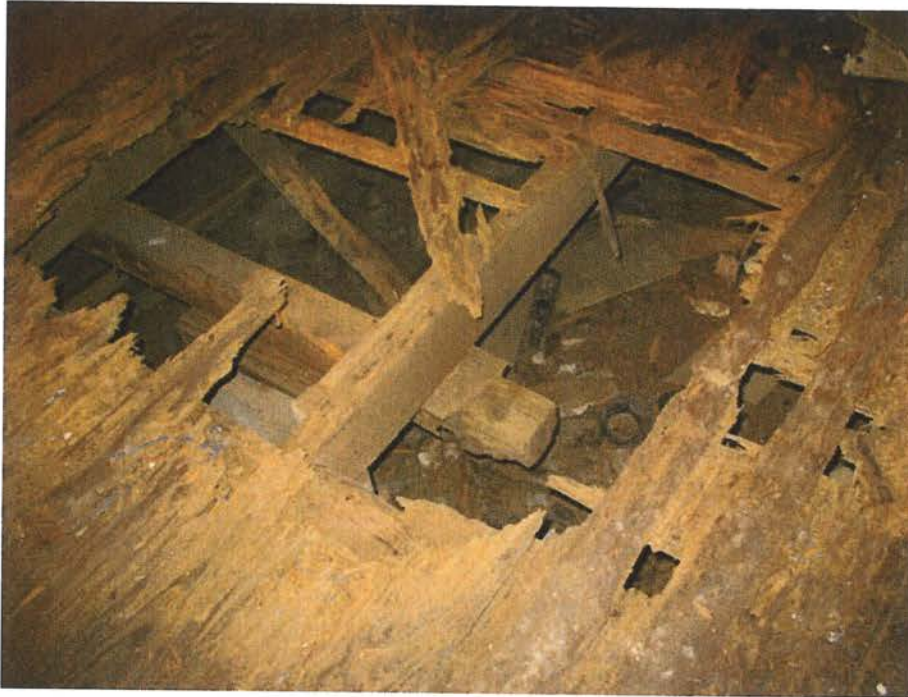
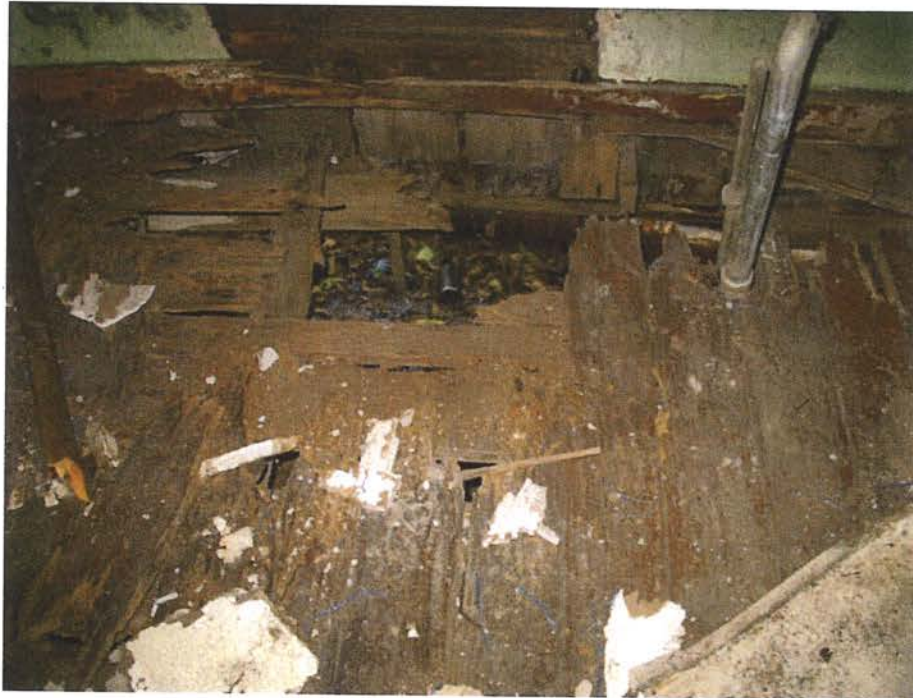
Damaged Flooring:

The upper level floors are in fair condition and some of the floor boards can be salvaged and reused. The lower level floor boards are deteriorated past re-use and need replacement.

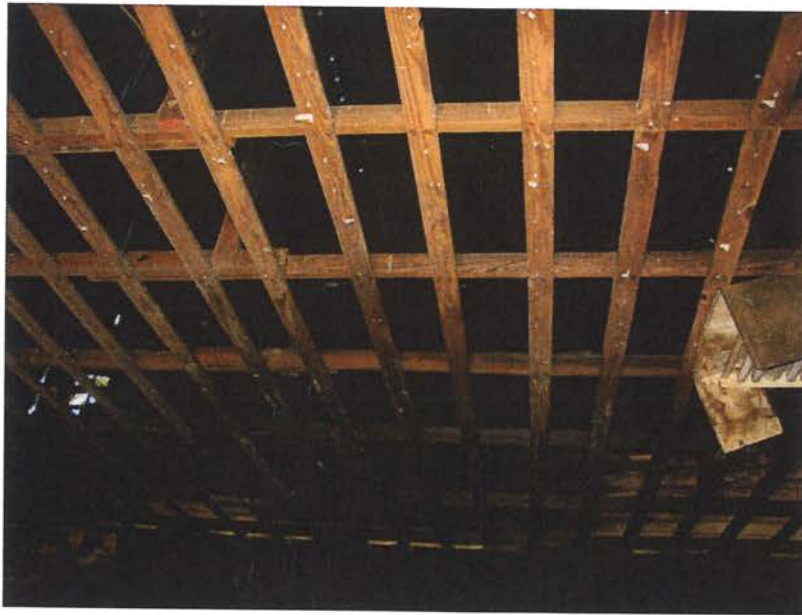
Damaged Ceiling near stage:

Paint is peeling on original side walls. The square tiles on the ceiling have almost all fallen onto the deteriorated floor downstairs. The side walls are mostly covered by modern medium brown interior paneling. This paneling appears to be covering original horizontal boards on the upper level and a vertical bead board side walls.

Ceilings – The balance of the acoustic ceiling squares should be removed. The wood nailers used to install it should be removed. A new bead board ceiling should be installed, primed and painted.
