## TRIP REPORT

**TRIP REPORT: FOPU**

**TASK:** Condition Assessments, and Analysis of the Jimmy Carter Depot

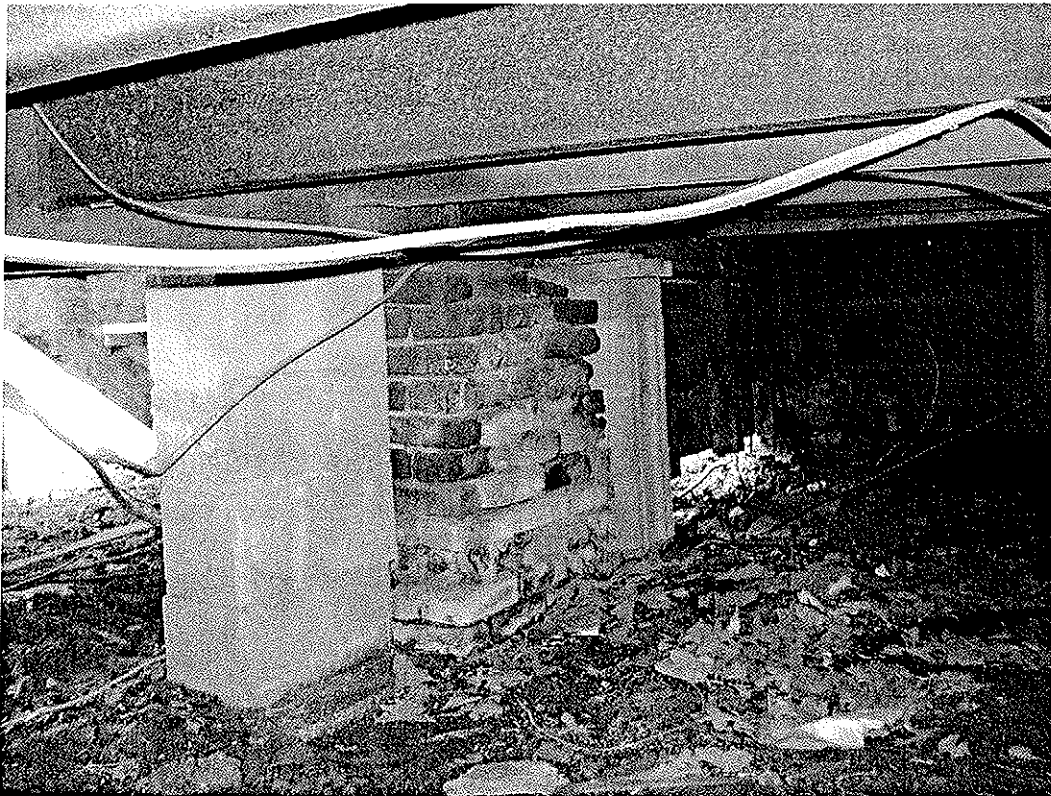
Approximately 11:00 AM a review of the Jimmy Carter National Historical Site Train Depot was begun. The building is a one story wood framed structure that has had stabilization problems. Cinderblock columns have been added next to the sides of the deteriorated brick columns, with wood wedges inserted on top to stabilize the floor structure. The columns range in size from approximately one foot by one foot to two feet by one foot. The columns appear to be constructed of a red clay brick and lime based mortar. The existing cinder block columns appear to be in sound condition and there is no indication of settling of these columns. The park plans to remove the cinder block columns to restore the historical appearance of the structure. The brick columns will require rebuilding prior to this action.

Cinder block added to stabilize deteriorating brick columns

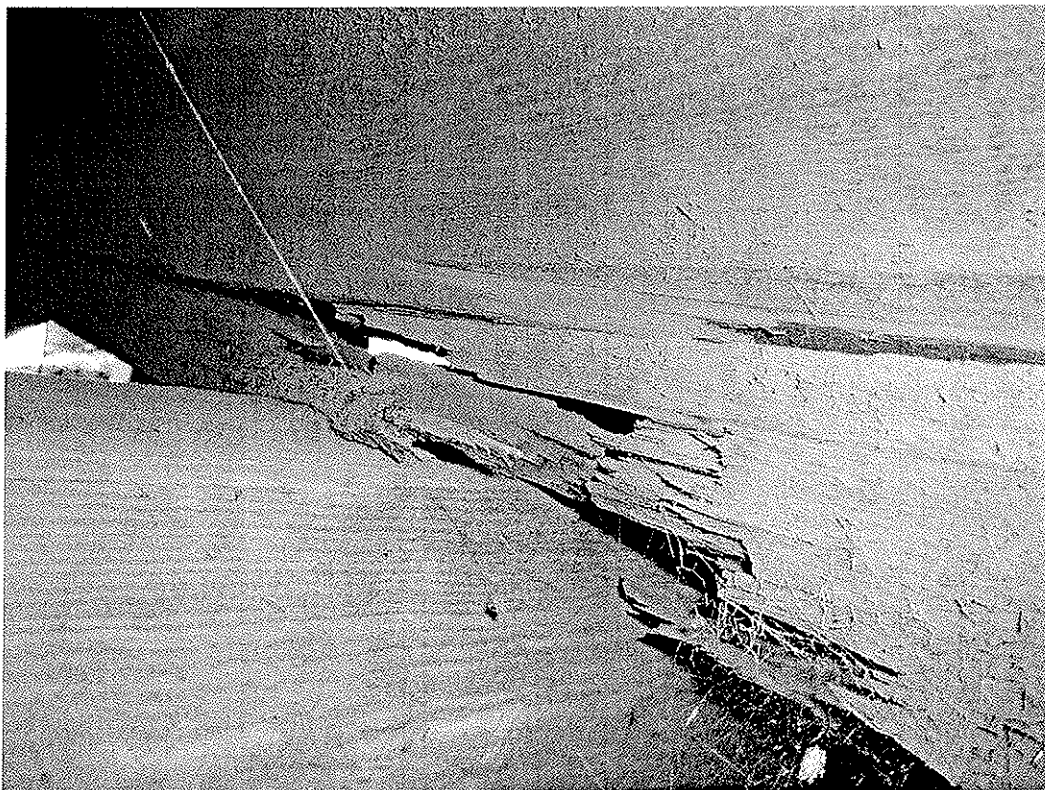
There are several 2 ½-inch x 9 ½-inch floor joists that have been damaged due to moisture and bug infestation. These will need to be replaced or shored until then. The floor joist spans are capable of carrying over 100 pounds of live load per square inch (psi). The loading rate required for a warehouse and meeting areas is 100 psi.

**Deteriorated joist setting on girder**

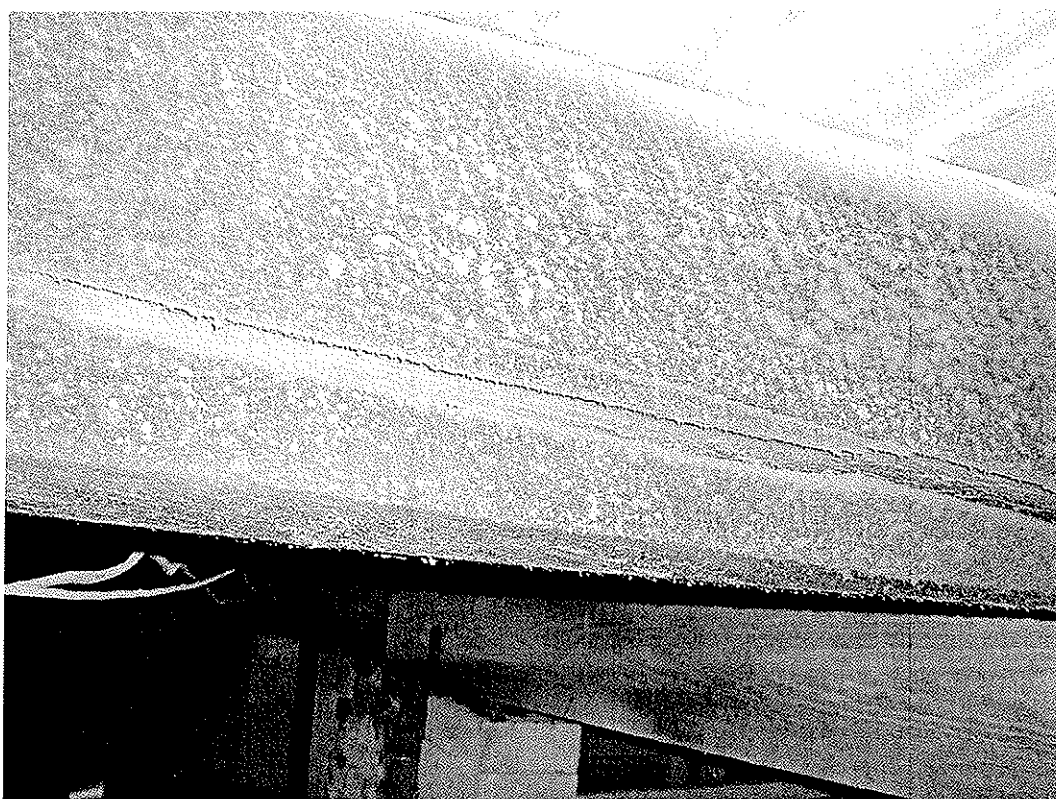
**Broken joist**

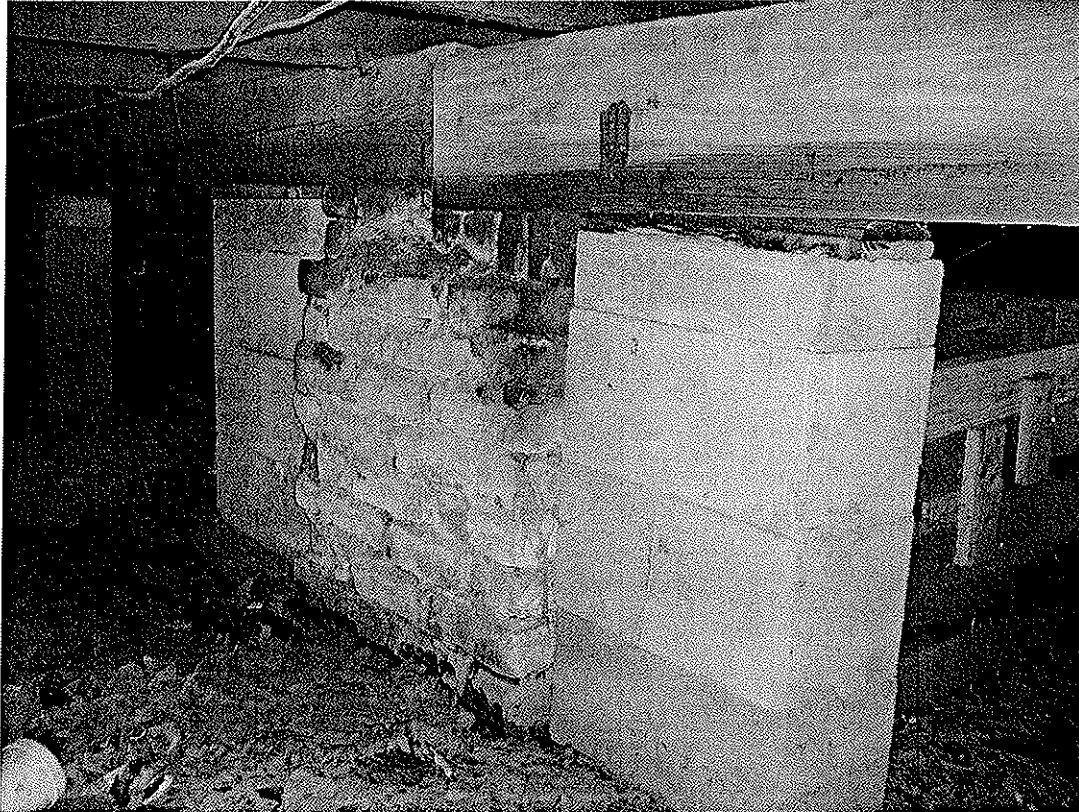
The girders and beams are largely in good condition. The maximum span of the girders between the columns should not exceed 8.3-feet from edge of column to edge of column to maintain the 100 psi of live load requirement.

6-inch x 8-inch girders under floor joist

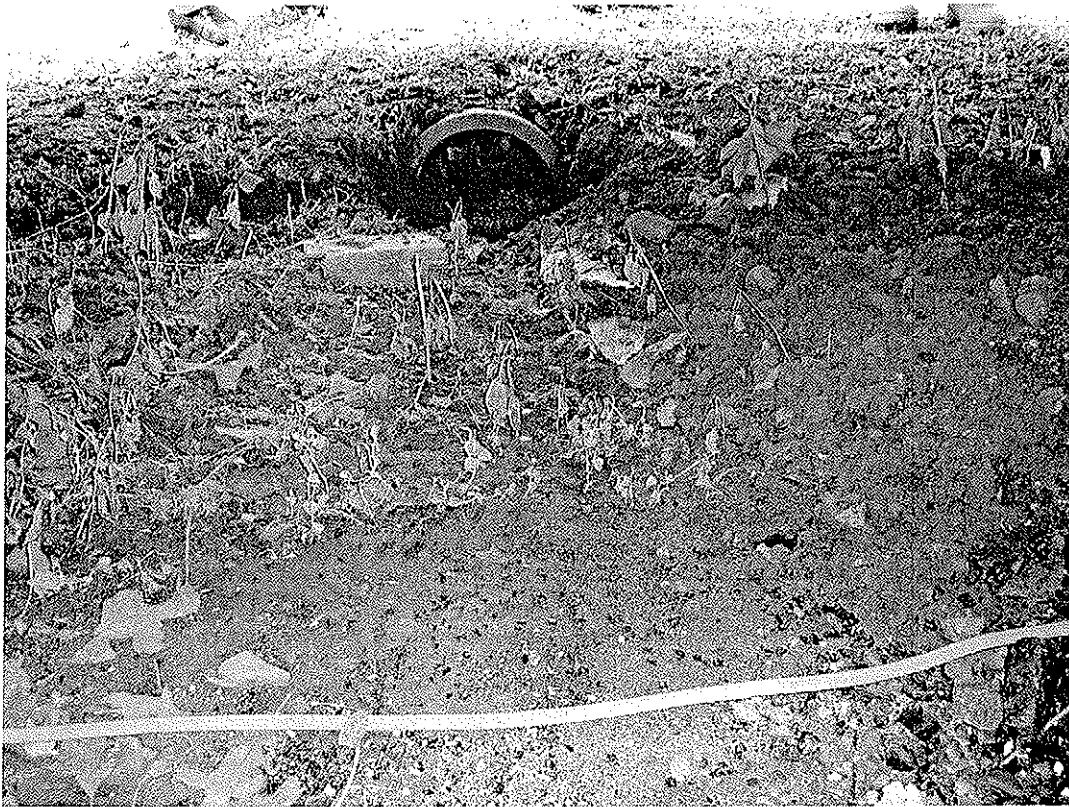
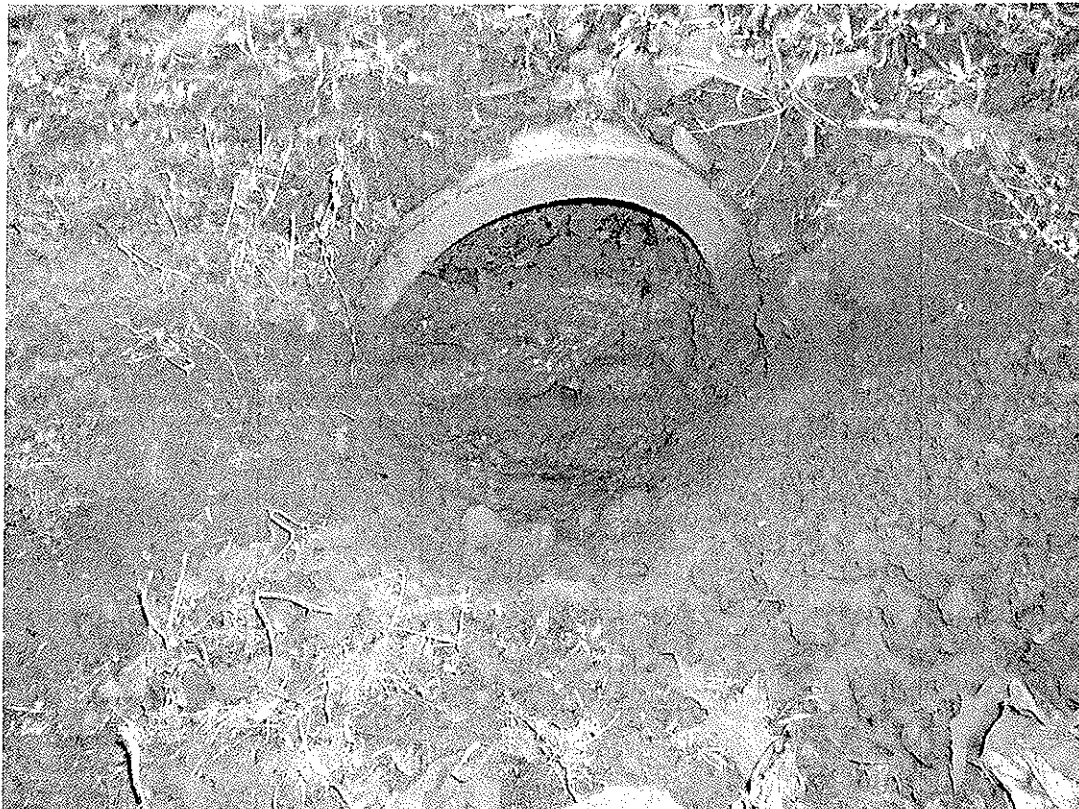
There used to be a clay drain pipe that carried the rain water to a storm drain on the other side of the track, but as can be seen in the following photos the drain pipe is plugged. After some digging it was found that the clay tile had been crushed. Reopening of this line would help alleviate the drainage problem.

**Plugged drain line**
