Geomorphological Assessment of Bank Erosion along the Missouri River near Fort Union Trading Post National Historic Site (FOUS) North Dakota – Update Report 2008.  
Fort Union Trading Post National Historic Site  
Lucy Ellis

**Geomorphological Assessment  
of Bank Erosion along the Missouri River  
near Fort Union Trading Post  
National Historic Site (FOUS)  
North Dakota – Update Report 2008**

Lucy Ellis

*February 2008*

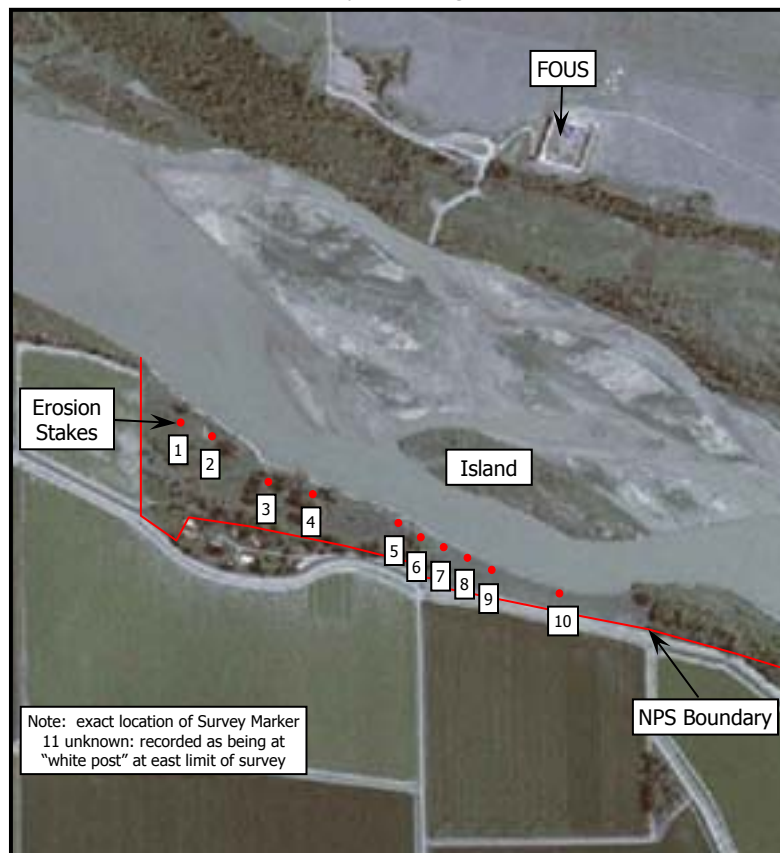
**Figure 3.1** Position of Erosion Monitoring Stakes along South Bank of Missouri River. GPS Coordinates Superimposed on 2004 Aerial Photograph. Image Source: NPS Image Collection.

- High rates of erosion occurred at Stakes 6 to 11 between September and December 2002. This may represent the period when the main thalweg channel shifted to the south of the island, causing rapid bank retreat.
- There was a slight correlation between the measured amount of erosion and the discharge magnitude and pattern over the same time period, but only at Stakes 1 to 5. This correlation is not apparent at Stakes 6 to 11, indicating that bank failure is affected by processes other than direct flow entrainment along this section.
- There is no indication that larger amounts of erosion occur during the late spring, due to ice breakup. The rate of erosion at Stakes 6 to 11 may, therefore, be related to the saturation levels of the banks. The diversion of the thalweg around the island, towards this section of the bank may also be responsible for the unpredictable erosion.

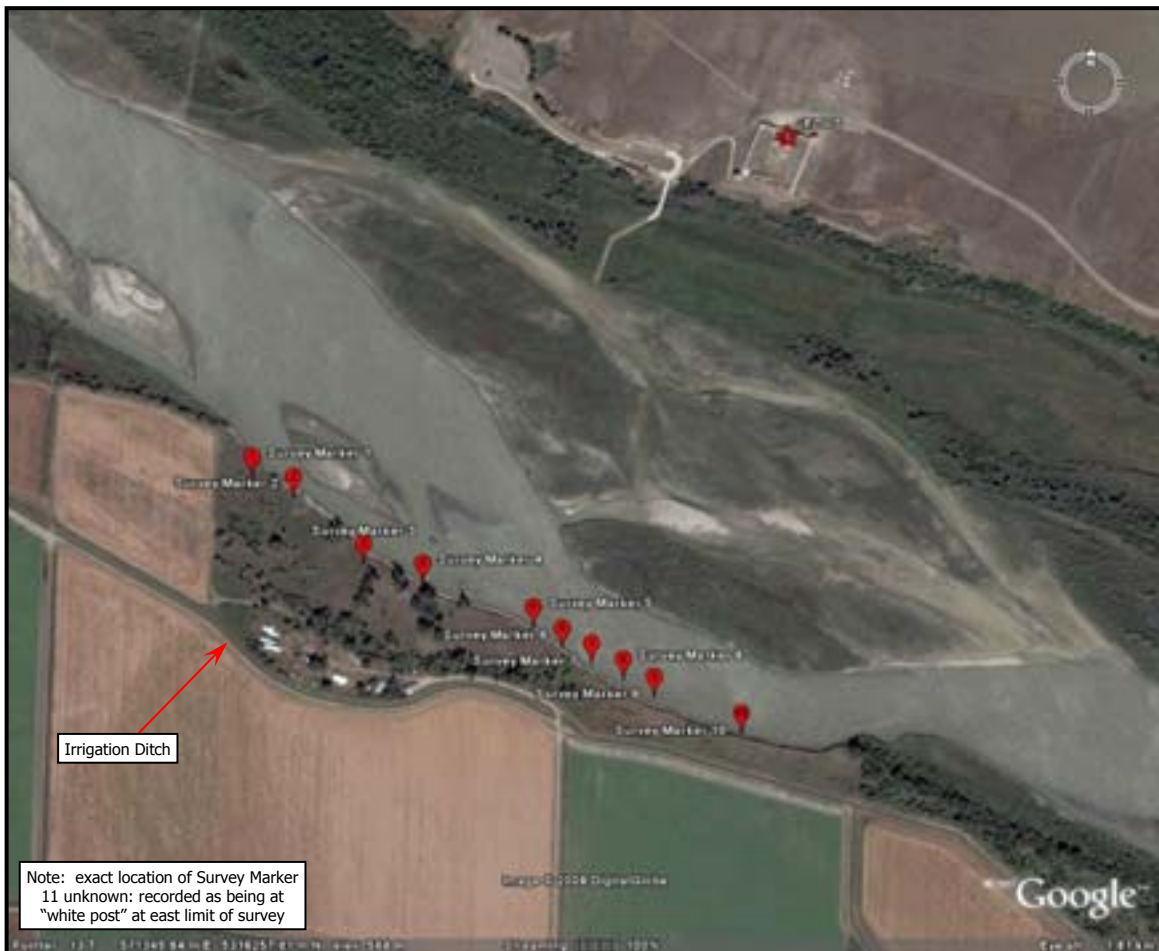
**Figure 3.2** 2007 GoogleEarth Image Showing Approximate 2005 Position of Marker Stakes (Note Position of Posts Mid-Channel). GPS Coordinates of Stakes Provided by NPS.

- It has been suggested that water leaking from the nearby irrigation ditch (which is closer to the downstream section of the study reach, see Figure 3.2) could be contributing to the rapid rate of erosion along the Study Site. However, NPS employees have reported that the ditch is dry during the winter (A. Banta, *pers. comm.*, March 2008). This would indicate that the high saturation levels of the bank materials are due to natural factors, such as recent prolonged precipitation; a high or perched water table and/or prolonged high water levels.

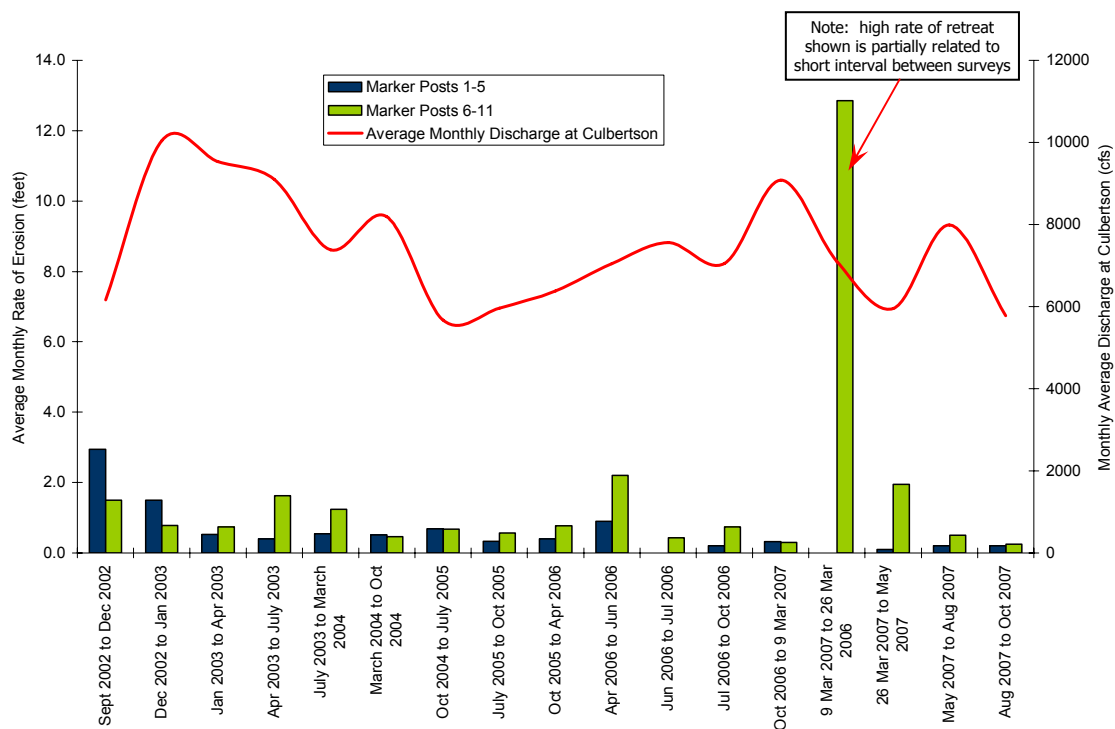
- The differences in the rate of bank retreat along the study site are not wholly explained by the fluctuation in the discharge of the Missouri River (see Figures 3.3 and 3.4). This indicates that other factors have an important controlling influence on the stability of the bank. These factors include: antecedent precipitation (which can also control the saturation levels of the bank); the effect of river ice; the formation and enlargement of tension cracks; and the presence of vegetation.

**Figure 3.4 Relationship between Monthly Average Rate of Erosion at Study Site and Monthly Average Discharge of the Missouri River at Culbertson. Note that Bars Represent Irregular Time Intervals and are Based on Erosion Measurement Records Provided by the NPS.**

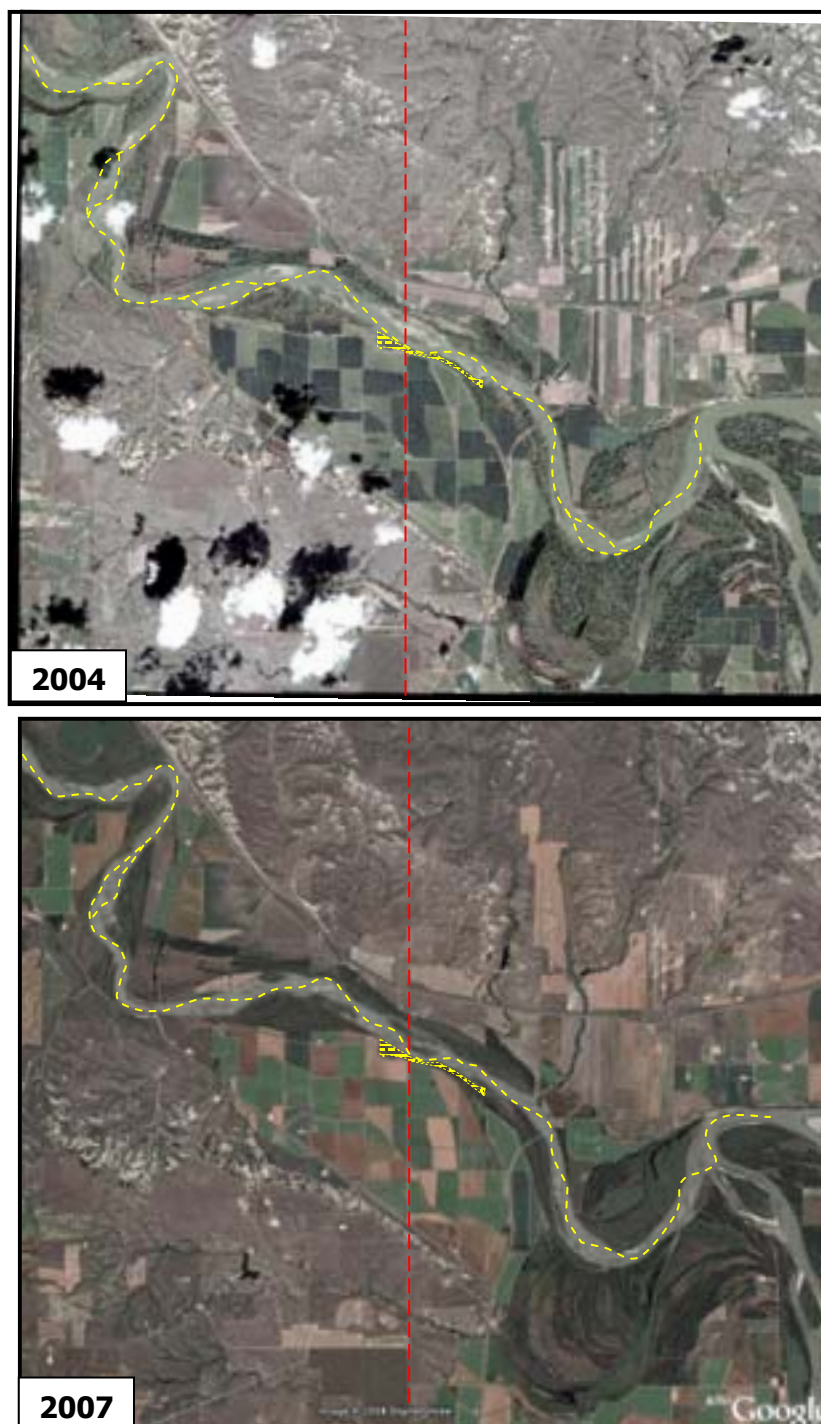
**Figure 4.1 Recent Planform Evolution of Missouri River Study Reach (Image Source: NPS Image Collection; GoogleEarth).** It should be noted that there may be copyright issues with GoogleEarth imagery. Therefore, the images contained in this report are intended for internal NPS use only, and should not be published externally.

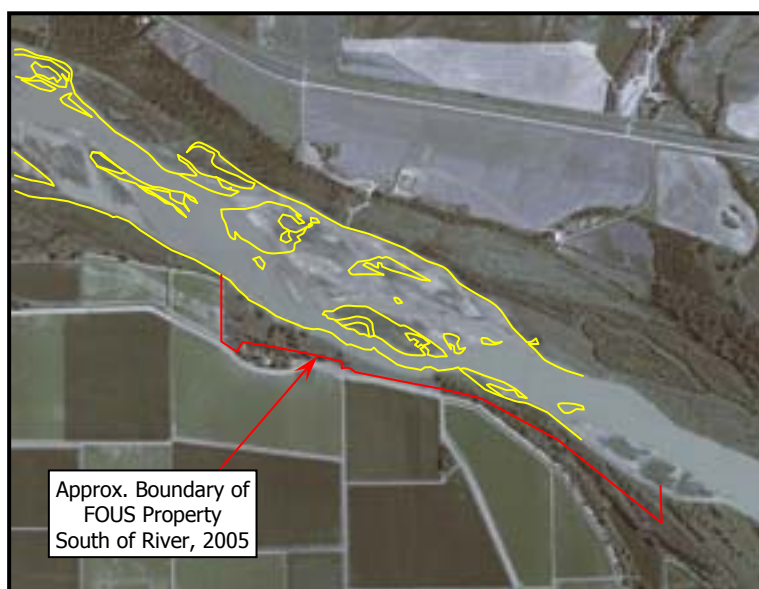
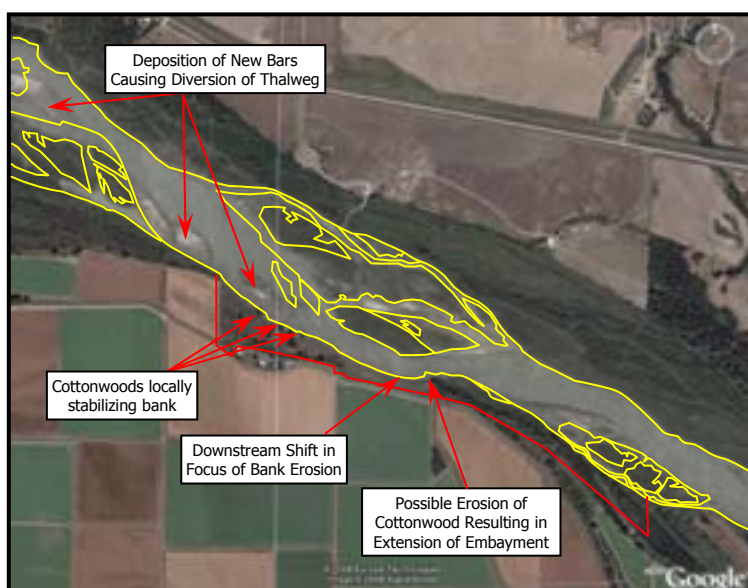
**Figure 4.2 Recent Planform Evolution of Study Reach at FOUS (Image Source: NPS Image Collection; GoogleEarth).** It should be noted that there may be copyright issues with GoogleEarth imagery. Therefore, the images contained in this report are intended for internal NPS use only, and should not be published externally.

- This increase in the braid index (the number of bars present in the channel) has caused an increase in the sinuosity of the active channel.
- The change in number and extent of channel bars appears to have caused the meander wavelength of the active channel to decrease. This has resulted in a shift in the focus of erosion along the banklines. The deposition of new bars and growth of upstream bar complexes has affected flow patterns through the study site, causing a downstream shift in the locus of bank erosion. Unfortunately, the bank along the downstream section of the study site is closer to the irrigation ditch (in spring 2007, the bank was approximately 130 ft from the ditch). Close monitoring of the position of the bankline should, therefore, continue, in order to assess the risk posed to the ditch.

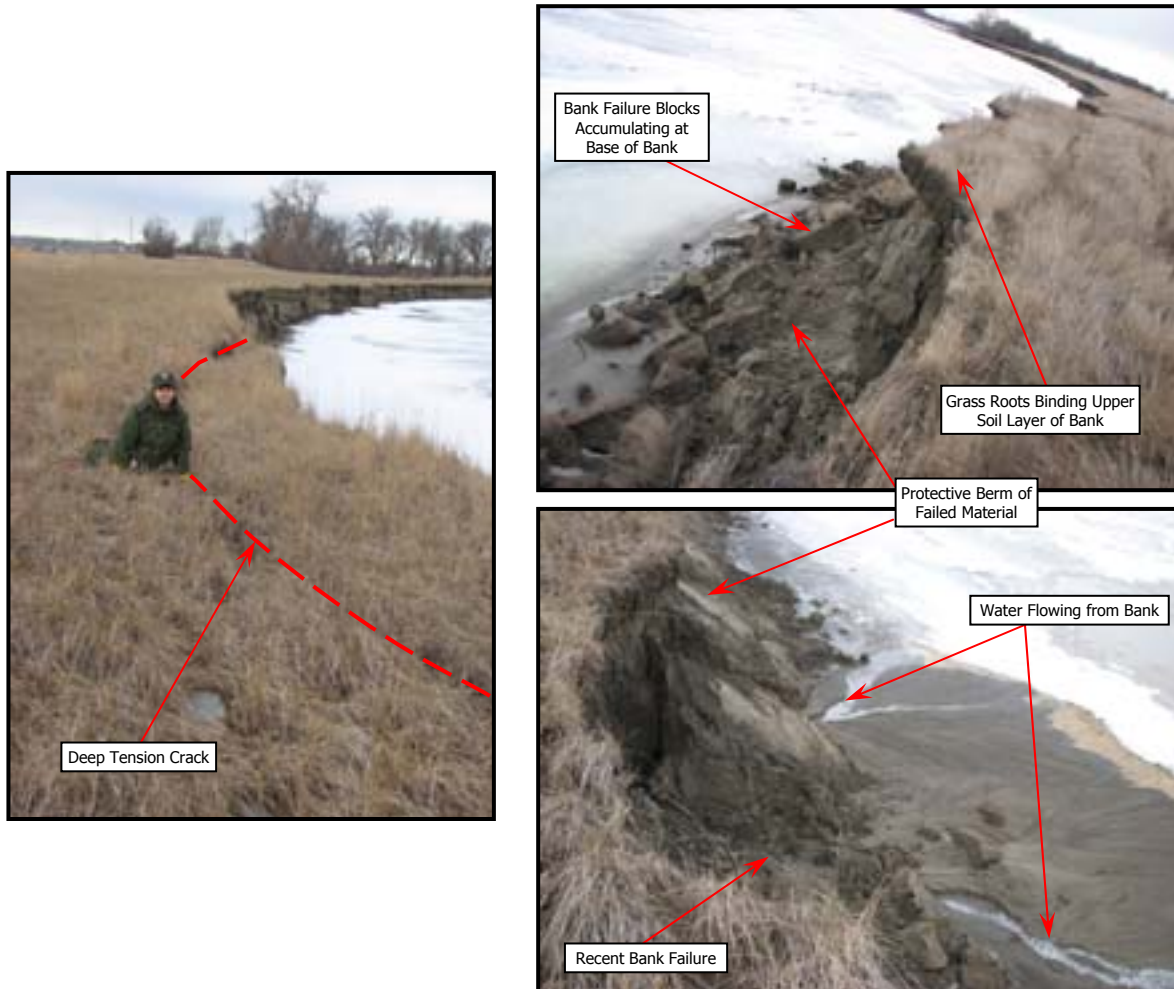
- Deep tension cracks are shown, indicating the instability of the banks and imminent failure;
- A protective berm of failure material can be seen at the base of the banks, indicating that failure is triggered by processes other than direct flow entrainment;
- Ice has developed at a fairly low water level. However, a considerable amount of erosion noted during ice-out shortly afterwards may indicate ice-damming and rapid

**Figure 4.3** Photographs Taken by NPS Employees on 9 March 2007 Shortly before Ice-Out, showing:  
a) Deep Tension Crack Approx. 7 ft from Bank Edge;  
b) Cantilever Overhang and Recent Bank Failure;  
c) Water Flowing from Bank and Recent Bank Failure.

- Failures again seem to have been triggered by the saturation levels of the bank, with the bank materials providing a contributory destabilising factor. Photograph 4.3c shows water flowing from the base of the bank, indicating high levels of saturation. The high water content of the bank may have been caused by recent prolonged precipitation or melting of ice and snow.

- Vegetation provides a stabilising influence. As Figure 4.3b indicates, grass roots can bind the upper soil layers, leading to the formation of a cantilever overhang. The stabilising effect of Cottonwood trees has been noted earlier.
