# **Structural Condition Assessment**

**Center Theatre  
Franklin, Louisiana**

**City of Franklin  
Franklin Historic District**

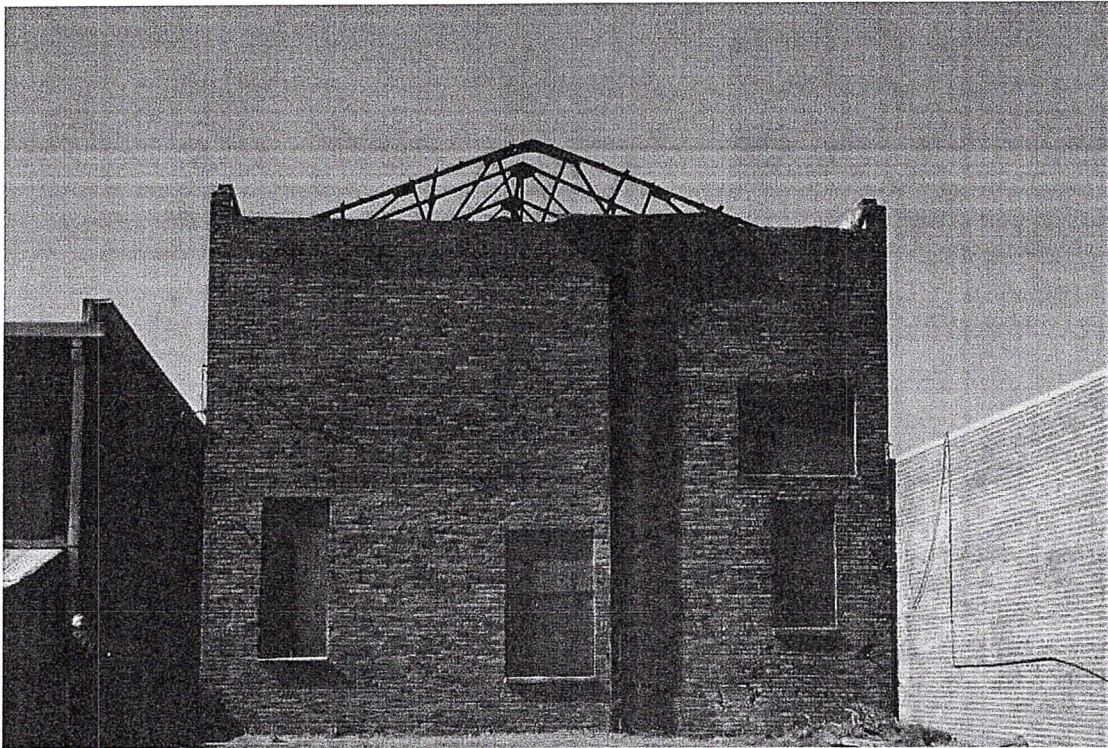
The brick masonry walls appear to be in good shape. Most of the masonry that could be examined in this investigation appeared to be intact with solid mortar joints. No significant deterioration of the masonry was observed. However, there was a significant crack in the rear masonry wall above the upper level window.

Rear View of building (from Teche Drive)

5.2.1. Additional investigation of the rear wall should be done to address the masonry wall cracking. The investigation should focus on possible settlement issues and other possible causes for the cracking. After fixing the root problem(s) for the wall cracking, the cracks should be sealed with cement mortar and/or flexible sealants will prevent additional water intrusion into the masonry wall.

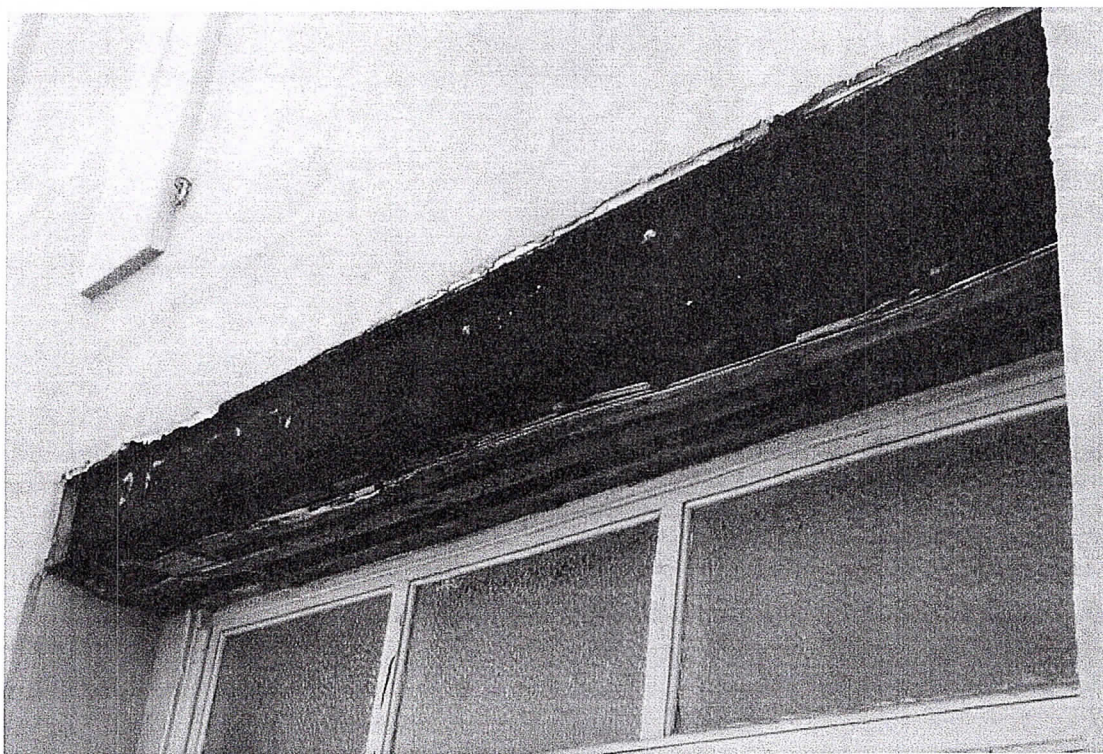
The front façade of the building is finished with stucco and appears to be in good condition. Two openings on the front of the building have been boarded up. The exposed steel beam supporting the upper section of the façade wall is exhibiting significant corrosion from the weather. Also, the wood French doors at the front

Steel Beam corrosion

5.1.3. Steel Components – Exposed steel components, such as the exterior beam at the front entry, should be cleaned of significant rust and coated to prevent further oxidation.

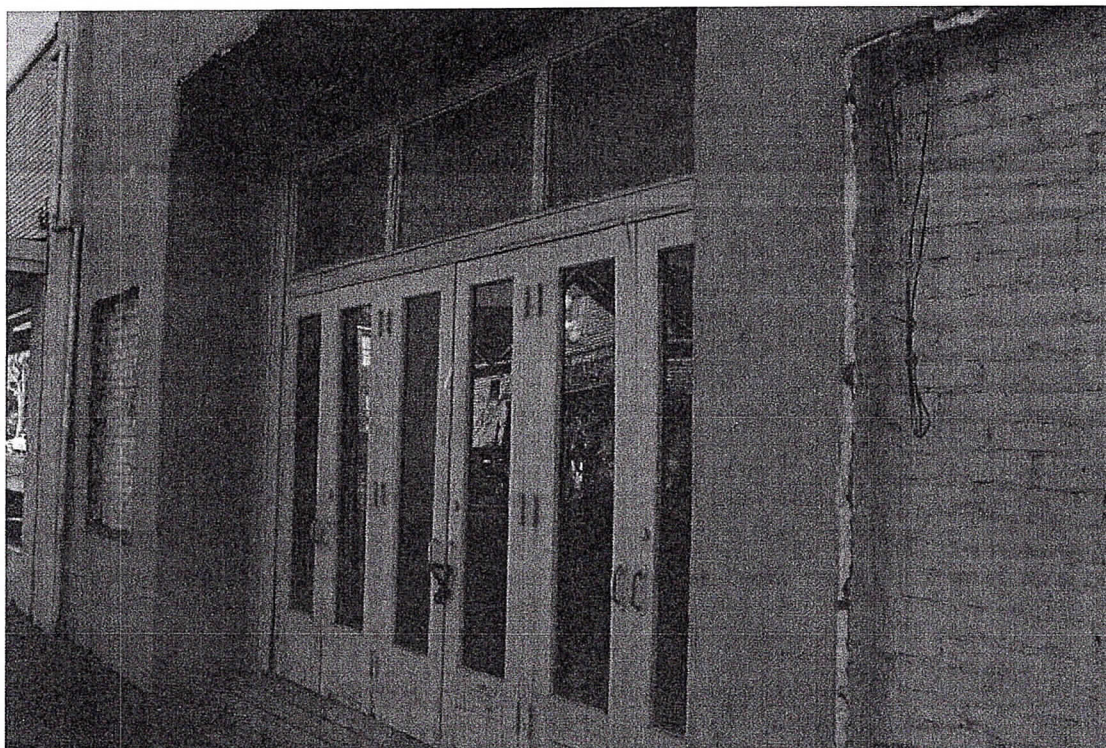
entry are exhibiting deterioration from the weather and are sticking and hard to open.

Front Entry

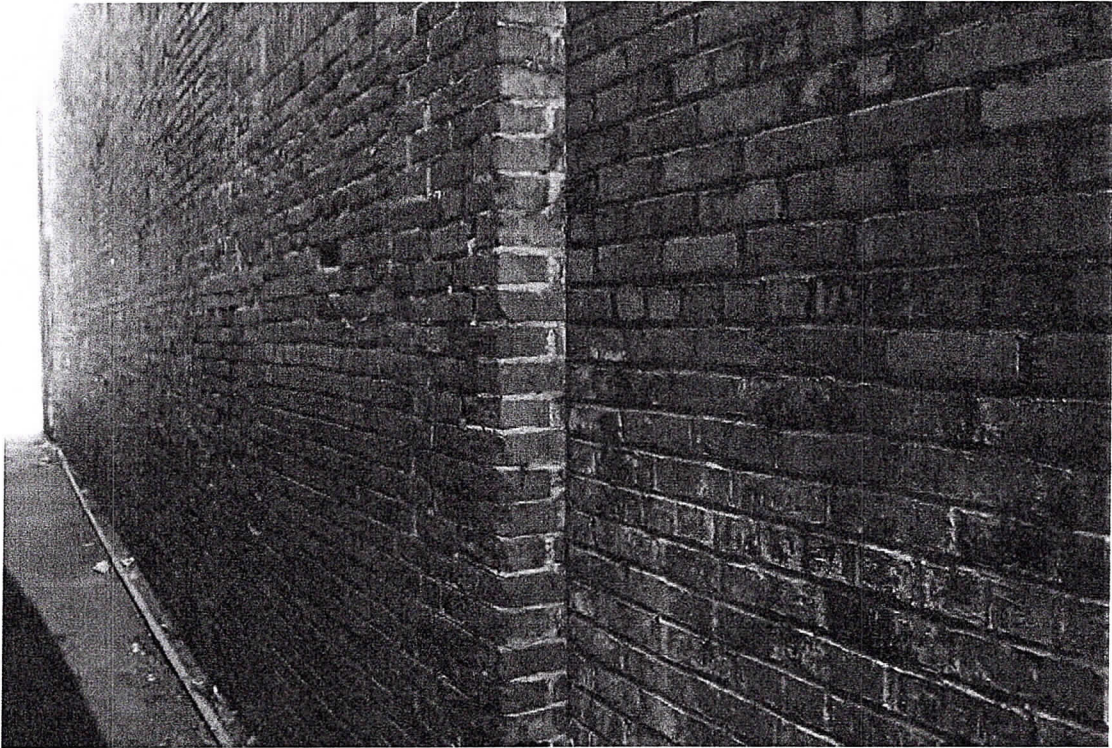
Masonry Wall in Alley Way (note differing bricks and evidence of openings bricked in)

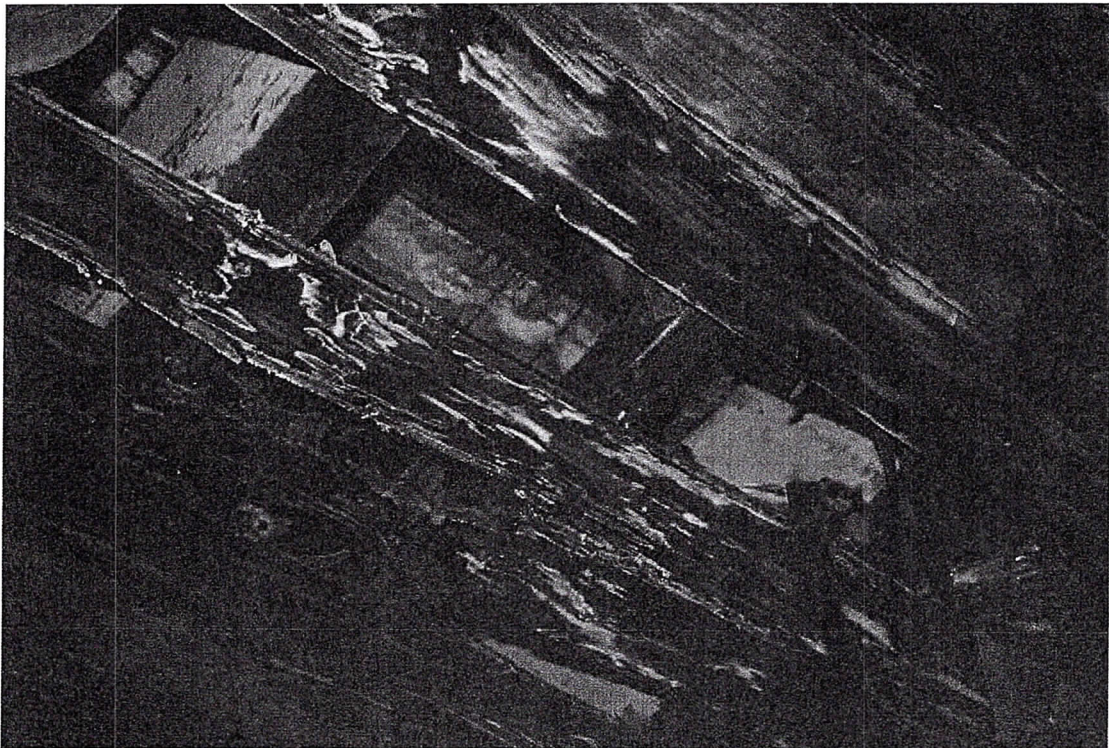
- 4.2.2. General, Interior – The interior of the building is in an advanced stage of deterioration. The wood balcony structure has deteriorated due to water intrusion and general exposure to weather. The balcony also has a perimeter framing of steel beams that are also exhibiting severe corrosion from the water intrusion. The stairs leading up to the balcony and the floor structure appears to be unsafe to occupy.

Ceiling area below balcony – water damage

5.1.2. Interior – The interior of the building should be cleared of vegetation and structural debris. The vegetation should be cleared to prevent any further damage to the masonry walls. The wood structural components of the balcony and remaining roof structures are a safety concern due to their advanced deterioration.

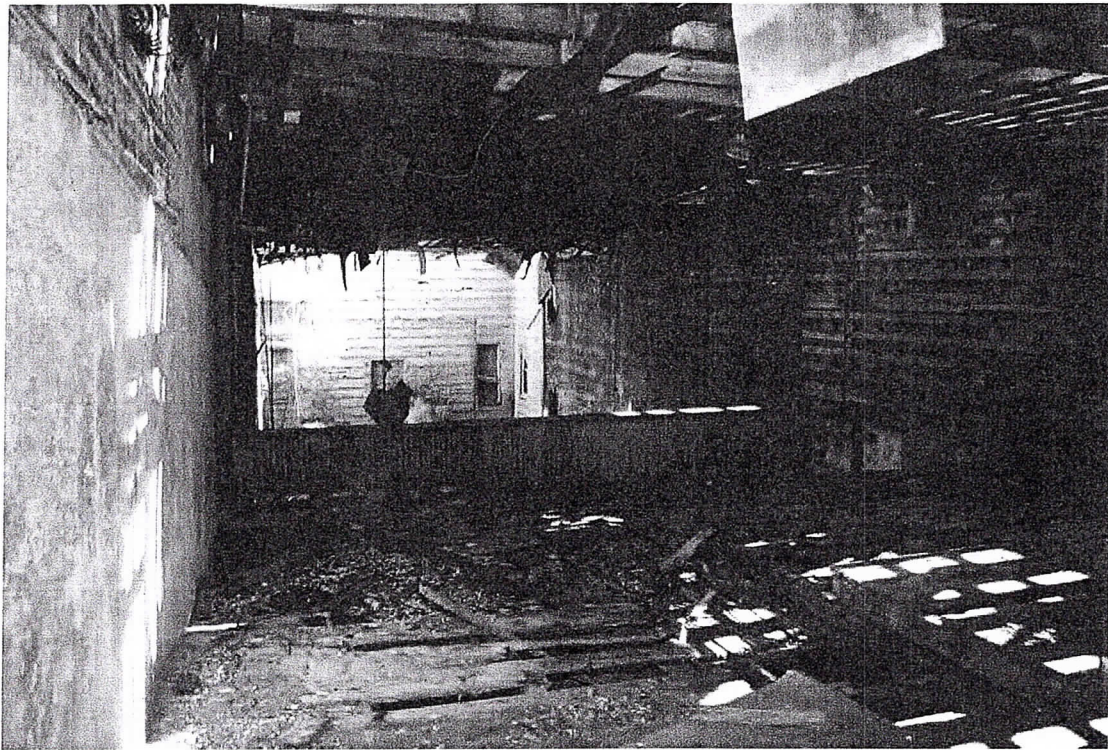
- 4.2.1. General, Exterior – In general, the building is currently in a state of advancing deterioration. The roof has partially collapsed at the rear of the building, which is allowing rain and humidity to invade the interior spaces. Birds and other wildlife can also access the interior spaces through the open roof.

Upstairs Balcony area – note sunlight at rear building and over balcony (roof collapse)

- 5.1.1. Roof Structure – Providing a roof to cover the building is essential to stopping the severe deterioration occurring in the structure. First, a roof structure will stop the intrusion of water into the building. This water intrusion is providing a mechanism for the on-going deterioration of wood, metal, and masonry building components.

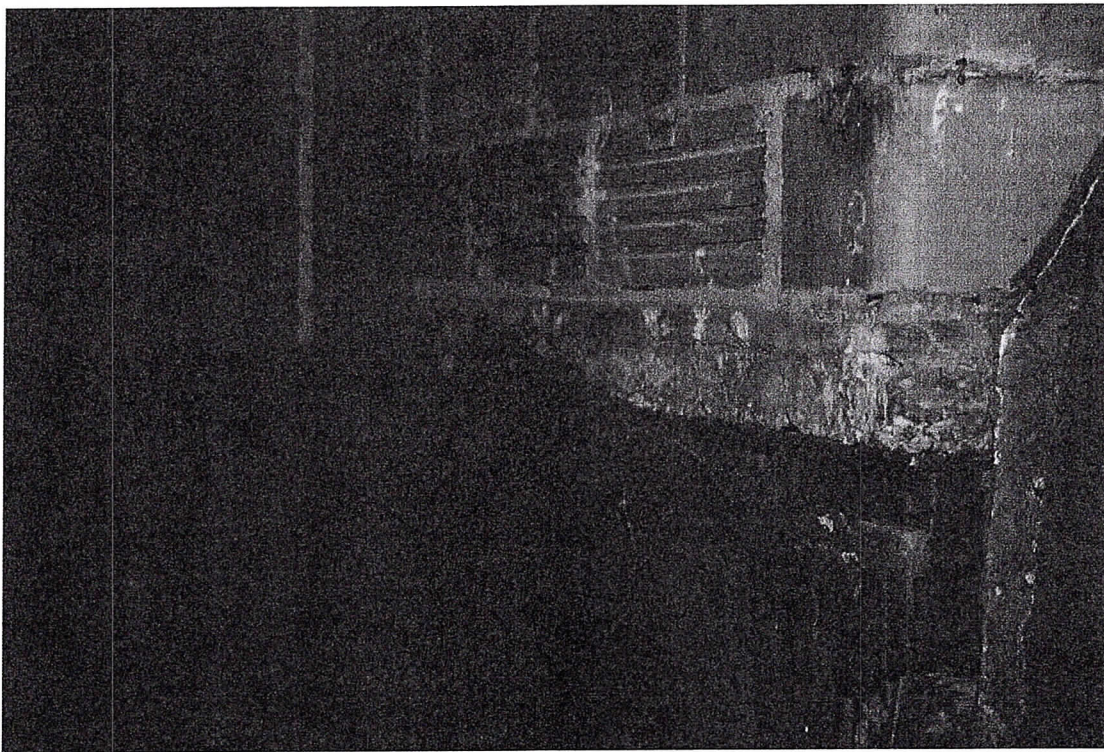
The central projection room at the front of the building is constructed of concrete masonry units (cmu) and poured in place concrete slab. The steel pan supporting the concrete is rusting due to water intrusion.

Central projection room

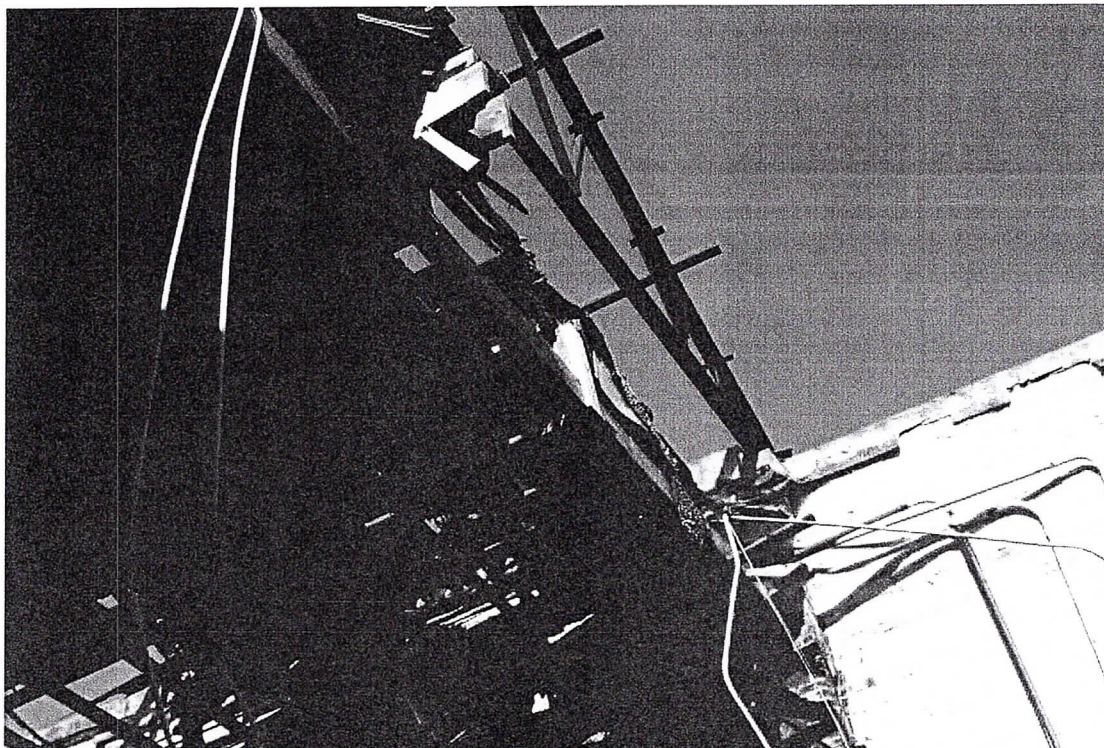
- 4.2.3. Roof – A large portion of the roof at the rear of the building has collapsed, allowing rain to enter the building. Also, the remaining roof is significantly deteriorated and has several large openings. The structure of the roof is constructed with wood members. It was originally a single slope roof draining rain toward the rear of the building. Several steel trusses have been installed at the rear of the building with no secondary structure or finish.

Roof collapse area (note steel truss installed above)

Continuing with steel trusses similar to those already installed at the rear of the building will provide for the structural lateral support. However, that type of structure will shed rain water toward each side. Provisions will be required to channel the rain water toward the rear of the building.

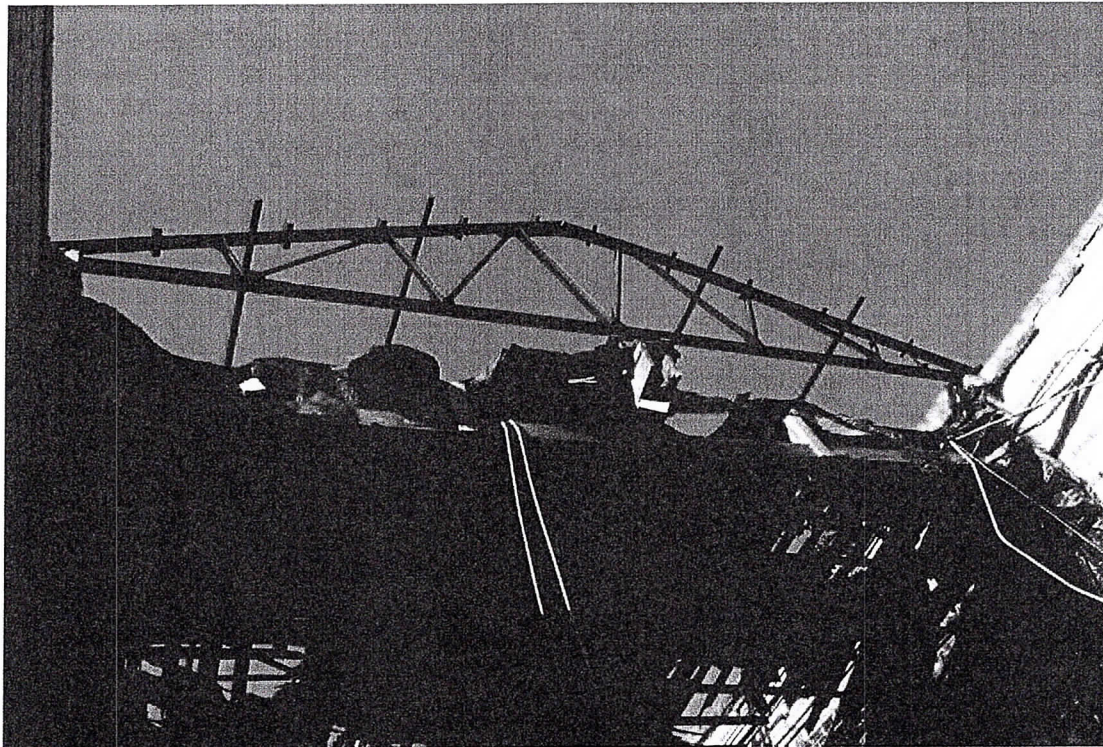
Steel truss installed at top of side walls

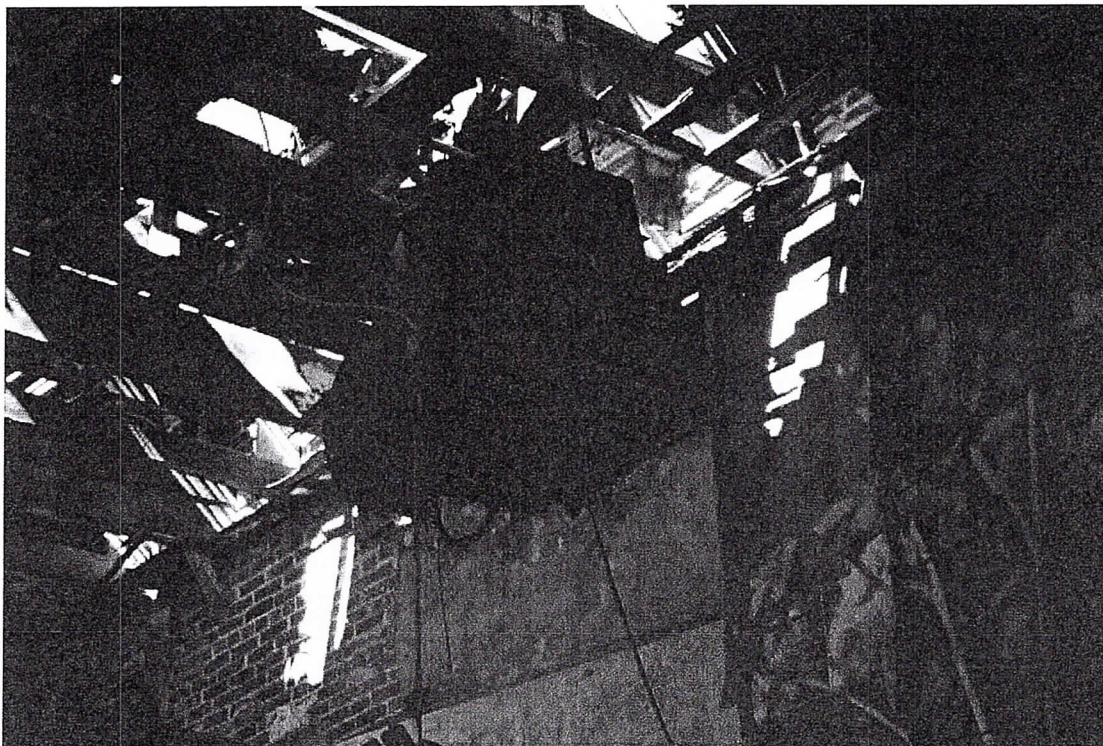
Mechanical equipment hanging from roof structure

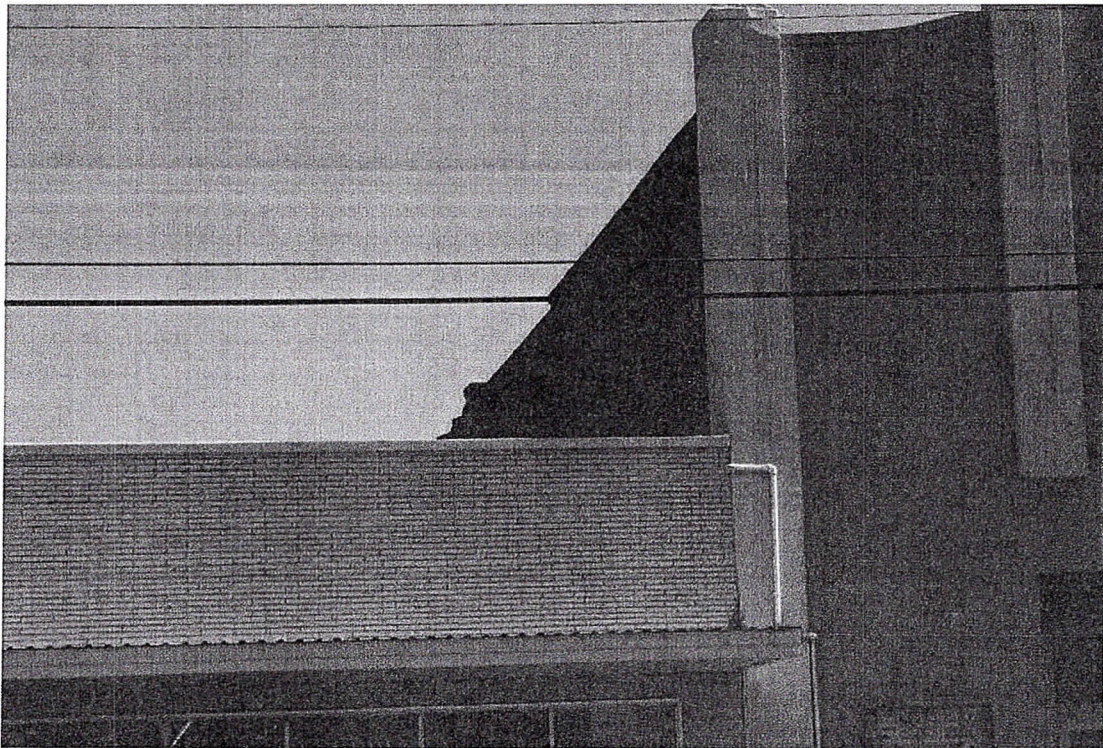
Exposed exterior wall above adjacent building
