## Structural Assessment and Stabilization Plan for

# Gurski Homestead

26 Obtuse Hill Road  
Brookfield, CT

January 7, 2014

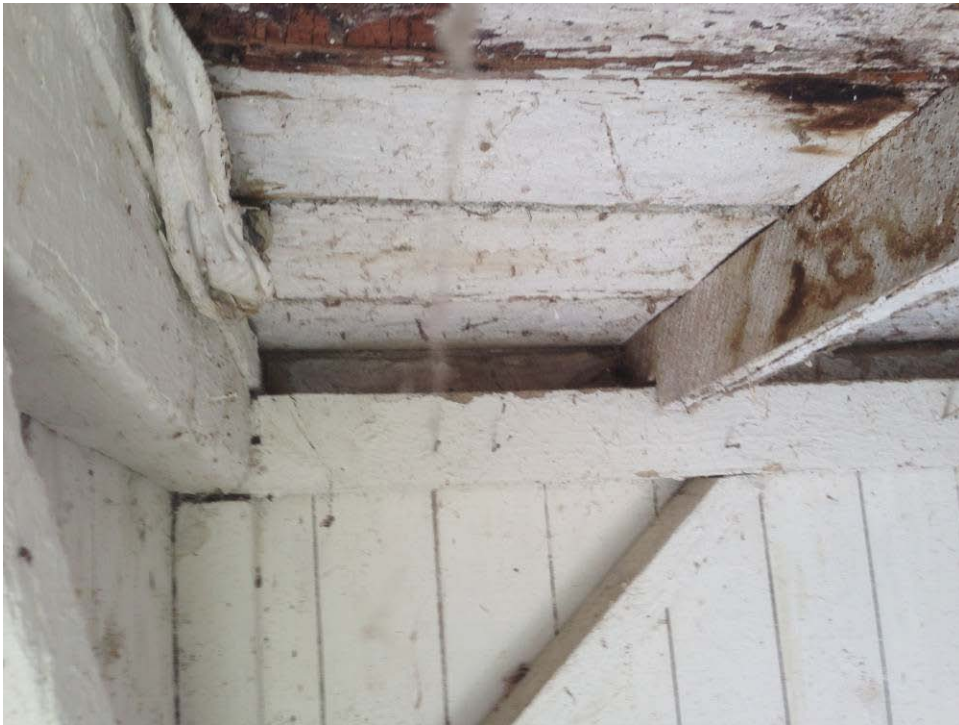
Building 1

The roof is framed with rough sawn rafters with rafter tail extensions beyond the face of the walls. The rafters, and particularly the tails, are severely rotted from exposure to the elements. The fascias along the rafter tails are also rotted from exposure.

Rotted Roof Framing

1. Construct new foundation
2. Replace rotted sill plate with pressure treated plate
3. Repair/replace rotted framing, including post bases, wall/roof framing, and fascias
4. Repair/replace rotted siding as required
5. Strengthen roof framing per Code

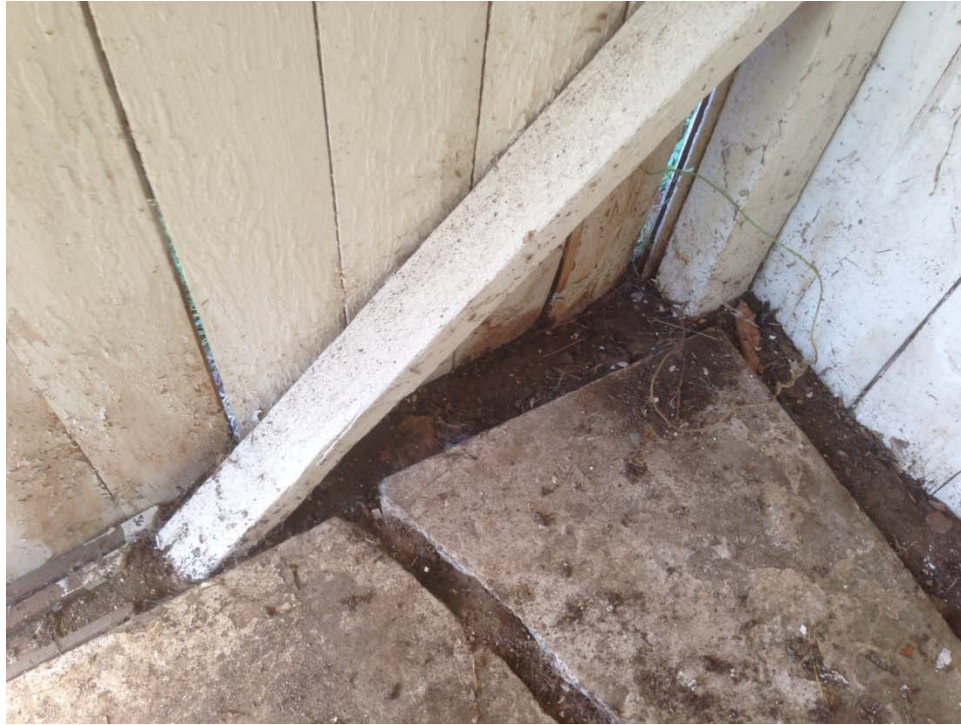
Building 1

The post and beam wall framing for this building sits atop a sill plate set on grade. The concrete slab on grade floor was cast on grade using the perimeter sill plate as a form. Since the sill plate is exposed to earth on two sides and concrete on another, its exposure is extremely severe and its condition is poor as a result. The lack of a proper foundation for this building is a major inhibition to permanent stabilization since contact between wood and the ground or concrete promotes premature decay of the wood. The building is also not founded below the Code required frost depth and is therefore vulnerable to seasonal movement of the subgrade.

Timber Framing Set on Grade

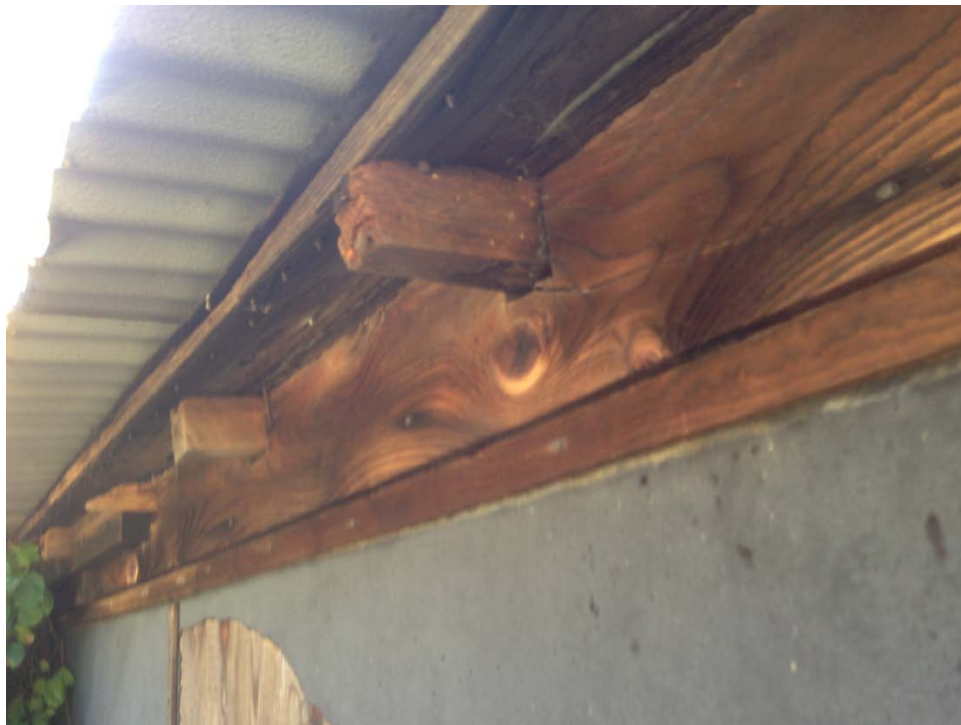
Building 1

Rotted Rafter Tails

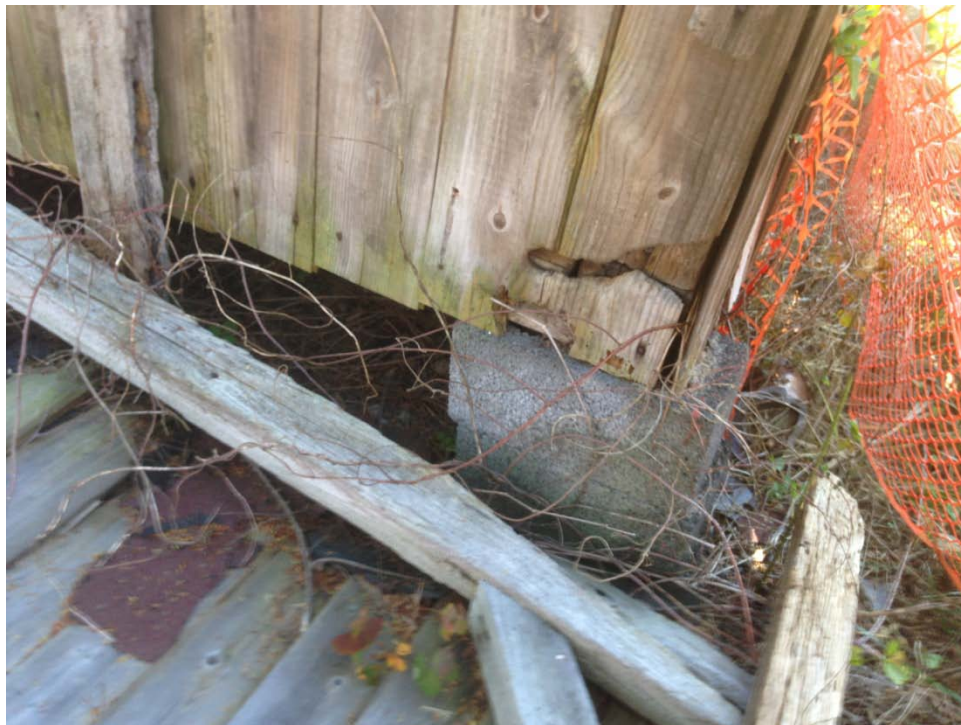
Building 3

All framing for this building is severely deteriorated. Floor framing was concealed by debris along the building interior, but viewable sections are in poor condition. The roof is improperly framed, not having a ridge beam or ties at the ceiling level to hold it together. Its condition is also extremely poor and the center of the roof is severely deflected. Siding is severely deteriorated throughout, as are the roof boards and roll roofing material which was improperly used on a high slope roof. This structure cannot realistically be salvaged since the framing is deteriorated to the extent that it is hollowed out and unable to hold nails that would connect any repair pieces.

Typical Base Detail with CMU Block

1. Reconstruct to match existing configuration. Salvage some exterior siding for replica structure.

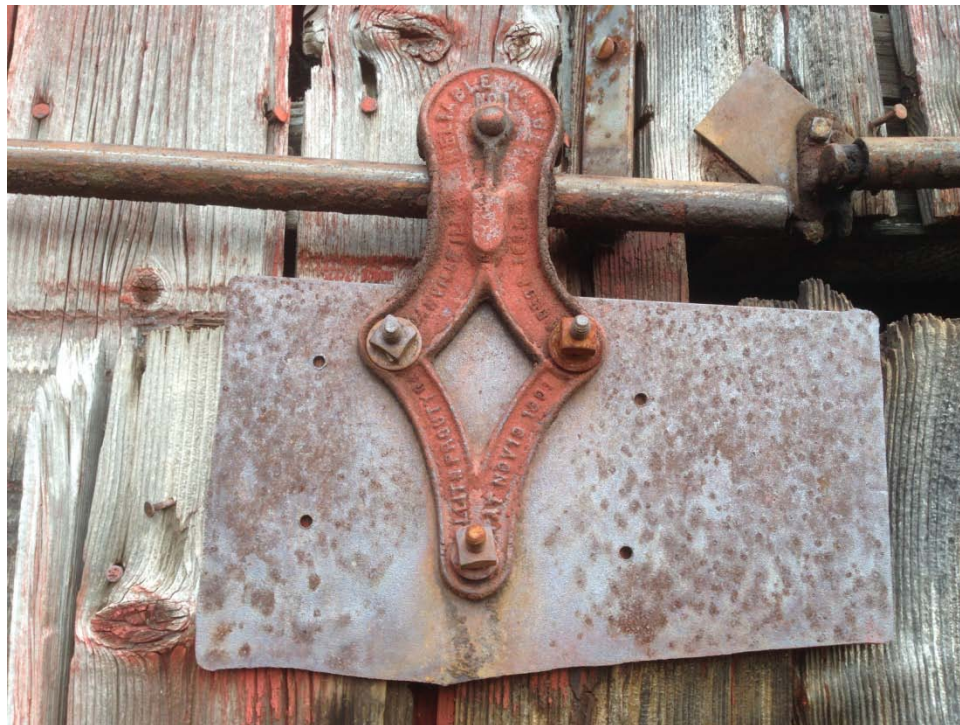
Building 4

There is a sliding door for entry into the shed. The door moves along a metal bar mounted to the face of the building. Operation of the door is extremely difficult due to the weight of the door and binding of the slide mechanism.

Sliding Door Mechanism

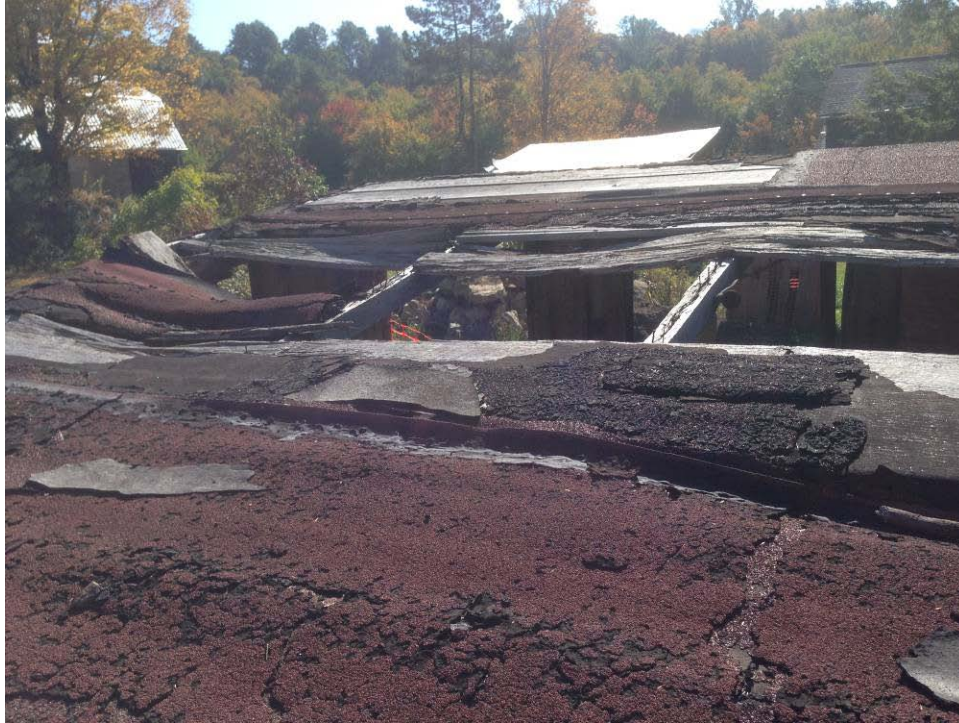
Building 5

All framing for this building is severely deteriorated. The roof is in extremely poor condition and is partially collapsed. Siding and roof decking are severely deteriorated throughout, as is the roll roofing material which was improperly used on a high slope roof. This structure cannot realistically be salvaged since the framing is deteriorated to the extent that it is hollowed out and unable to hold nails that would connect any repair pieces.

Typical Roof Condition

1. Reconstruct to match existing configuration. Salvage some exterior siding for replica structure.

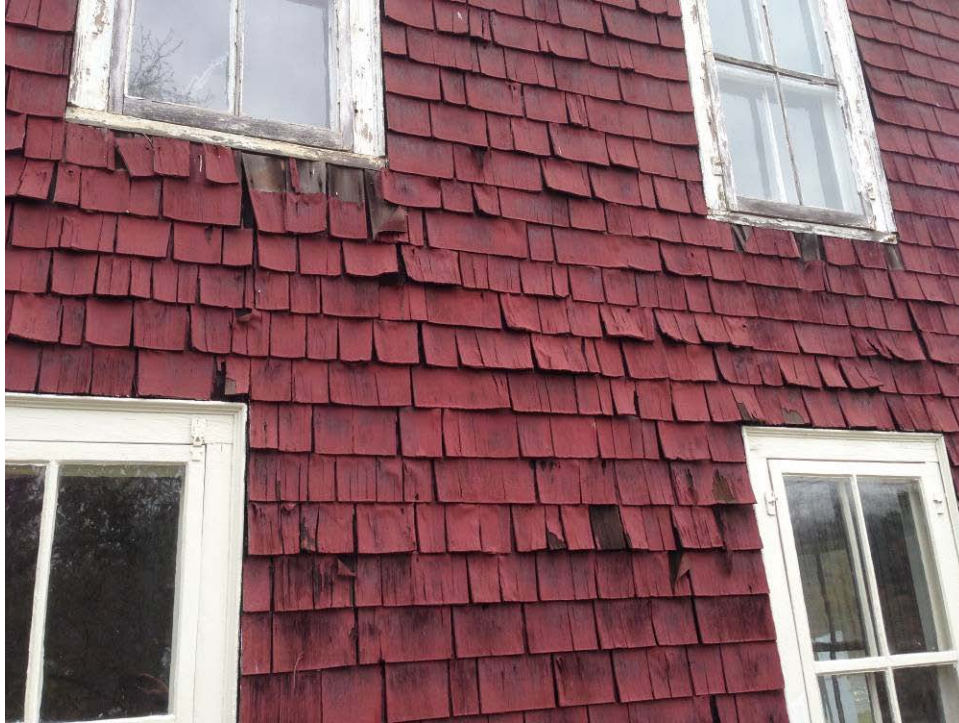
Farm House

The exterior finishes have been partially restored. The roof covering appears to be relatively new as do some trim boards. There are two layers of siding present. The outer layer is cedar shakes. The base layer, which is visible only near the east entrance, is wood clapboard siding. The cedar shakes are in poor condition throughout. Where clapboard is visible, it is also in poor condition.

Wood window frames and trim are all in poor condition. All trim requires scraping and painting and some is rotted and in need of removal and replacement. Windows, which have wood frames with true divided lights, require scraping, painting, and reglazing. Flashing between the low roof on the north side and the clerestory wall above it is peeling off and in need of replacement. The porch roof along the south side of the house meets the front wall very near the second floor window sill elevation. This configuration is vulnerable to water infiltration with accumulating snow.

Defective Siding and Deteriorated Window Frames

1. Remove and replace failed roof timbers
2. Replace siding throughout
3. Replace flashing at several locations
4. Scrape and paint all windows and trim, reglaze windows
5. Repair/replace exterior trim/window sills
6. All floor and ceiling finishes are in need or replacement. Some floor boards may be salvageable.
7. Level floor finish as required at floor depressions
8. Add areaway pumps at basement window wells
9. Repoint chimney
10. Consider heat trace along porch roof below second floor windows

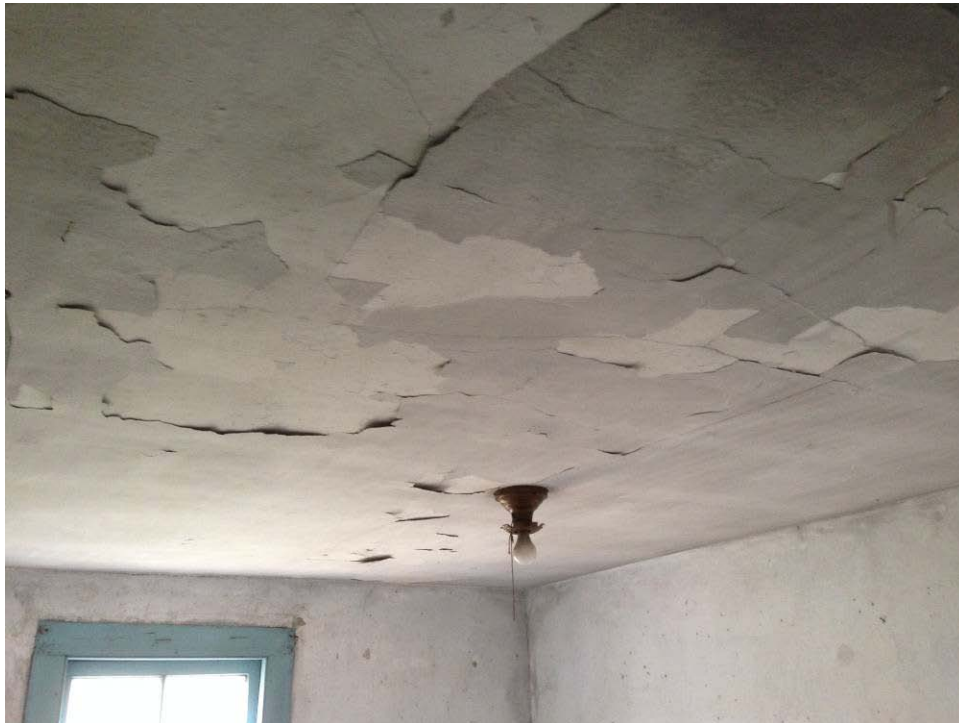
Farm House

The interior plaster walls and ceilings are in extremely poor condition. Plaster is cracked and bulged throughout, and several sections are loose and delaminating from the substrate.

Cracked Plaster Ceiling

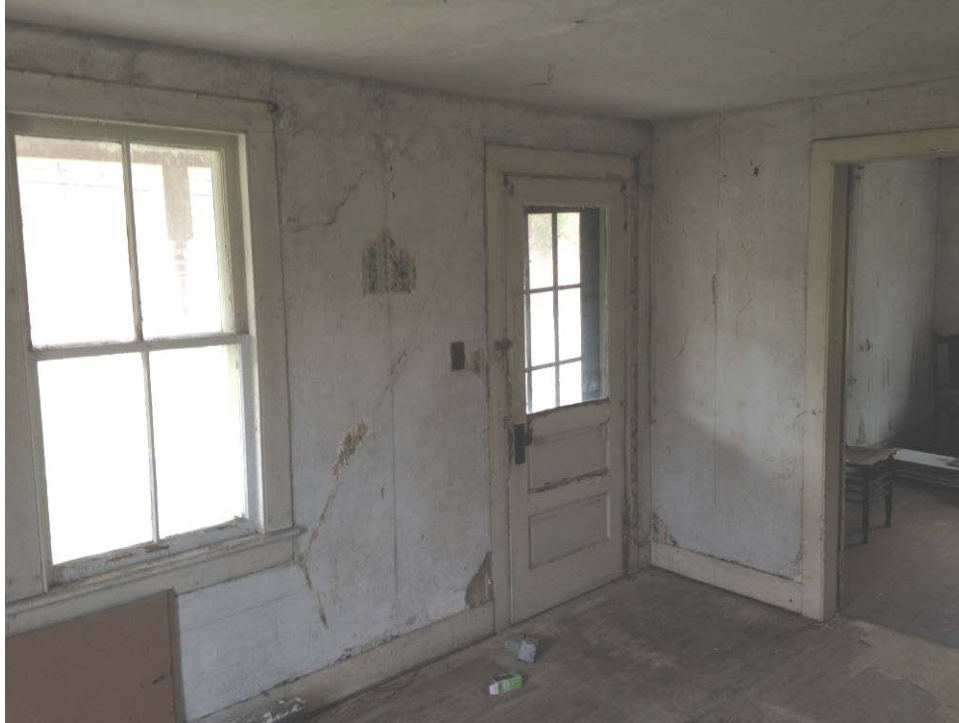
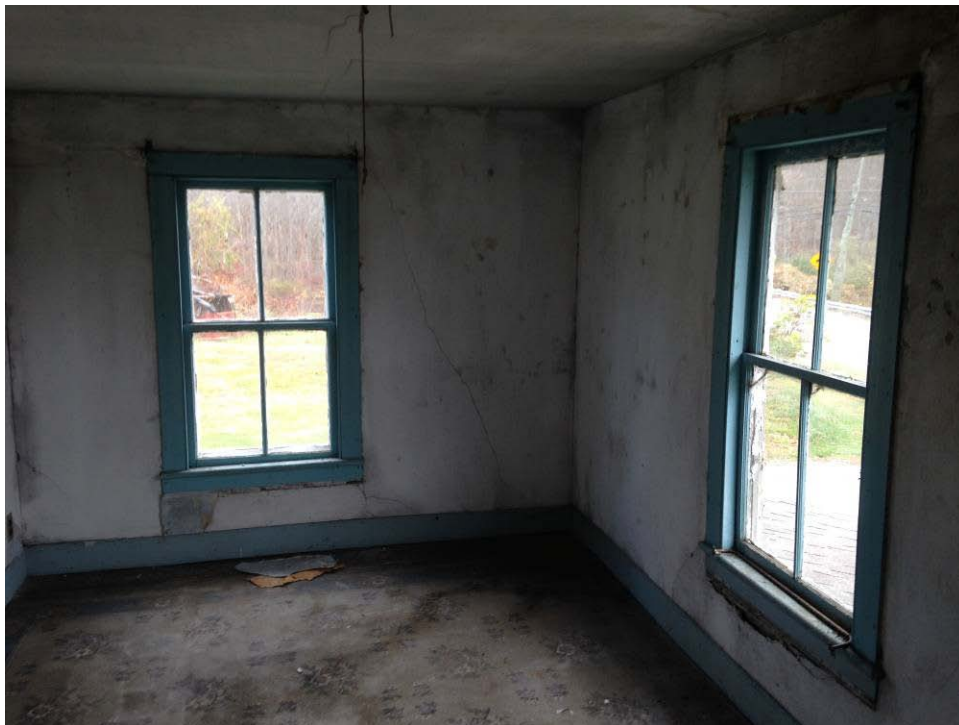
Farm House

Cracked Wall Plaster

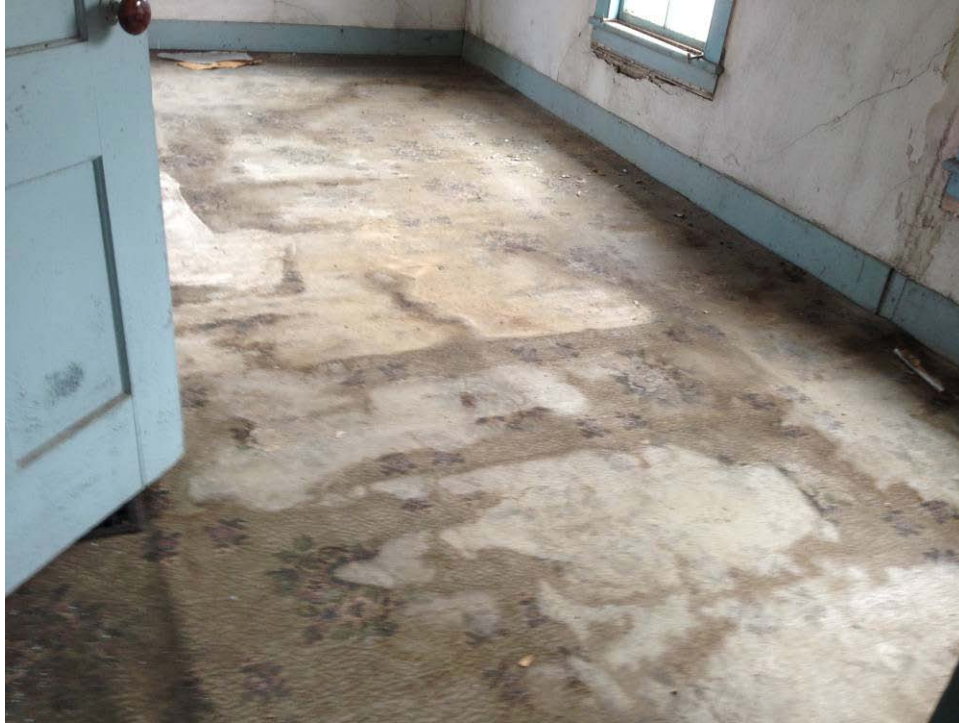
Farm House

Defective Vinyl Floor Covering

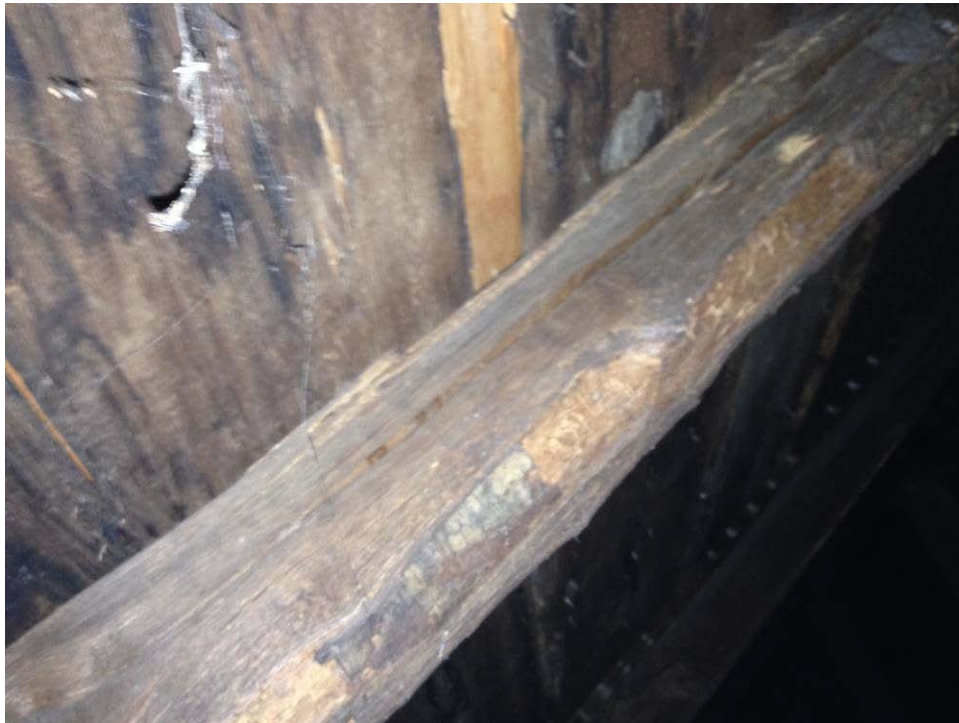
Farm House

The roof of the house is framed with rough sawn timbers spaced at four feet on center. There is a pronounced depression in the north side of the high roof. We observed the roof framing from a position on a ladder in the attic access hatch. There is one failed timber coinciding with the depression location and another failed timber along the framing around the chimney. The original roof decking is severely rotted, although it was previously covered with plywood and is no longer supporting the roofing materials. We could not verify the thickness or span rating for the newer plywood, although we note that the rafter spacing is much greater than plywood less than 3/4" can safely span.

Cracked Roof Rafter

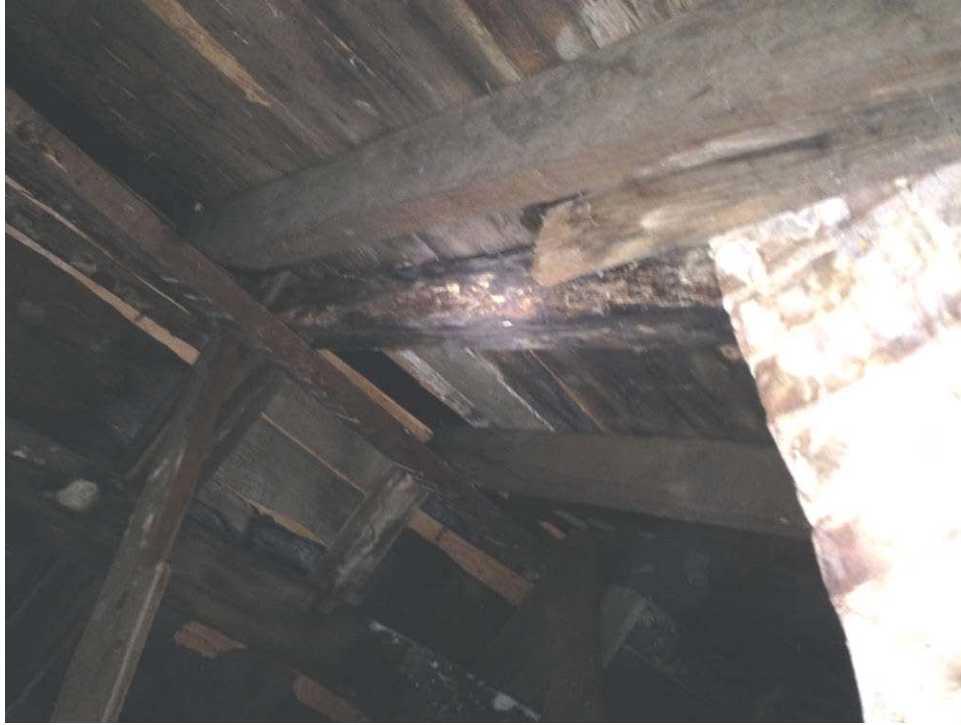
Farm House

Defective Roof Framing Around Chimney

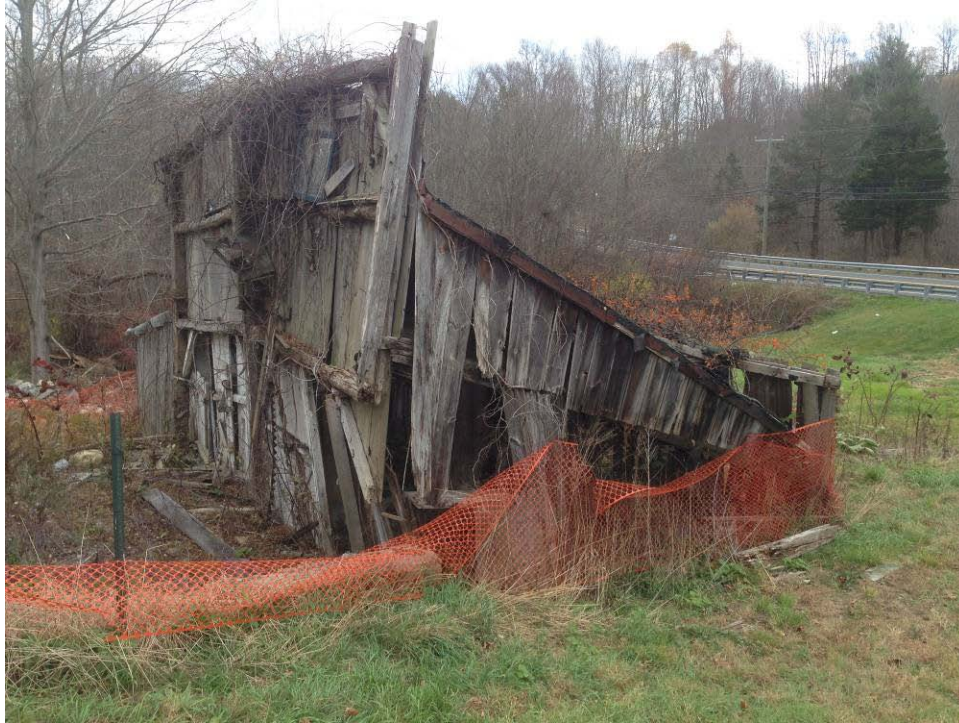
Barn

There is a collapsed section of the barn to the south of the main barn structure. This section is completely collapsed and not salvageable.

Collapsed Adjoining Structure

7. Collapsed connecting structure on south side is not salvageable. Remove and dispose entirely.

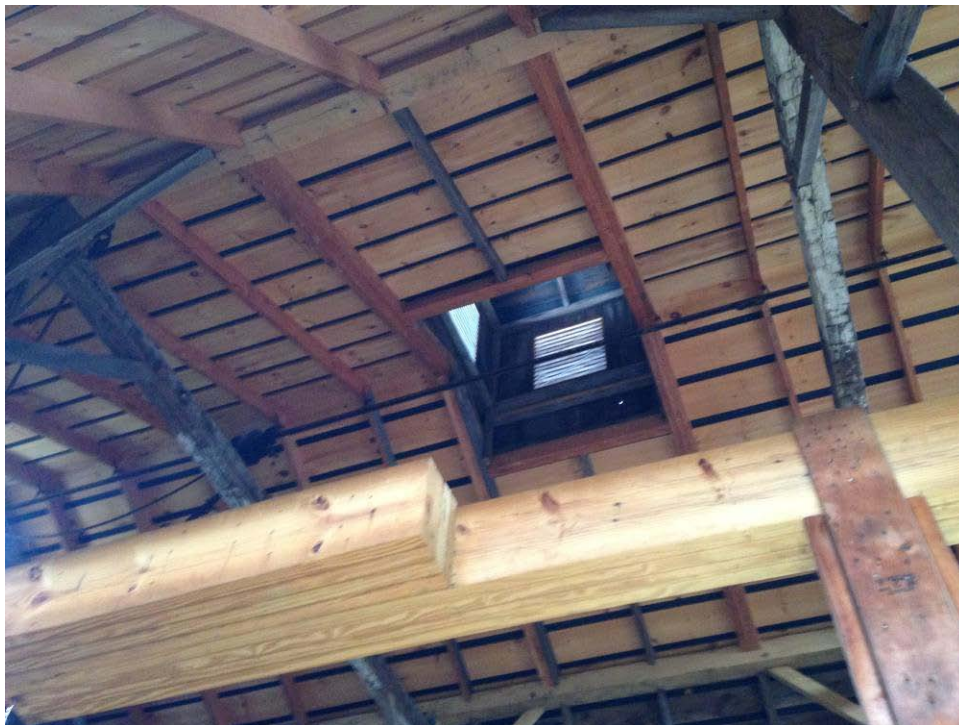
Barn

As we understand it, the barn was shored and partially repaired in 2007/2008. Most of the roof framing is new and there is temporary shoring throughout the barn. Roof framing appears to be stable and in fair condition.

Previously Repaired Roof Framing

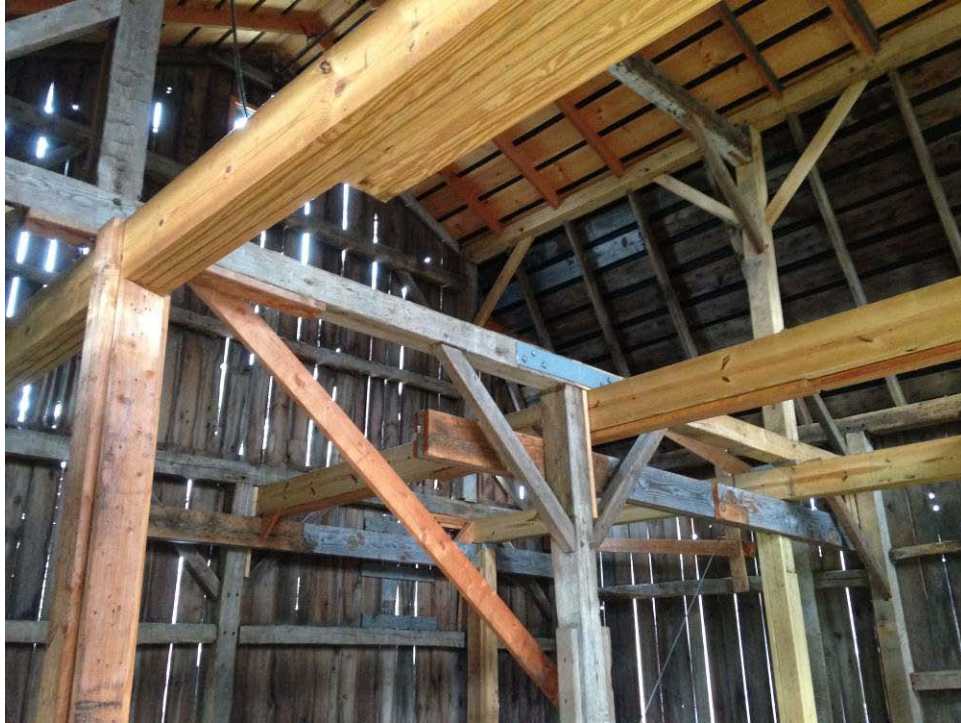
Barn

Temporary Shoring for Roof

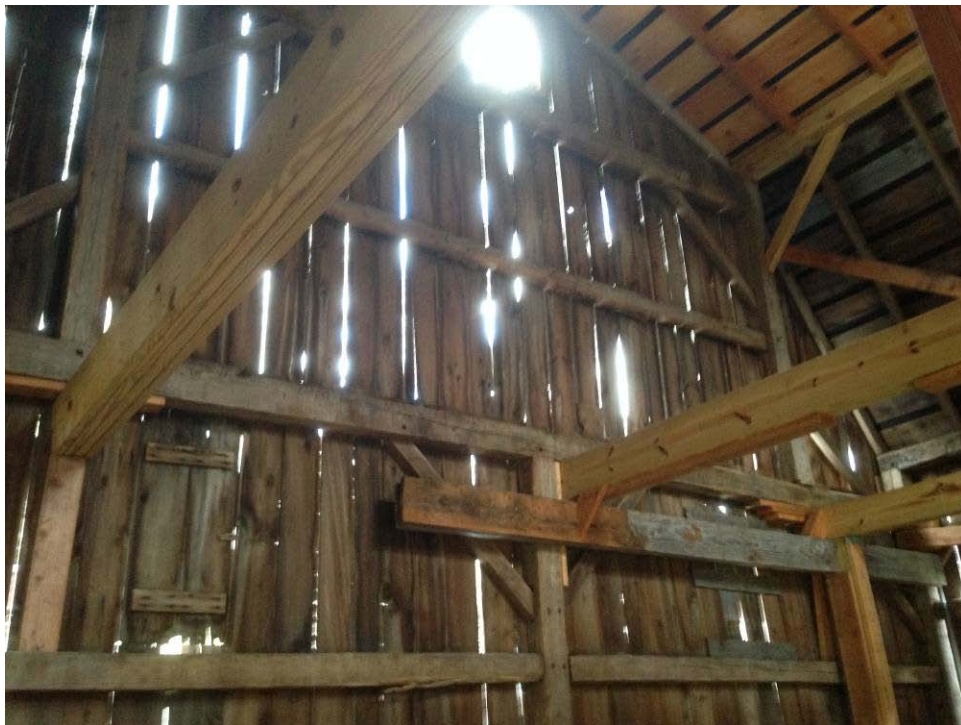
Barn

The walls and roof are constructed of post and beam framing typical of early American timber framing. The walls are framed without full height or full width framing that would provide out of plane lateral stability for the walls. It is possible that a loft level was part of the original barn construction. A loft level would brace the exterior walls and tend to stabilize the building overall.

Gable Wall Framing

1. 100% of the main floor framing is rotted not salvageable. Remove and replace all main floor framing.
2. Construct new foundations for interior columns.
3. Timbers along exterior walls are rotted and cannot hold nails. Once main floor framing is made safe for investigation, probe wall framing and design repairs as required.
4. Configuration of gable wall framing is not stable based on current design practice. Consider adding a loft level for wall bracing.
5. Shoring was not intended to remain permanent. Roof framing will need to be investigated once main floor is made safe and permanent support designed.
6. Approximately 60% of siding may be salvaged. Balance should be replaced.

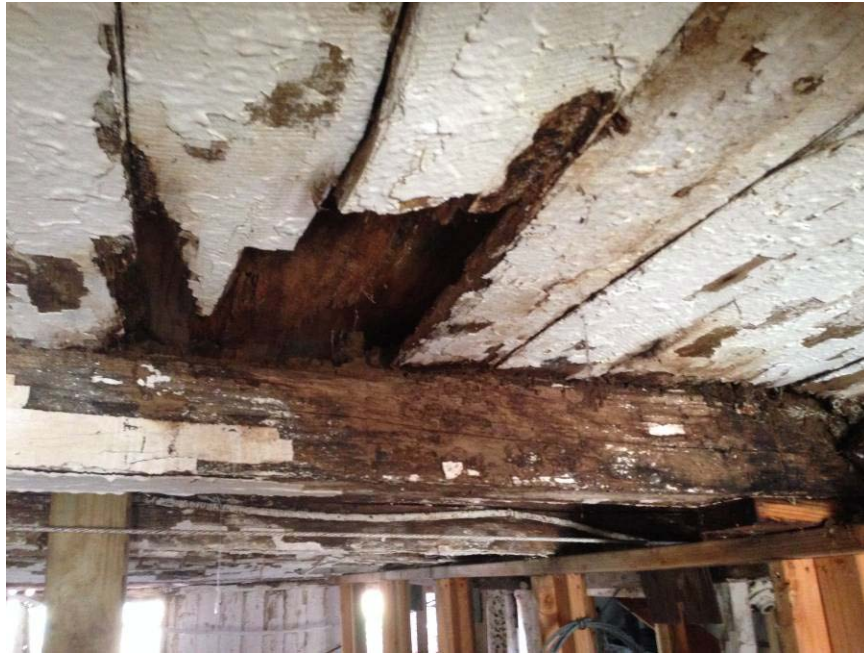
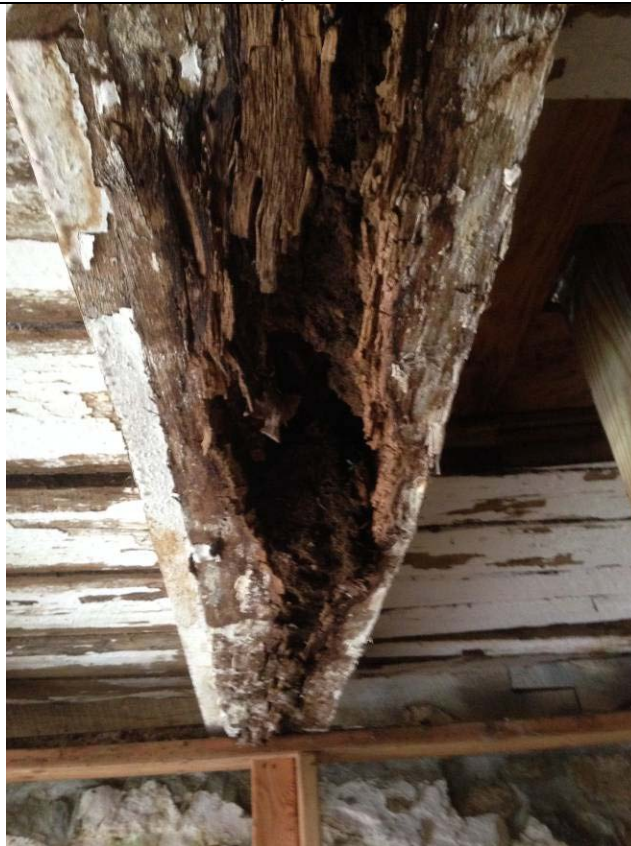
Barn

The first floor framing is in extremely poor, unstable condition. The 2007/2008 repair project included continuous lines of temporary shoring throughout the lower level for support of the first floor framing. The timber decking, which is not shored, is in extremely poor condition and not safe even for incidental access. The framing is also not engaged with the west side foundation wall. There is no positive mechanical connection between the two, and the entire building appears to have drifted away from the foundation.

Severely Rotted Main Level Floor Fanning

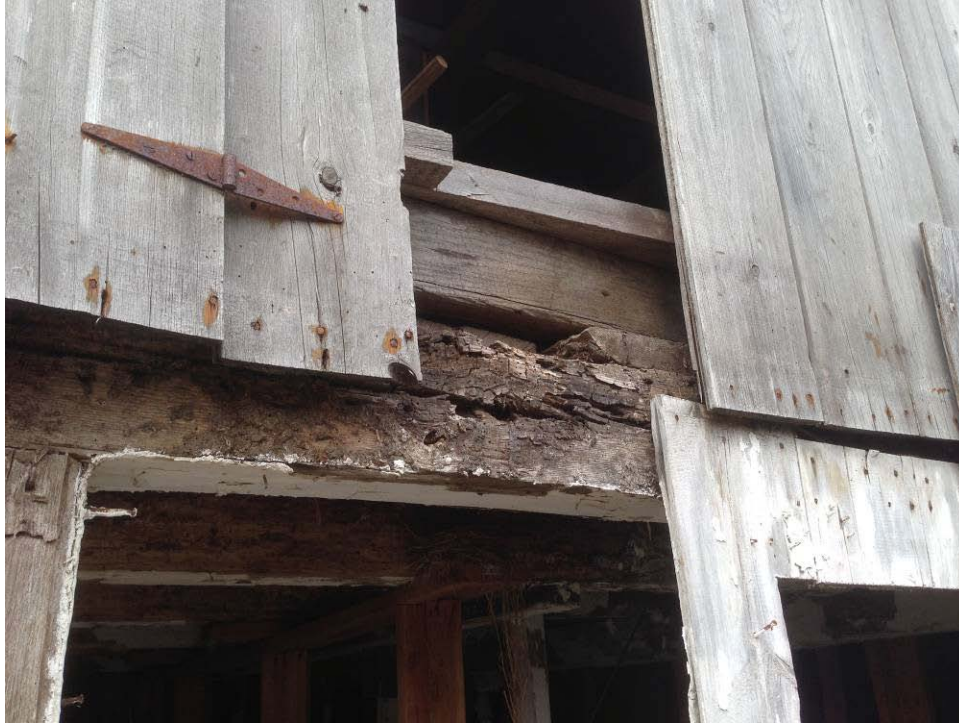
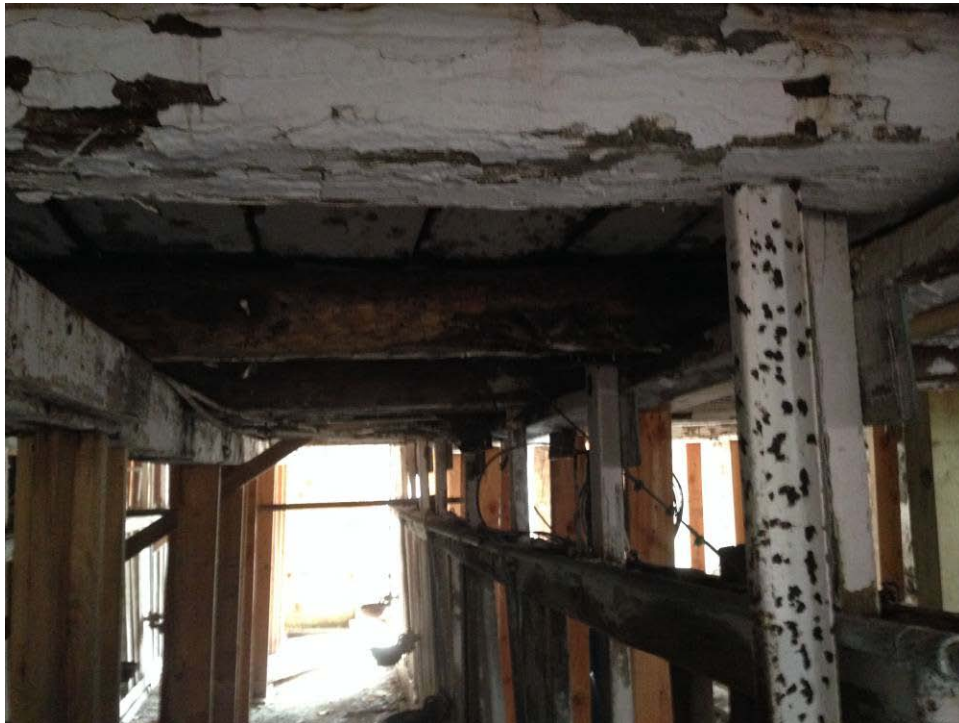
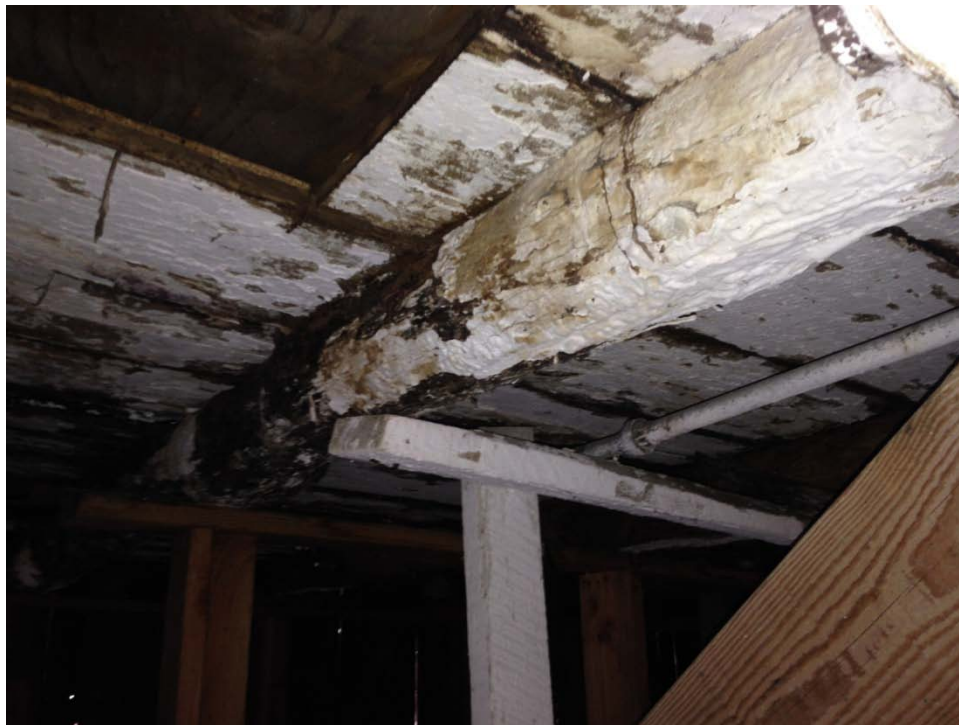
Barn

Severely Rotted Main Level Framing

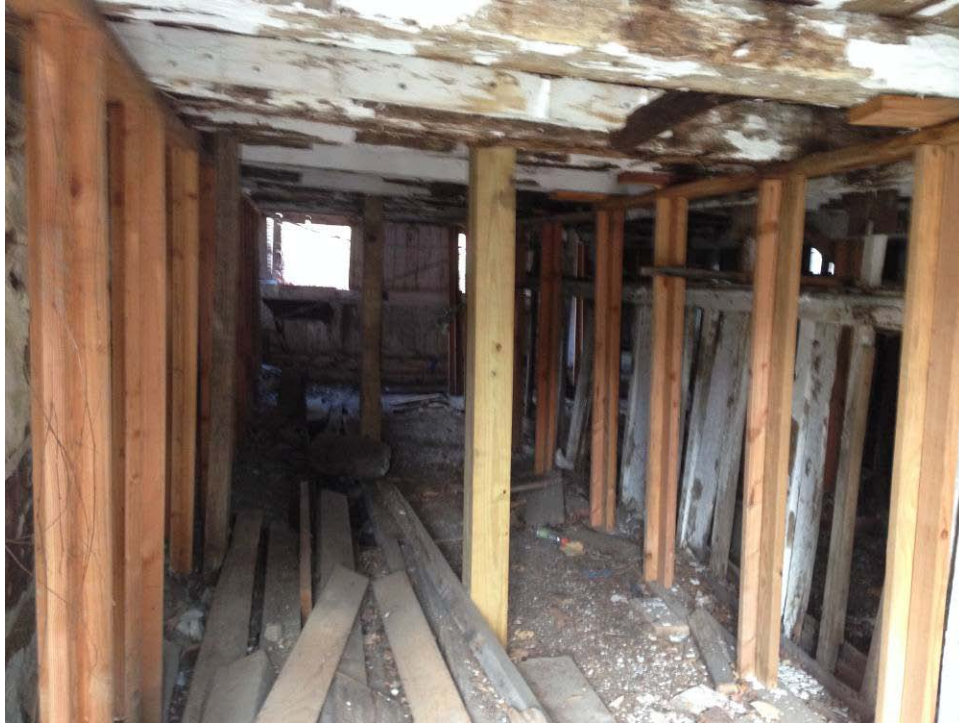
Barn

Temporary Shoring at Main Level

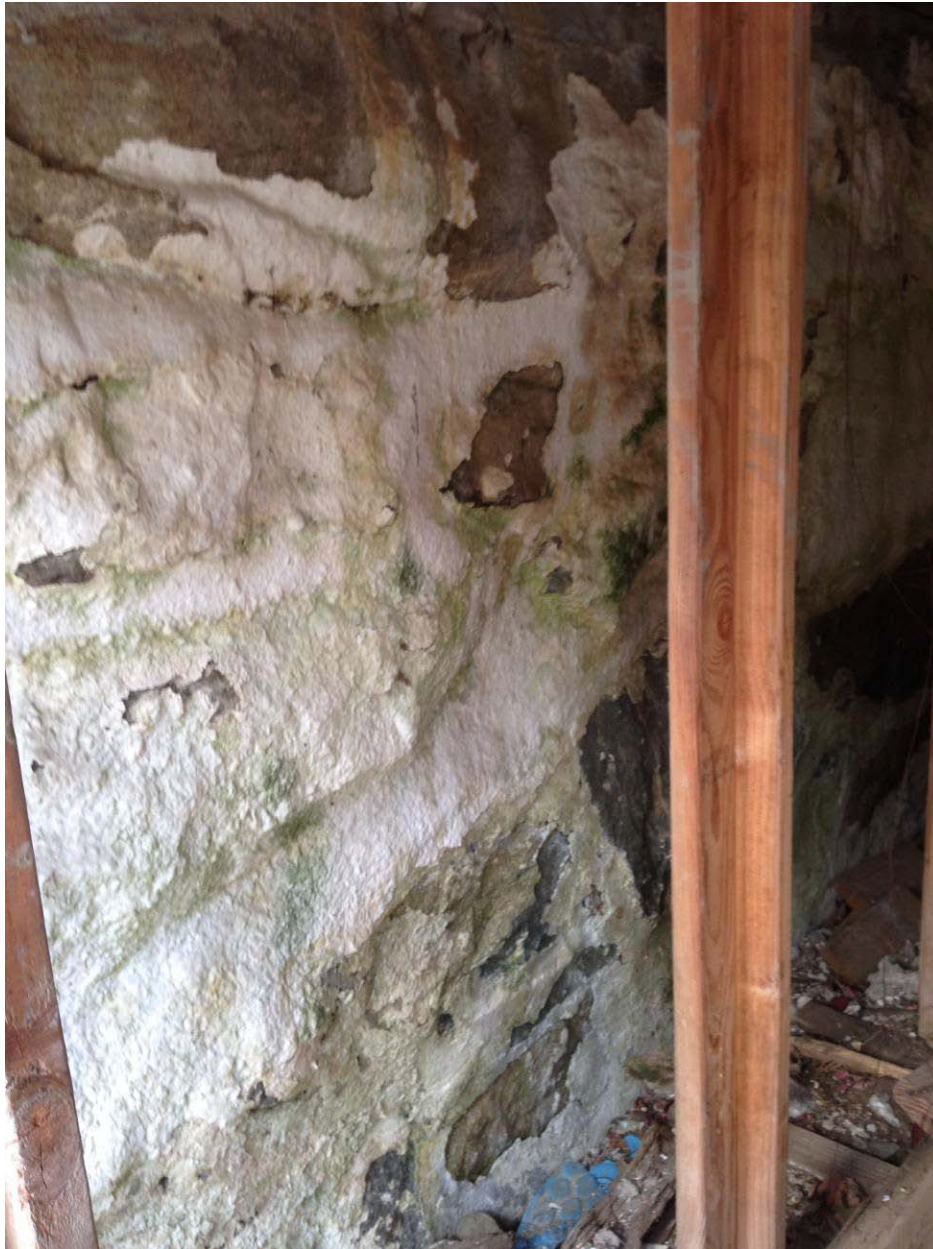
Barn

The foundation is mortared stone and is in fair condition. The west side foundation is a full height wall that retains the higher grade along that side of the barn. The wall is in fair condition, although the disengaged floor framing would normally be considered a defect since such walls typically rely on bracing by floor framing for stability.

View of Foundation

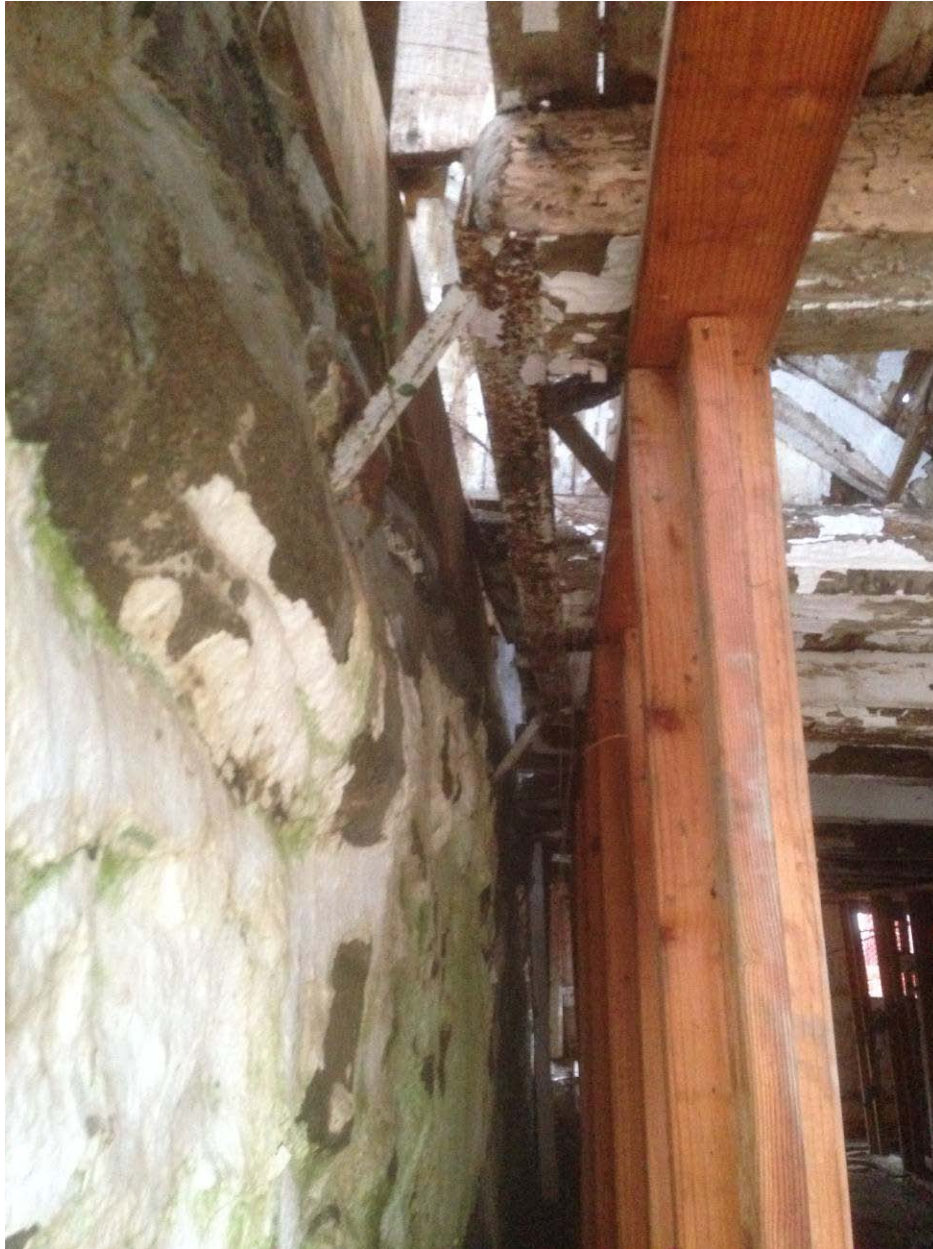
Barn

View of Floor Framing Disengaged From Foundation
