December 15, 2014

**Re:   Wichita-Sedgwick Historical Museum Building Condition Assessment and  
Maintenance Plan  
CASE Project No. 2439001**

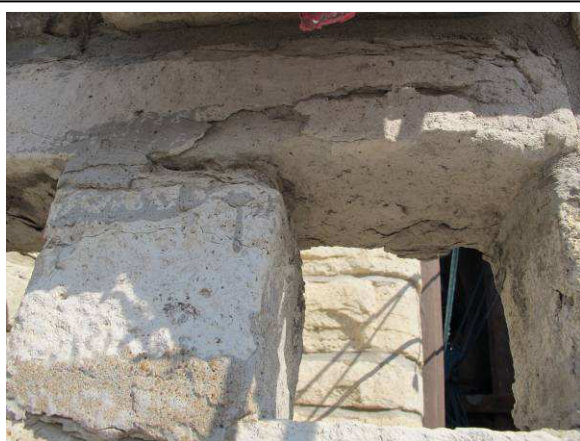
**Deteriorating limestone at balcony rail**

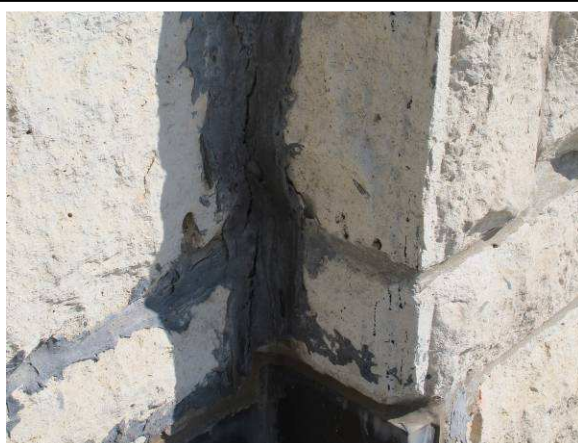
**Poor mortar installation at return**

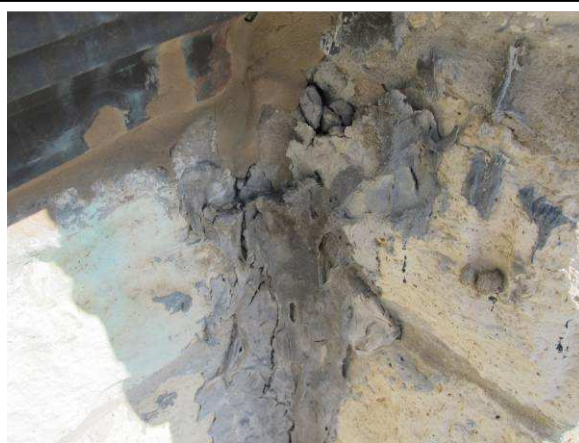
**Failed caulking near flashing**

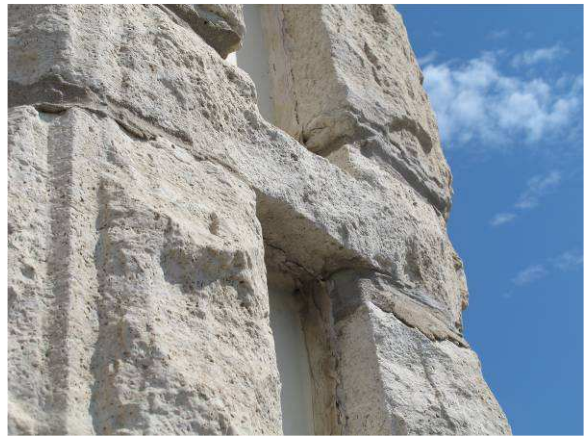
**Spalling stone and poor mortar**

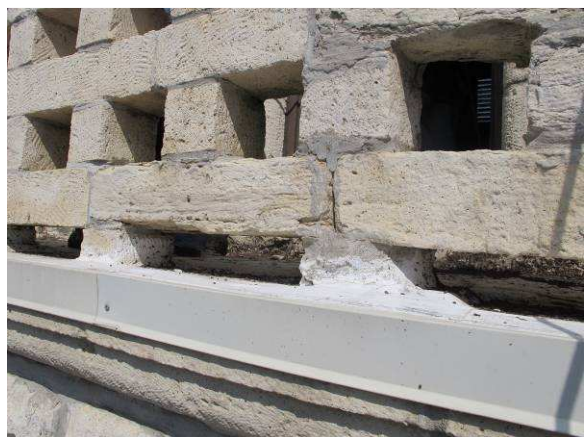
**Poor repairs and deteriorating stone at balcony**

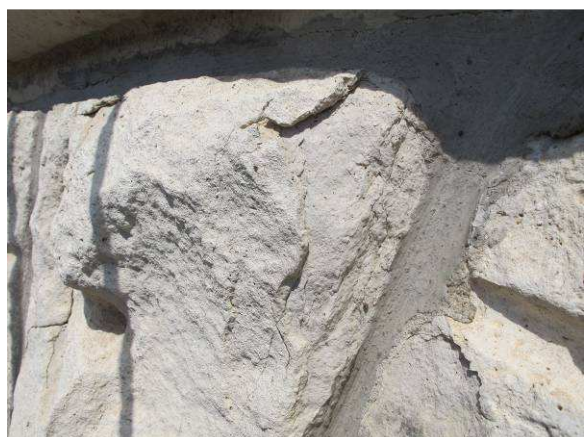
**Deteriorating stone**

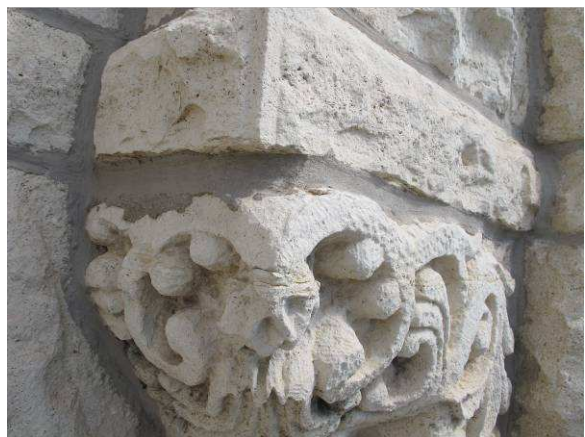
**Poor mortar installation**

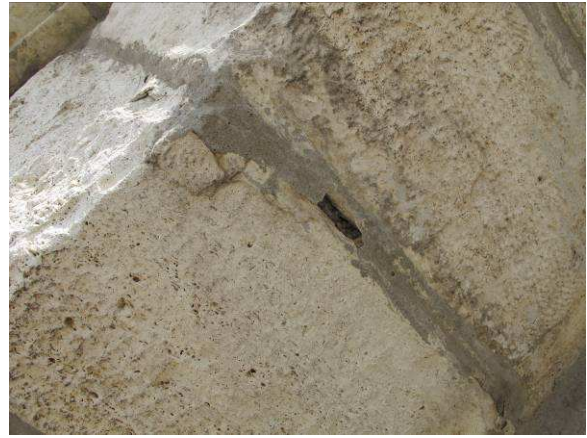
**Open mortar joint**

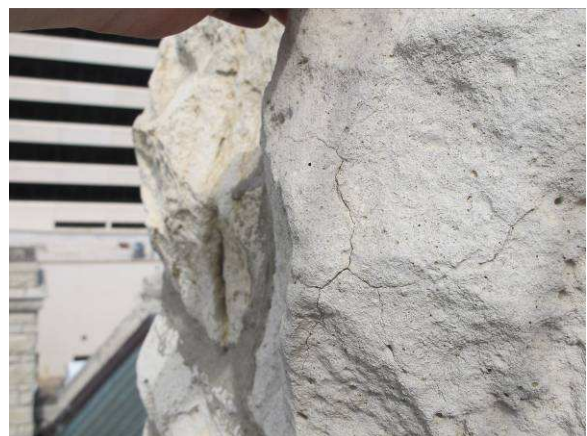
**Deteriorating and spalling stone**

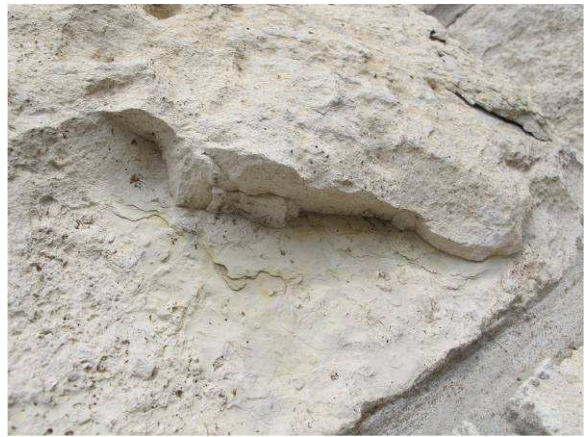
**Partially spalled stone**

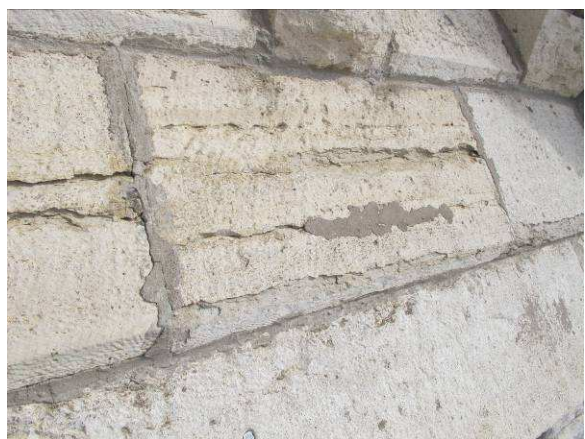
**Failing stone and mortar below columns**

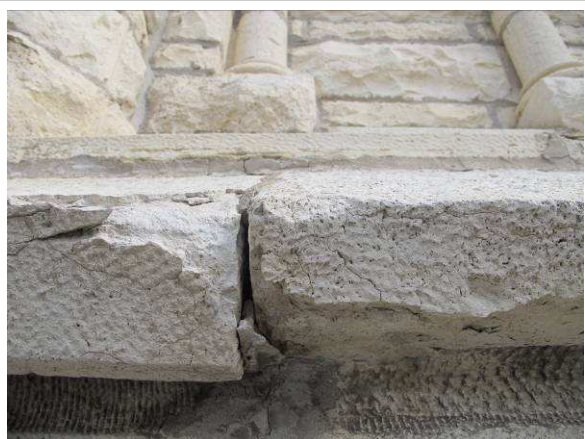
**Failed mortar joint and spalled stone**

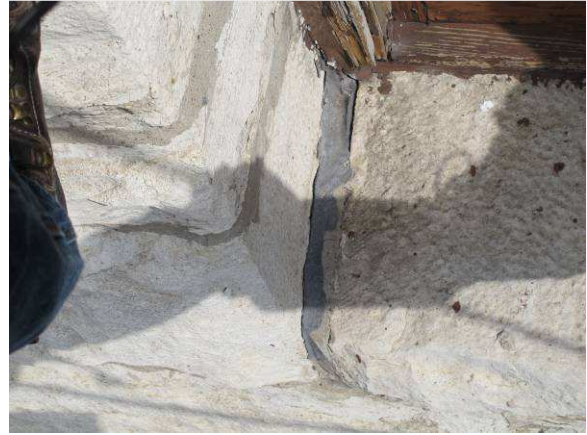
**Separated caulk at window**

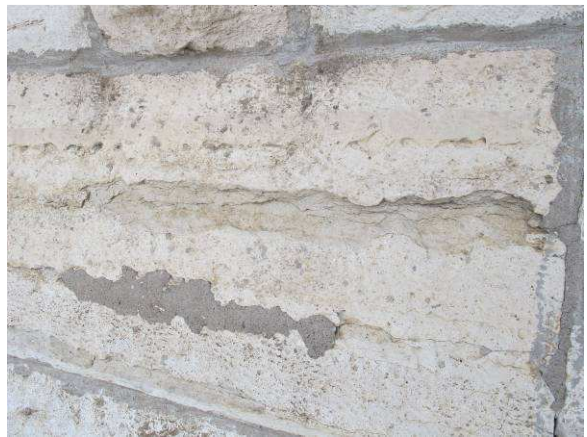
**Deteriorating stone and poor repair below column**

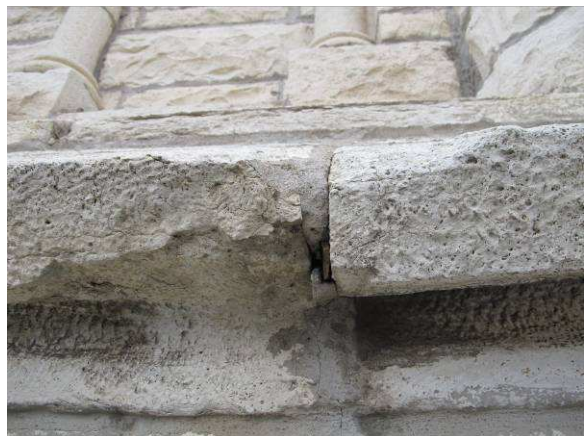
**Deteriorated stone at joint**

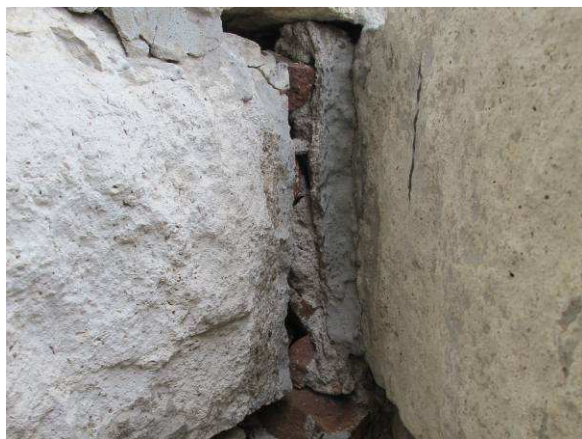
**Exposed brick at balcony corner**

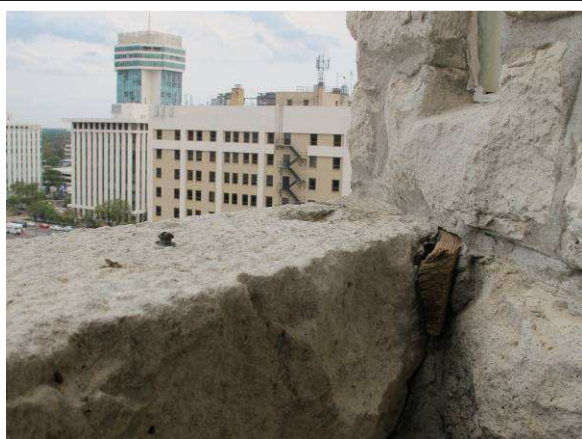
**Exposed brick at balcony corner**

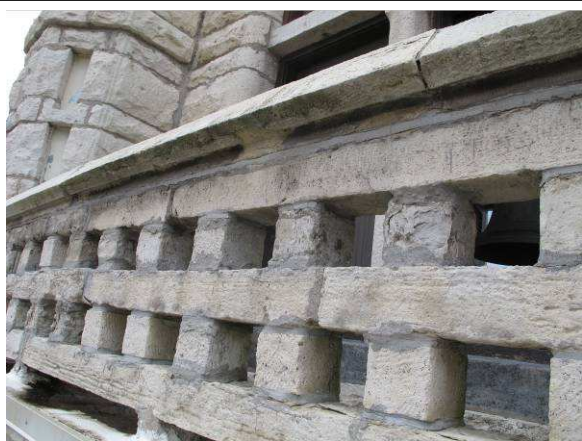
**Deteriorating balcony**

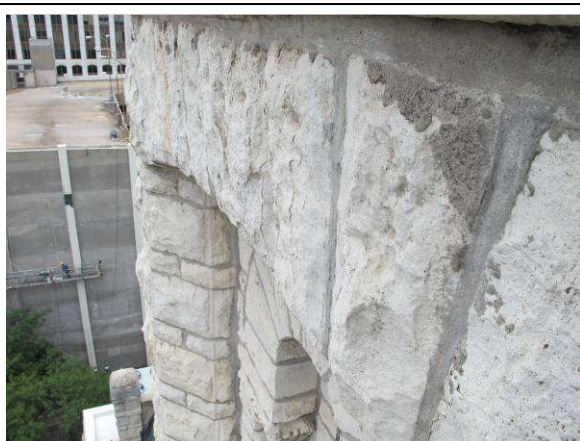
**Deteriorated limestone and poor mortar**

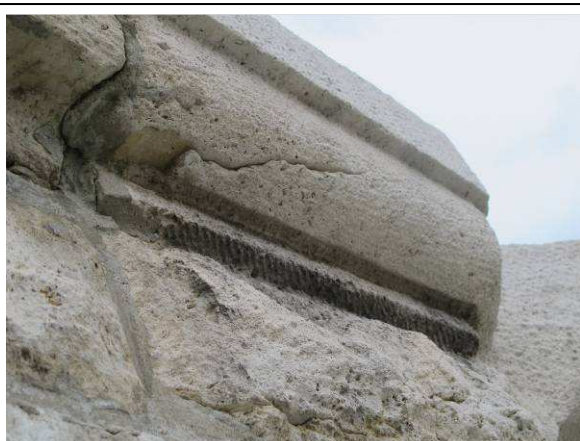
**Spalling limestone**

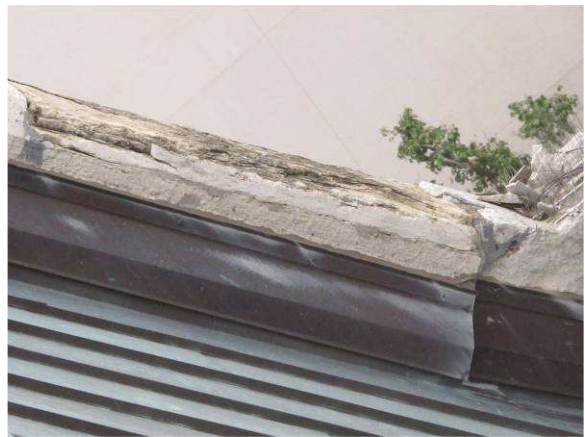
**Close up of deteriorating stone**

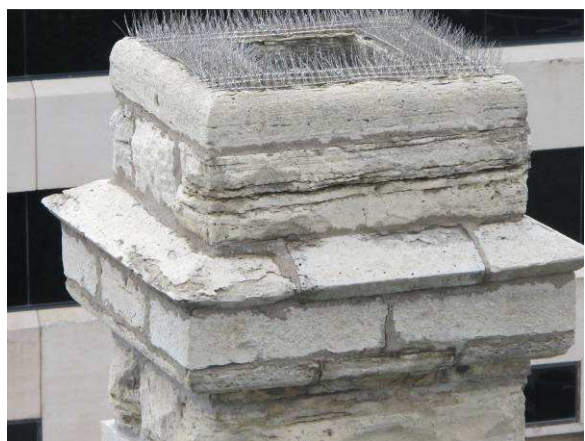
**Mortar loss and deteriorating stone**

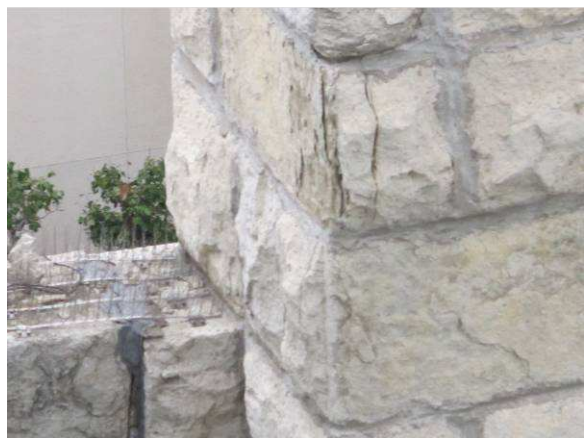
**Close up of stone damage**

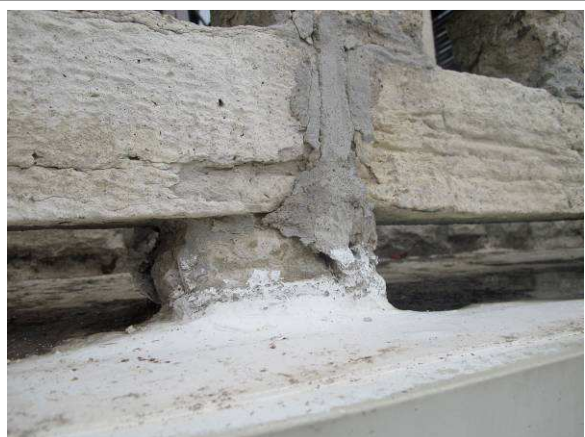
**Poor mortar installation**

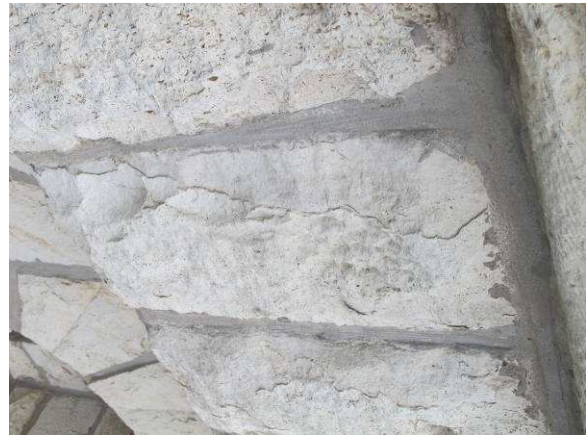
**Spalling limestone**

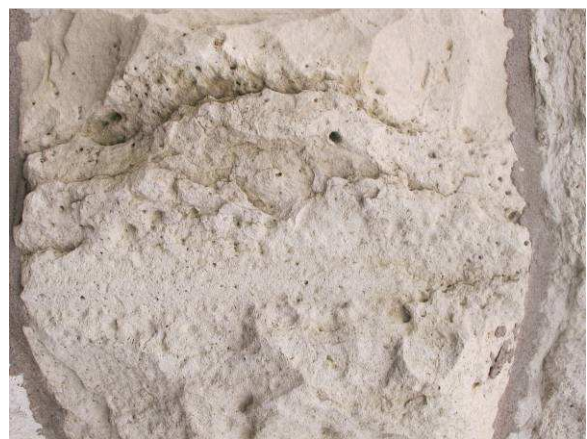
**Deteriorating limestone**

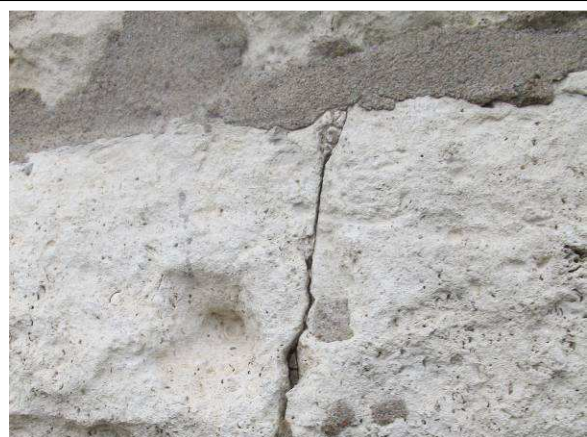
**Broken stone**

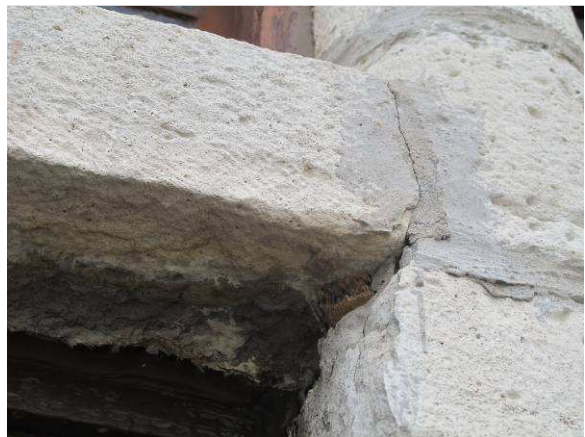
**Crack in mortar at header**

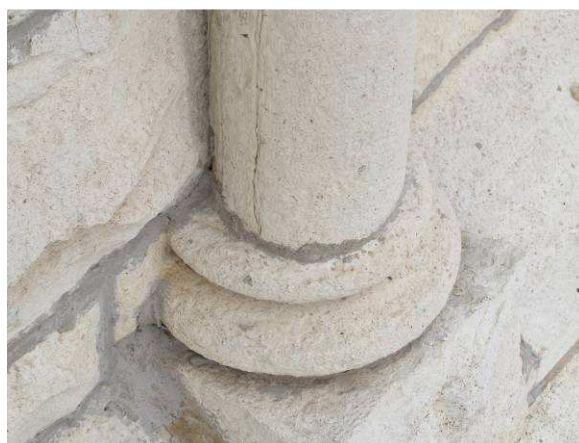
**Crack in column stone**

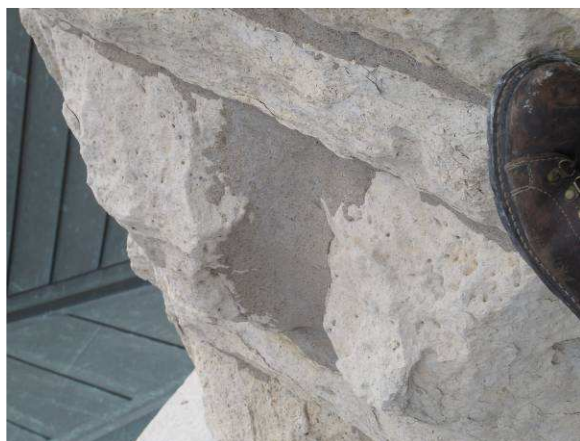
**Poor stone patch**

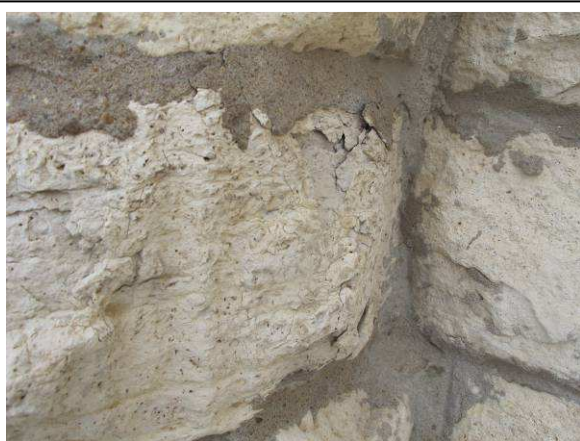
**Poor mortar installation and deteriorating stone**

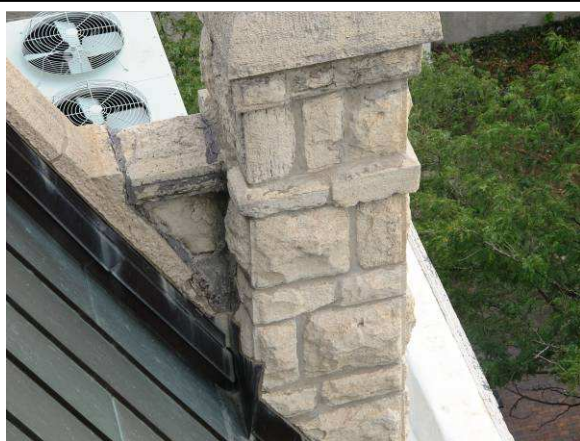
**Failed mortar**

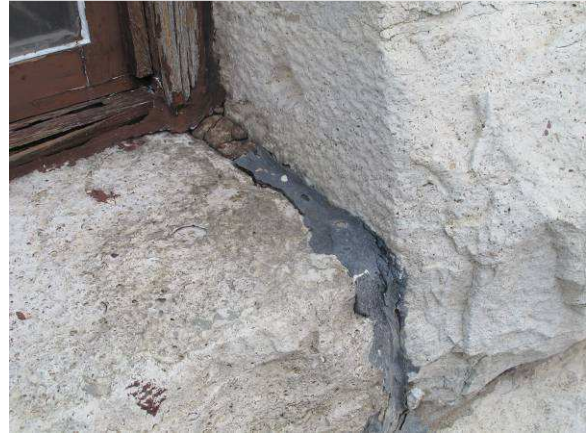
**Failed caulking and deteriorated wood**

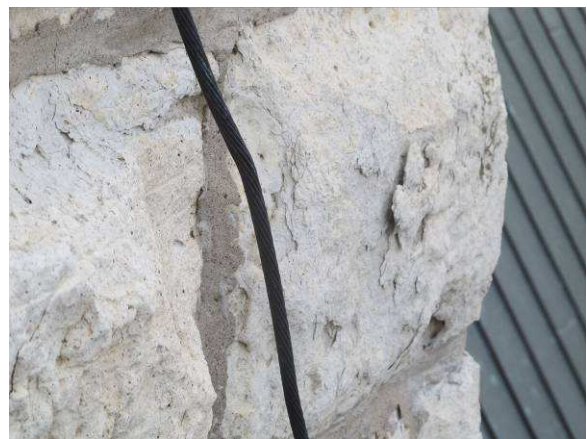
**Spalling stone**

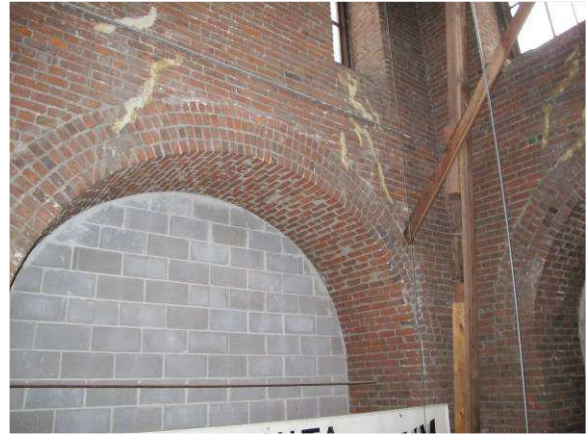
**Repaired cracks above arch**

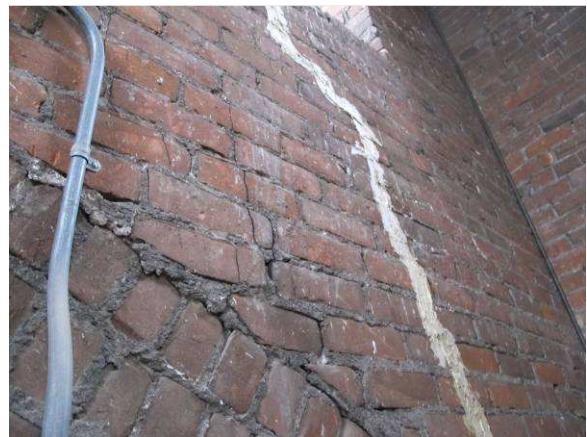
**Close up of repaired crack**

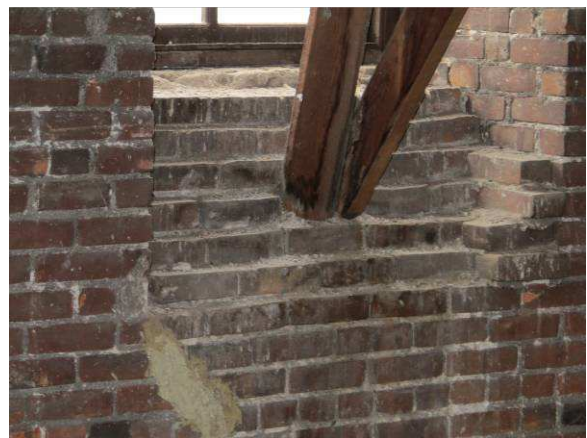
**Repaired crack below window**

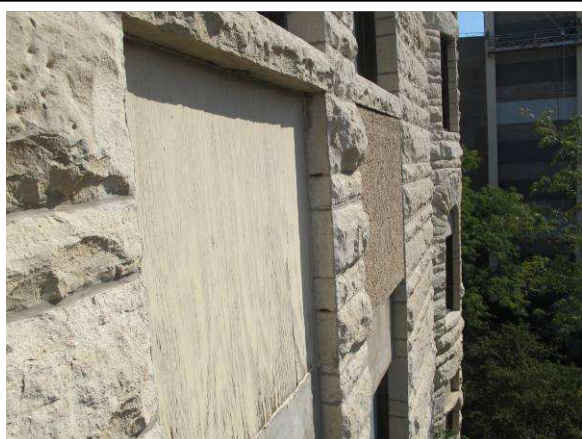
**Missing cement board**

| <b>Year:</b> | <b>Scope:</b> | <b>Estimated Cost:<br/>based on 2014 \$</b> |
|---|---|---|
| | Design and specifications: | \$10 - \$12,000 |
| | Construction: | \$70 - \$80,000 |

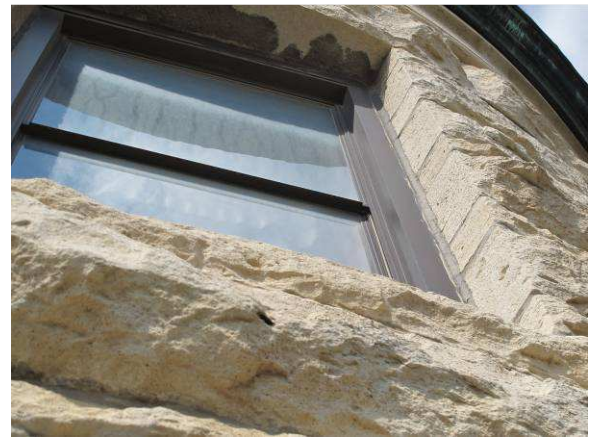
**Water damage on underside of window header**

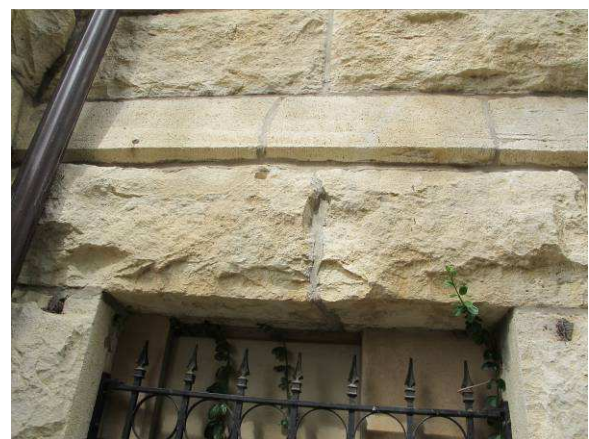
**Cracked stone above window**

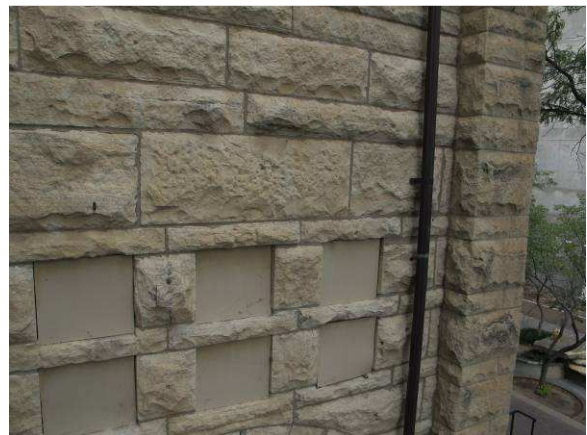
**Infilled windows**

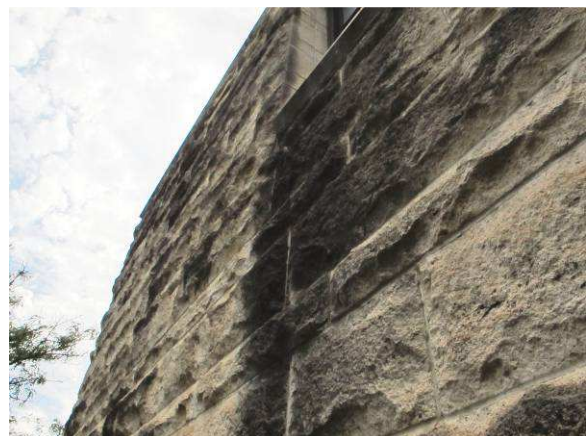
**1938 Addition:** The stone and mortar in the addition is in good condition. In question is the presence of airborne deposition on the surface of the stone not seen elsewhere on the building. The material appears to be dirt particulates, perhaps due to the protected nature of this side of the building and the lack of air movement and rain that might facilitate its natural removal. But the presence of landscaping suggests that organics may play a role. There is no visual evidence of the material causing damage to the stone so the issue is mainly aesthetic.

**Deposition on surface of stone**

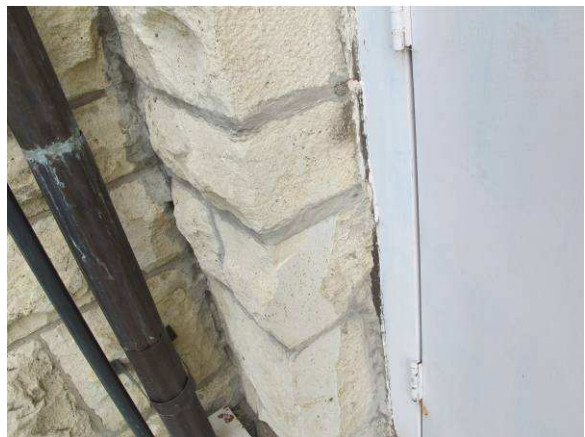
**Failing mortar**

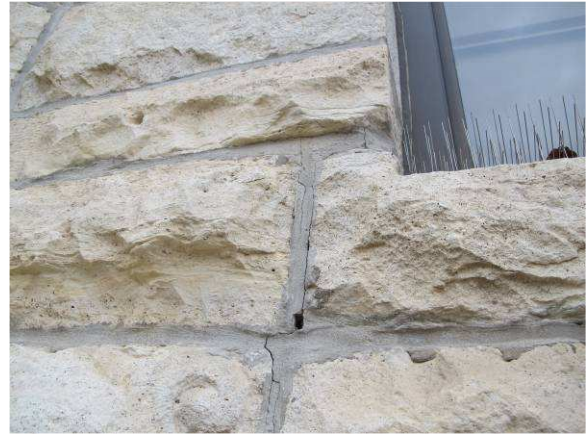
**Missing, cracked and separated mortar**

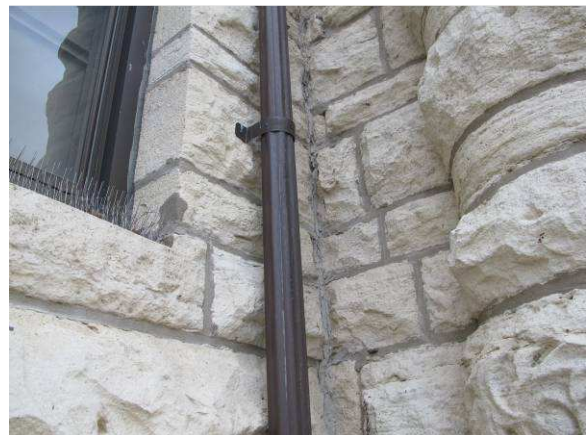
**Poor mortar installation at return**

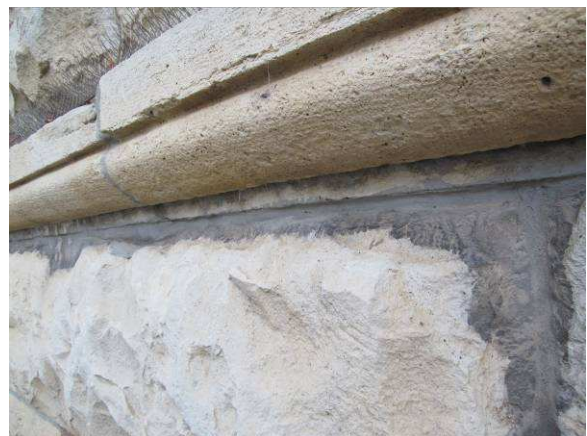
**Poor mortar installation below spalled stone**

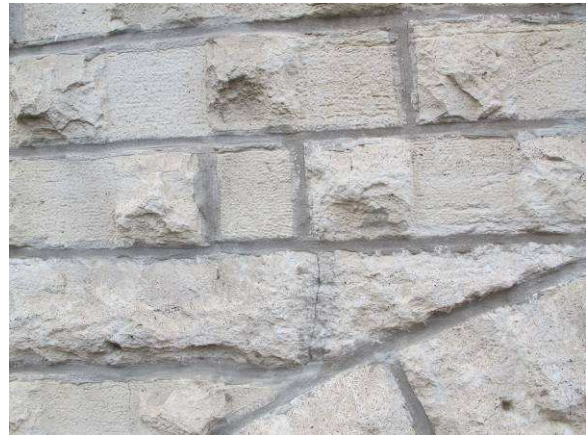
**Separated mortar joints**

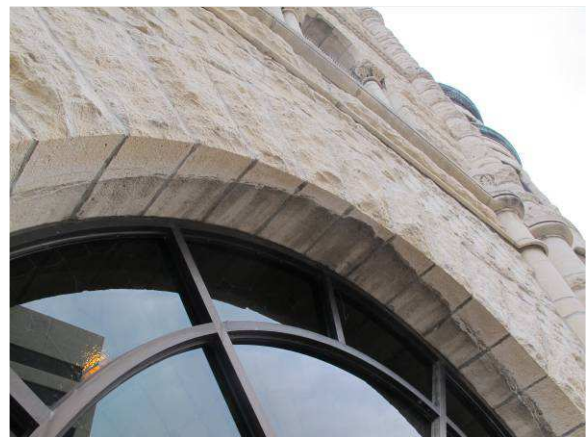
**Evidence of water damage above arch**

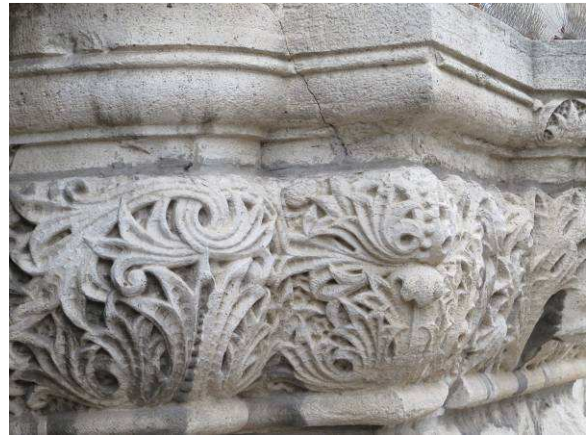
**Cracked stone**

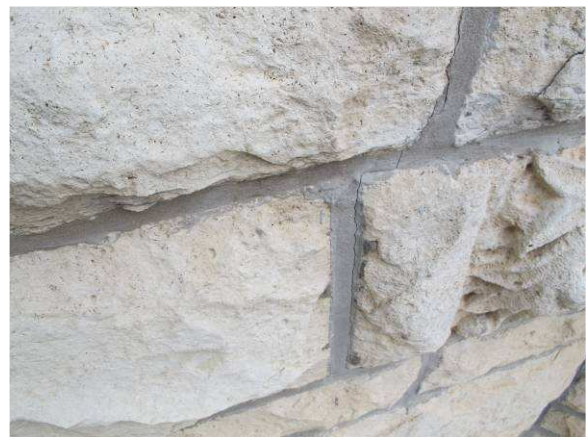
**Cracked mortar joint**

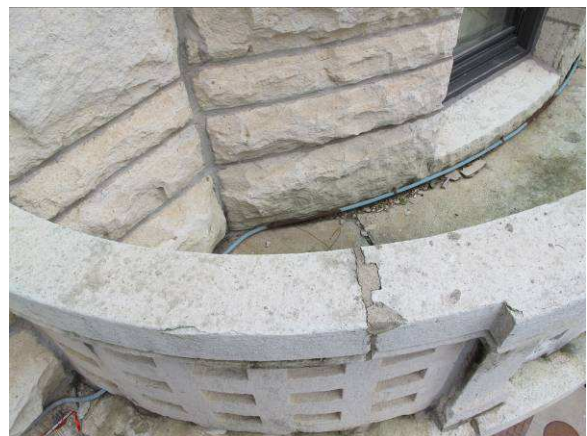
**Failed mortar repair**

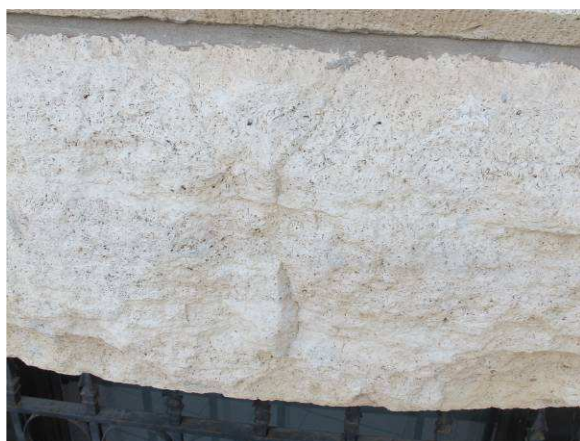
**Cracked header stone**

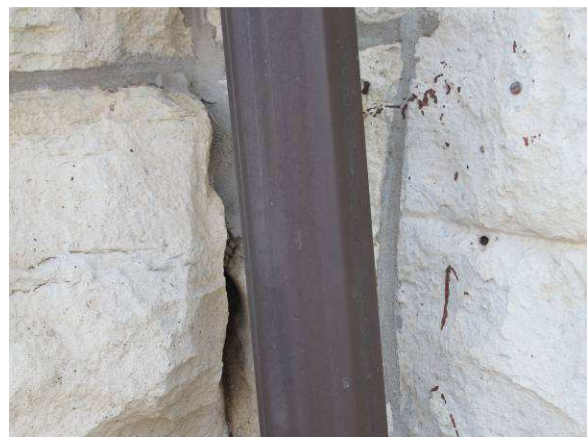
**Missing mortar**

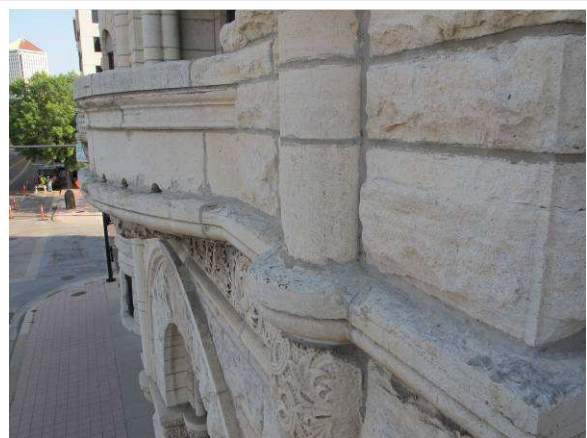
**Deteriorating stone at balcony above main entry**

| <b>2015 -<br/>2017</b> | Repair main entry balcony | |

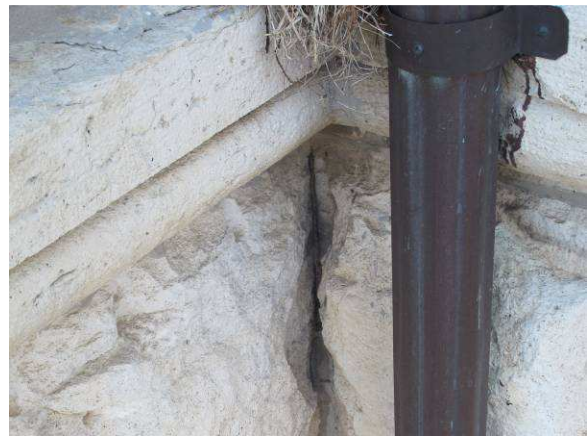
**Missing mortar**

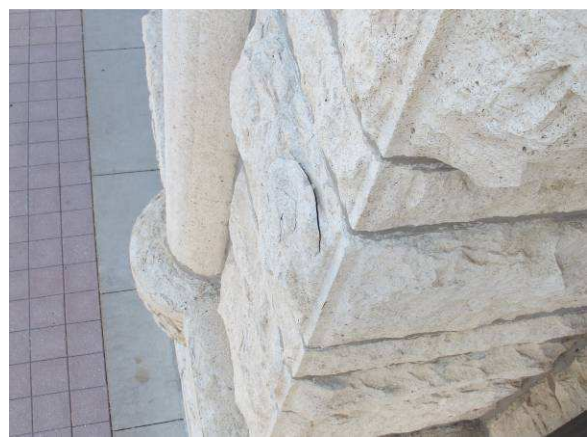
**Spalling limestone**

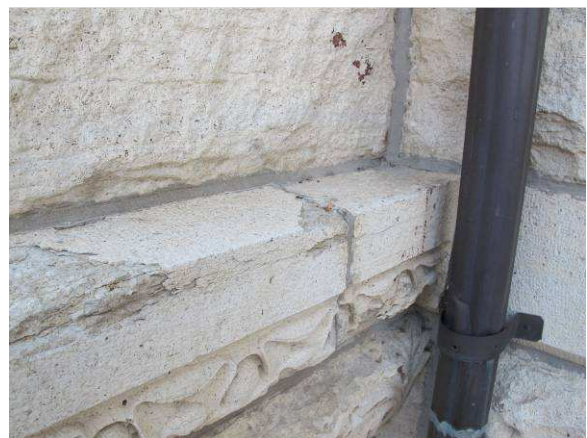
**Deteriorating stone**

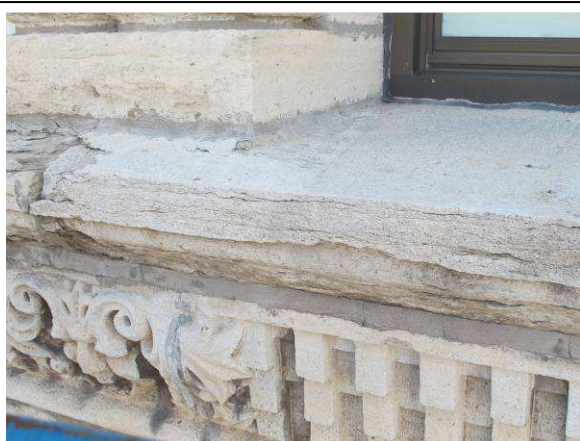
Damaged stone

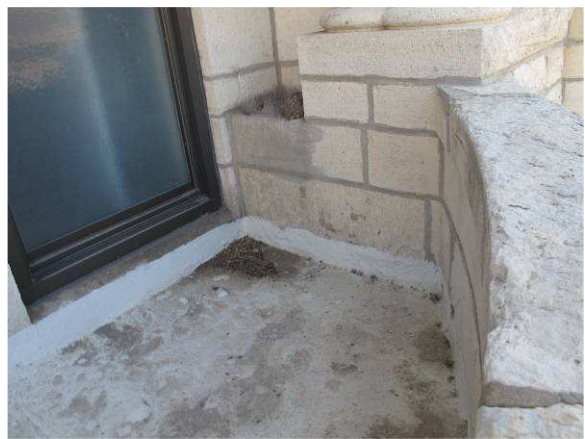
**Extensive sealant around balcony**

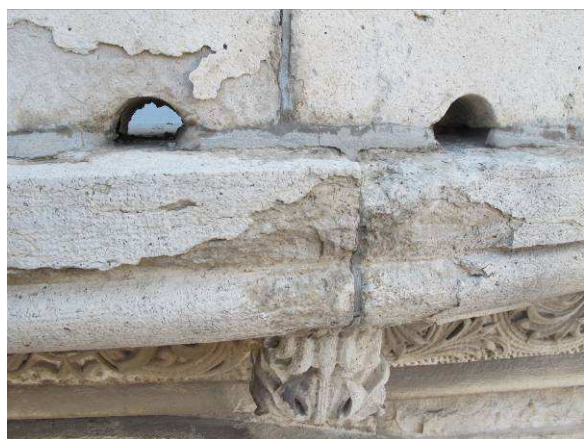
**Deteriorated stone at balcony**

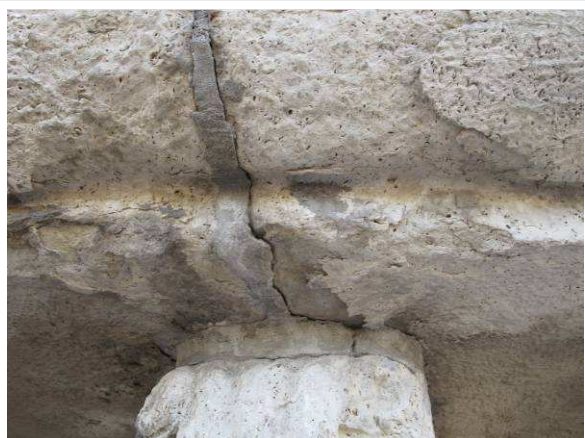
**Failed joint and deteriorated stone**

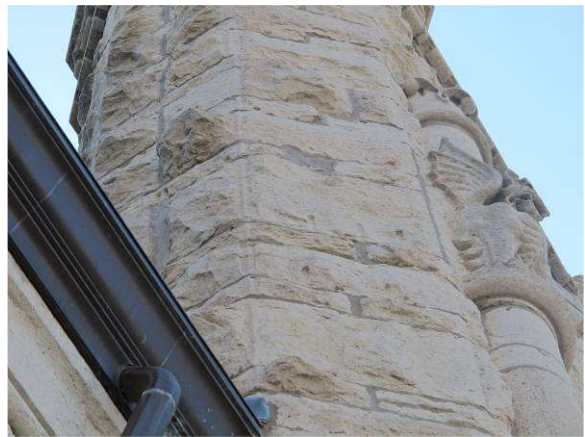
**Deteriorating stone**

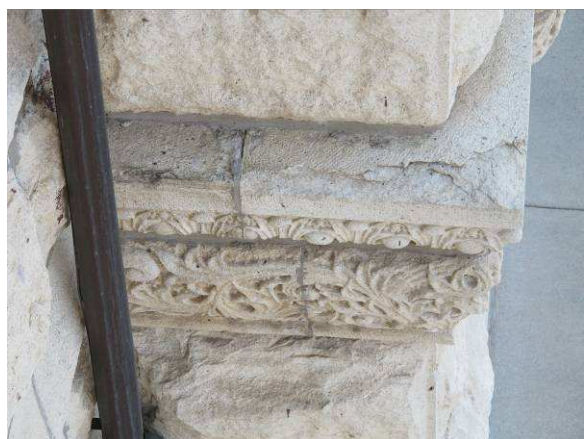
**Deteriorating stone**

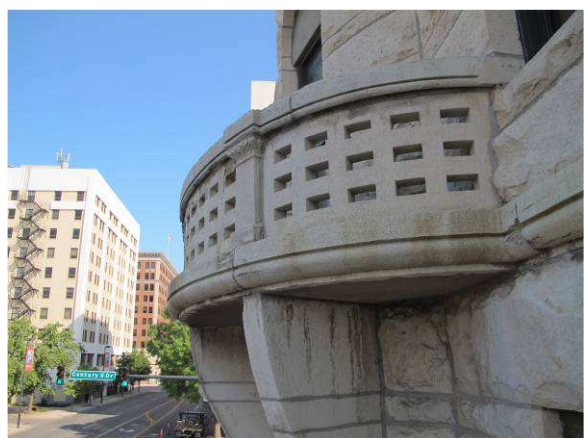
**Deteriorating mortar**

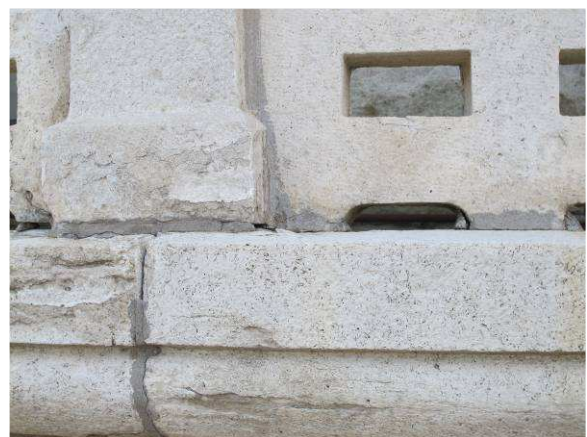
**Failed mortar and deteriorating stone**
