# Old Covington Fire Station Feasibility Study

RE: Old Covington Fire Station Feasibility Study

# **HISTORIC FIRE STATION BUILDING ASSESSMENT REPORT**

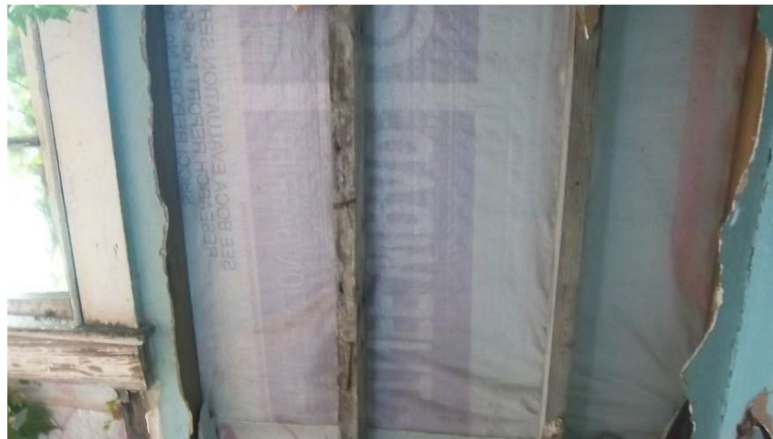
The interior and exterior walls consist of stick framed 4" wood studs spaced 16"-20" on center. The rear exterior wall is load bearing and partially sheathed with wood; a portion of the building is unsheathed. The front wall is penetrated by openings which once acted as garage doors for the fire trucks. The garage door openings are supported by a beam that bears on the columns that separate them. The columns, which are likely steel, are set onto built up concrete footings and clad in wood trim. Traditional lap siding wraps the building's exterior up to the roof's eave and gable on the outside. House wrap separates the siding from the sheathing and the studs where no sheathing is present.

*House wrap between studs and rigid foam board*

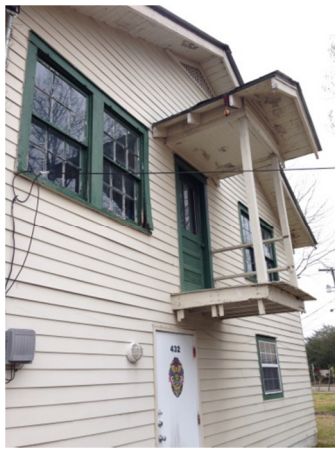
The building has 2x floor joists that span from the load bearing exterior walls to a beam that bisects the building lengthwise. The beam appears to be constructed of either (2) 2x8 or (2) 2x10 wood members fastened together. This beam was observed through minor localized demolition; the sizes cannot be verified without more invasive demolition. The beam transfers the load to first floor columns which appear to be either 4" or 6" steel columns which subsequently transfer the weight to the foundation. The beam supports a continuous 2x4 load bearing wall that runs the length of the building supporting the mid-span of the 2x8 ceiling joists. There is a cantilevered second floor porch that once acted as an access to an exterior stair; the stair has since been removed.

*Cantilevered porch to former exterior stair*

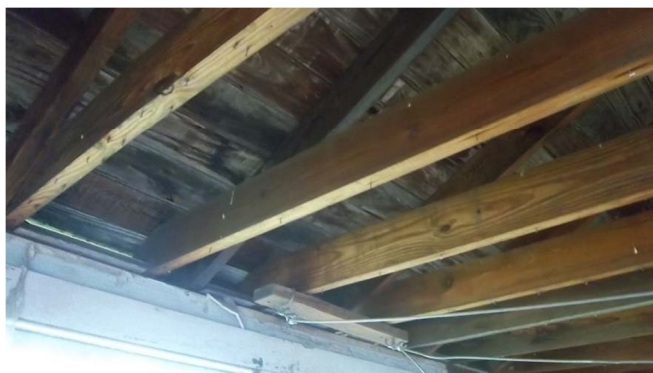
The original roof is a gable roof constructed of 2x6 rafters spaced approximately 24 inches on center with 2x8 cross ties at their base. 1x6 plank wood acts as the roof deck/sheathing. The roof is skinned in what appears to be a light gauge metal panel roof over roofing felt. The roof system appears to be keeping water out as there was no visible evidence of damage to the roof deck.

*Wood rafters and plank wood roof deck*

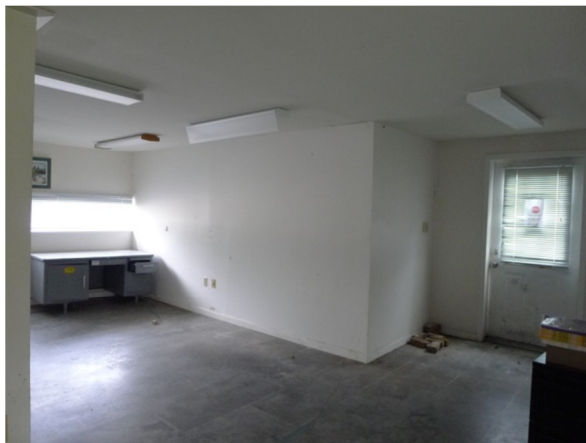
The first floor finished flooring is ceramic tile laid over the concrete slab. Walls, partitions, and ceiling are painted sheetrock. The rooms are usable albeit unappealing. The interior space as it is currently divided and finished masks the history and charm of what was once there. It would be reasonable to think that the area could regain some of its original character by opening up the space and removing the more recent finishes.

*First floor interior*

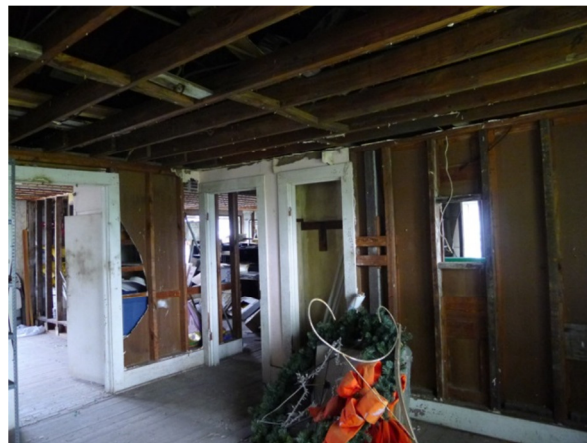
The second floor finished flooring is long leaf pine planks. The wood floors are in fair to poor condition but can be salvaged in place through patching and refinishing. The exterior walls' interior have been stripped of their finishes through exposing the wood framing. The materials used to deck the roof, build the walls, and lay the flooring is of a fine quality. Should this space remain intact, it would be reasonable for these materials to be refinished and exposed.

*Second floor interior*

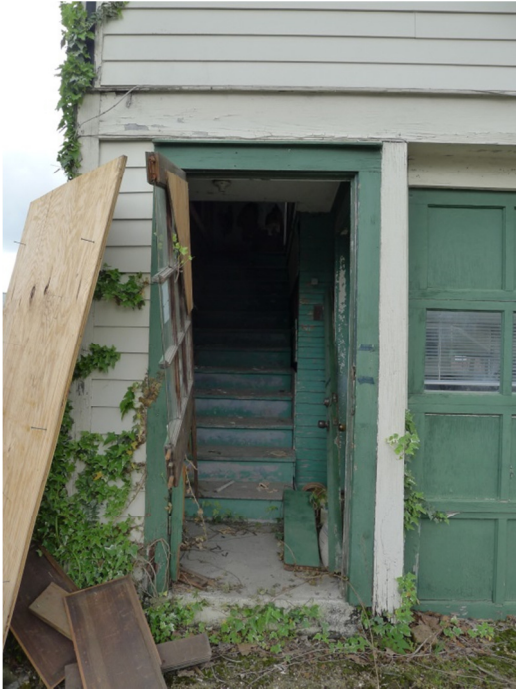
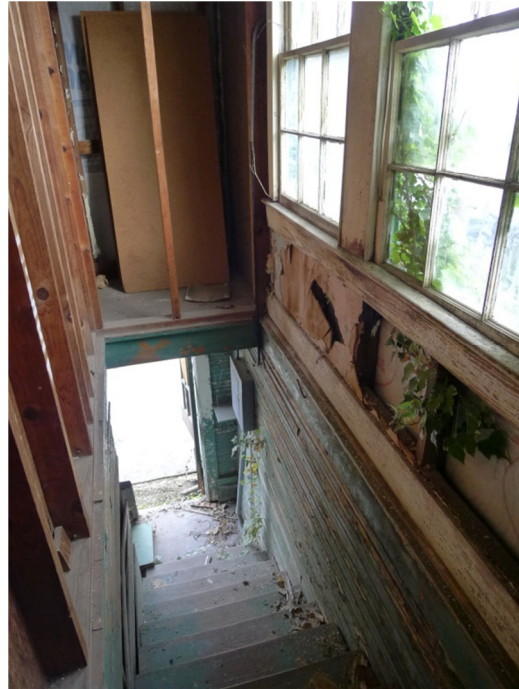
The ground floor has two access points, one door located at the northeast and another door located at the southwest, which are both lockable and functional. The second floor has one access door located at the northwest side of the building, but the entrance is boarded as the door is damaged beyond use.

*The exterior door to the second floor is boarded up and beyond repair*
