***Exterior Condition Assessment  
Of The  
Wren Community Hall  
34996 Wren Road  
Philomath, Oregon***

**Architect:**

*The Office of Robert Dortignacq*  
Architecture • Historic Preservation  
1915 NW 26<sup>th</sup> Ave, Portland, Oregon 97210

**August 28, 2015**

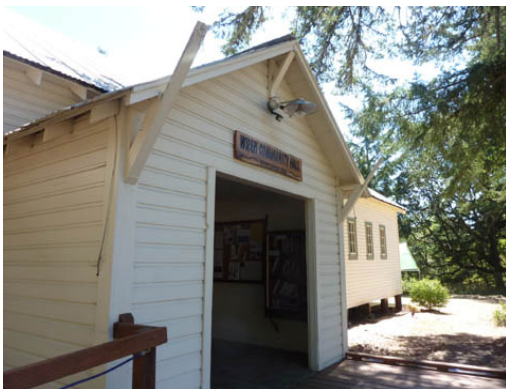
*Entry Vestibule*

The entry vestibule is in good condition, provides shelter, and one has no trouble in recognizing the primary entry point. While it has an exterior sign and an events bulletin board inside, highway drivers are unaware of upcoming events. A sign visible from the highway would be beneficial to increase public awareness and use.

The entry ramp allows full access. It could be improved with the addition of 'hand friendly' smooth handrails. For ADA compliance they are to extend past the ramp at each end.

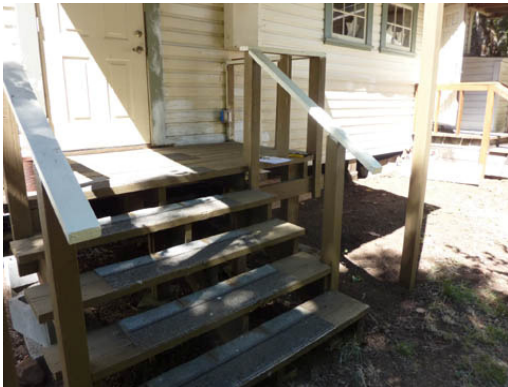
*Main Hall East Porch*

The rear porches and their roofs are in good condition and do not need repairs. Although simply constructed, they are serviceable for their needs. The rough framing railing should have grip handrails as a safety provision. A long term improvement would be to construct new porches, roofs and doors that better integrate and fit the design and materials of the historic building. If desired, a rear deck or patio area could be designed and constructed for ancillary use by the Main Hall.

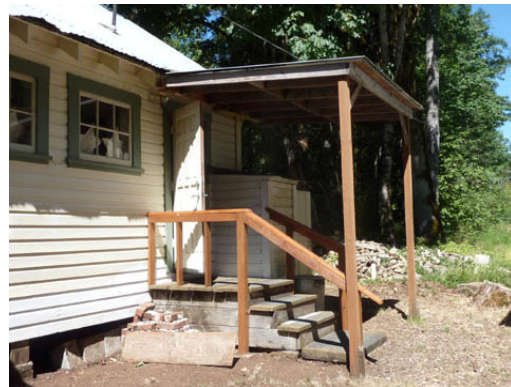
*Porch and Roof at North*

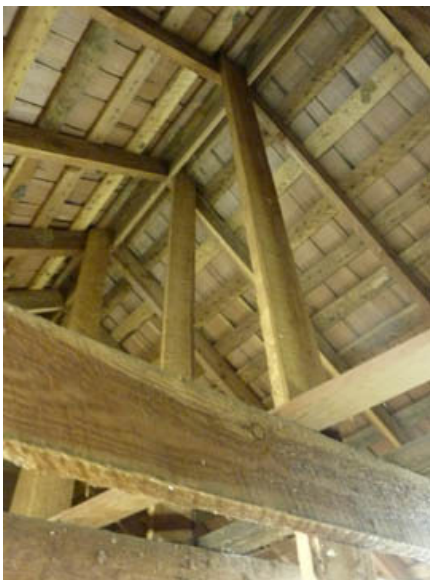
The roof lines and framing are straight and appear in good condition. No areas of deterioration were discovered. There is substantial debris in the attic on the hall's ceiling boards that are installed directly to the joists. Some of the debris is tree litter that may have filtered through the shakes, or fallen down during the metal roof installation. Other litter may have been brought in by creatures including mice. There are remains of numerous old wasp nests, particularly toward the south end of the attic.

*Attic Framing at Addition*

The joist spaces of both attics should be cleaned well of debris and waste. A vapor barrier should then be installed over the ceiling boards. This is more to keep the interior space in a relatively clean and sanitary condition than for vapor management. This is recommended prior to any ceiling insulation.

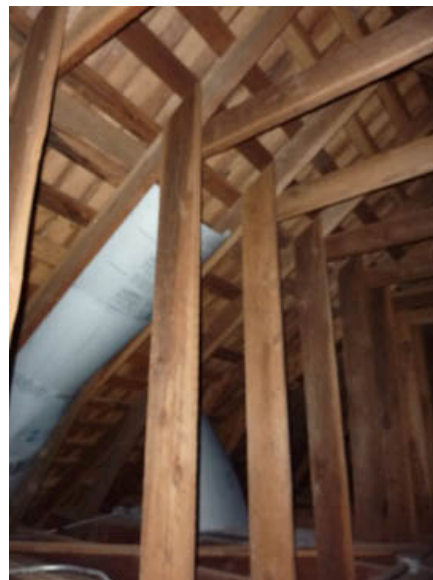
*Attic Framing Over Hall  
Note Metal Drip Catcher*

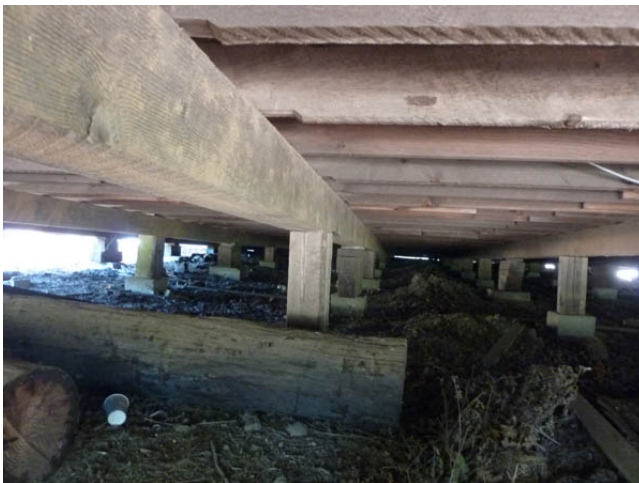
The floor framing and beams generally appear to be in good condition, no deterioration was found. However, deterioration may be encountered in areas where the grade is close to the framing, particularly at the perimeter. Some of the beams and joists appear to have been previously replaced. The wood piers vary in condition. Some have been replaced with heavy timber or the power pole sections, or have been replaced with multiple timber blocks, while others are deteriorated and in need of replacement. The piers are untreated wood that is typically not separated from the concrete and prone to rotting.

*Main Floor Framing; Joists Interior Beam and Posts*

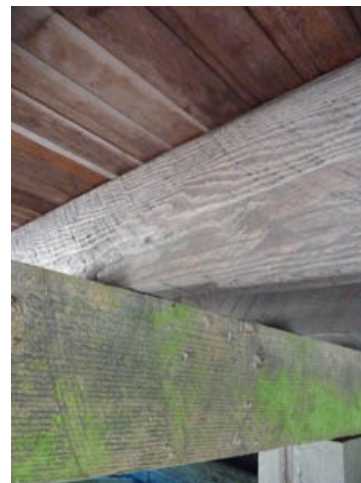
*Flooring, Joist, Beam*

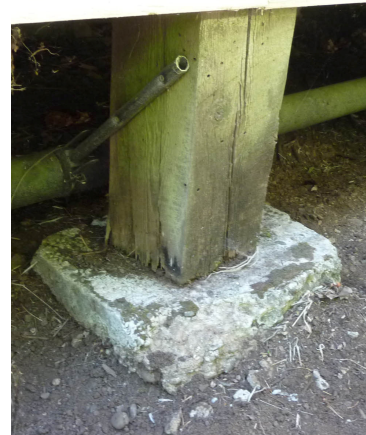
*Deteriorated Post on Pad*

Most of the floor framing is in good condition. There are some members that are deteriorated. These primarily are the posts under the beams particularly those along portions of the perimeter, and around the entry vestibule. No deterioration was found in the beams or joists. Although none was found, some deterioration should be expected on the north end and around the entry where the grade is close to framing and there is less ventilation. There are a very few concrete post pads that should be replaced due to their damaged condition. Replacement materials can match the existing, except posts should be preservative treated and separated from the concrete with a membrane, raised base or other means.

| 4. Replace Deteriorated Posts and Siding | \$9,000 |

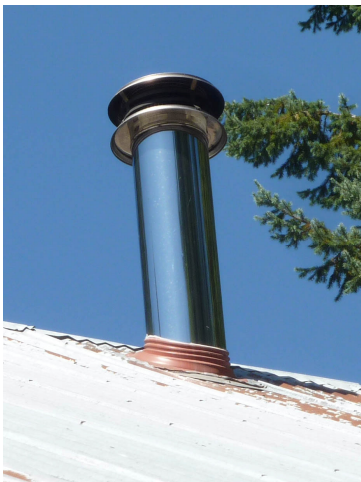
The main hall chimney is relatively new and in good condition. It has a cap and is flashed well to the roof. The roof framing where the prior brick chimney once rose has been cut and is not repaired. The block chimney for the addition's stove is not flashed well to the roof. There are spalls in the block units, particularly above the roofline, but there are also some around the roof level.

*Main Hall Chimney*

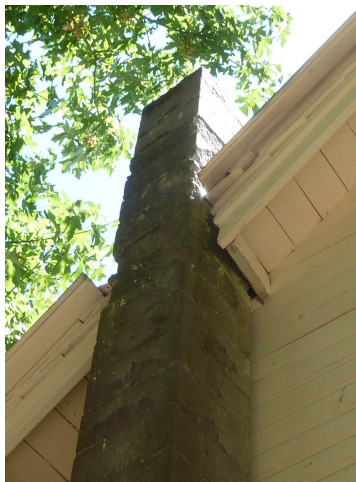
The main hall is heated by a large wood stove. The stove uses a double wall painted metal chimney inside and a stainless steel chimney with cap at the roof. There is a section of brick chimney that remains in the attic on the north side of the north wall of the main hall east of the ridge line. The chimney is not used and has been taken down to be below the roof framing. It may have been used for a stove at either space. The north addition is heated with a smaller wood stove that exhausts through the north wall and into a 16" square concrete block chimney that is exposed on the north wall where the roof overhang is notched to allow it to pass. This chimney does not have a cap.

*Addition Chimney*

The Main Hall has a new replacement metal chimney that is in good condition. The addition's concrete block chimney should have some improvements. The masonry needs to be flashed well to the roof, and a new cap is advised for spark and rain protection. The concrete block is spalled from moisture. It can be sealed with a thin cementitious coating. That can then be painted if desired, or left natural. An alternative is to replace this chimney with a metal flue rising straight up through the roof. If this occurs, the roof notch and wall needs to be infilled and repaired.

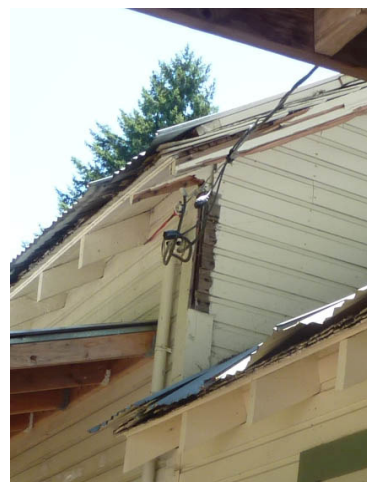
*Detail of Electrical Connection*

Wren Community Hall has an overhead electrical service with a 240 volt single phase cable that feeds from a power pole approximately 130 feet north of the building. The weatherhead is located at the northeast corner of the main hall. Conduit descends the exterior of the east wall from the weatherhead to a surface mounted digital meter box. The building's main panel is located directly inside. The panel is a Cutler Hammer 200 amp unit. The distribution for the building has been arranged with numerous circuits that divide the requirements well. There are six spares for future needs. Building wiring is in conduit [older installations] and flexible MC cable [newer installations]. New wiring and service has been installed competently and is in good condition. There are a few exterior power outlets. They use ground fault interrupt devices (GFI). Exterior lighting is minimal with a ceiling light at the entry vestibule, flood lights at rear porches, and RLM metal shade fixtures above the entry and at south roof eave corners [these are missing lamps and reportedly are not used]. One issue is that the service cable's connection to the building has broken the rafter tails and is now on a temporary tie off. This situation is reportedly due to tree limbs falling on the overhead wiring during past storms.

The electrical service and distribution are well installed. The most significant issue is the overhead service connection from the power pole to the north. This service should be routed underground to the building. This would reduce power outages and damage to the building. If this is not a near term possibility, an independent power pole located near the building could be installed to reduce potential building damage and to allow more ground clearance for the wire that now dips to within twelve feet above the ground.

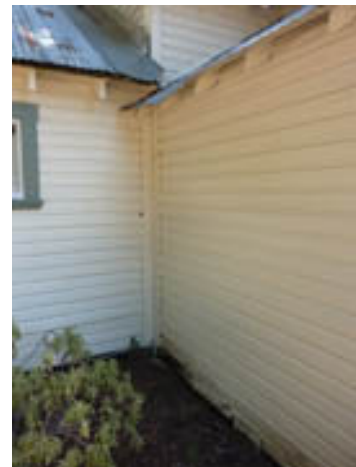
There is a small portion of the siding where the entry vestibule joins to the main hall on the north side that has some deteriorated boards at the bottom of the wall. This area is close to grade and receives rain that is funneled off the main and entry roofs, as well as added surface runoff. The siding there needs partial

replacement, but the long term solution is to address the water issue that is due to a combination of factors. Rain water needs to be directed away from the base of the building. This can be accomplished by sloping the soil away from the foundation, or by collecting with gutters or drains and piping away. Full gutters are not recommended due to their maintenance problem. Gutters for selected roof eaves may be reasonable. A perforated drainage line in this area, and possible along the north side of the building is a preferred solution.
