## **Structural Condition Assessment Report**

### **Storey County Courthouse Virginia City, Nevada**

### **Melvyn Green and Associates Structural Engineers**

October, 2014

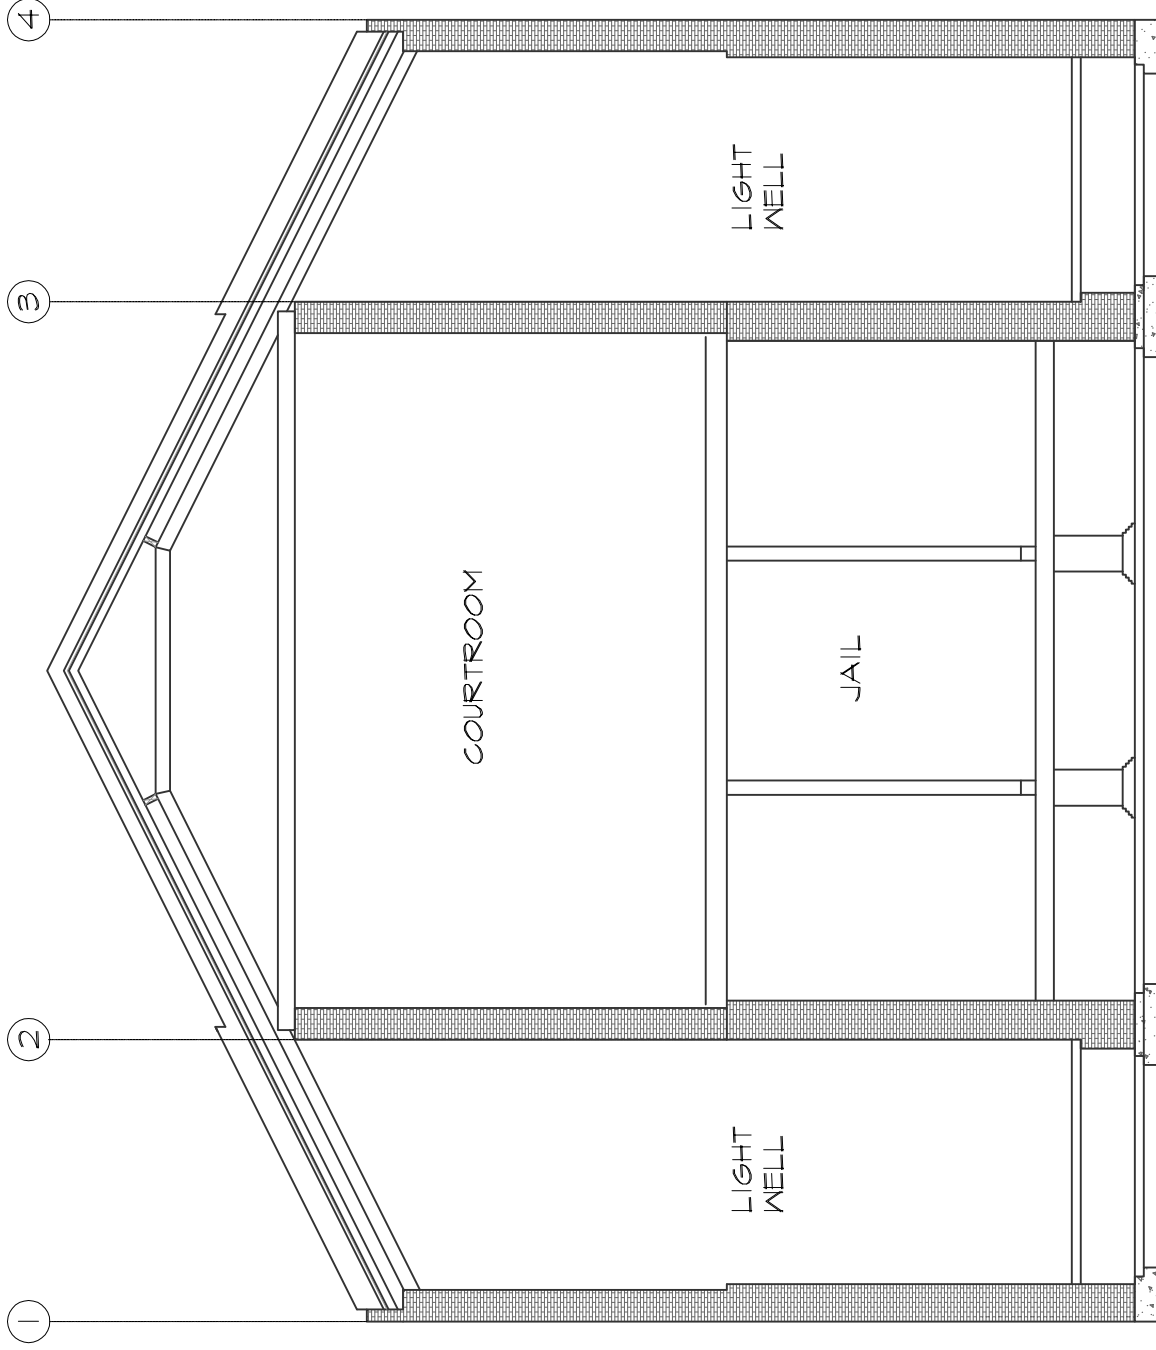
FIGURE 3  
SECTION THRU LIGHT WELL

Brick walls typically support an intermediate floor in addition to the roof. In the north and south lightwell enclosure the exterior walls are full height from the first floor to the roof, an unsupported height of about 37 feet. There are intermediate steel tie rods between the exterior wall and the wall of the jail.

The severe cracking of portions of the building's lightwell walls is a sign of ongoing movement. The width of cracks has increased significantly since our previous inspection. Unless structural repair is undertaken, the cracking will probably continue until the walls become unstable. In our opinion, this is an urgent item for installing additional bracing and repairs.

The potential causes of cracks in building walls are numerous. However, wall cracks which occur soon after completion of construction are usually related to differential movements of the building foundations. This did occur; early cracking was noted in the *Daily Territorial Enterprise* for April 25, 1877. Such cracking, however, only remains active for a few years. Moreover, if foundation settlement were the entire cause, we would expect to see some cracking throughout the building. In fact, significant cracking is located only in the stairwells probably indicating some localized foundation issue.

Strengthening will involve the installation of horizontal braces from the exterior wall to the walls that are perpendicular to them. In addition some strengthening will be required at the interior wall cracks to tie the walls across the cracks.

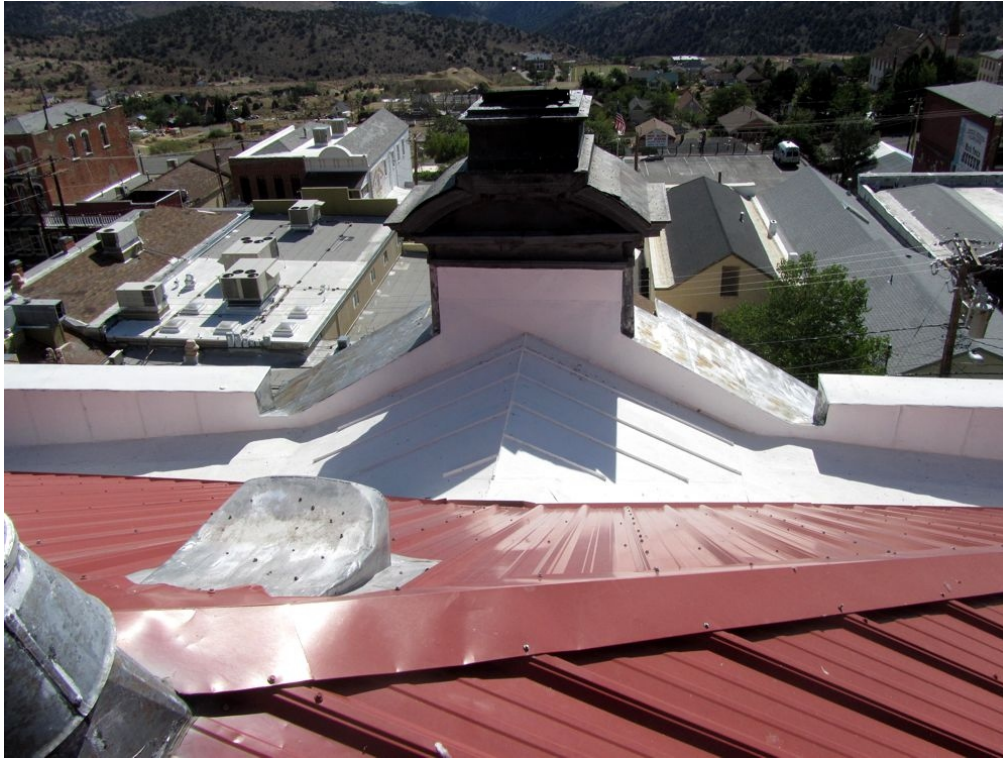
Photo 1. Back of tall parapet on the east side of the building. This requires bracing.

- East Elevation – Brace the parapet and the gable wall. This will involve bracing on the back side of the parapet with diagonal braces extending to the roof system. The gable will be braced on the interior side of the brick with steel shapes anchored to the wall and to the roof and ceiling framing (the ceiling framing may need some strengthening in the attic).
- West Elevation – This will require bracing within the attic similar to that described for the east elevation.

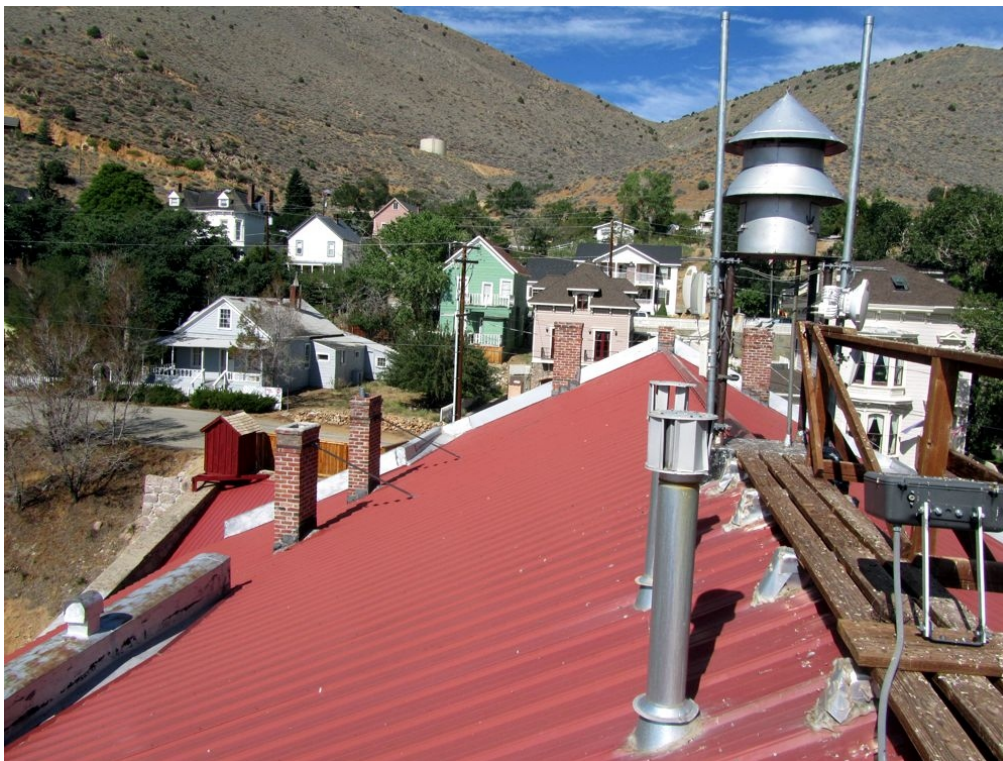
Photo 2. View west. Chimneys require additional bracing.

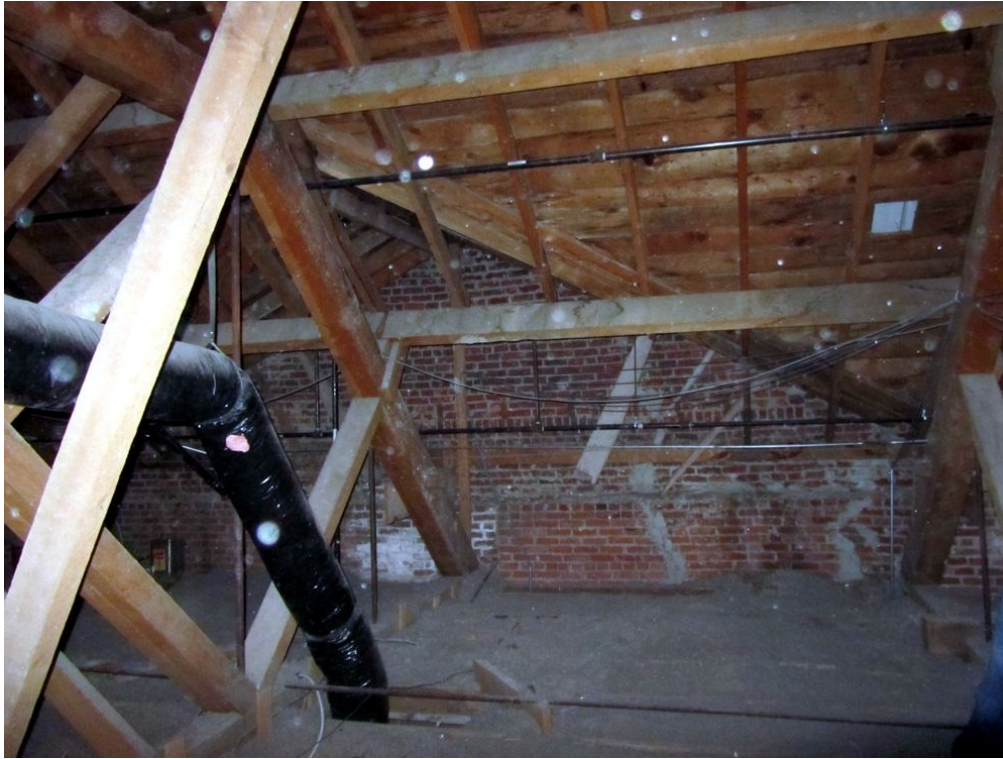
In a similar manner, the east parapet will tend to rock and fall outward in an earthquake. Parapet collapse is usually the first thing that happens to this type of building in an earthquake and should be considered a priority strengthening task. The portion of the wall between the roof and the ceiling of the second floor is a gable. It too tends to act as a parapet and fall outward. Gables occur at both the east and west elevations of the building.

Photo 3. Interior view of the building facade from within the attic. Gables tend to fall outward and require bracing. This would be from within the attic.

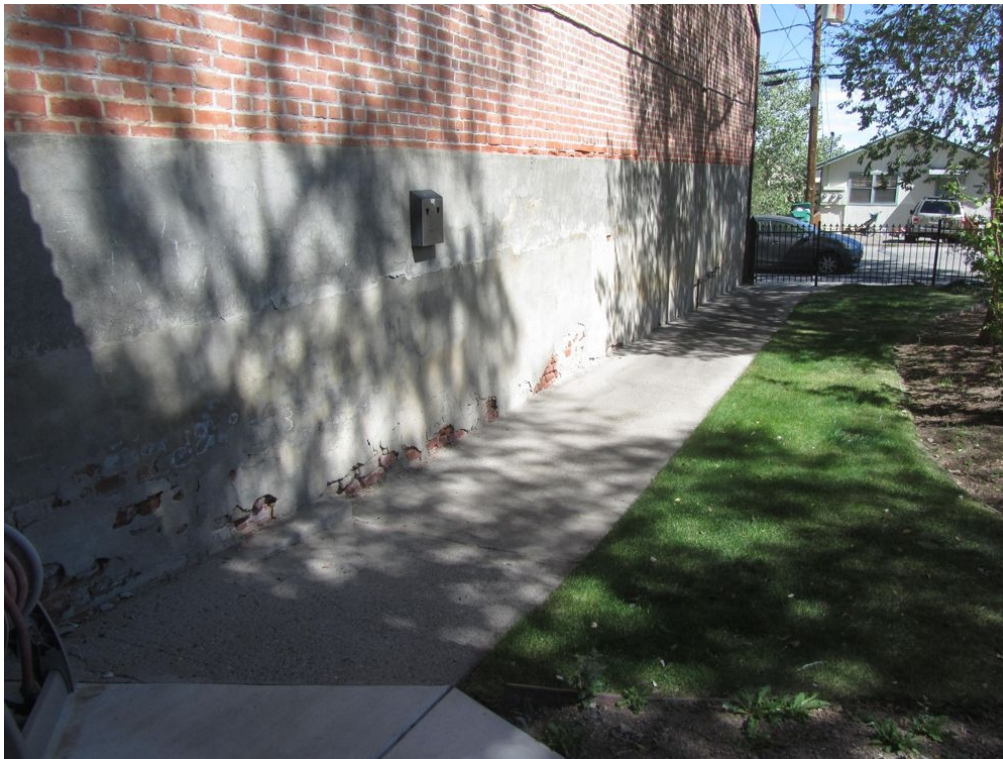
Photo 4. South wall. Brick deterioration at the base and at the top of the applied cement plaster. Repointing of brick joints and some brick replacement is needed.

Repointing of masonry walls is an important maintenance task to preserve brick buildings. The need for this is getting urgent on areas of both the north and south walls in selected areas. Planning for repointing all the walls should be considered. All new mortar should match the existing in material properties.
