# Historic Structure Report for Lincoln Hall

University of Nevada, Reno Historic District  
Reno, Nevada

Prepared for:  
The University of Nevada, Reno

August 2015

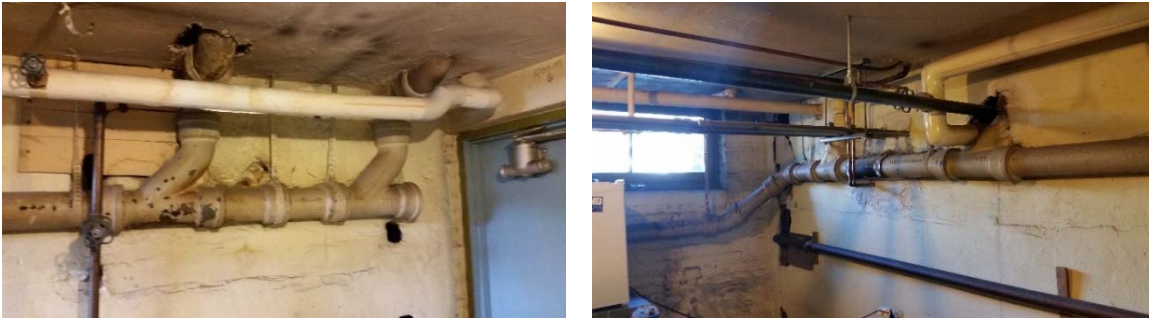
**Figure 11:** Building Waste Piping – Room 6

Existing sewer piping throughout the building is old cast-iron piping. It is assumed that some of the piping is original to the building and some is newer when plumbing improvements were made to the building. Based on the age of the pipe, it is anticipated that piping is in need of replacement due to corrosion. It is also known that approximately 160 feet outside the building, the main sewer piping continually clogs and needs to be cleaned out on a routine basis by UNR staff. An alternate route for the main waste piping existing the building will alleviate this problem. Based on the age of the pipe and the extent of the building renovation, all the waste and vent piping in the building will require replacement. Refer to [Figure 11](#) for typical sewer waste piping found in the building.

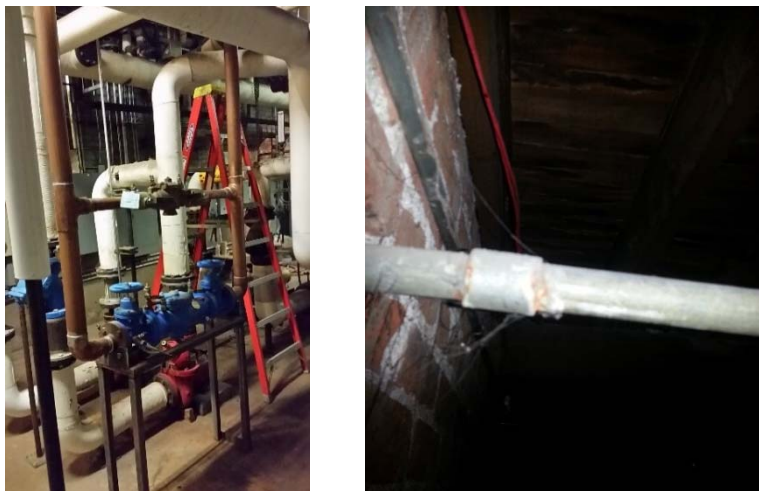
**Figure 12:** Domestic Water Piping – Room 7

Some of the newer domestic hot and cold water piping is copper. However, there is still galvanized iron piping in the building. Because of the mixed piping type and the extent of the building renovation, all the water piping in the building will require replacement. The main water piping enters the basement level in the mechanical room. Two backflow preventers are located within the building. Refer to [Figure 12](#) for domestic water piping found in the building.

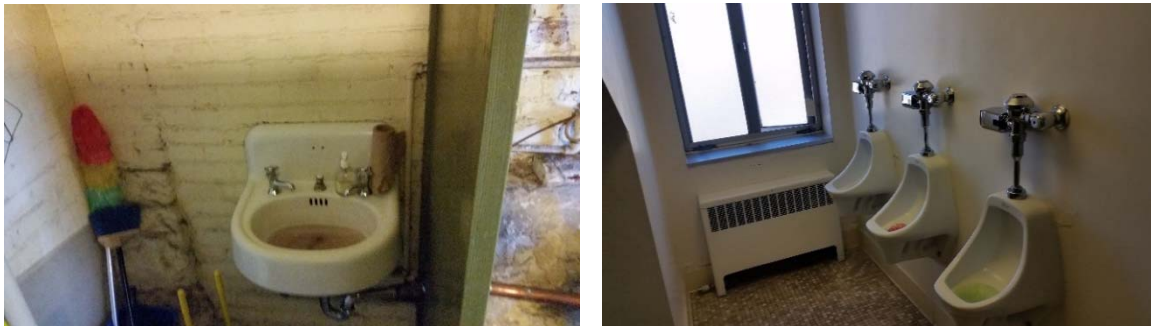
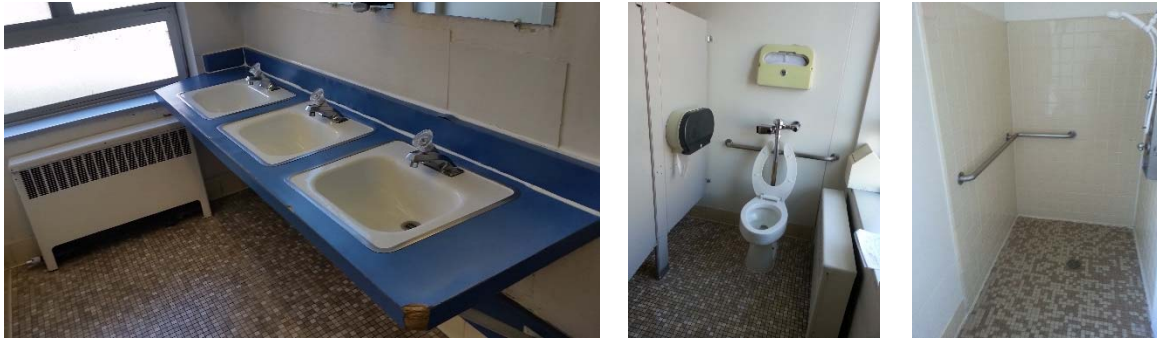
**Figure 14:** Plumbing Fixtures - Typical

The lavatories, sinks, showers, and water closets throughout the building appear to be upgraded sometime in the 1980s. All of the plumbing fixtures in the building should be removed due to the extensive building renovation and the age of the fixtures. Refer to [Figure 14](#) for typical plumbing fixtures found in the building.

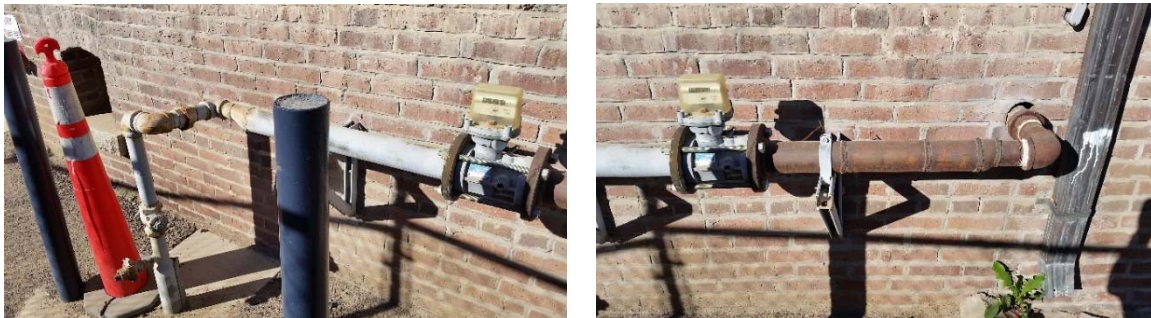
**Figure 15:** Natural Gas Piping – East Side of Building

The main natural gas piping service entrance is on the east side of the building. The gas meter is located at this entrance. A seismic gas valve is not installed on the main piping entering the building. The exterior piping is rusting and needs to be coated with a protective coating. The piping routes from the meter location into the boiler room. This gas service also appears to fuel a natural gas fired generator located to the north of the building. Refer to [Figure 15](#) and [Figure 16](#) for typical gas piping found in the building.

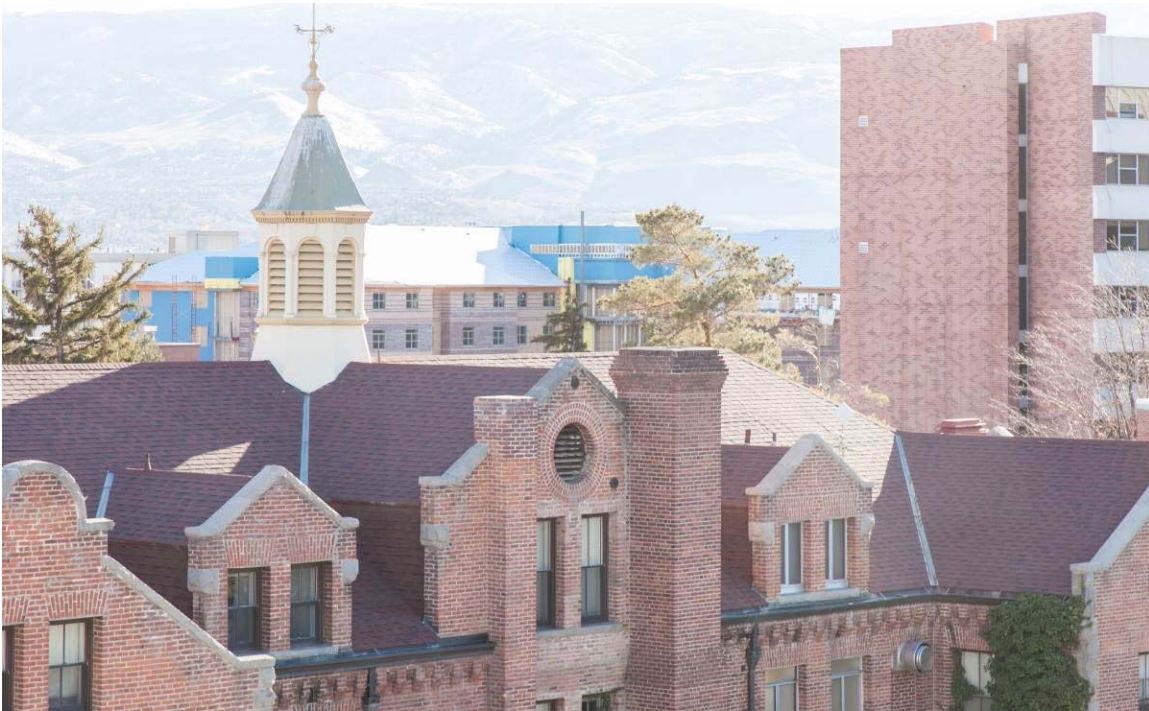
**Figure 27:** View southwest of roof. Note that valley flashing at right of frame appears to be rusting. Image Source: IS Architecture, March 2015.

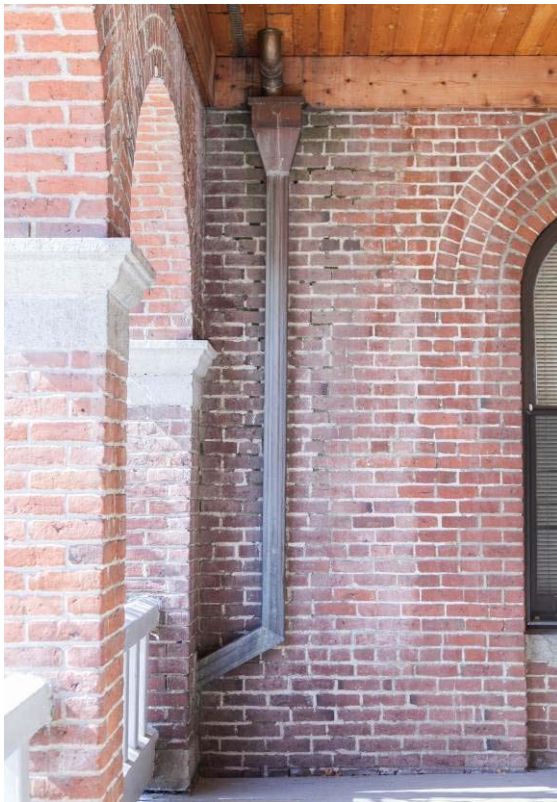
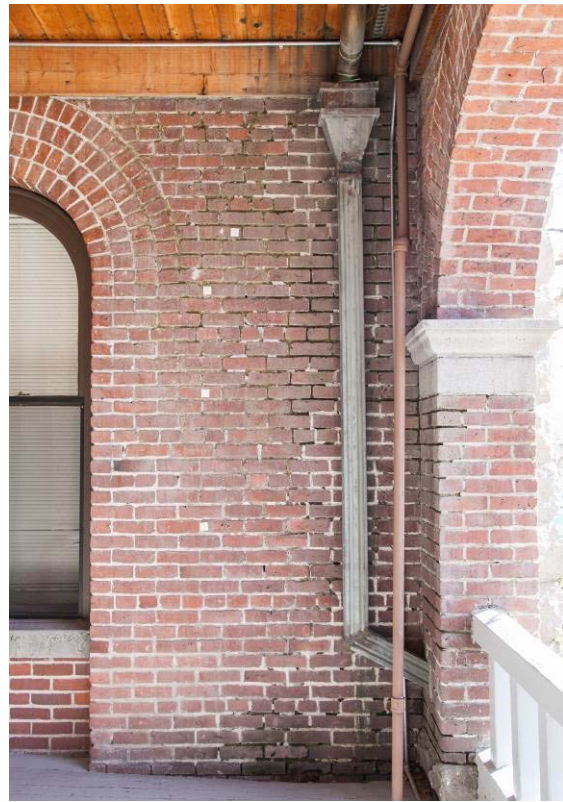
**Figure 31 and Figure 32:** West and east walls of porch showing water damage to brick wall. Image Source: IS Architecture, March 2015.

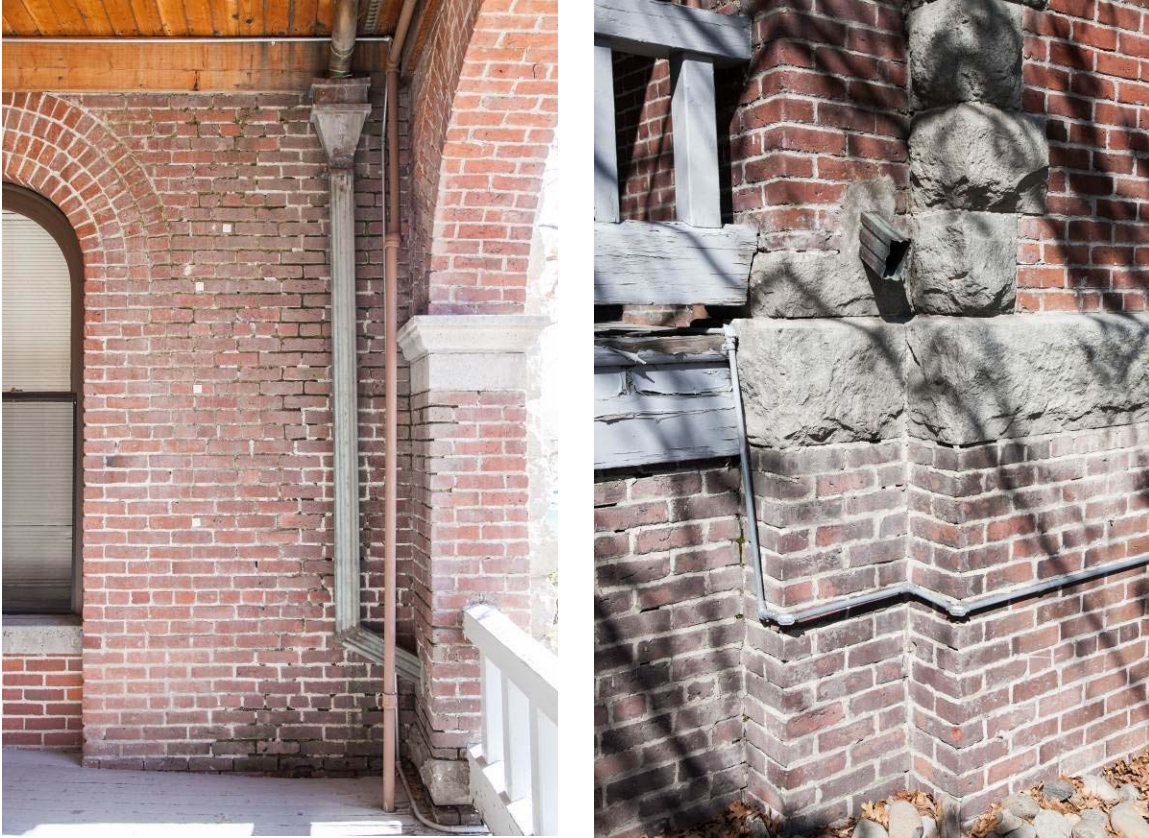
**Figure 33:** East wall of porch showing route of existing drainpipe, leader head and downspout. Note water damage to brick wall. **Figure 34:** Downspout outlet for the porch's east drainpipe. Image Source: IS Architecture, March 2015.

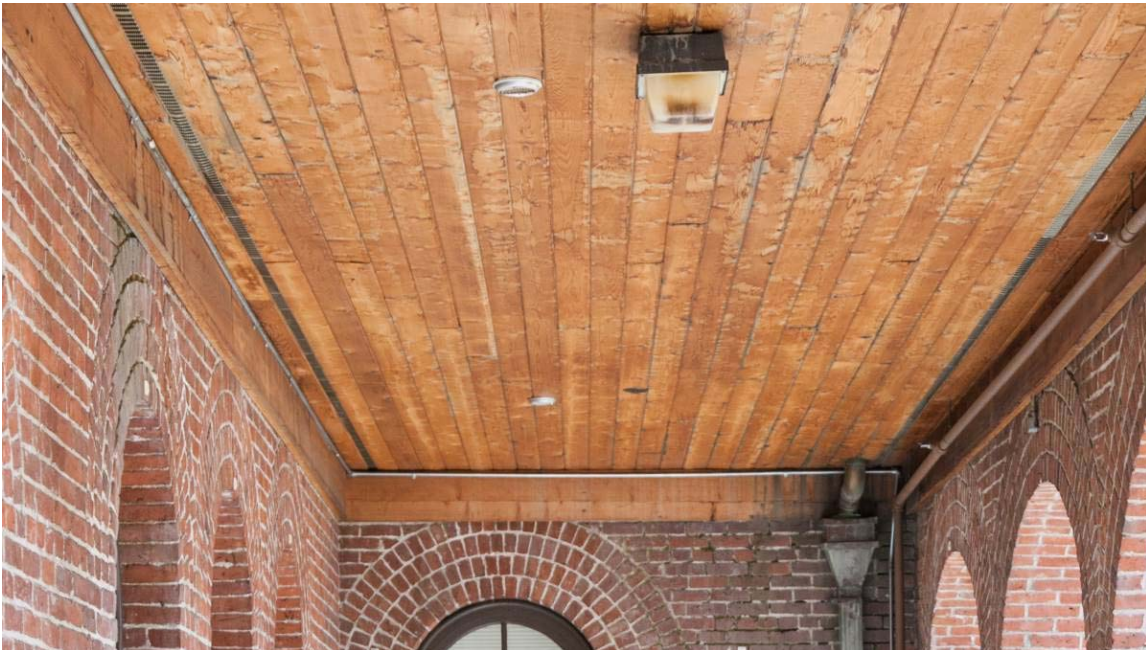
**Figure 38:** Porch ceiling as it appears today. Note: box beams are missing and ceiling boards have been replaced. No historic material remains. Image Source: IS Architecture, March 2015.

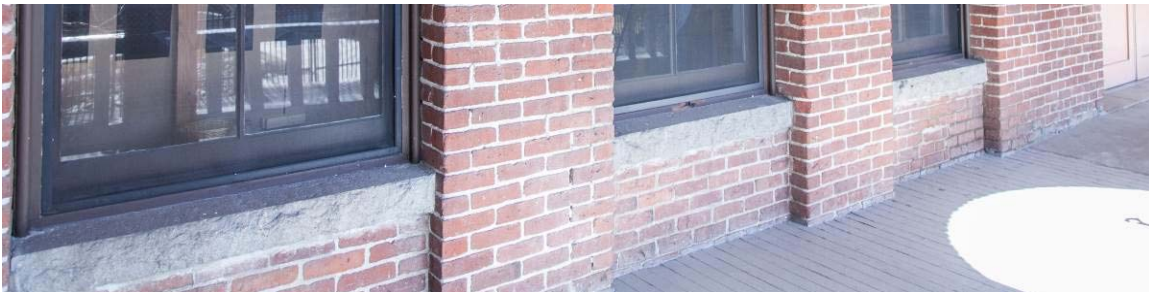
**Figure 39:** Porch floor as it appears today. Note warped floor boards along brick wall. Image Source: IS Architecture, March 2015.

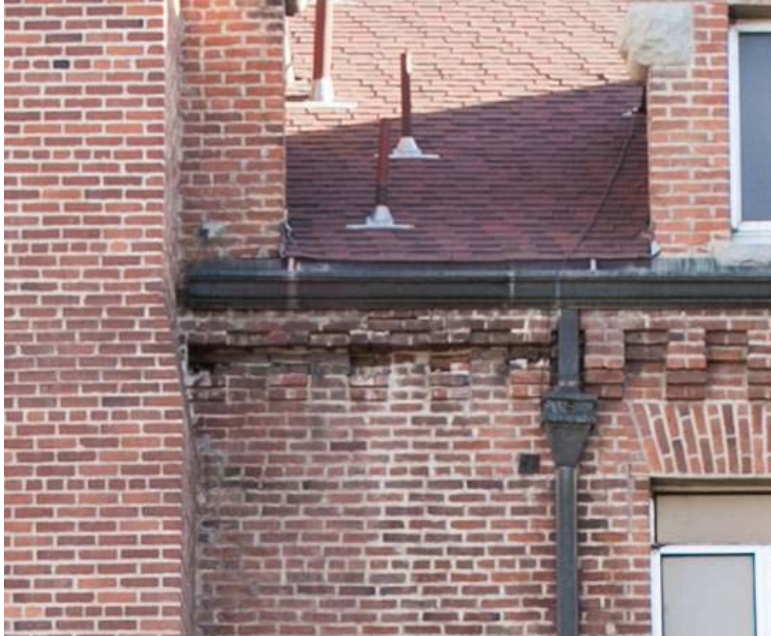
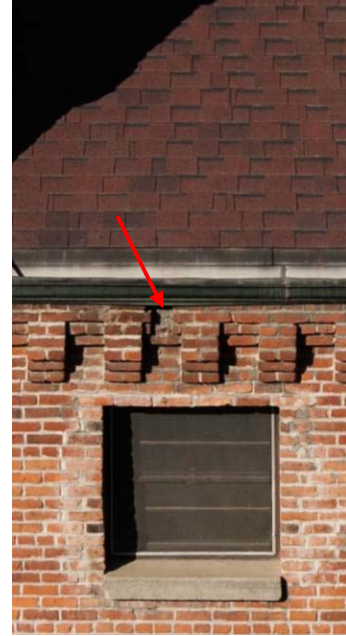
**Figure 42 (left):** Brick corbels on the north façade were removed when in 1952 a fire escape was installed. **Figure 43 (right):** Detail view of the east façade showing missing brick corbels. In this case, a downspout was installed at an unknown date and removed in 1952. Image Source: IS Architecture, March 2015.

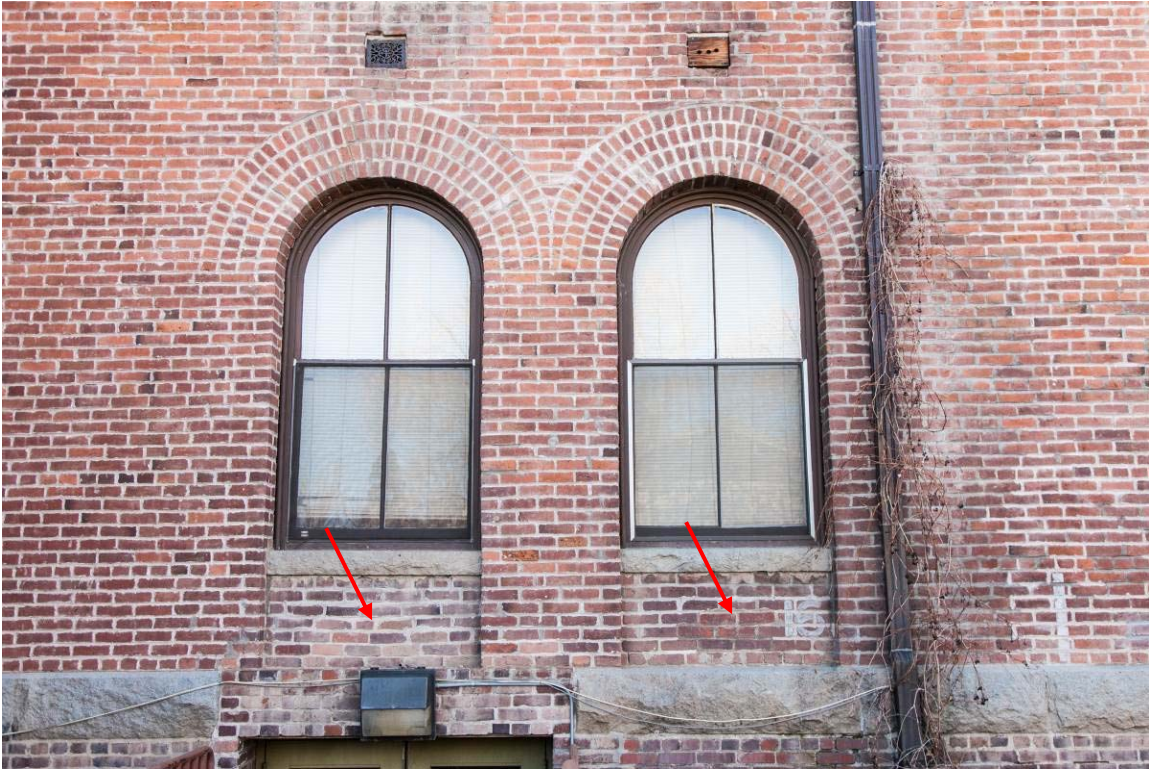
**Figure 44:** Overview of various condition issues related to the decorative grille vents on the north façade of Lincoln Hall. Upper left grille appears to be loose. The upper right grille is missing, but the opening is intact. Two decorative grille vent openings below the windows have been in-filled with brick. Image Source: IS Architecture, March 2015.

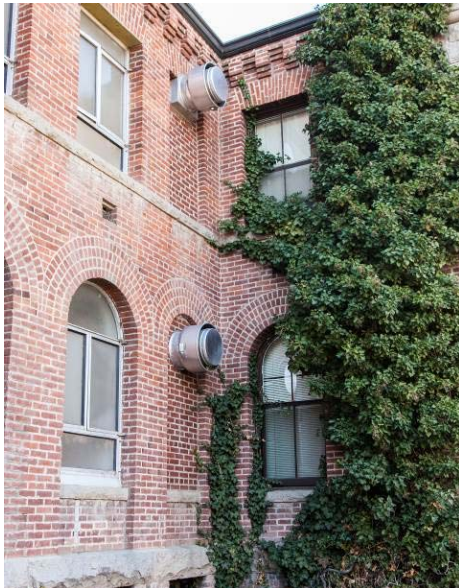
**Figure 50 (left):** West interior corner of north façade showing ivy growth over existing drainage assembly.

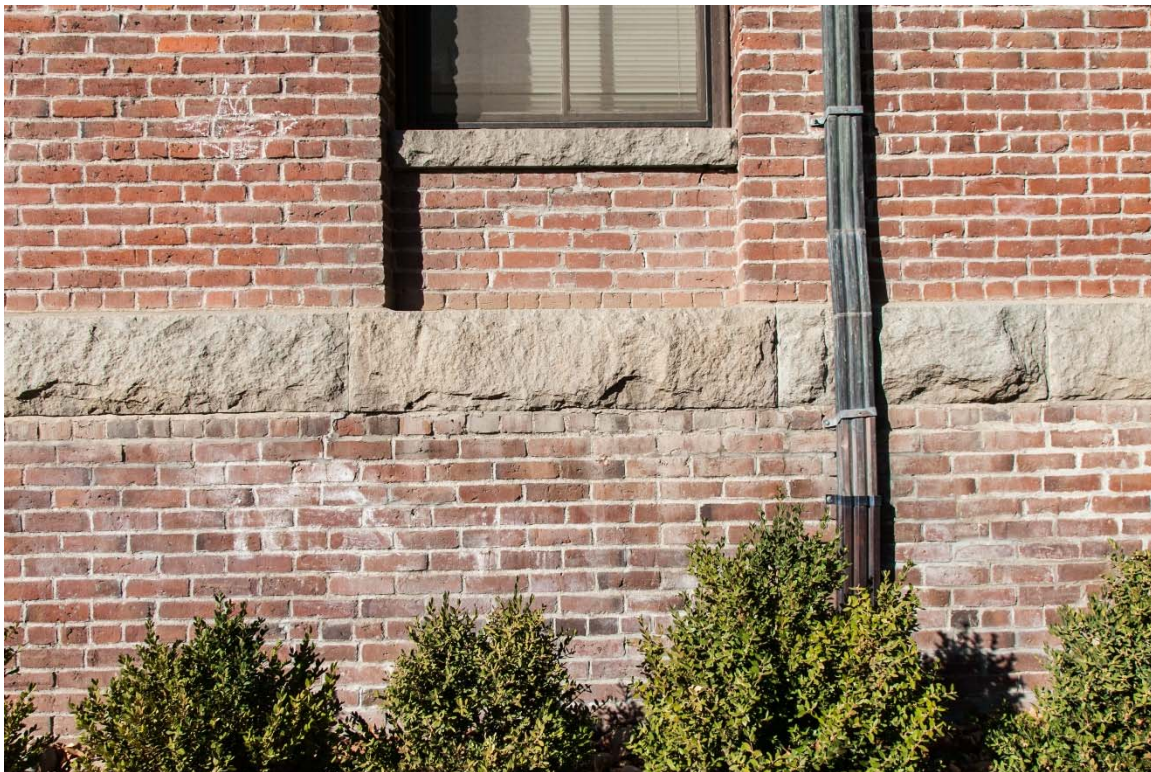
**Figure 52:** View of east façade showing brick experiencing efflorescence. Image Source: IS Architecture, March 2015.

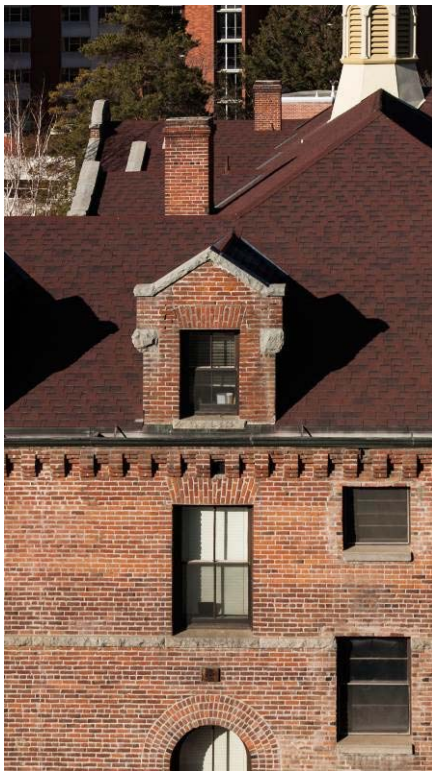
**Figure 53:** Detail view of east façade showing mortar loss at dormer. Image Source: IS Architecture, March 2015.

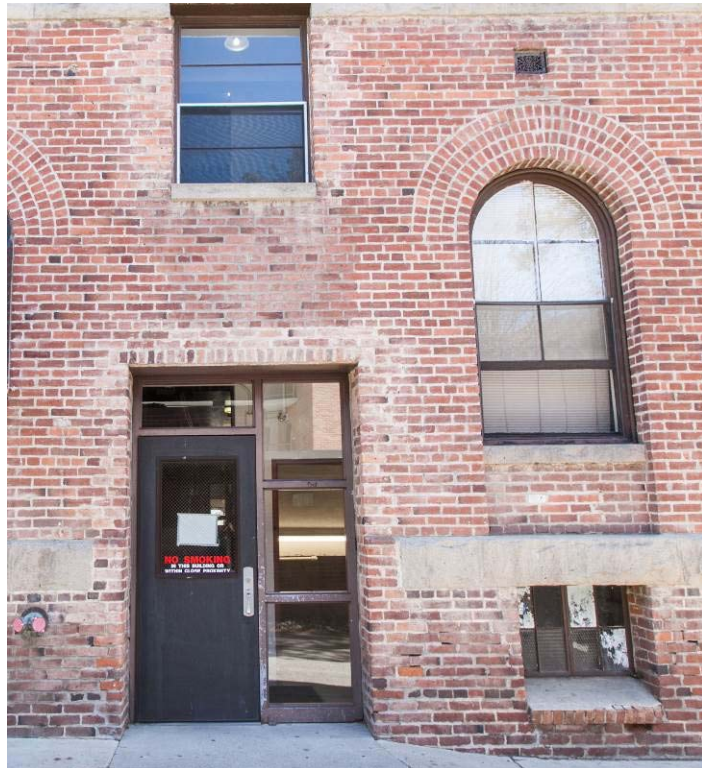
**Figure 54:** Detail view of west façade showing mortar loss at basement level. Image Source: IS Architecture, March 2015.

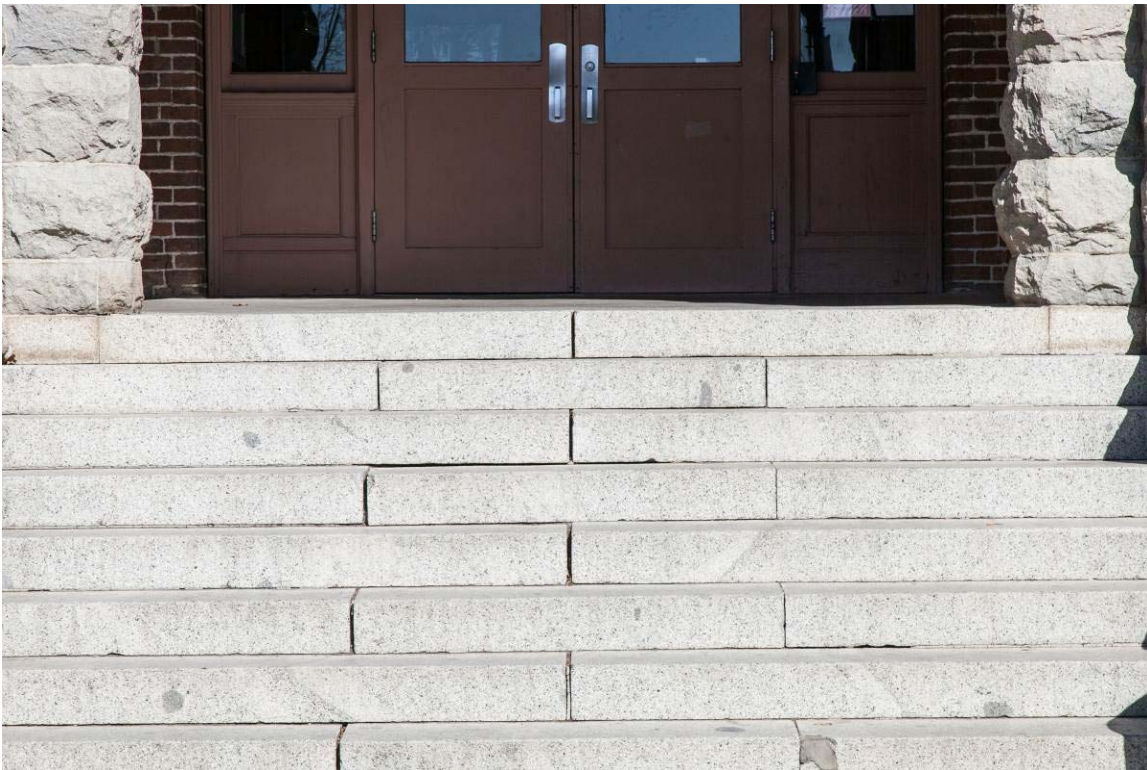
**Figure 55:** Detail view of south entry steps. Some of the granite steps have become wobbly due to mortar loss. Image Source: IS Architecture, March 2015.

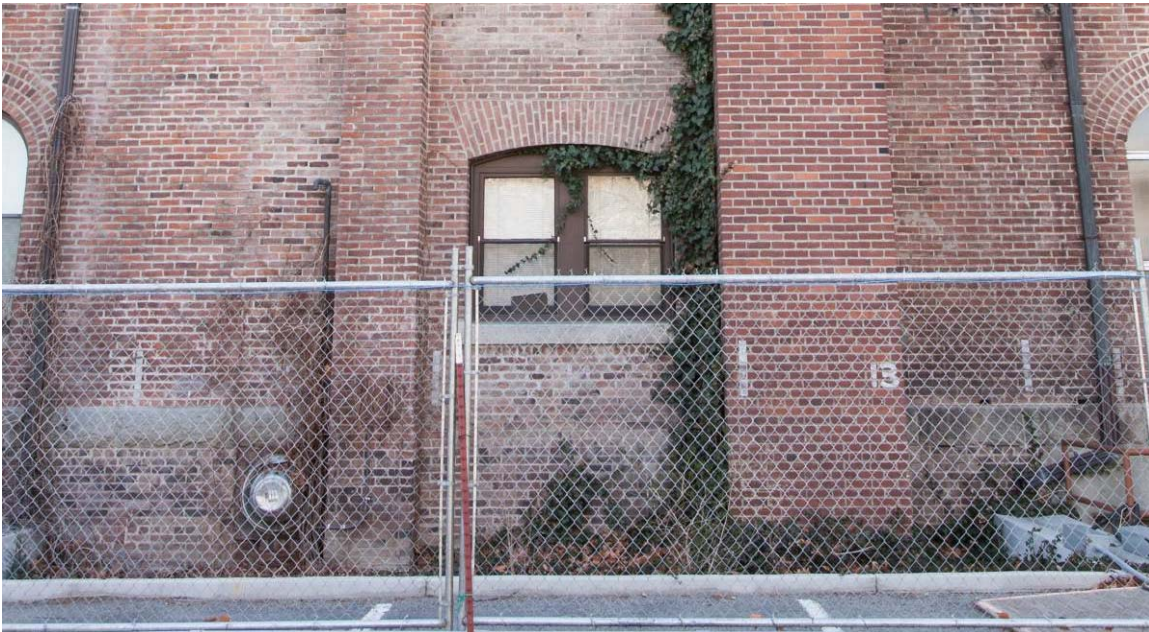
**Figure 60:** View south of north façade where a window has now replaced the original north entry. All that remains is the segmental arch and the granite threshold (now the window sill). The original opening width has also been retained. Image Source: IS Architecture, March 2015.

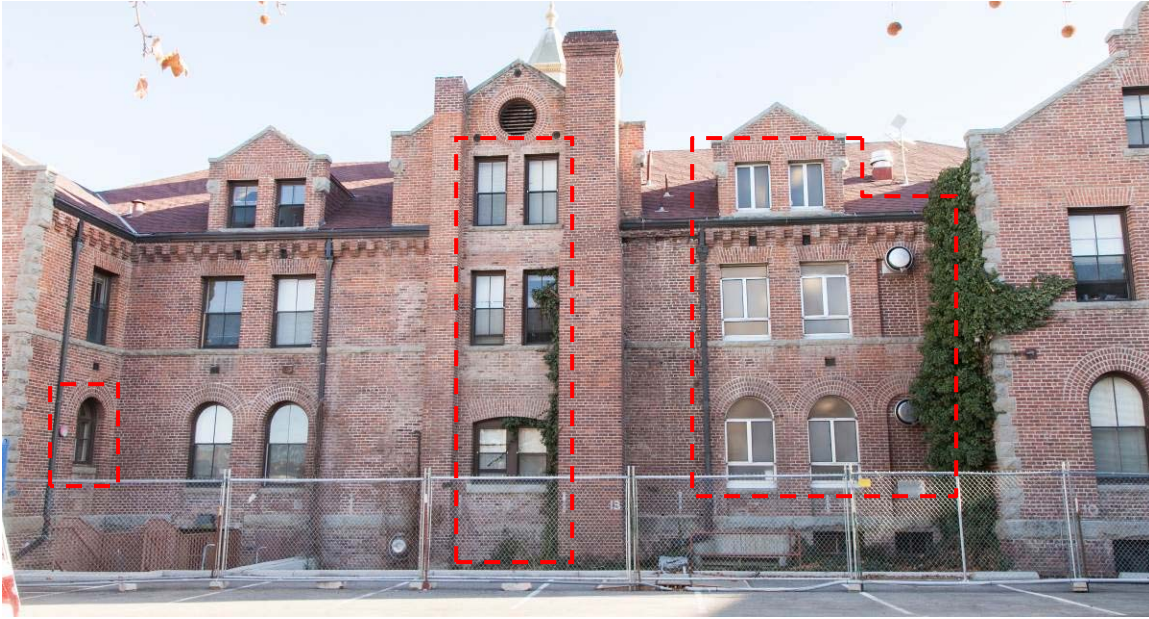
**Figure 62:** North façade of Lincoln Hall with arrows indicating missing or altered windows. Image Source: IS Architecture, March 2015.

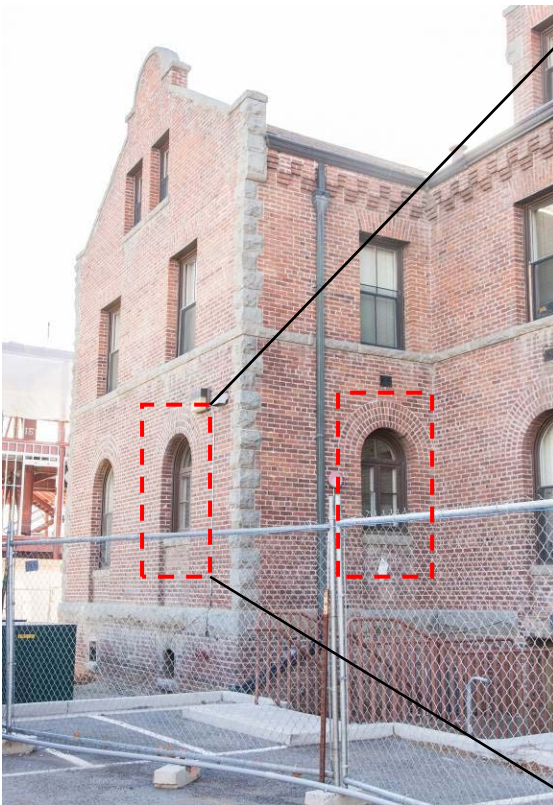
**Figure 63:** East interior corner of north façade with dashed outlines showing windows of Room 118 that have been altered. Image Source: IS Architecture, March 2015.

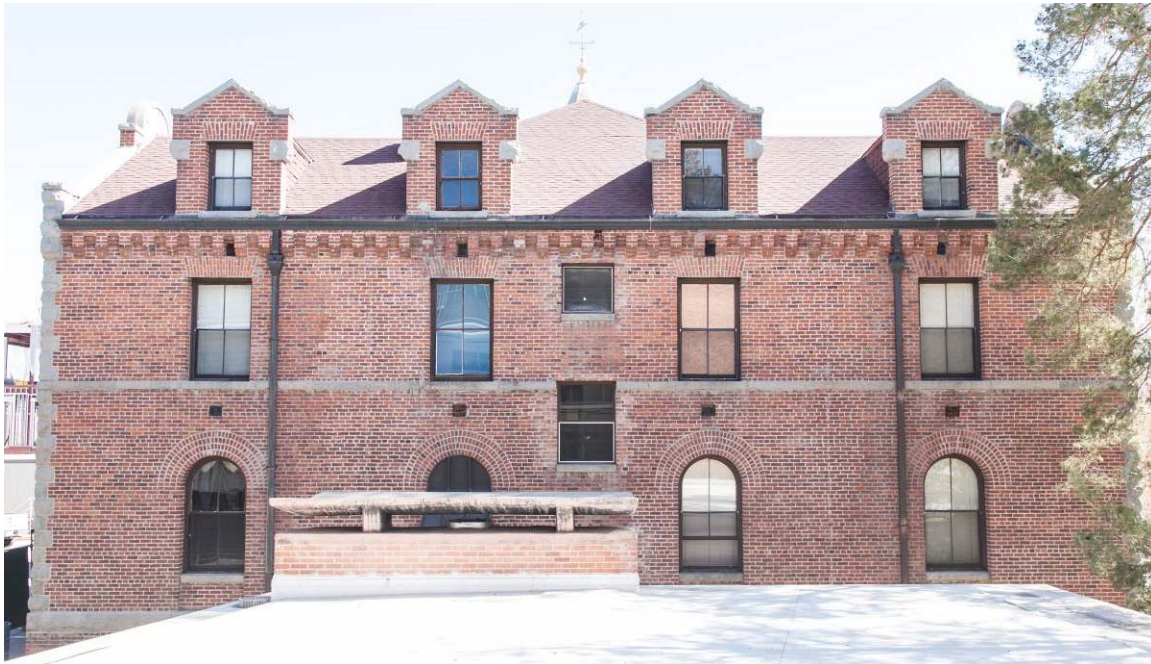
**Figure 65:** View east of west facade. Note the detracting blue material hung in the windows. Image Source: IS Architecture, March 2015.

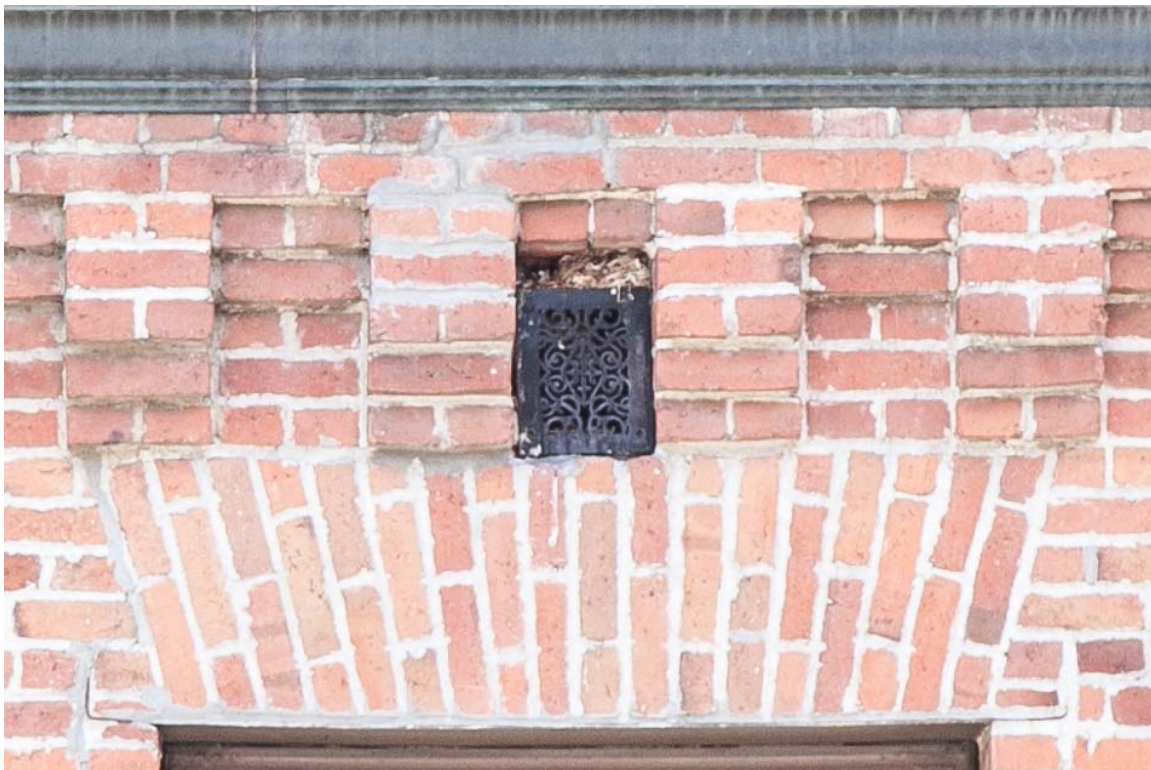
**Figure 72:** Detail view of decorative grille vent opening on west facade. The grille has become loose and wildlife appears to be nesting in the wall cavity. Image Source: IS Architecture, March 2015.
