# HISTORIC PAINT FINISHES REPORT

THE MARYLAND BUILDING:

THE 1876 EXTERIOR FINISHES

### **The Maryland Building from the Centennial Exposition of 1876 Exterior finishes of 1876**

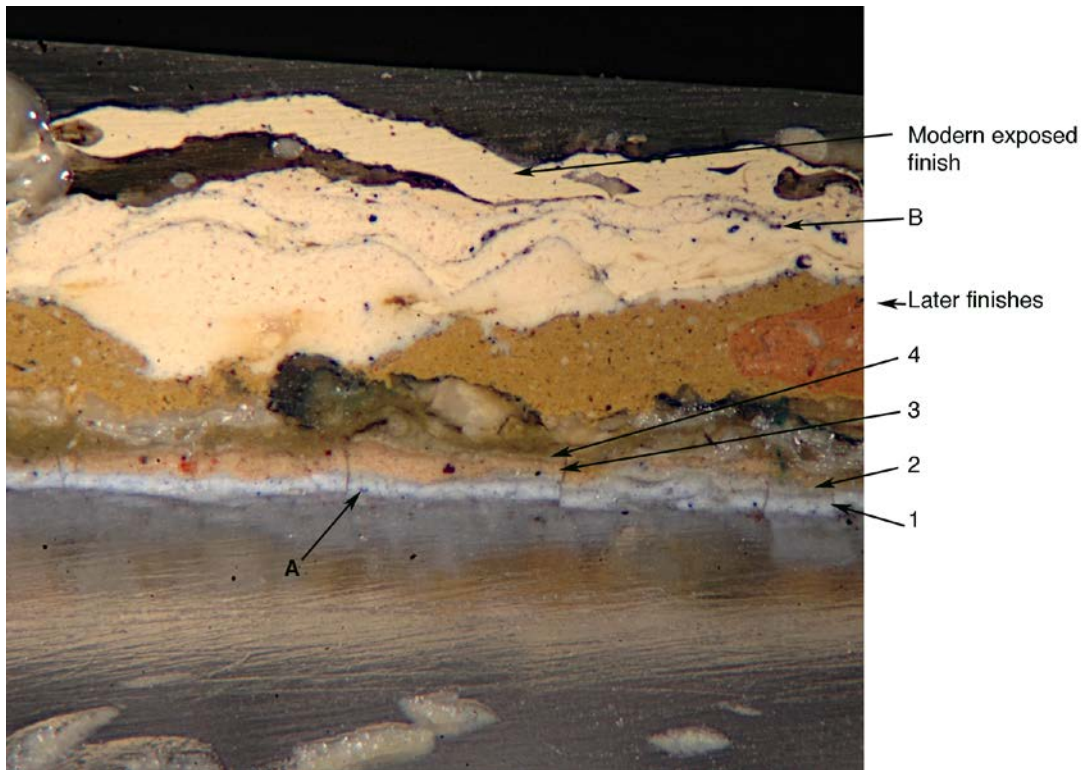
**Maryland Building: Siding: surface protected by porch ceiling, First Floor North wing  
North East Porch**

Note: The surface has been subject to extensive paint removal probably over fifty years ago. The sample seen above was extracted from the recessed bead where paint layers were not damaged by the paint scraping. Note the earliest finish (1) is a prussian blue and white combination. The prussian blue pigment particles are clearly seen (A). There is a second finish, a blue gray (2), which is followed by a brownish-pink (3) and a warm tannish gray (4). Some evidence of disturbance in the paint sequence is then seen, followed by later colors. Note the surface particulate (B) on most of the layers. The modern yellowish finishes are distinct.

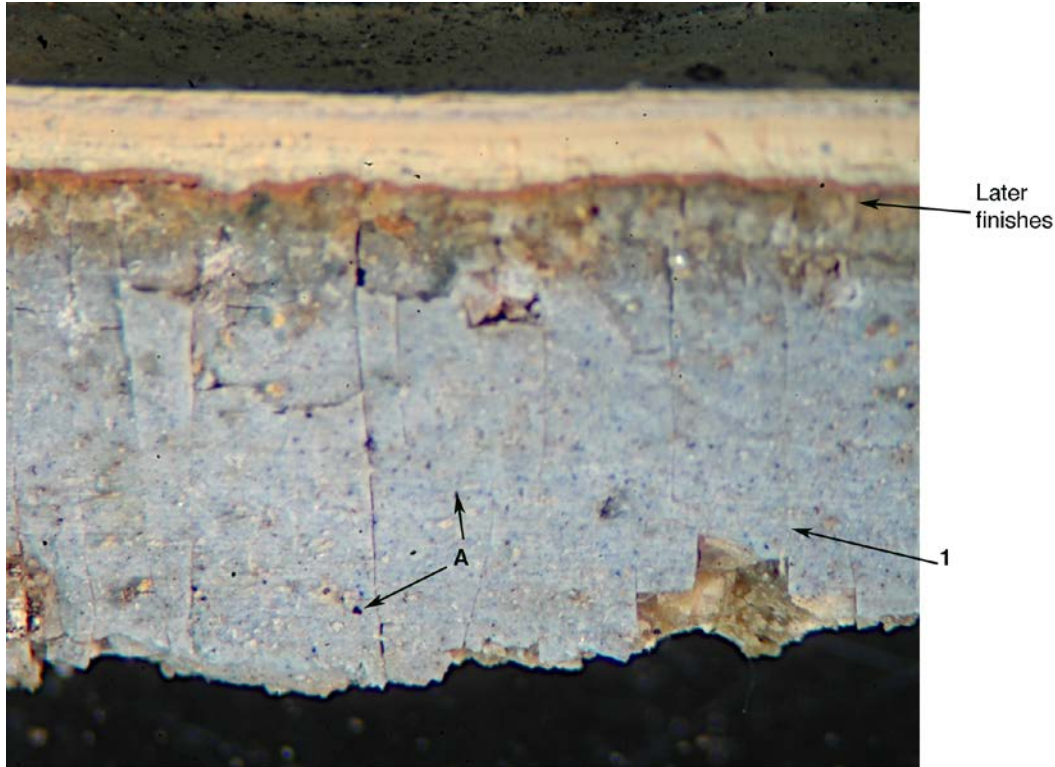
**Maryland Building: Siding: surface protected by porch ceiling, First Floor North wing**

Note: The sample seen above was extracted from the recessed bead where paint layers were not damaged by paint removal elsewhere on the building. Note the earliest finish (1) is a prussian blue and compound white combination. The prussian blue pigment particles are clearly seen (A). The sample is seen from the underside: the later finishes are seen at the rear of the sample.

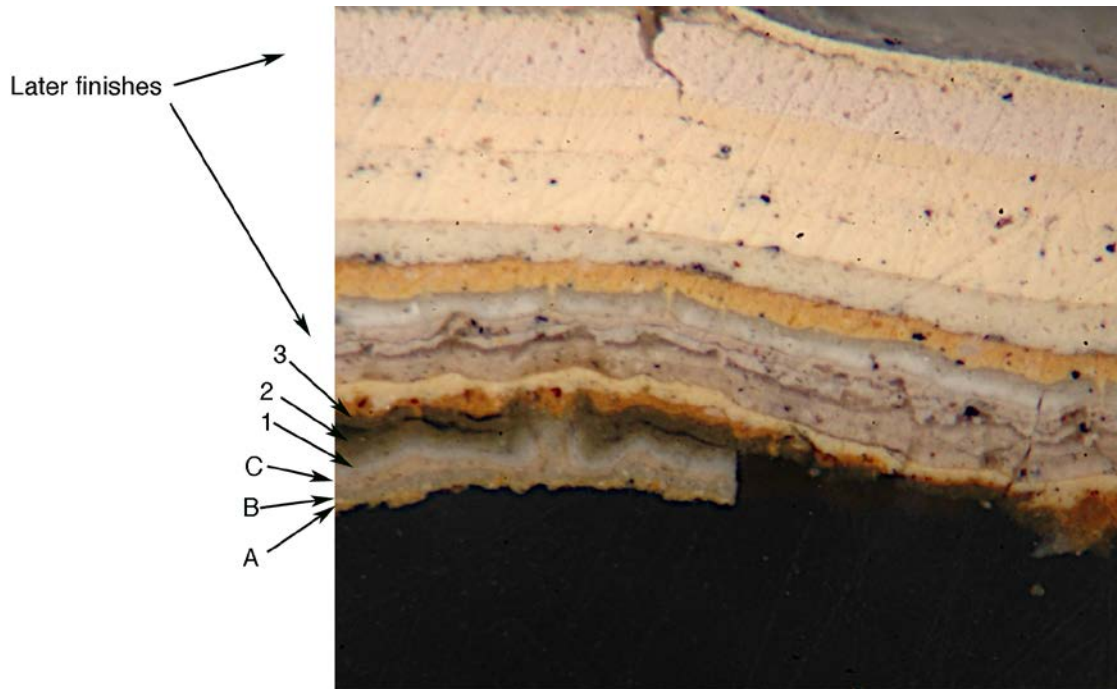
**Maryland Building: Truss-work (Project North) Elevation, Center pavilion, supporting roof**

Note: This is a very interesting sample because it showed three paint layers that may have been test colors or under-coatings (A, B, C). The next layer (1) is the finish seen on the siding behind the truss-work, with one coat of a semi-transparent coating. The next layer (2) is the FIRST finish, a dark gray that has yellowed dramatically (2) so that it looks green. The next layer (3) is a repeat of this dark gray, which is also very discolored and looks like a dark olive green. Later finishes are also noted.

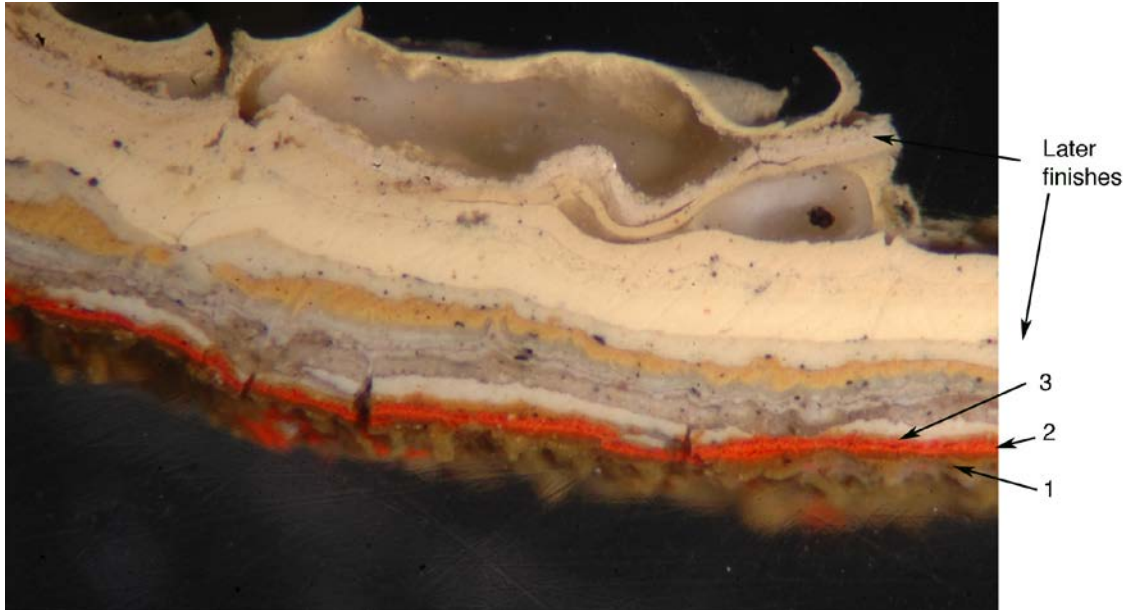
**Maryland Building: Truss-work Chamfer (Project North) Elevation, Center pavilion, supporting roof**

Note: This sample has been mounted in polymer resin. The earliest layer is a thin application of the dark gray (discolored) that served as the finish on the other surfaces of the truss-work. The first finish on this surface was the brilliant vermilion red (2). A second application of the same type of vermilion red (3) probably postdates the re-building of the structure in Druid Hill Park.

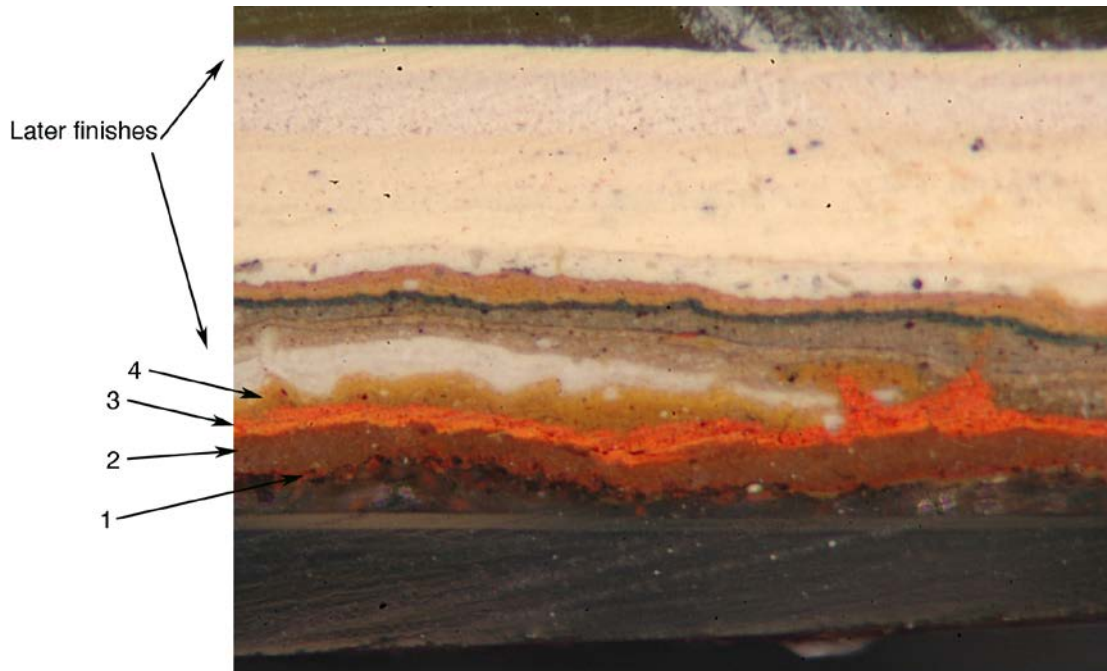
### Maryland Building: Main Truss, Chamfer (project North) Gable

Note: The sample has been mounted in polymer resin, cut and polished for additional examination. The earliest surviving layer is the first finish, the dark red ochre (1) that was the first finish on this chamfer surface. The next layer is a dark brown ochre used as an undercoating (2) to support the vermilion finish that appears to date to the re-building of the structure in Druid Hill Park (3). A notable layer yellow ochre finish is also visible (4). Later finishes are also seen.

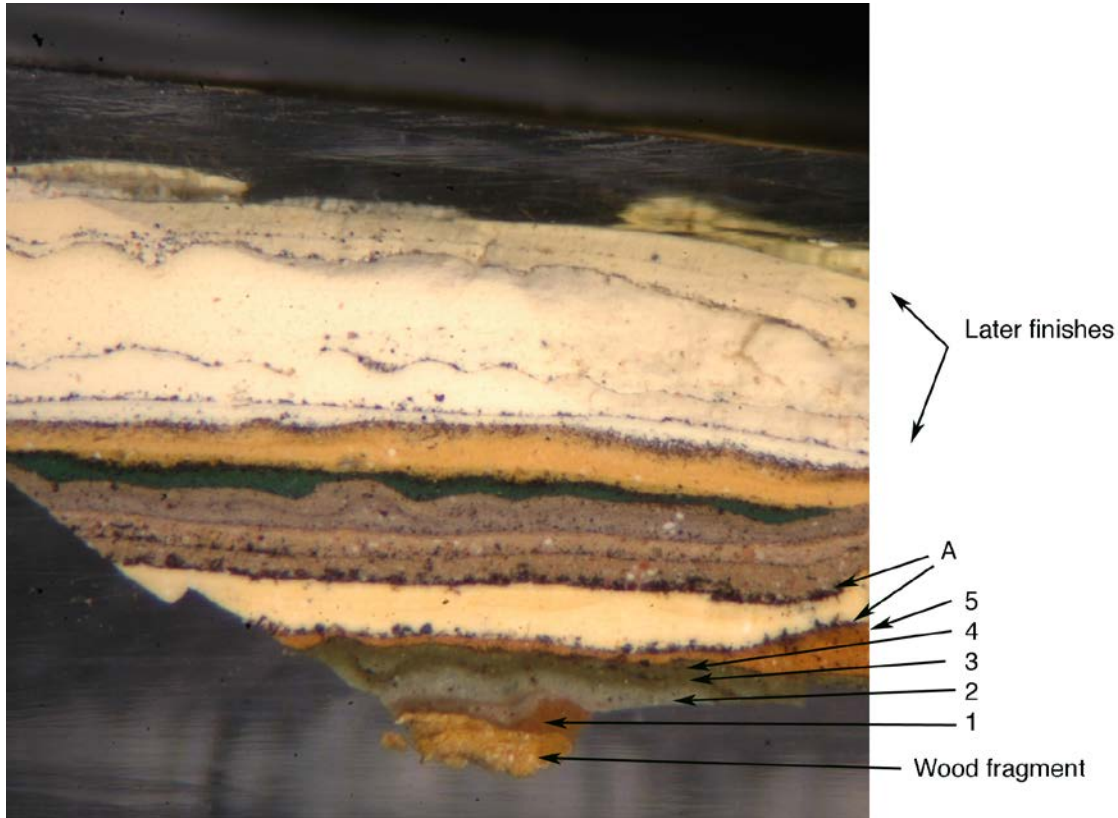
### Maryland Building: Bracket Pierced rosette, Chamfer (project North) Gable

Note: This sample has been mounted in polymer resin, cut and polished for additional examination. The wood substrate is clearly seen at the base of the sample, which supports a clear coating (sealer). The second layer is the bluish gray that was used as the finish elsewhere: here is an undercoat. There is the thin semi-opaque layer (3) followed by the first finish, the dark gray (4). This dark gray now appears as green due to the yellowing of the oil medium. The later deep yellow-brown ochres are also seen (5). Note the heavy surface particulate (A, fly ash and coal dust) that is seen on the surface of some of the finishes. Later finishes are also seen.

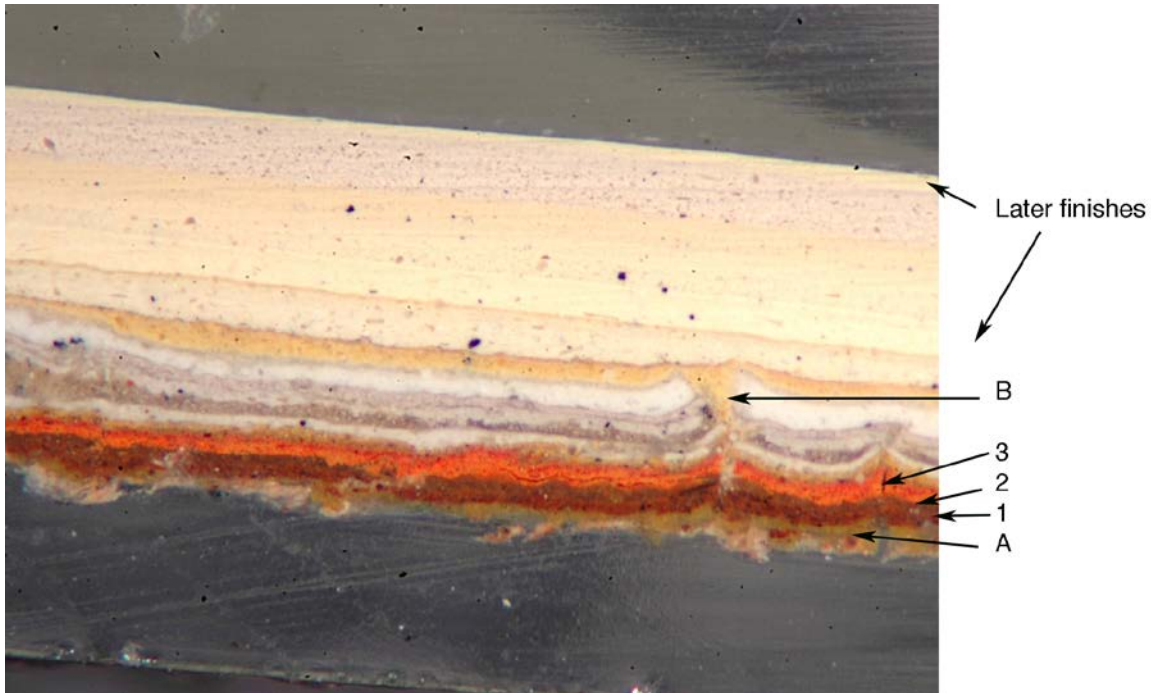
## Maryland Building: Window casing and cresting North Elevation

Note: This sample has been mounted in polymer resin, cut and polished for additional examination. The first layer is a n under-coating (A) made with yellow ochre. This is followed by the dark red ochre finish (1). The next layer is a brown ochre under-coating (2) for the vermilion red finish (3). Note the interesting cupping (B) that deforms the paint layers as they age in the extremes of heat and cold: note the flow of the later paint into the crack that is created. Later finishes are also seen.

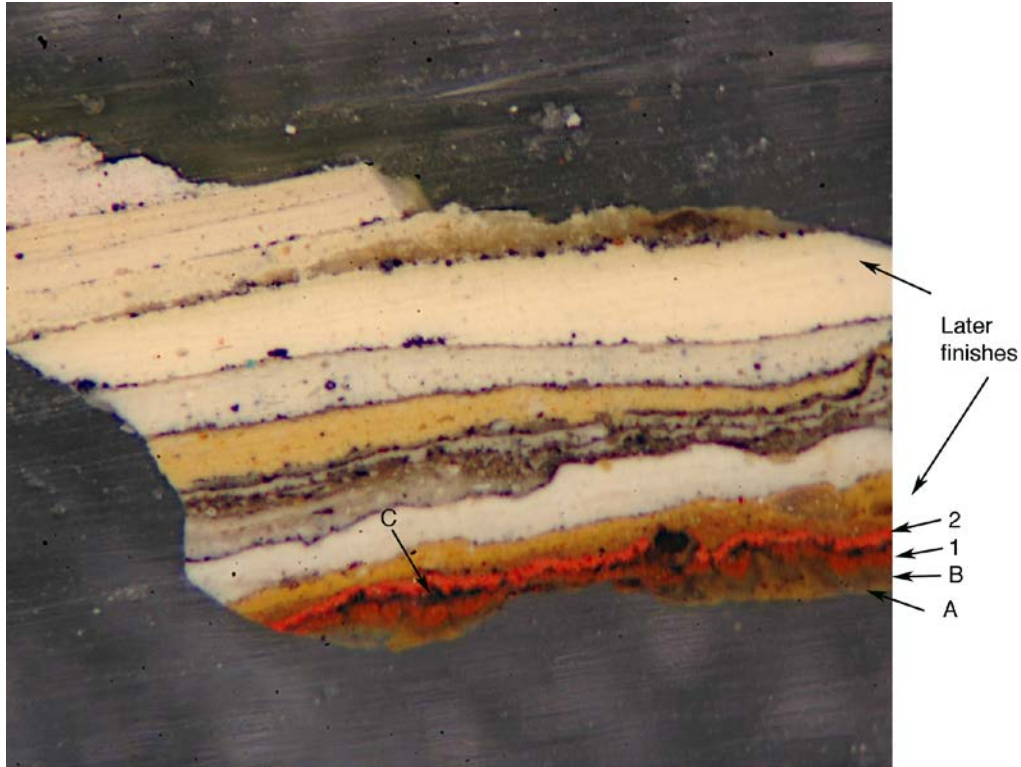
## Maryland Building: Façade, Center pavilion Flower form A

Note: This sample has been mounted in polymer resin, cut and polished for additional examination. The first two layers are under-coatings made with yellow and brown ochres (A, B). This is followed by the first vermilion finish (1) and the second vermilion finish (2). Later finishes are also clearly seen. There are very distinct surface particulate lines indicating the finish periods.

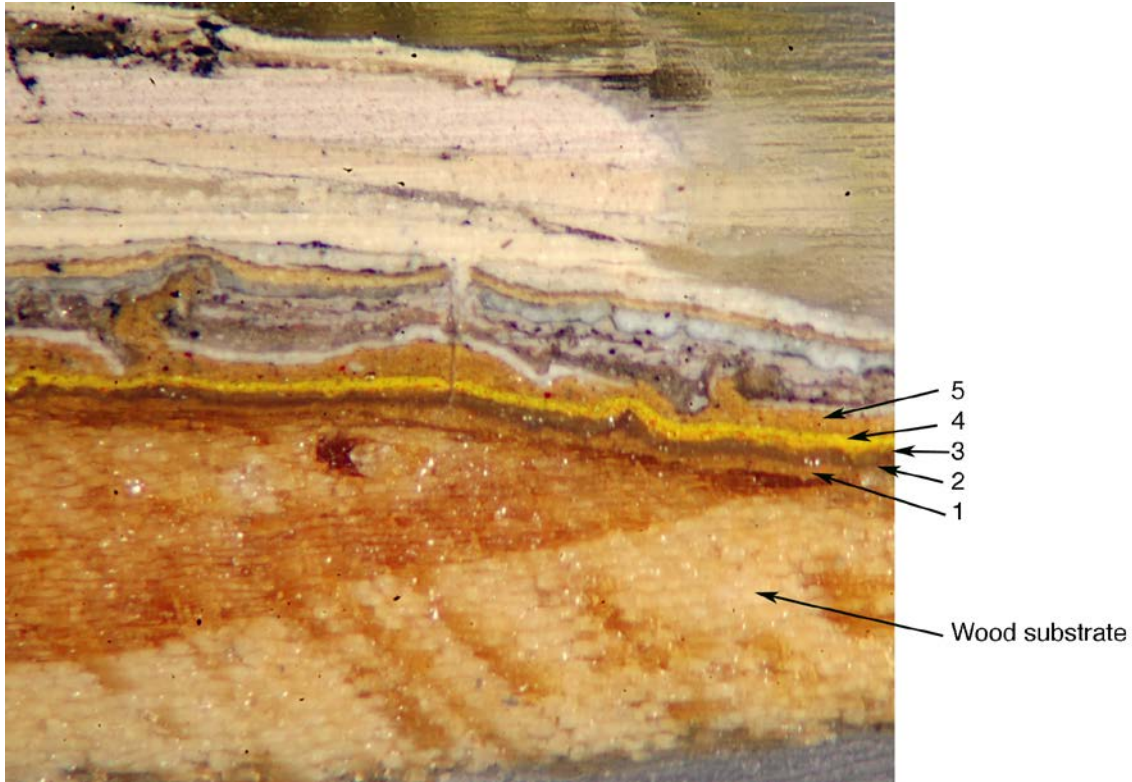
### Maryland Building: Façade, Center pavilion Flower form B

Note: This sample has been mounted in polymer resin cut and polished for additional examination. The wood substrate is clearly seen and is noted. This supports the bright yellow ochre initial finish (1) that has a coating of clear varnish (2); the clear varnish is very discolored and appears greenish. The chrome orange/yellow ochre undercoat layer (3) is seen next: this was applied to support the chrome yellow finish (4) that appears to have been applied when the Maryland Building was re-constructed in Druid Hill Park. A later yellow ochre finish (5) is also seen, as are later finishes.

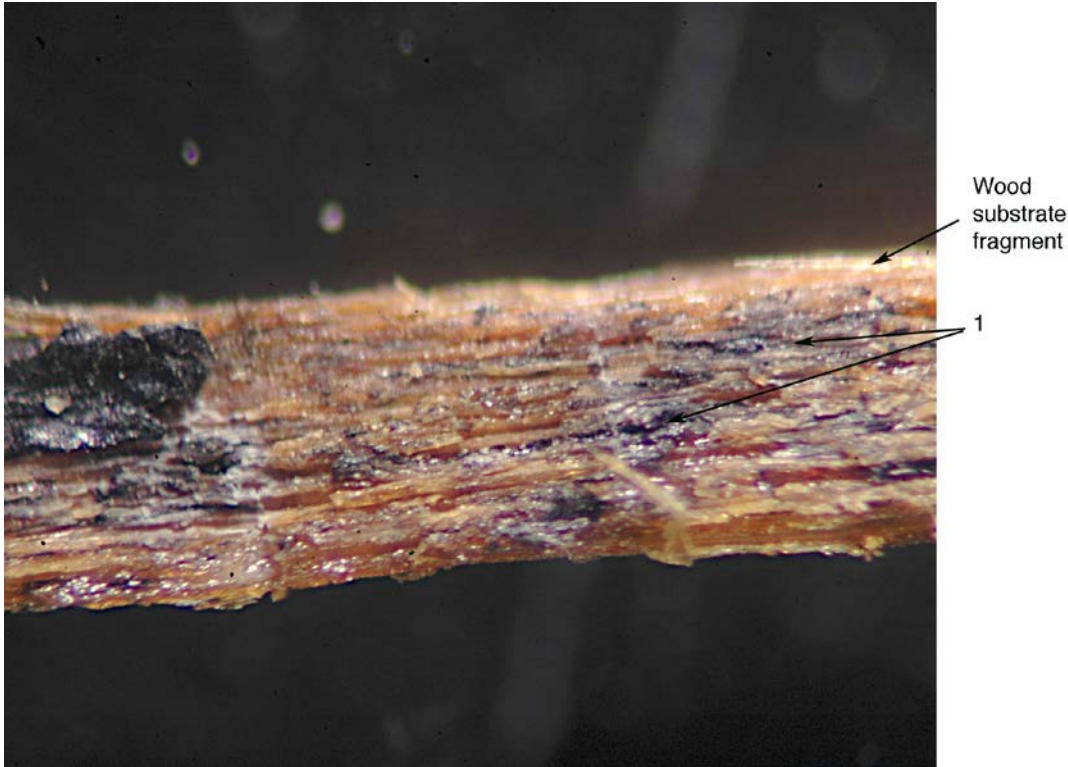
### **Maryland Building: Façade, Center pavilion “Maryland” sign, Background**

Note: The wood substrate is clearly seen on this fragment that was extracted from the sign background. The earliest remnants are of a black enamel (1) that is seen staining the wood fibers. This may be the first finish.

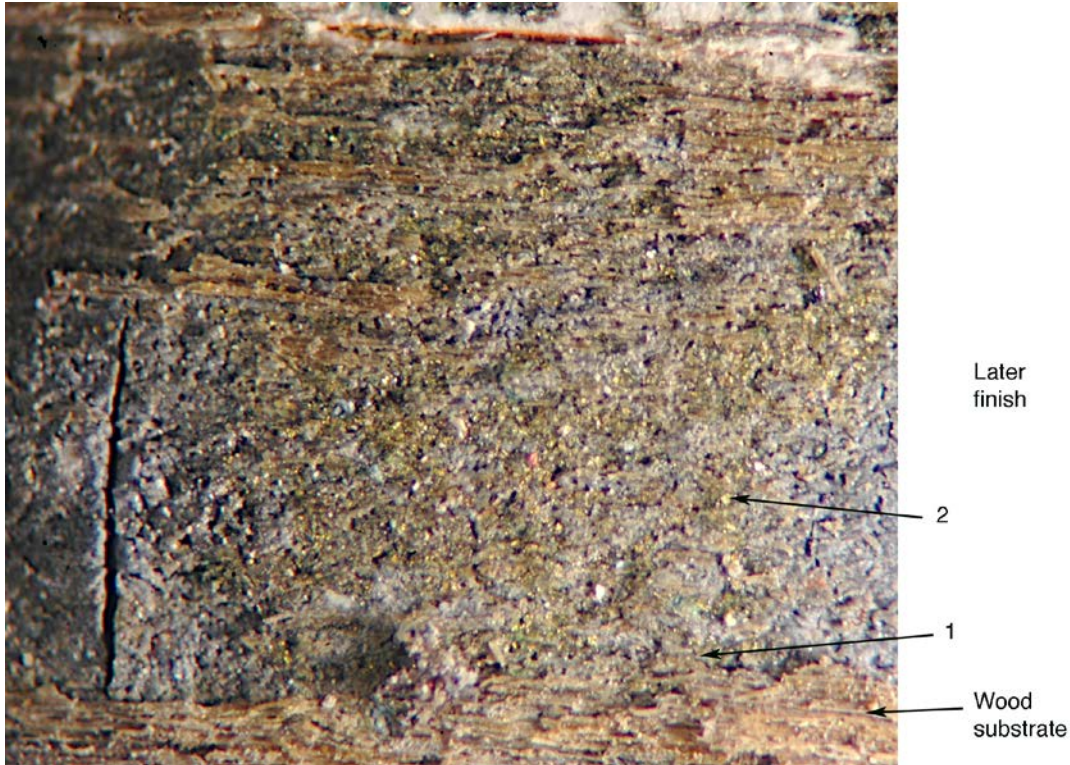
### Maryland Building: Façade, Center pavilion “Maryland” sign, Lettering

Note: The view of this sample is seen from the underside. The wood substrate is clearly seen; remnants of the earliest surviving finish (a light brown) are seen (1). The second finish may date to the re-building of the structure in Druid Hill Park (2): note that it is a gold metallic finish (2).

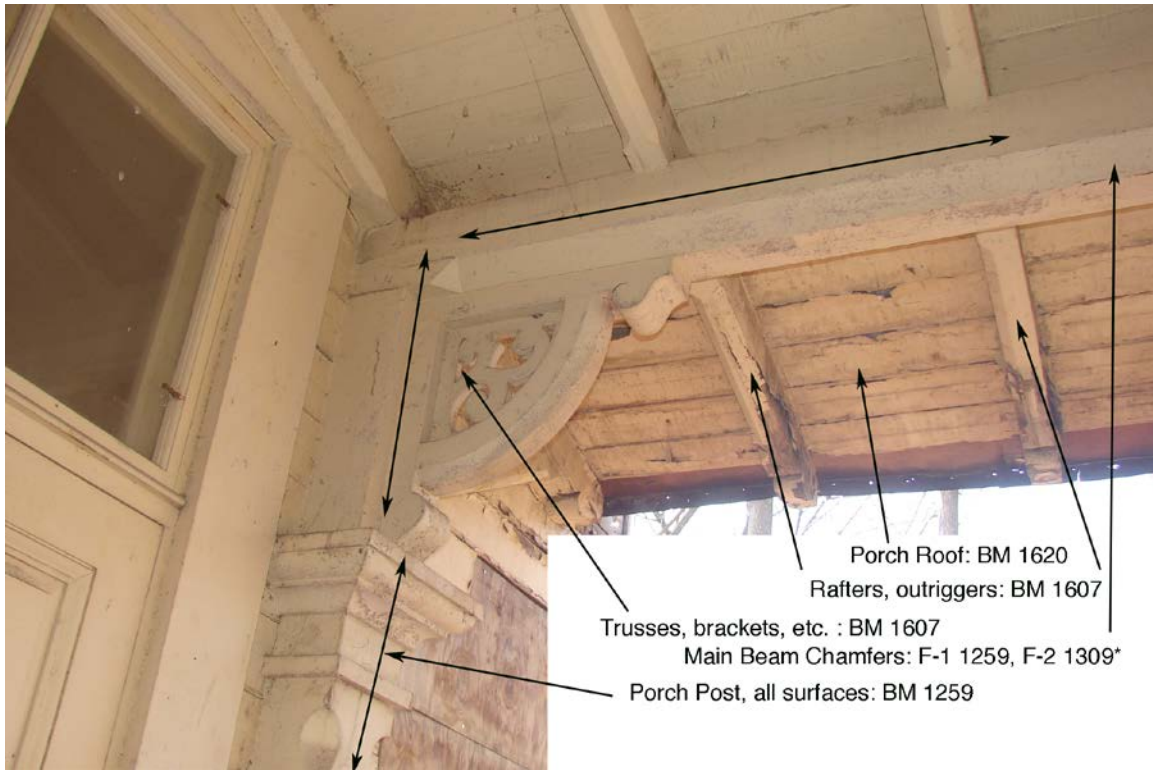
## Finish Schedule: Porch Construction

The porch posts appear to have been painted entirely with BM 1259. This was based on surviving remnants of paint, which has stained the wood.

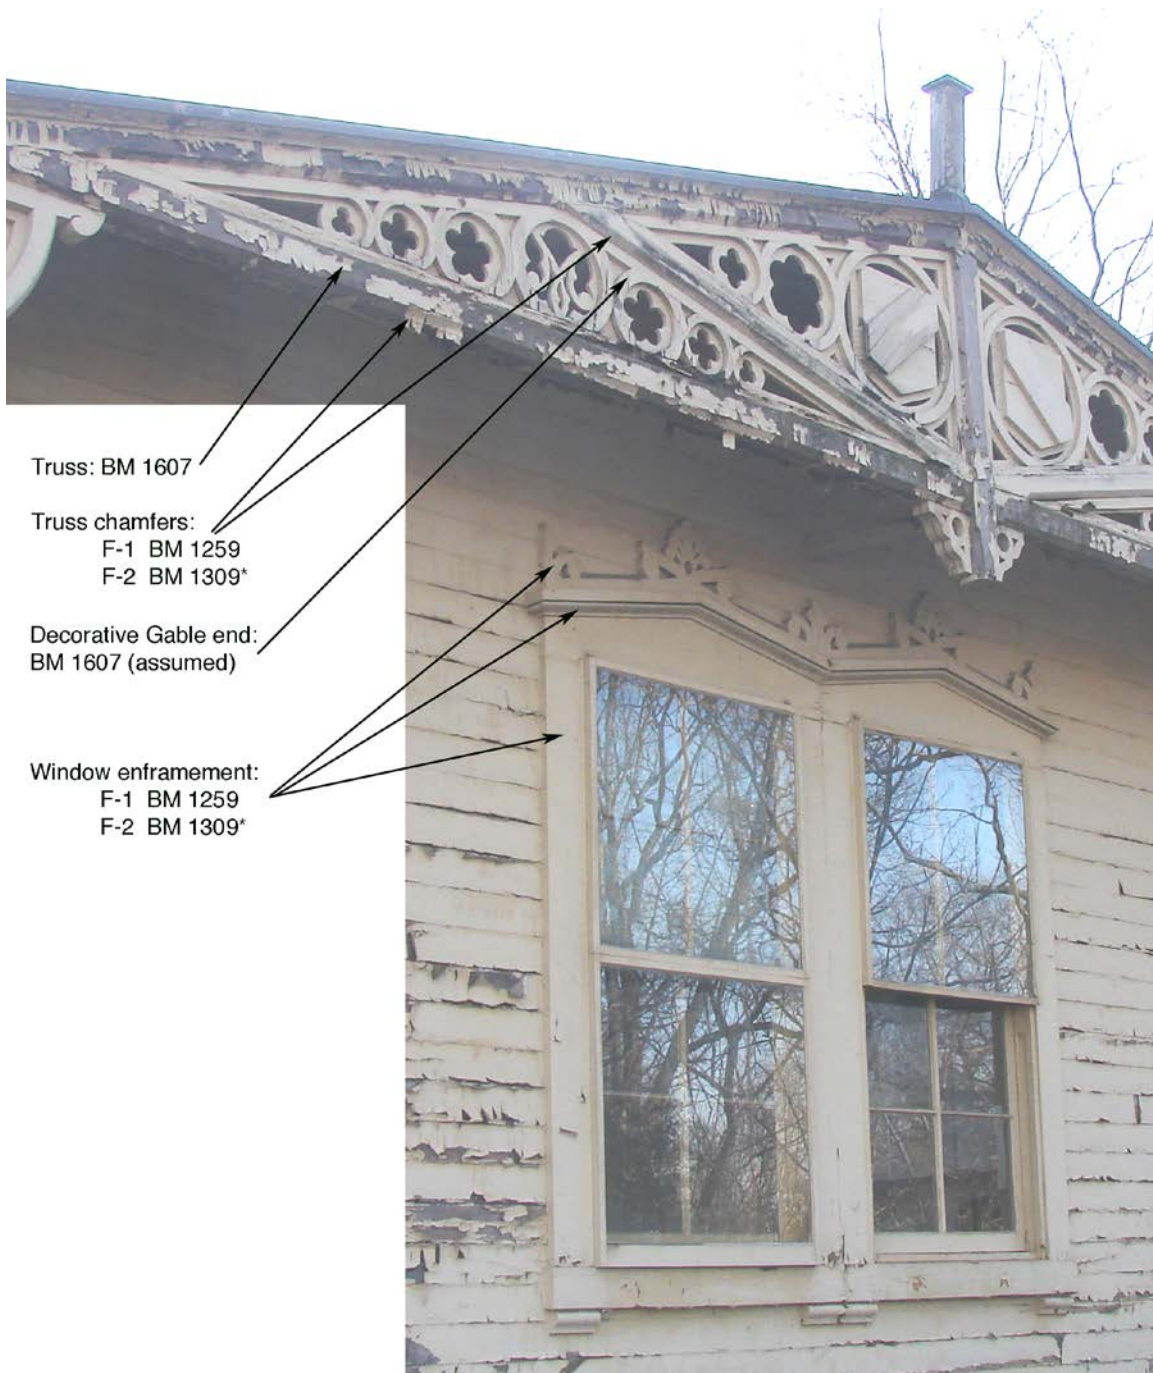
**Finish Schedule: North Wing, Gable End (typical)**

The physical evidence survived on the inside face for the trusses and the chamfers, as indicated. It is possible that the decorative inset elements (script “M”, the cinque-foil, quatre-foil and trefoil) were painted with the red-brown ochre color BM 1259. This would be a curatorial decision, as there were no surviving early elements to examine.

Additional: All window sash: Dark reddish brown: BM 1260
