## **HISTORIC STRUCTURES REPORT**

# **Old Faithful Lodge Yellowstone National Park**

**NOVEMBER 1995**

Prepared By:  
**JAMES R. MCDONALD ARCHITECTS**  
**224 North Higgins Avenue**  
**P.O. Box 8163**  
**Missoula, Montana 59807**

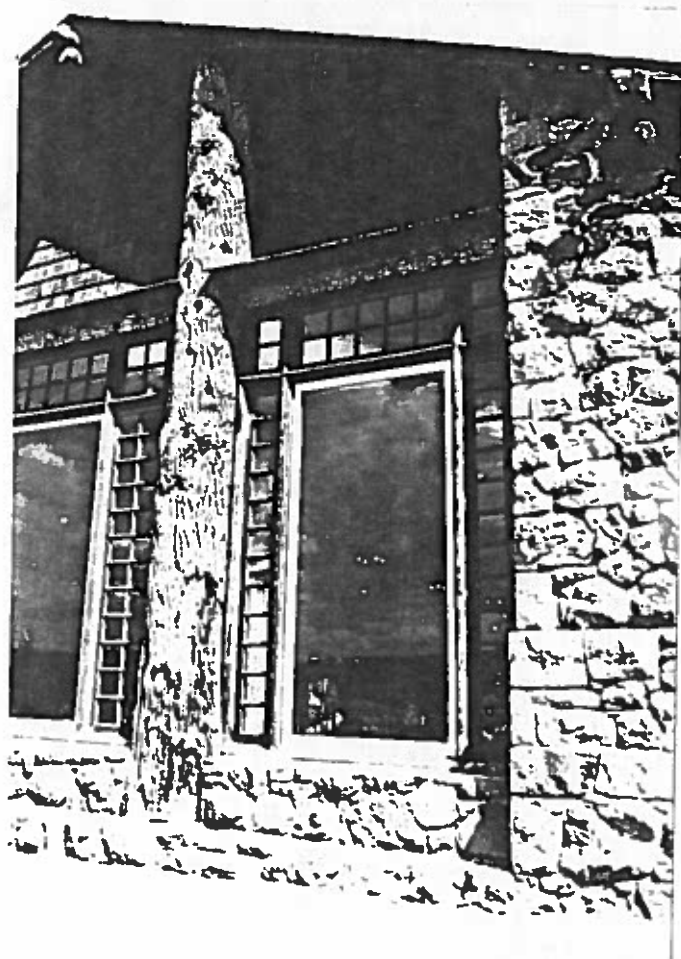
**Figure 37:** Looking east at the base of one of the columns on the front of the Lodge. Note the missing bark and rot in the tree trunk. The stonework has also opened up letting water into the interior structure.

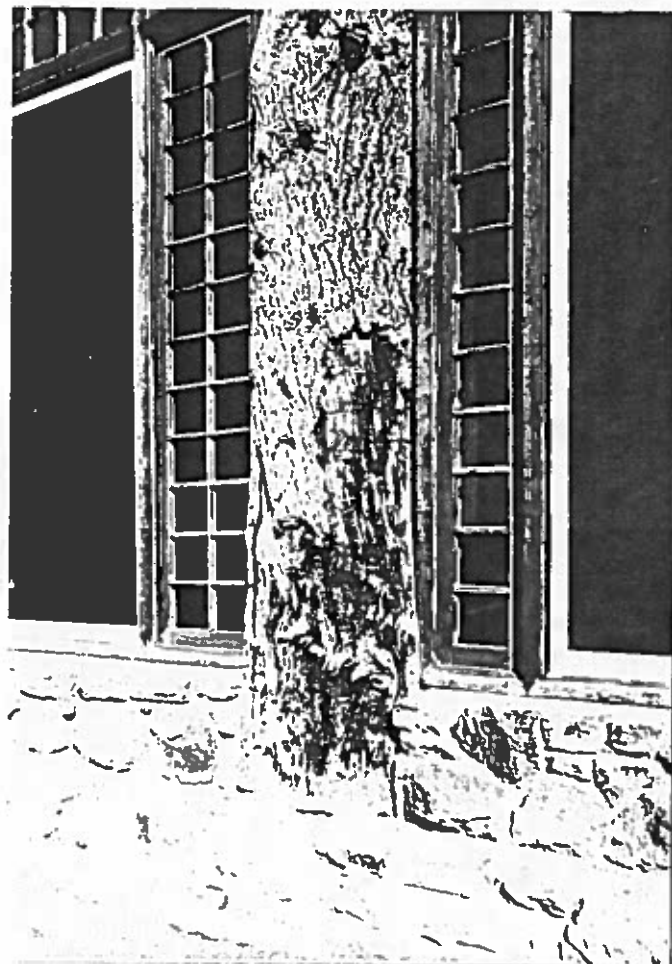
**Figure 38:** Looking southeast at the main windows in the Lodge. The stonework is in good condition with the exception of some minor missing mortar.

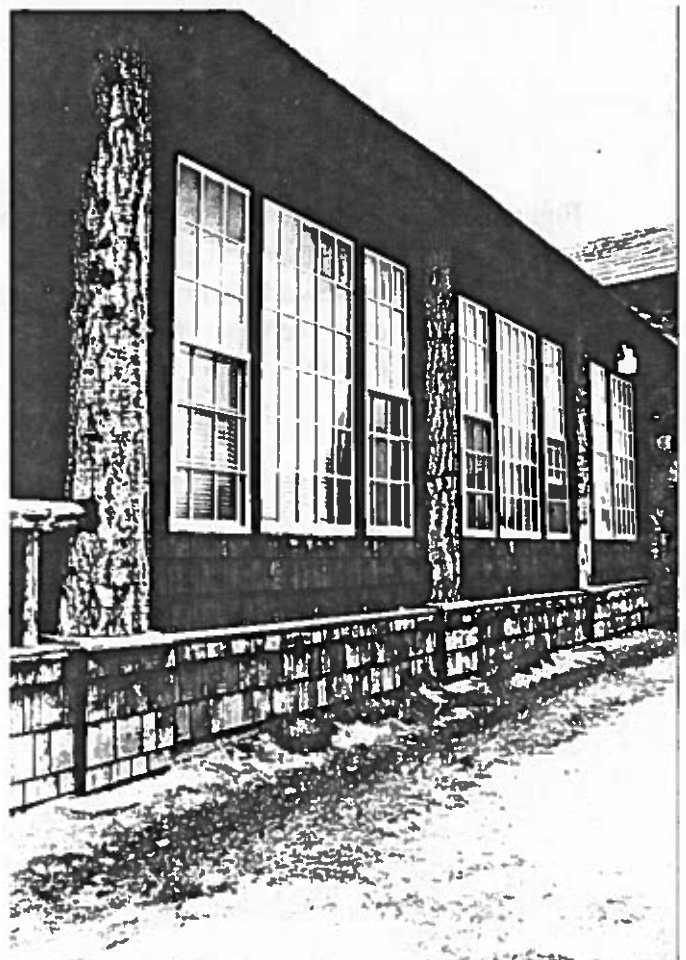
**Figure 41:** Looking east at a section of windows on the west side of the Lodge. The sills are weathered and there is some paint missing. Also, note that the base shingles are weathered and waterstained.

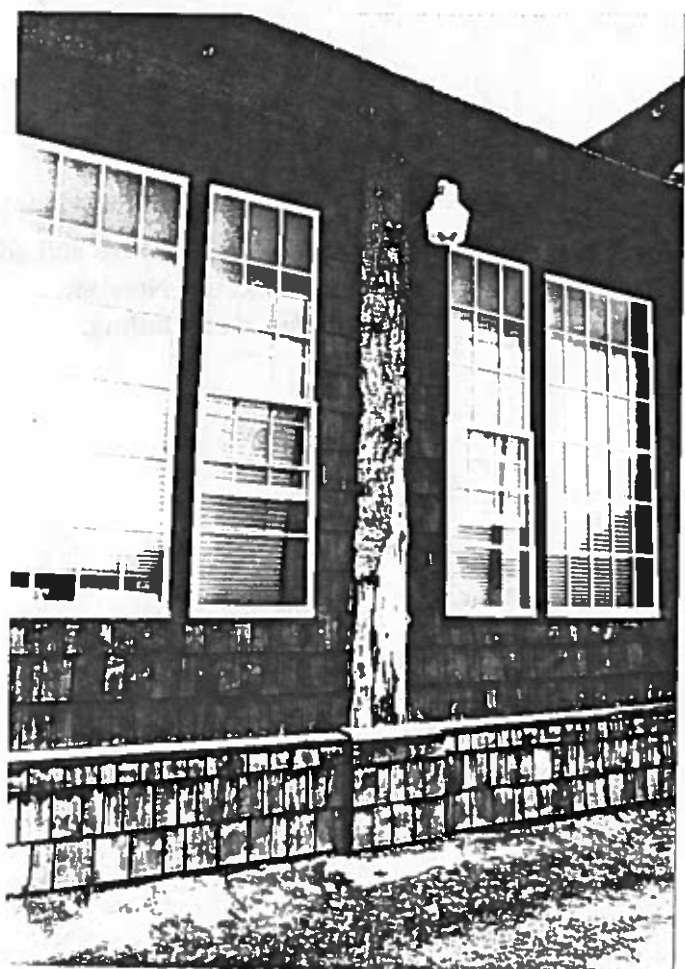
Figure 43: Looking northeast at the porch area on the west side of the Lodge. Note the weathered shingles at the base and the ditch that has been created close to the building because of roof water runoff.

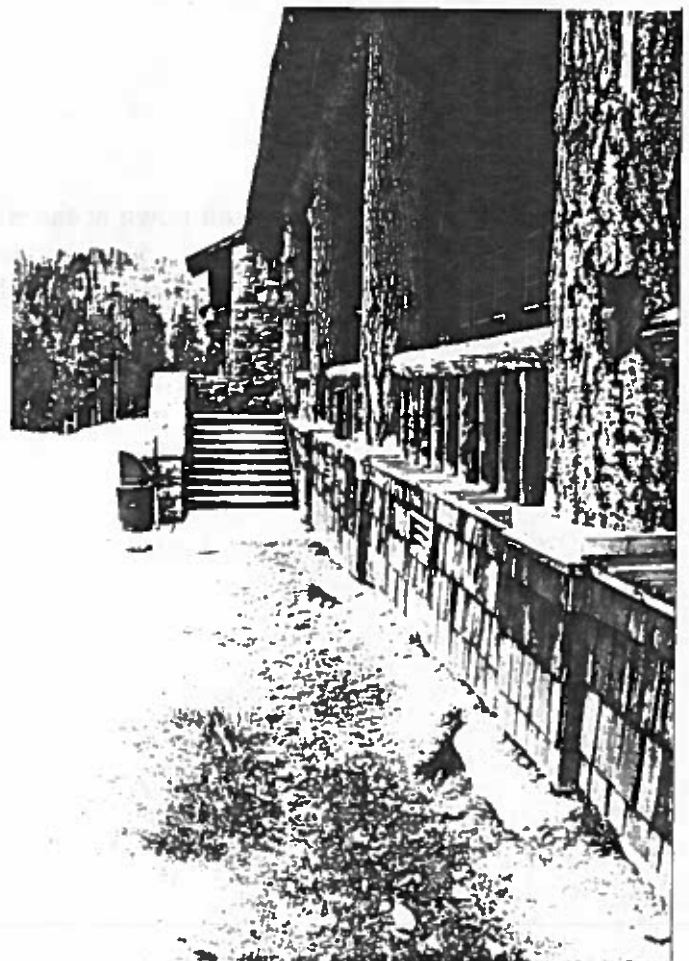
**Figure 47:** Looking north at the steps up to the porch on the west side of the Lodge. The steps are in good condition.

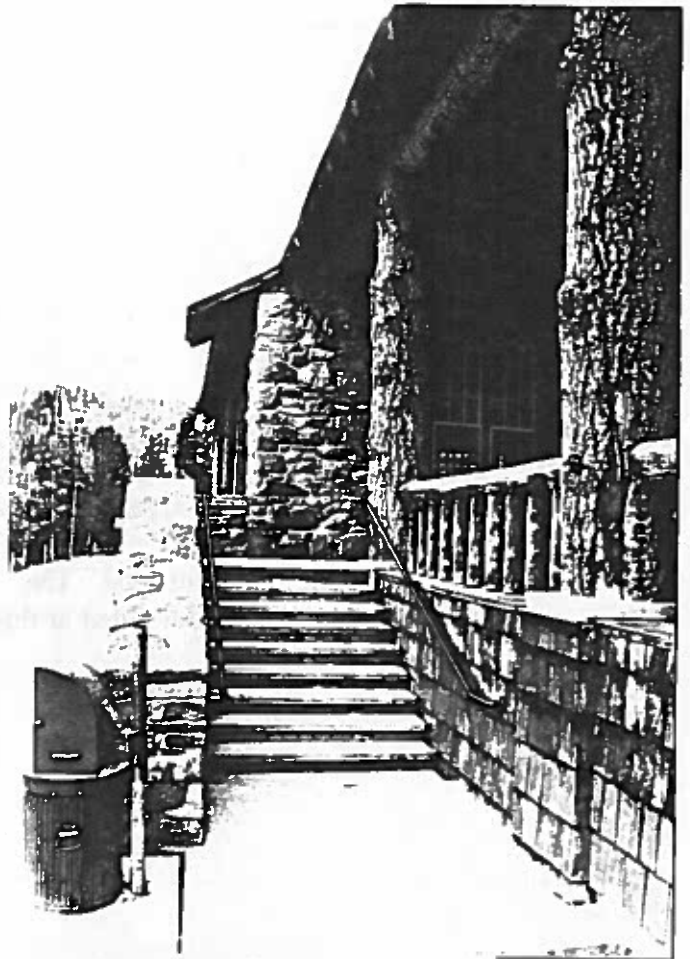
**Figure 48:** Looking south down at the steps to porch. The open deck area is starting to cup, weather and the joints are opening up.

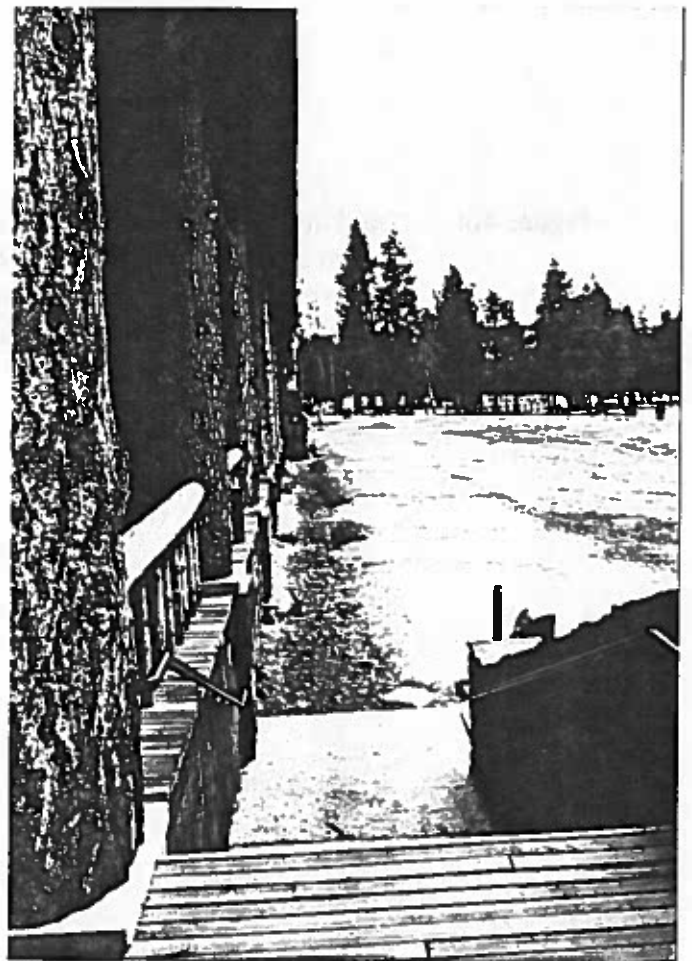
Figure 49: Looking southeast at the porch on the west side of the Lodge. Note the weathered and dry wood. The wood deck is in better condition at this point because of the covered roof area.

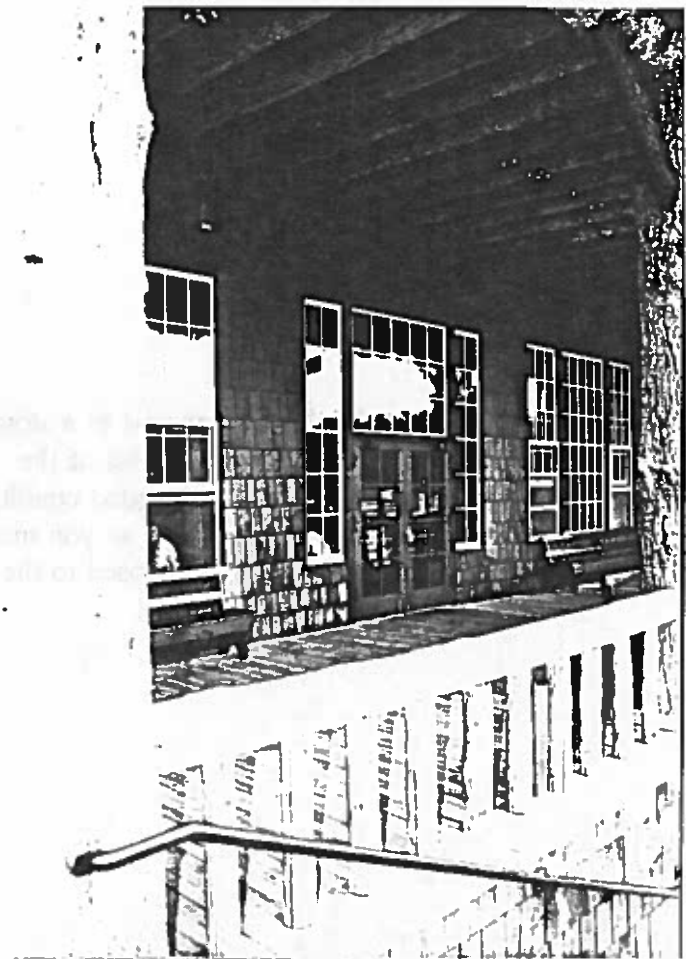
Figure 50: Looking north at the covered porch on the west side of the Lodge. The materials are in good condition in this area.

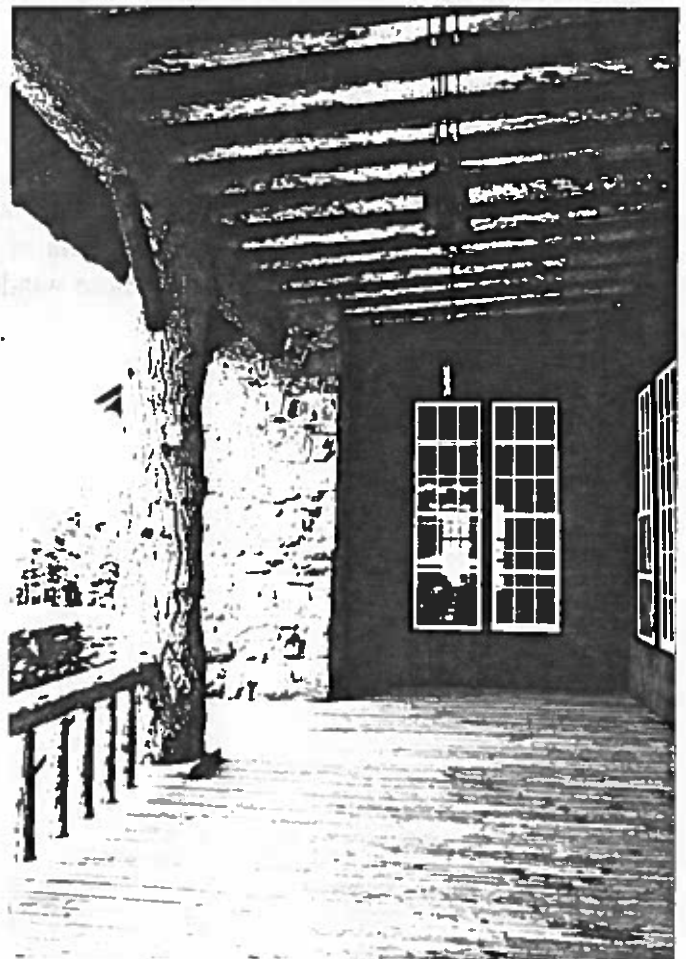
Figure 51: Looking northwest at a stone corner on the porch. Most of the stonework is in good condition with some open joints as you move out into the area exposed to the weather.

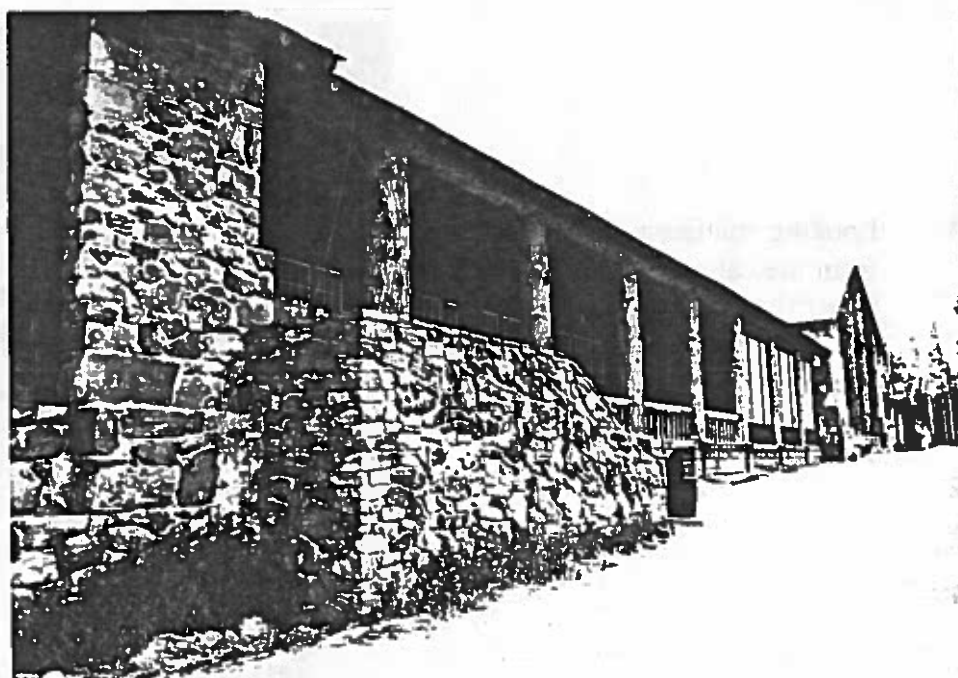
Figure 56: Looking southeast at the stone wall and stonework along the west wall of the Lodge. Note some missing mortar and various mortar patches not compatible with the original stonework.

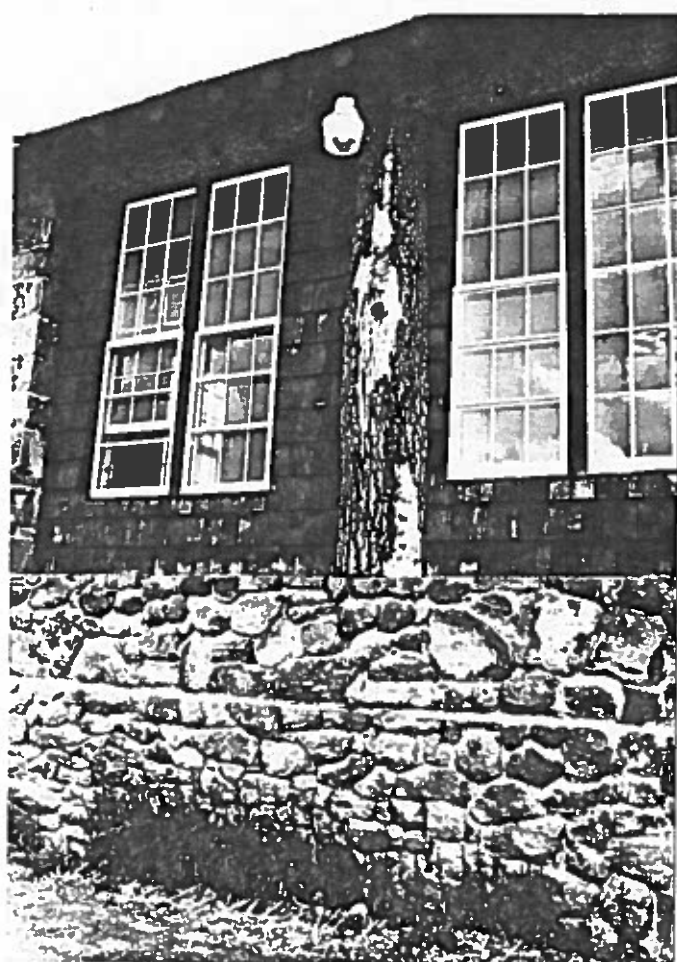
Figure 58: Looking east at the log column and the stone base. The windows have some weathered sills and sash, and some peeling paint.

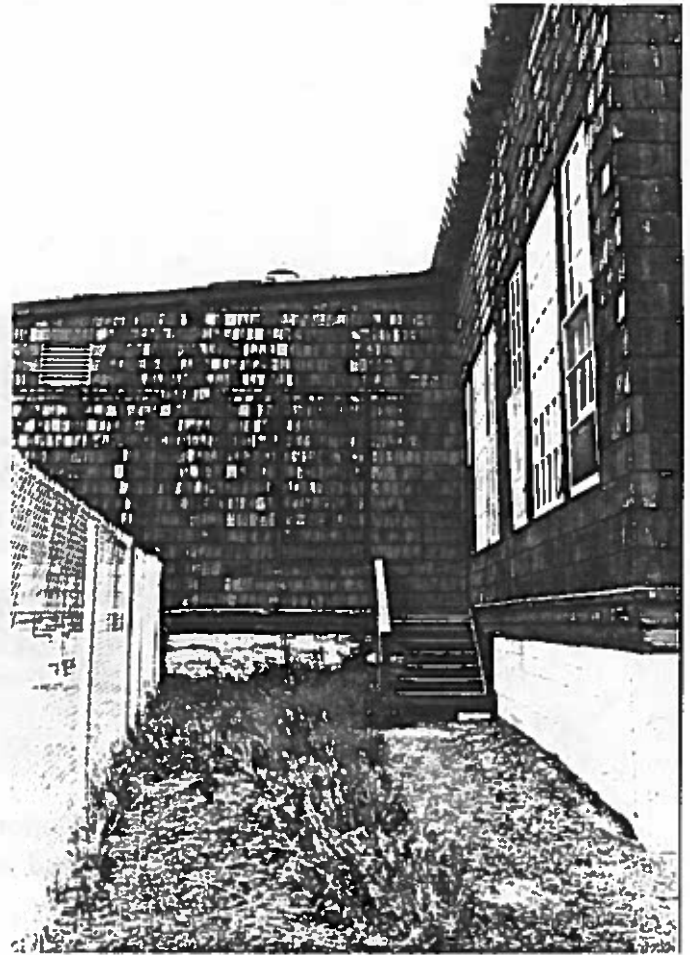
**Figure 66:** Looking southwest at a bank of windows and an exit door on the east side of the cafeteria. Note the stained and weathered wood wall shingles and water table. The windows have some peeling paint and weathered wood.

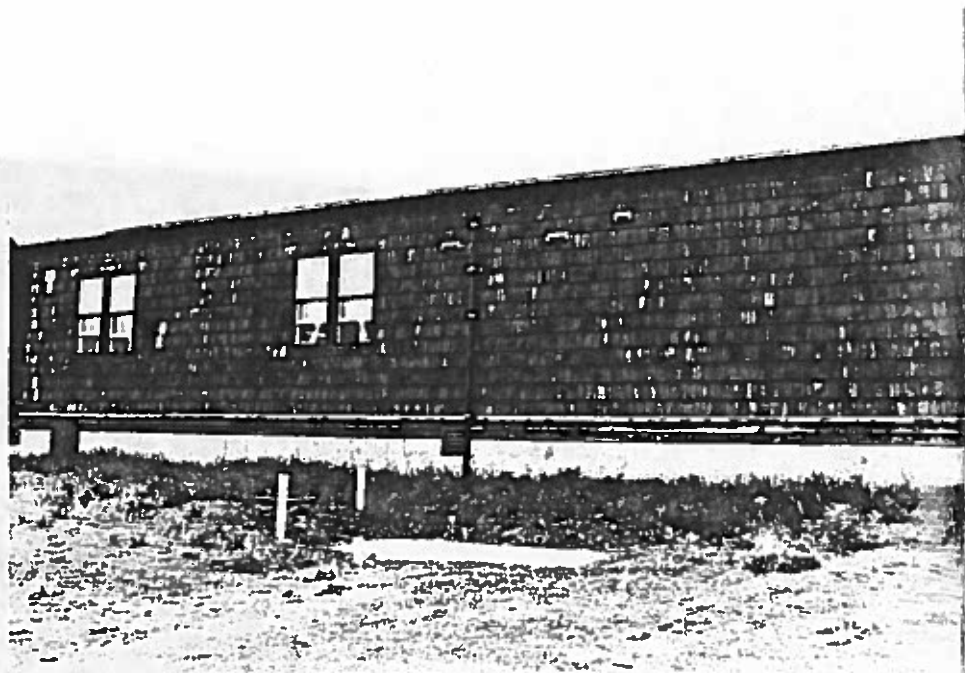
Figure 67: Looking south at the exterior wall of the kitchen and the employee ~~dining~~ room. Note the weathered wood shingles and the water table. The ~~windows~~ are also weathered.

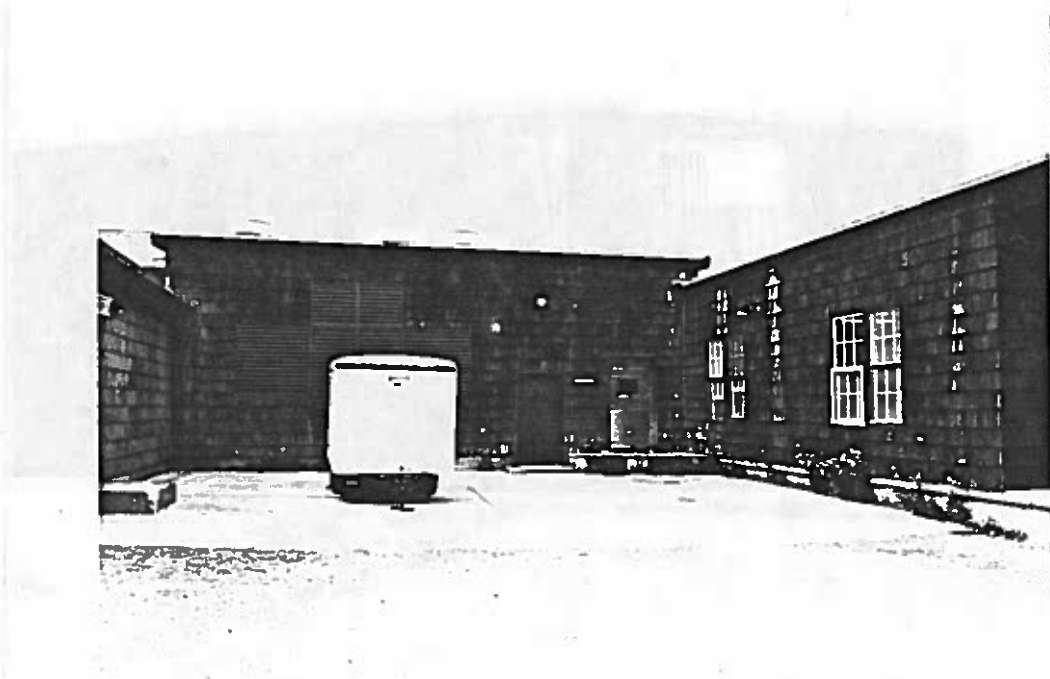
Figure 71: Looking at the infilled sections of original and added buildings tied together by the wood wall shingles. Note the weathering and staining of the wall material.

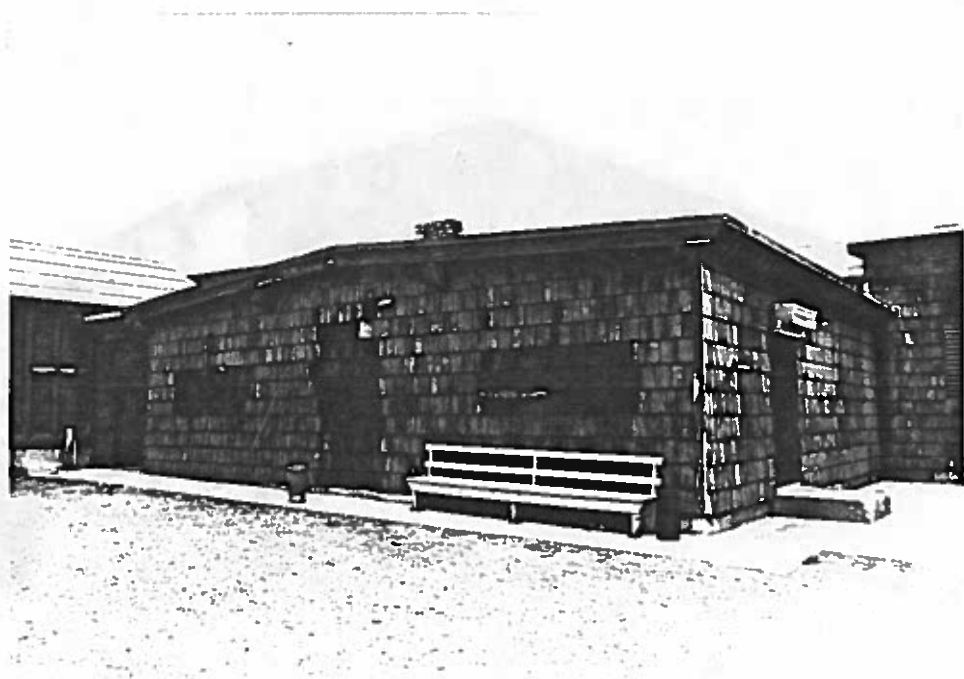
Figure 72: Looking west at another infill building with infilled windows. Note the different stains.

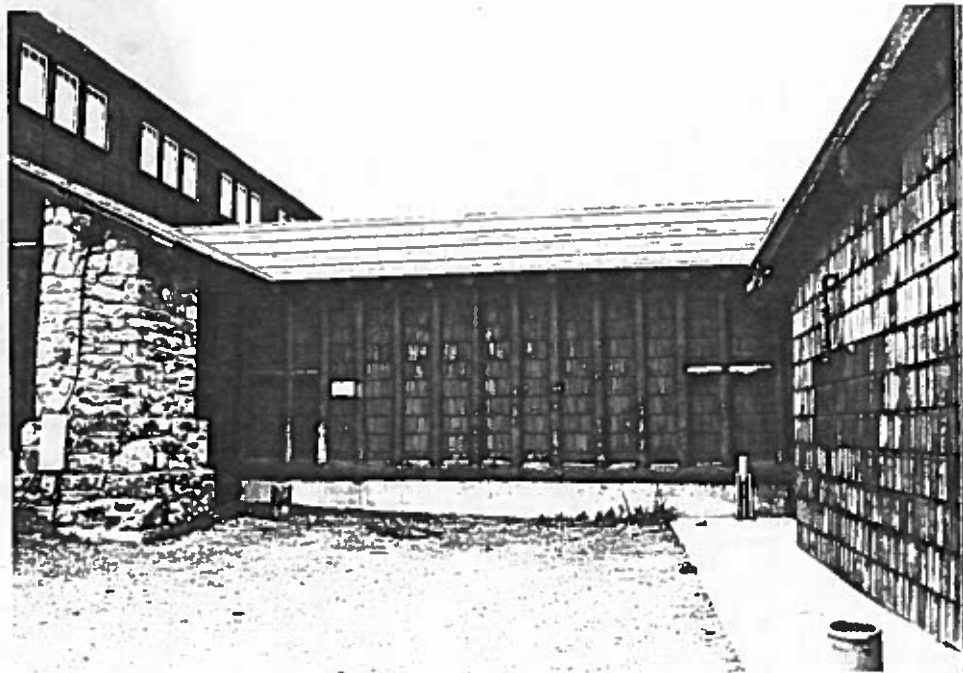
Figure 73: Looking south at a log-out structure which connects the kitchen storage area with the Rec Hall. The roof appears in good condition. The walls have some loss of stain.

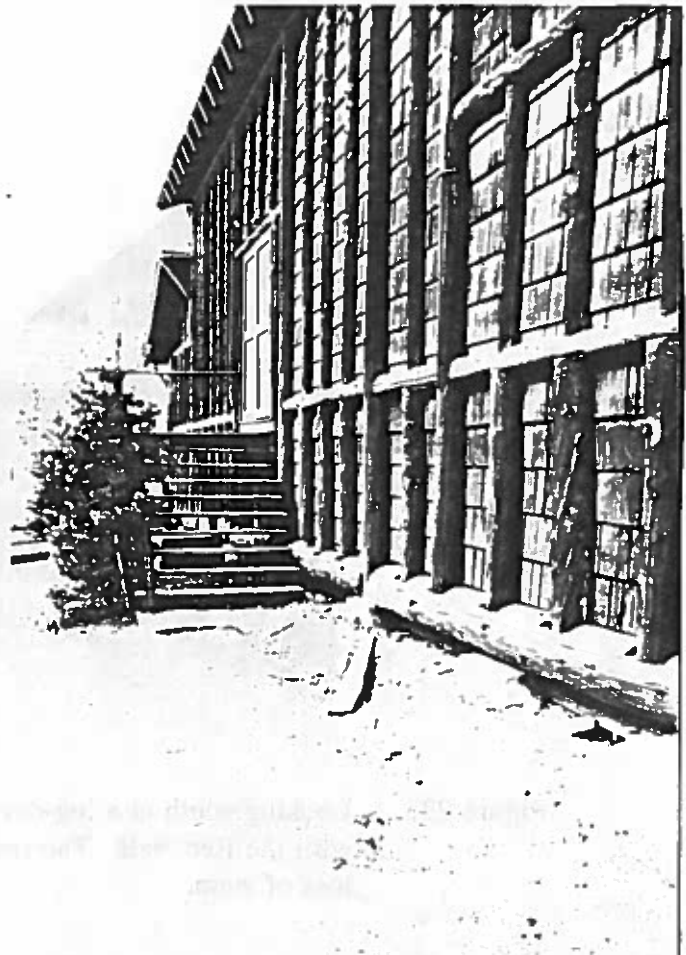
**Figure 76:** Looking south at the stage doors and platform. Note the tipped concrete piers and bent metal pipe rail.

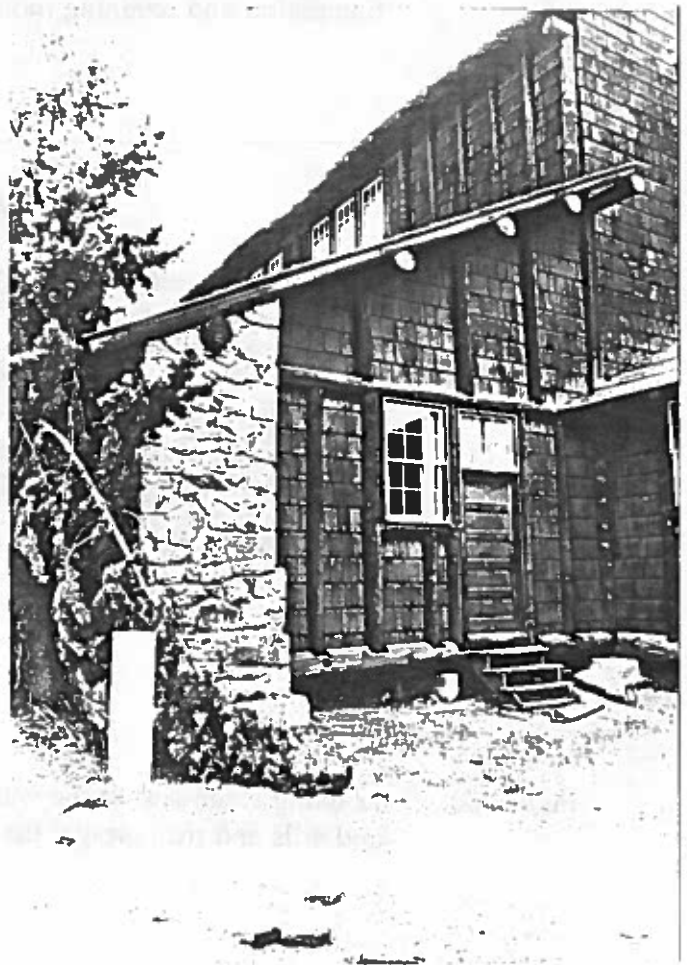
Figure 78: Looking south at the side aisle roof and walls of the Rec Hall. Generally the wood is in good condition with some weathering of the wood materials.

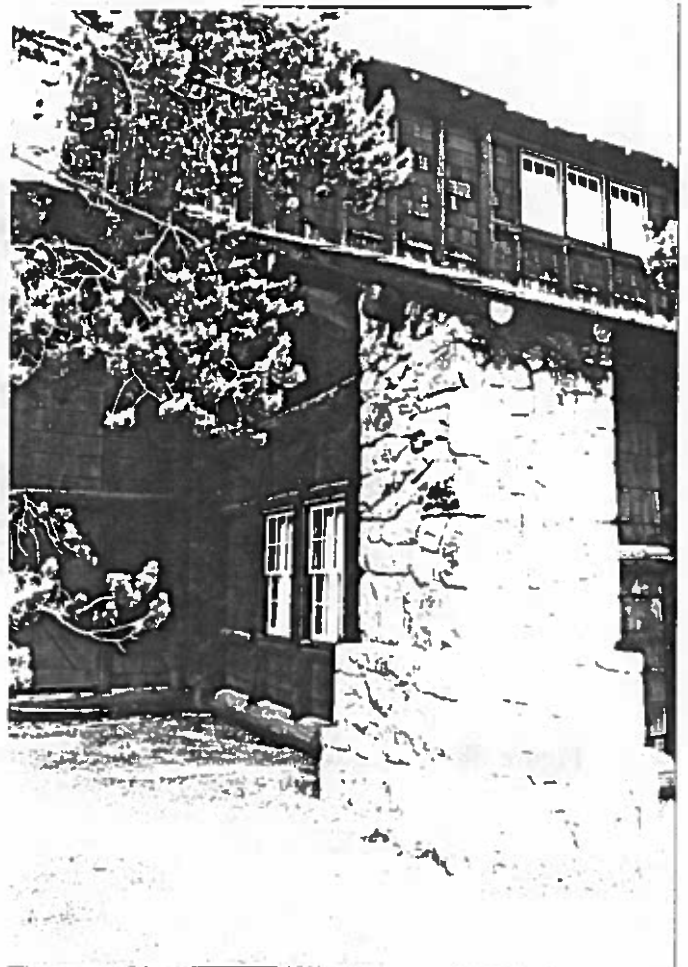
**Figure 86:** Looking northwest at a stone corner on the Rec Hall. There are some minor missing mortar.

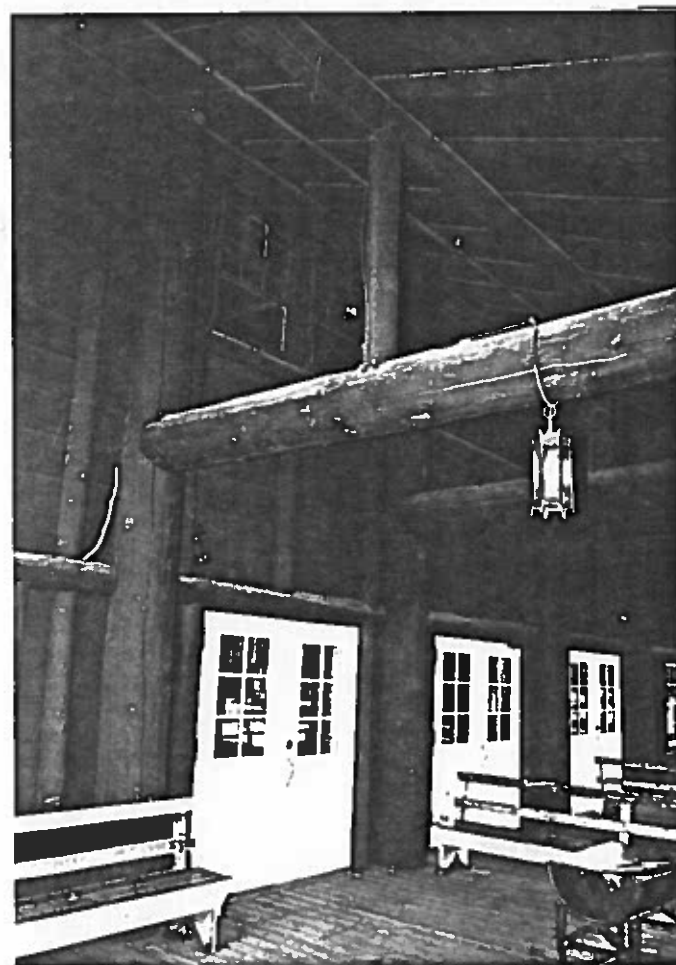
**Figure 91:** Looking west at the south porch and log structure. Note the original light fixtures. Snow and water setting on the floor surface has cupped and weathered the wood.

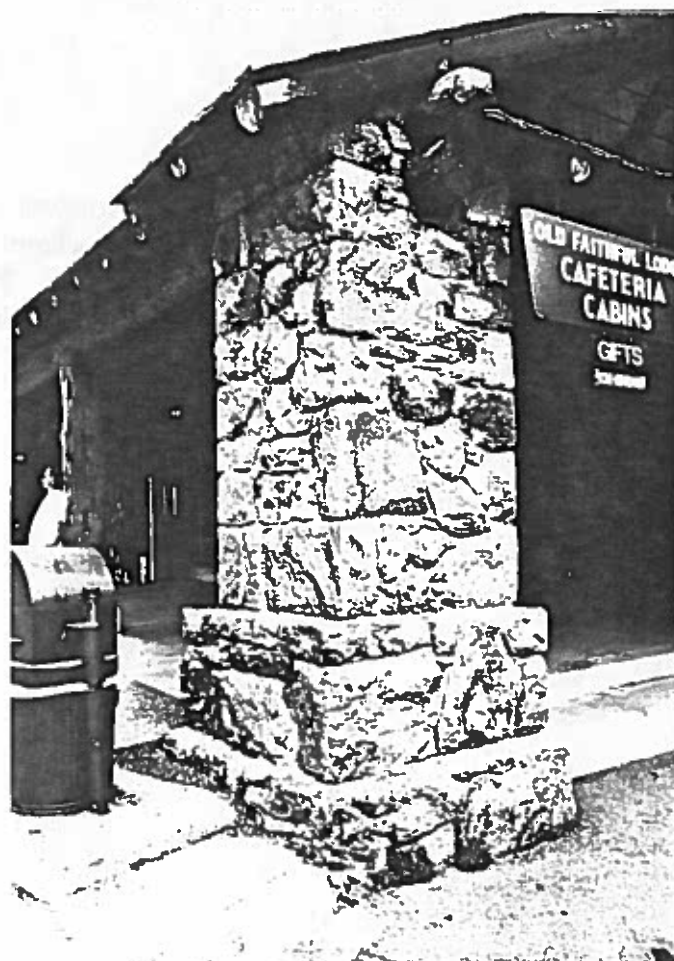
**Figure 109:** Looking northeast at the covered walkway on the west side of the building. Note the weathered and rotted areas on the base of the columns.

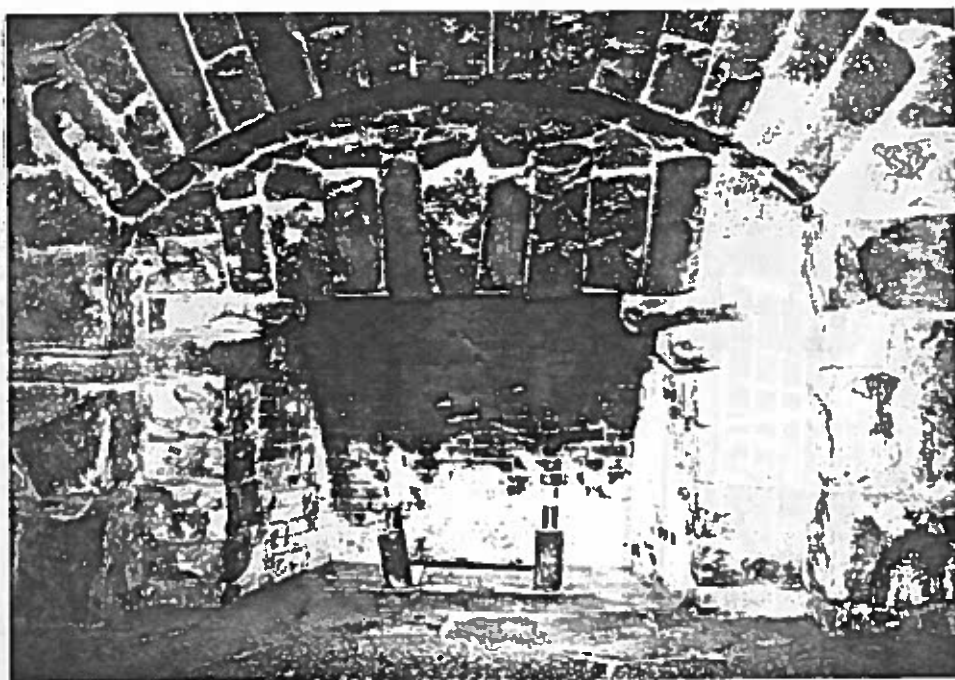
Figure 122: Looking east at the hearth of the fireplace. Note the soot on the face of the stone.

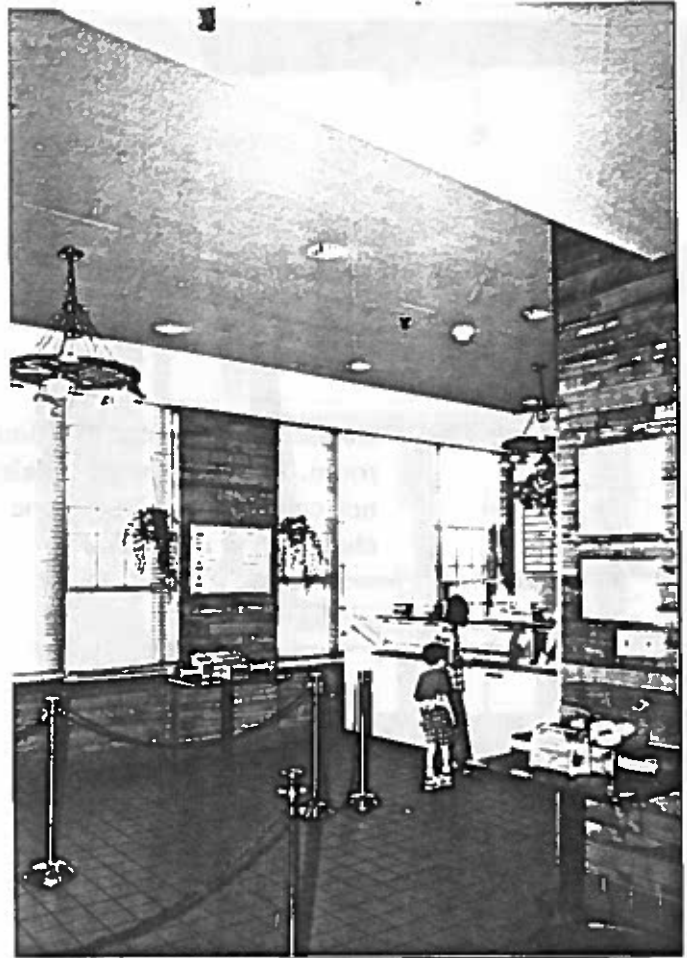
**Figure 138:** Looking north at the interior of the dining room. The ceiling covers up the original log truss system that gave some rustic qualities to the Lodge.

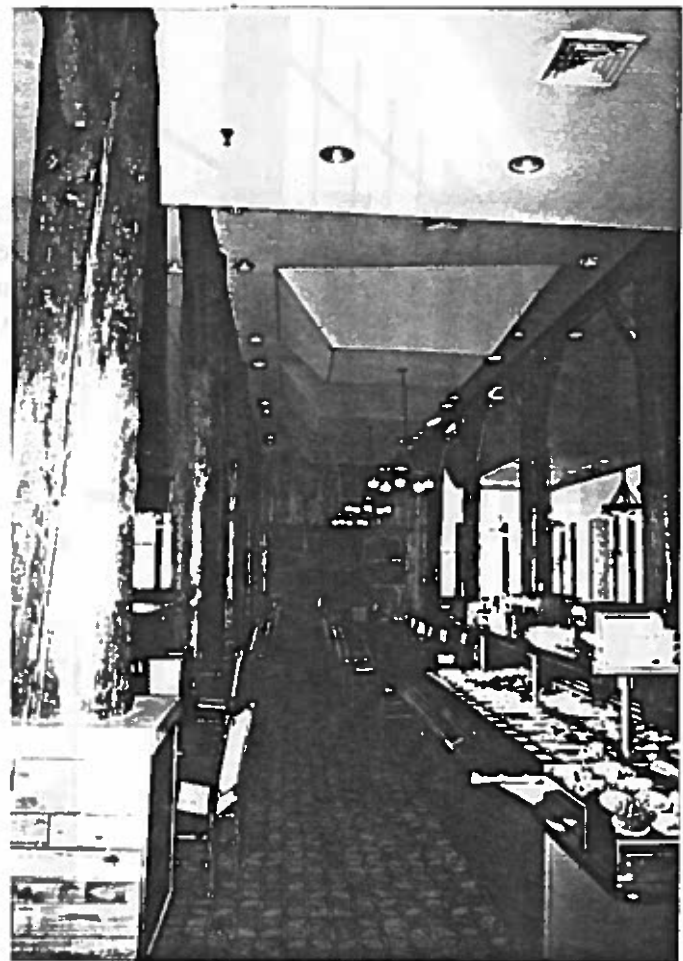
Figure 143: Looking northwest at the fireplace at the north end of the dining room. The mortar joints have been repointed with a wide lime mortar. The wood around and above the fireplace has been wet is cupped and rotted.

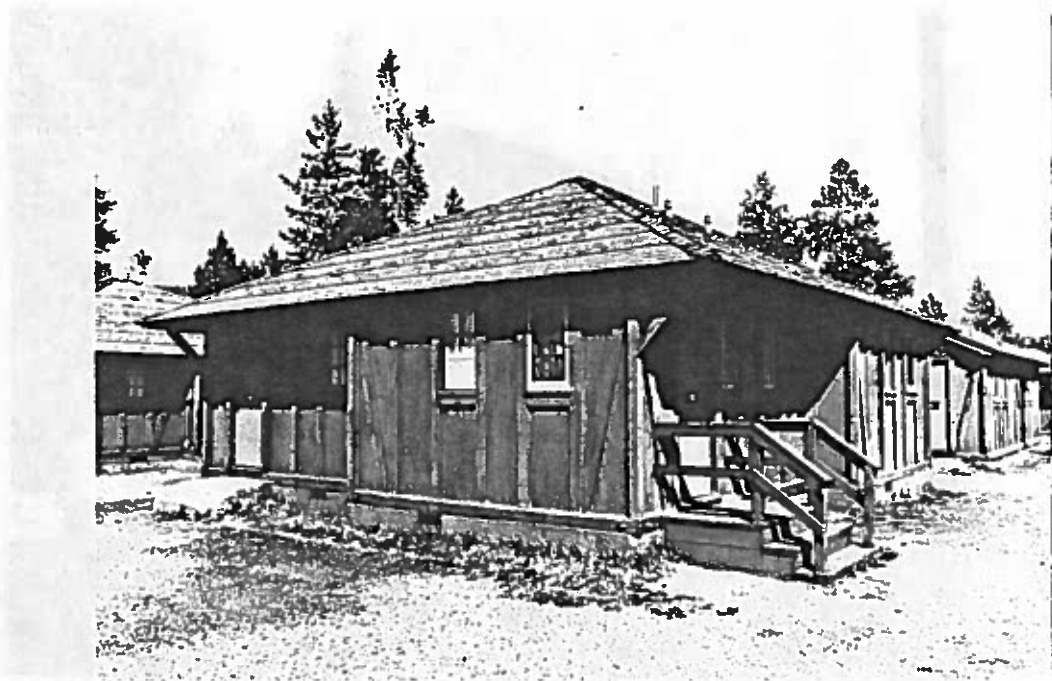
Figure 168: Looking northeast at a typical frame-out quad cabin (#110-113). Note the deteriorated concrete stoop which occurs on over thirty cabins in the area. The sill plate is weathered and is showing some rot in a few areas.

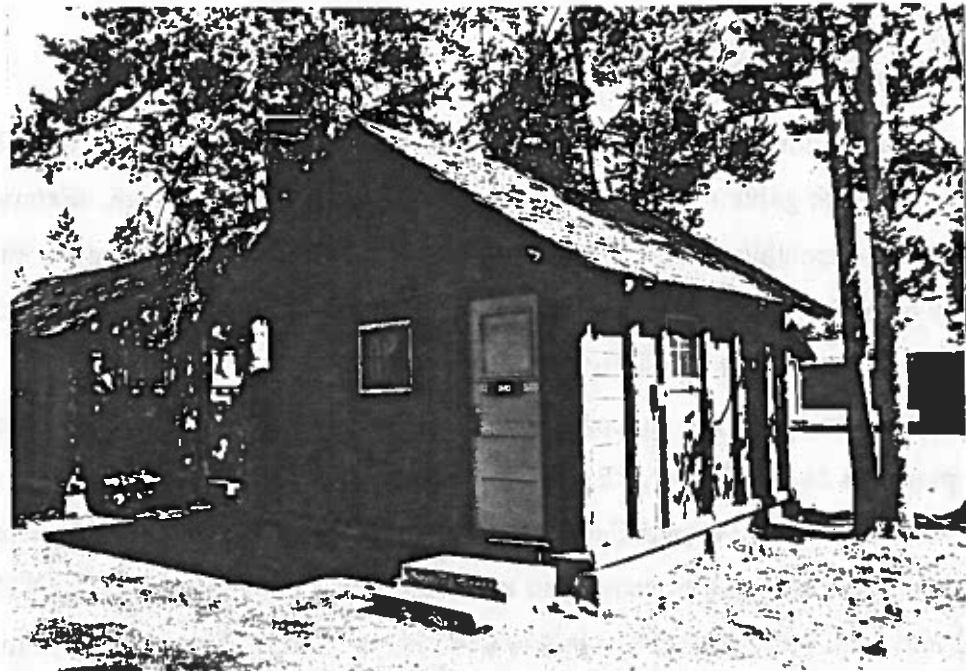
Figure 178: Looking southeast at a typical log-out single cabin (#240). Note the deteriorating wood shingle roof and the poor concrete stoop. The sill log has some rot.

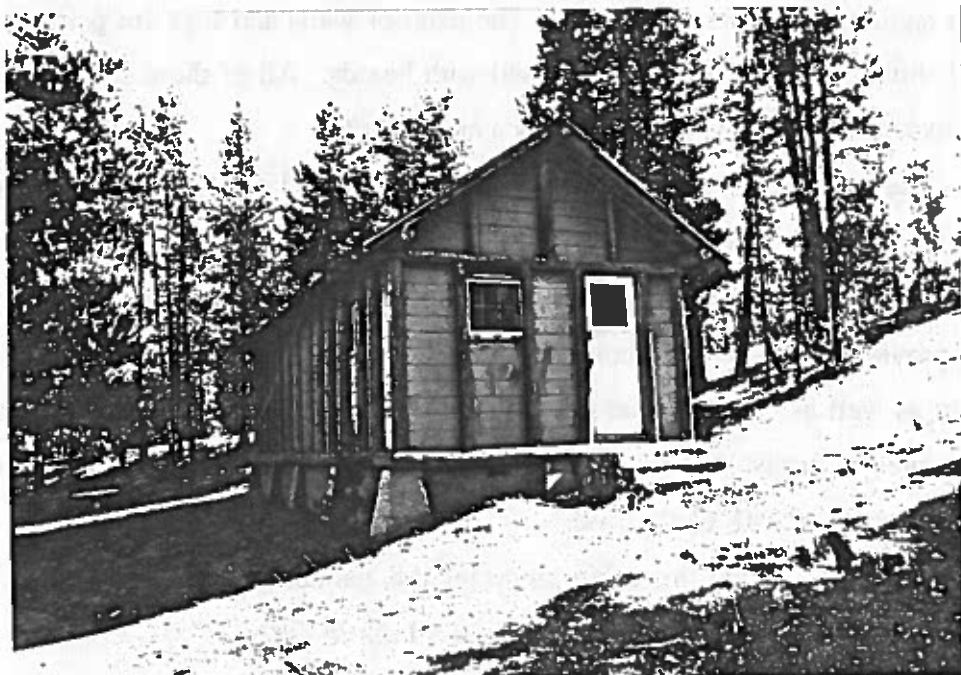
Figure 179: Looking south at a typical log-out duplex cabin (#230-231). Note the different painted boards. The roof is deteriorating and the concrete steps are in poor condition.

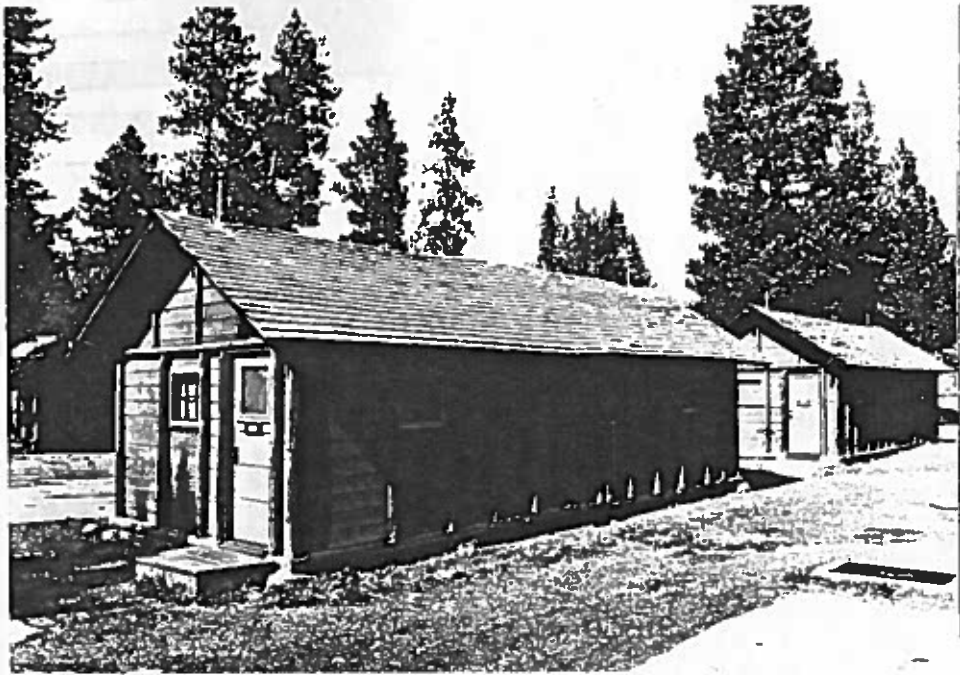
**Figure 180:** Looking northeast at a typical log-out duplex cabin (#236-237). This cabin is in good condition with the exception of some sill log rot and some rot in the wood stoop.

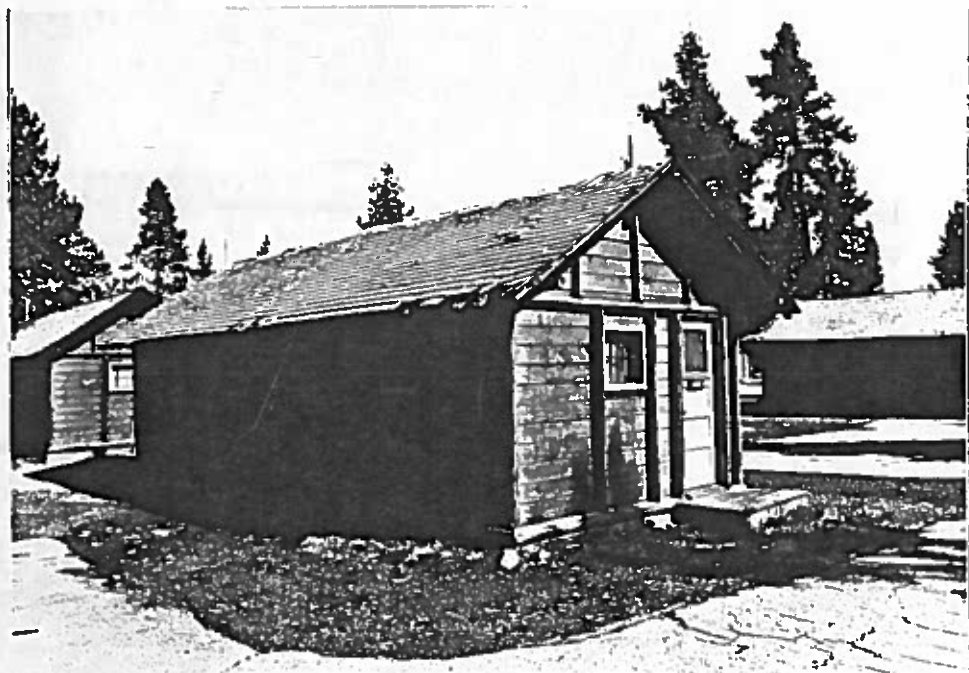
**Figure 181:** Looking southeast at a typical log-out duplex cabin (#238-239). Note the broken roof shingles and deteriorated ridge board.

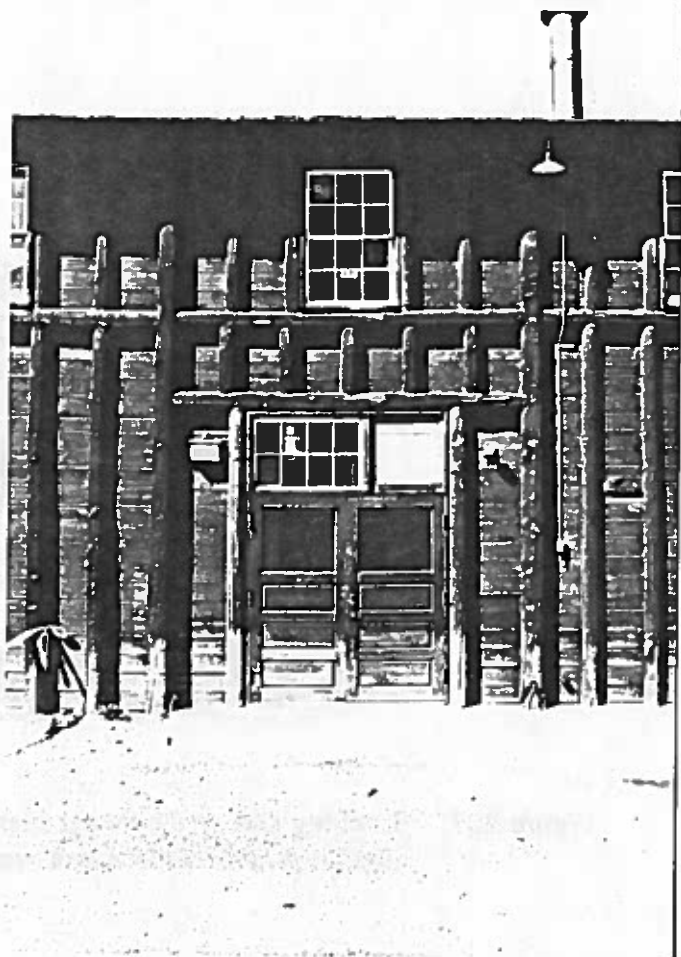
Figure 206: Looking northeast at the Boiler Plant building. The wall logs other than the bases appear to be in good condition.

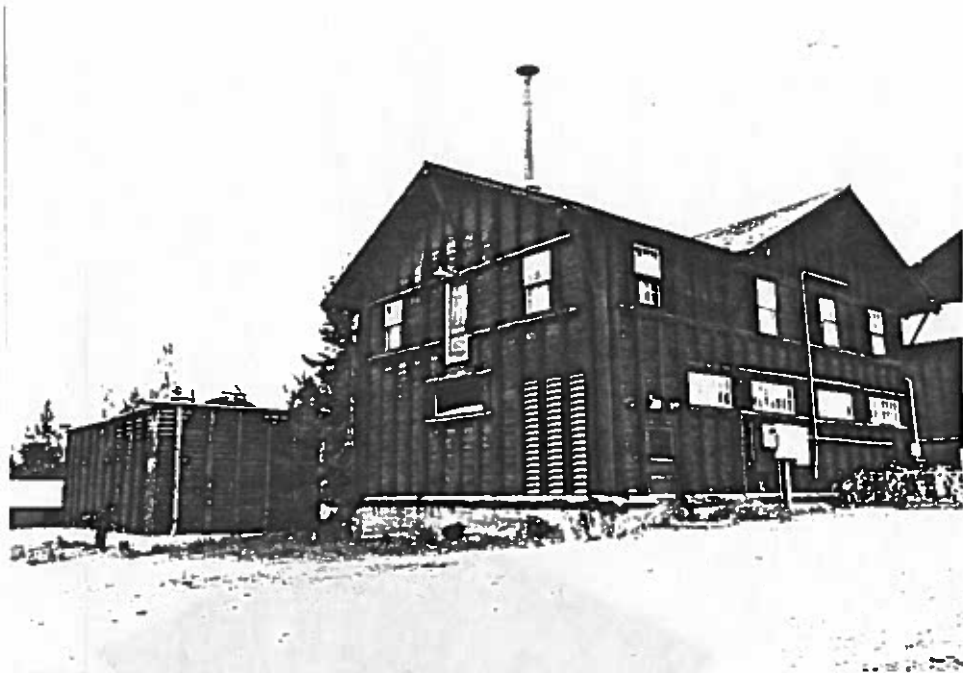
Figure 209: Looking southeast at the Boiler Plant building. Note the concrete base which appears to have some deteriorated surfaces.

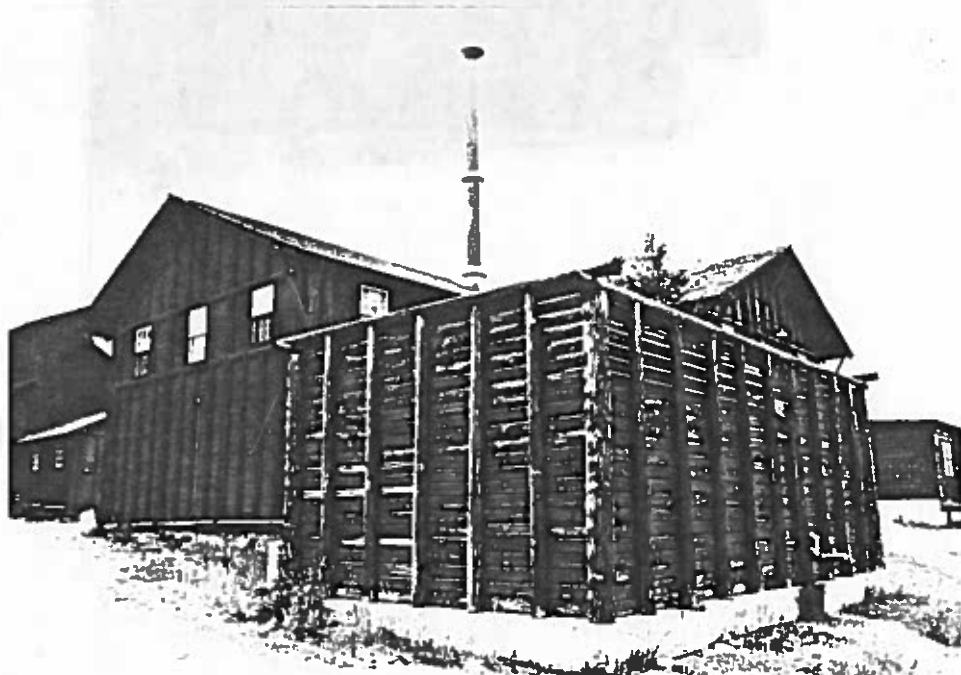
Figure 210: Looking southwest at the fuel tank enclosure at the Boiler Plant building. Note the weathered and deteriorating wood on the structure.
